## 2 Carrington Road

## Asbestos Refurbishment & Demolition Survey Report

Job No:                              EPG - 2358

Survey Date:                      12<sup>th</sup> April 2022

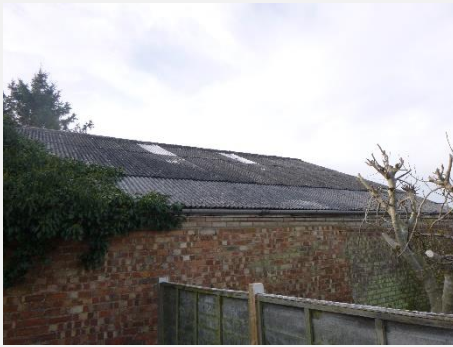
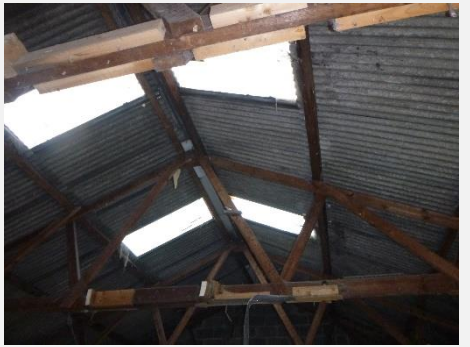
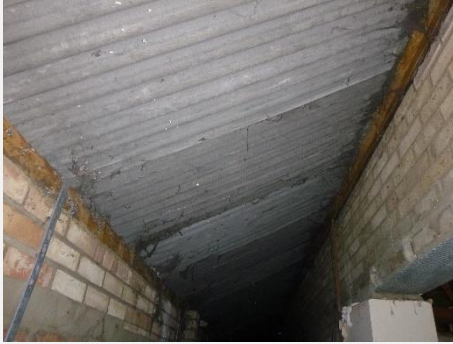
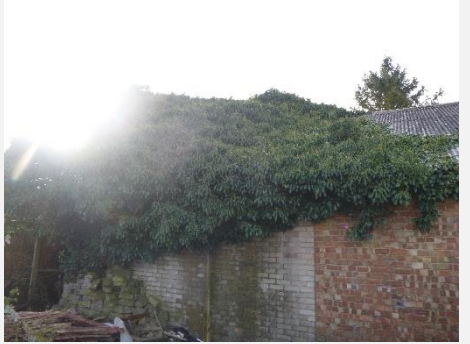
**S 01**

| <b>ASBESTOS DETECTED IN SAMPLE</b> | | | |
| <b>Item/Location:</b> | | Corrugated cement sheet as ceiling/roof | |
| Condition | High damage | 3 | |
| <b>Material Assessment Total</b> | | <b>6</b> | |

Recommendation: **Remove**

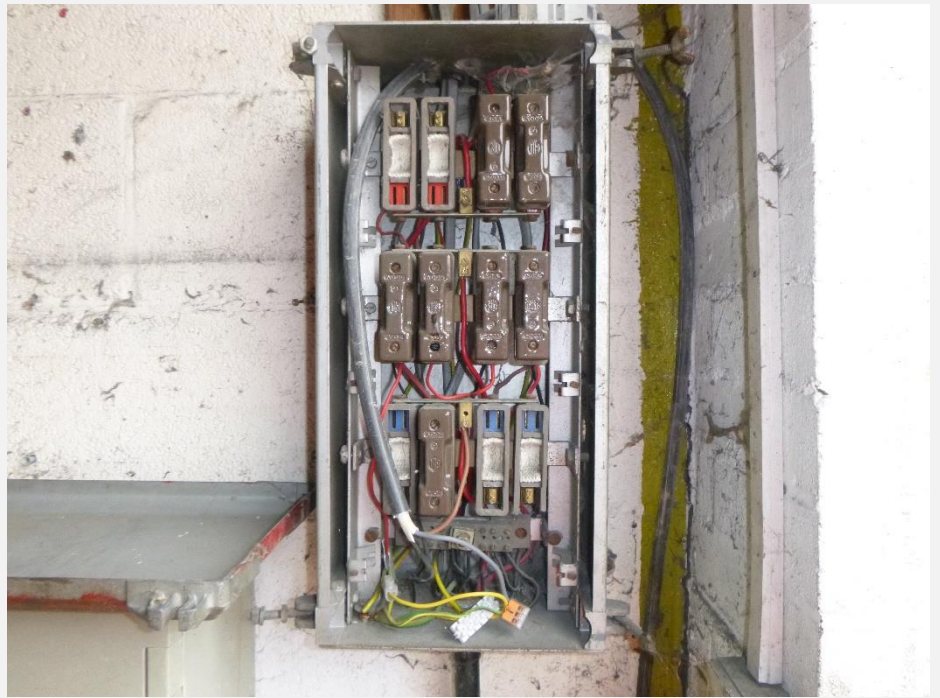
| <b>NO SAMPLE TAKEN</b> | |

Rope to fuse box

| Condition | High damage | 3 |
| <b>Material Assessment Total</b> | | <b>7</b> |

Additional Notes: Presume asbestos to be present until proven otherwise and access with caution.

Recommendation: **Remove**

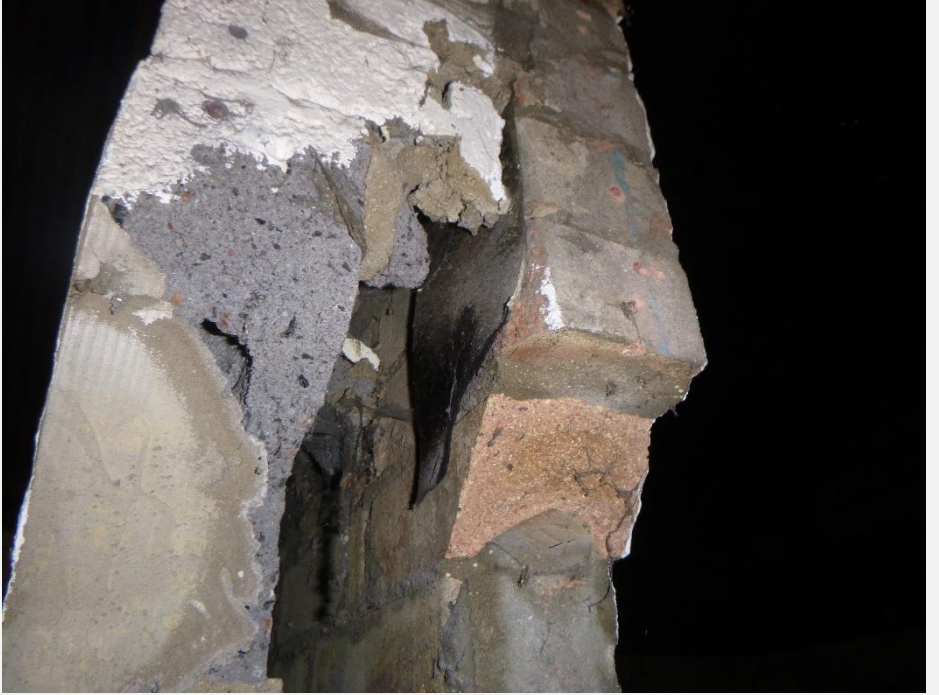
| <b>NO ASBESTOS DETECTED IN SAMPLE</b> | | |
| <b>Item/Location:</b> | Damp proof course to perimeter wall and in cavity around window and door reveal | |

Additional Notes: This damp proof course is also present to Store – G 02 and is strongly presumed as sample taken.

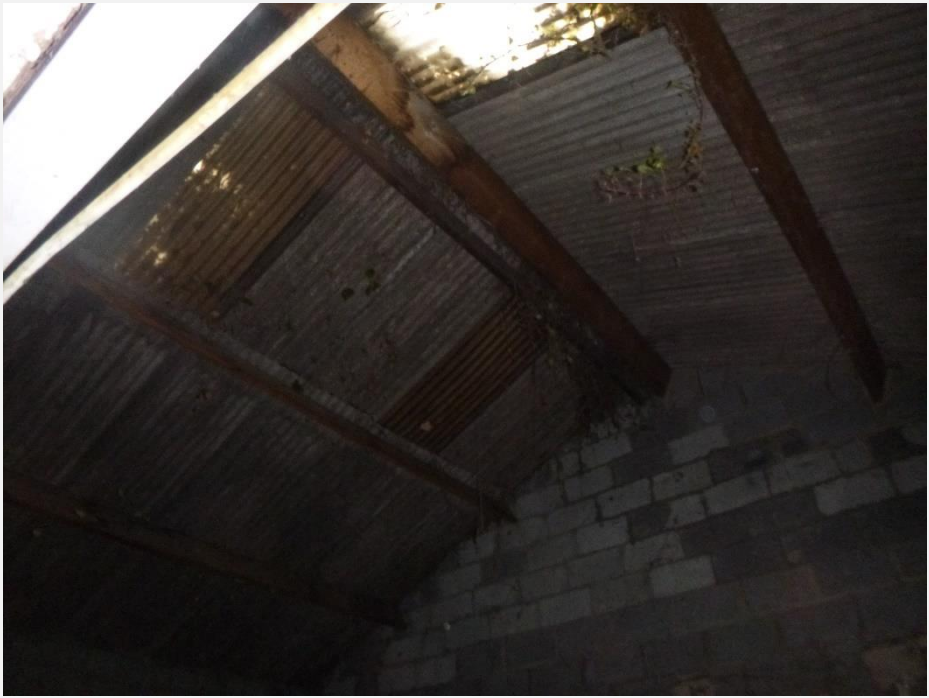
SPST 01

| <b>STRONGLY PRESUMED as SAMPLE TAKEN</b> | | |
| <b>Item/Location:</b> | | Corrugated cement sheet as ceiling/roof |
| Condition | High damage | 3 |
| <b>Material Assessment Total</b> | | <b>6</b> |

Additional Notes: This corrugated cement sheet extends above WC – G 03

Recommendation: **Remove**

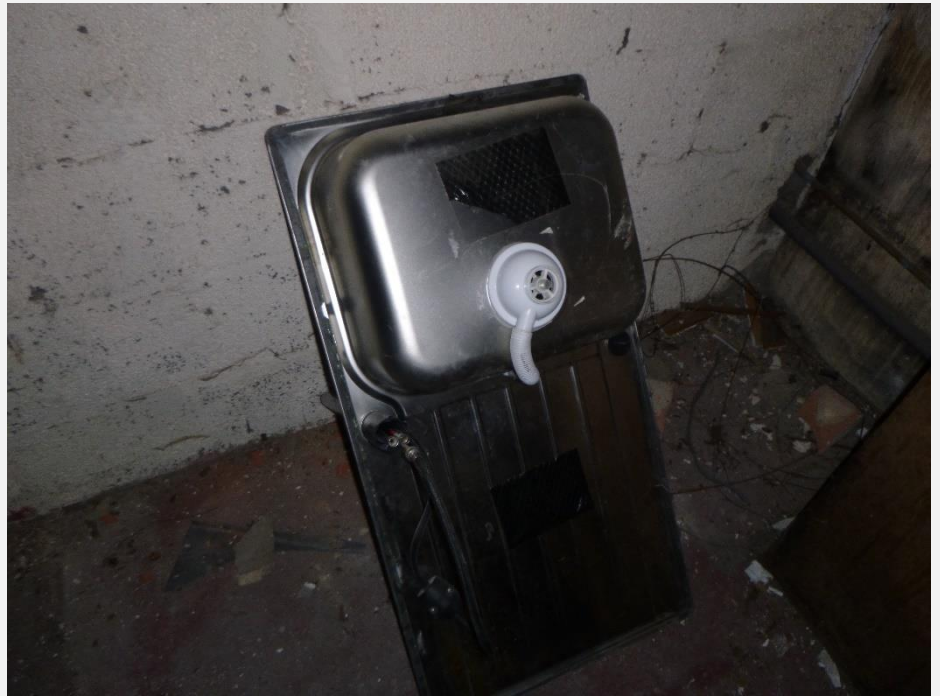
S 03

**NO ASBESTOS DETECTED IN SAMPLE**

Bitumen pad to underside of sink and drainer

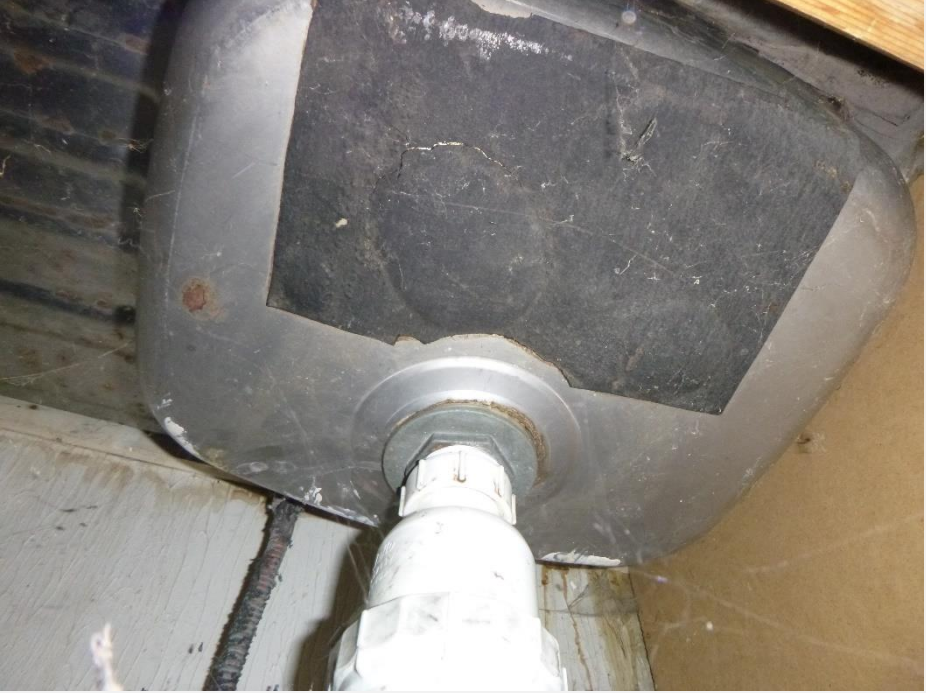
S 04

| <b>NO ASBESTOS DETECTED IN SAMPLE</b> | | |
| <b>Item/Location:</b> | Bitumen pad to underside of sink | |

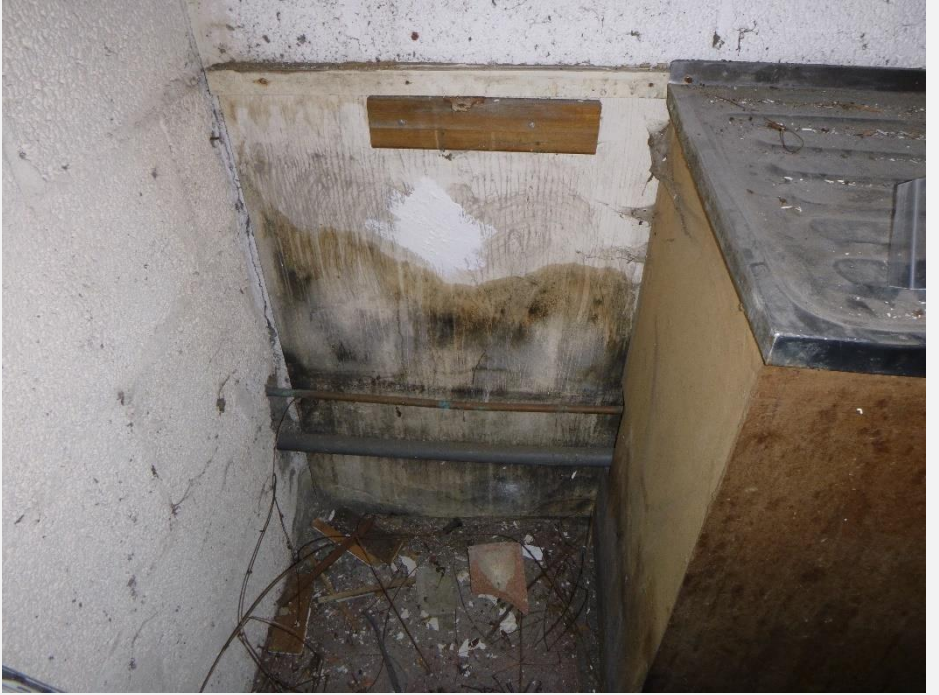
S 05

| <b>NO ASBESTOS DETECTED IN SAMPLE</b> | | |
| <b>Item/Location:</b> | | Textured coating to wall – timber panel |
