Bridge Farm

Holbeach Road, Spalding, PE12 6JP

Asbestos Management Survey Report

Report Type: Asbestos Management Survey

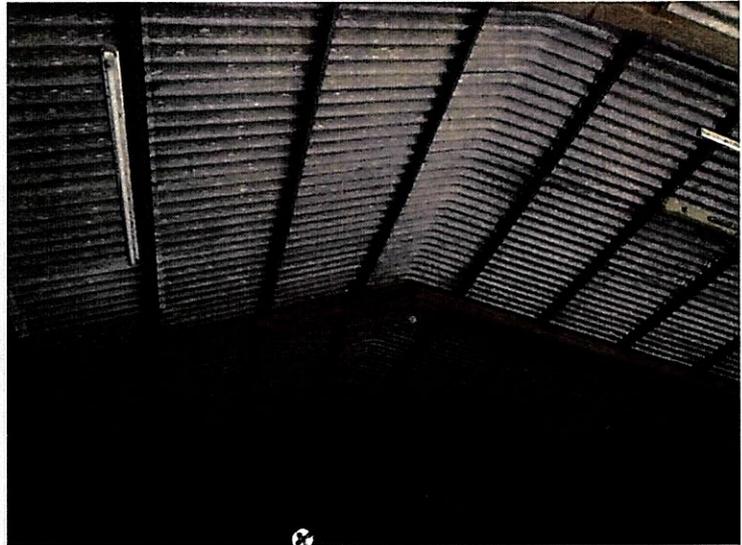
Level of ID Identified
 Bulk Cert No. SCO/24/7667
 Extent 400 Sq. m
 Accessibility Medium

Corrugated cement sheet as ceiling/roof

Product Type	Cement	1
Condition	Low damage	1
Surface Treatment	Cement	1
Asbestos Type	Chrysotile	1
Material Assessment Total		4

Additional Notes: Materials are of low damage internally, externally – extensive moss covering materials.

Recommendation: **Label and Manage**

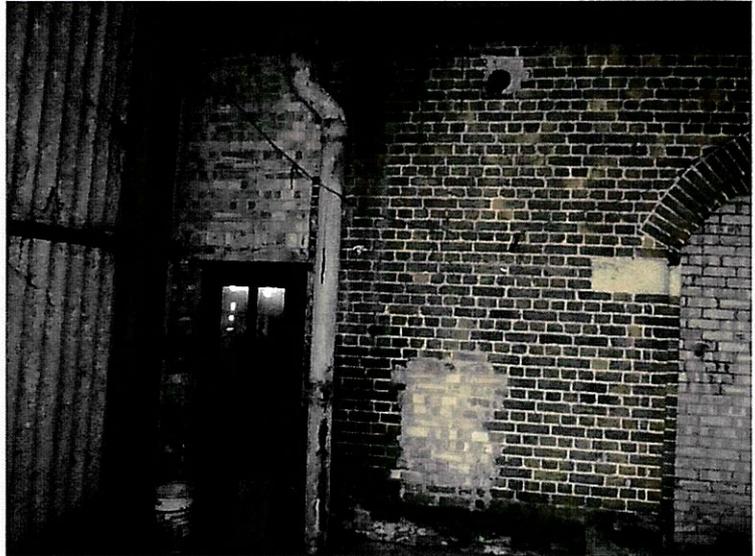
Level of ID Identified
 Bulk Cert No. SCO/24/7667
 Extent 4 Ln. m
 Accessibility Easy

Product Type	Cement	1
Condition	Low damage	1
Surface Treatment	Cement	1
Asbestos Type	Chrysotile	1
Material Assessment Total		4

Recommendation: **Label and Manage**

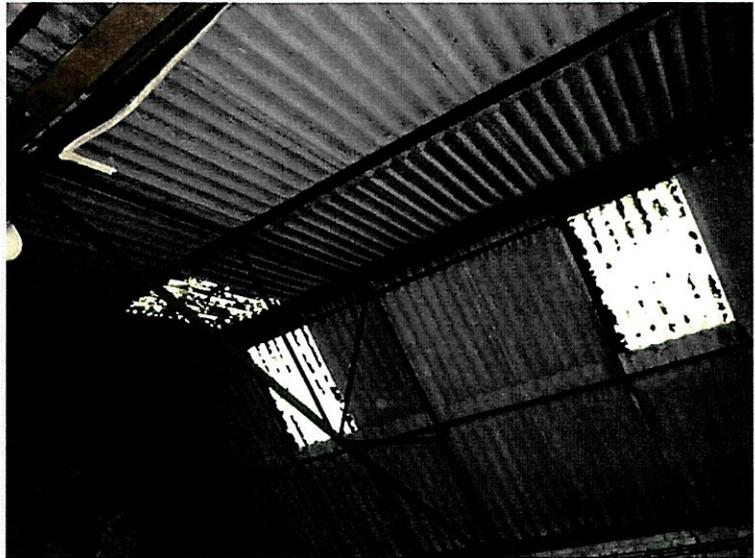
Corrugated cement sheet as ceiling/roof

Product Type	Cement	1
Condition	Low damage	1
Surface Treatment	Cement	1
Asbestos Type	Chrysotile	1
Material Assessment Total		4

Additional Notes: Materials are of low damage internally, externally – extensive moss covering materials.

Recommendation: **Label and Manage**

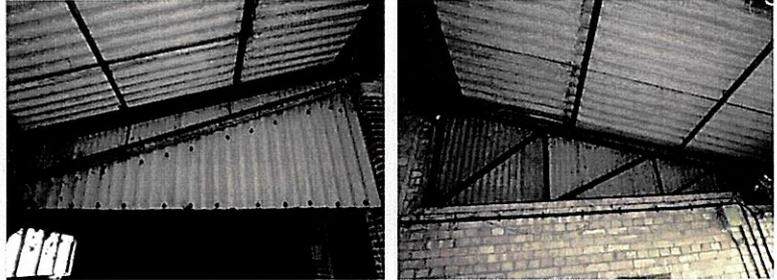
Corrugated cement wall sheets – high level

Product Type	Cement	1
Condition	High damage	3
Surface Treatment	Cement	1
Asbestos Type	Chrysotile	1
Material Assessment Total		6

Recommendation: **Repair, Encapsulate or Enclose**

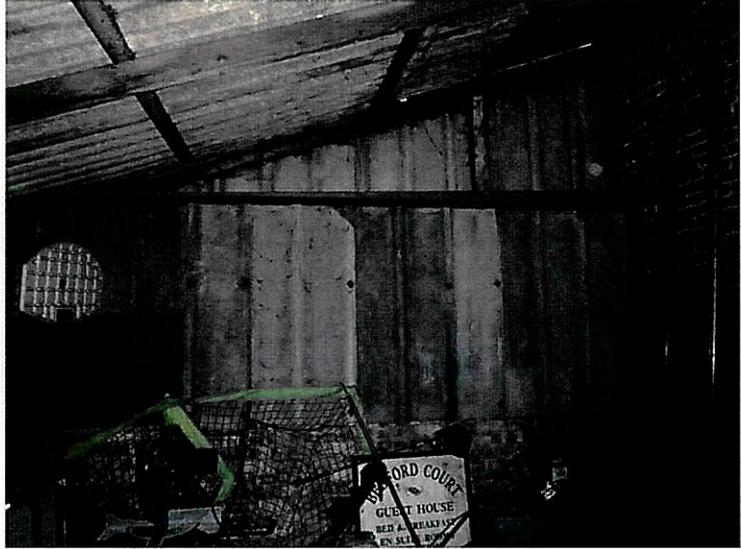
Corrugated cement gable wall sheets

Product Type	Cement	1
Condition	Low damage	1
Surface Treatment	Cement	1
Asbestos Type	Chrysotile	1
Material Assessment Total		4

Recommendation: **Label and Manage**

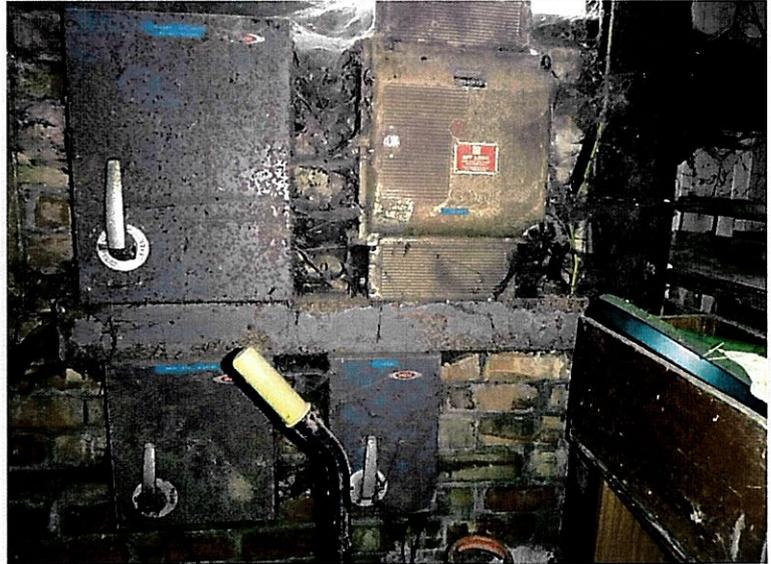
Level of ID: Presumed
 Bulk Cert No.: -
 Extent: 4 Items
 Accessibility: Hard

Product Type	Textile	2
Condition	Low damage	1
Surface Treatment	Enclosed	1
Asbestos Type	Chrysotile	1
Material Assessment Total		5

Recommendation: **Label and Manage**

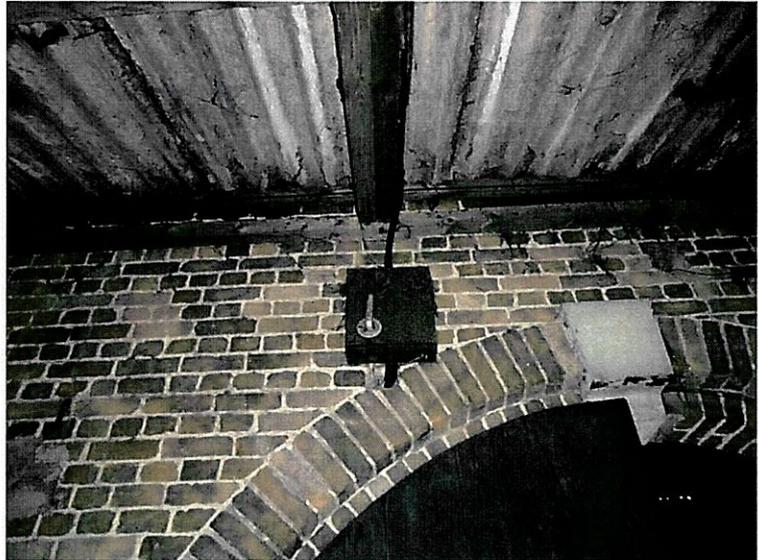
Electrics to wall

Product Type	Textile	2
Condition	Low damage	1
Surface Treatment	Enclosed	1
Asbestos Type	Chrysotile	1
Material Assessment Total		5

Recommendation: **Label and Manage**

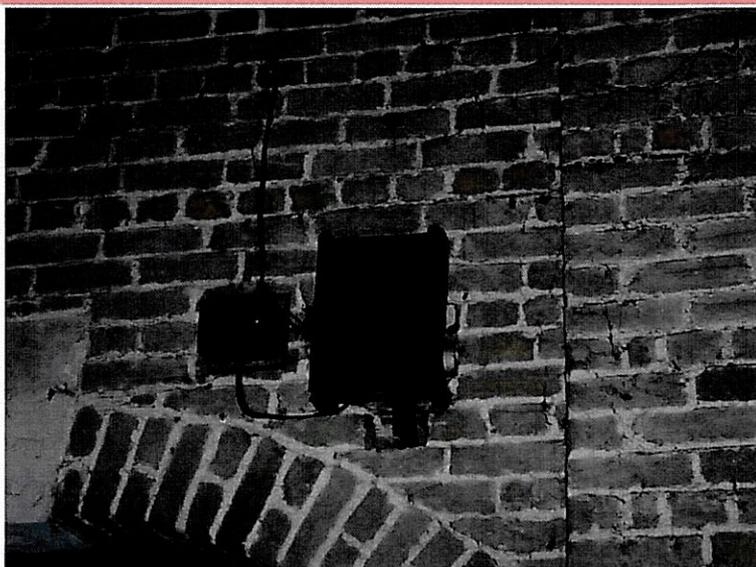
Electrics to wall

Product Type	Textile	2
Condition	Low damage	1
Surface Treatment	Enclosed	1
Asbestos Type	Chrysotile	1
Material Assessment Total		5

Recommendation: **Label and Manage**

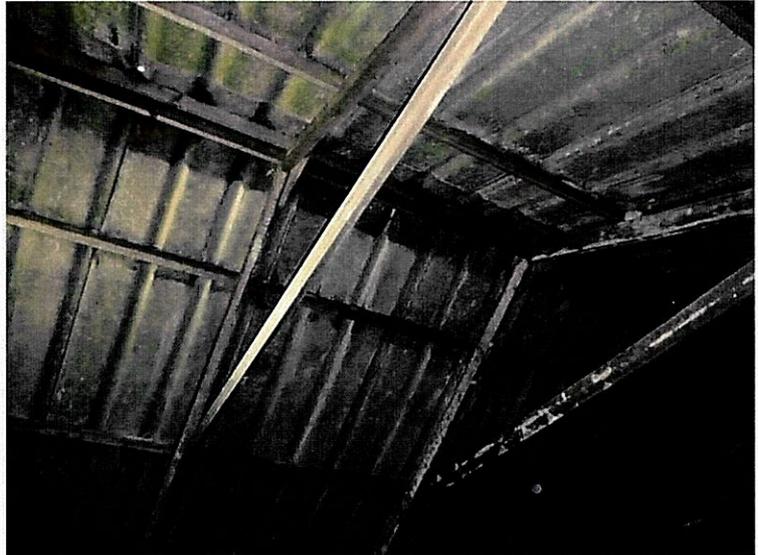
Corrugated cement sheet as ceiling/roof

Product Type	Cement	1
Condition	High damage	3
Surface Treatment	Cement	1
Asbestos Type	Chrysotile	1
Material Assessment Total		6

Additional Notes: Materials are generally of low damage with areas of high damage internally. Externally – extensive moss covering materials.

Recommendation: **Repair, Encapsulate or Enclose**

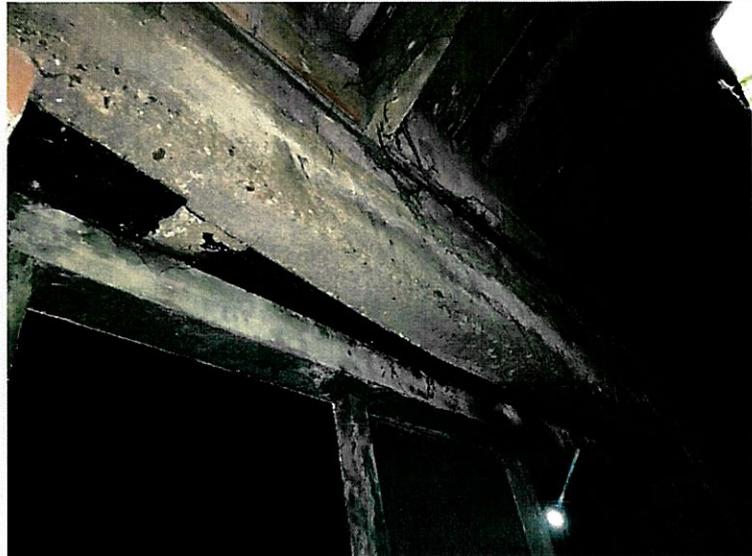
S 08

Damp proof course to window reveals

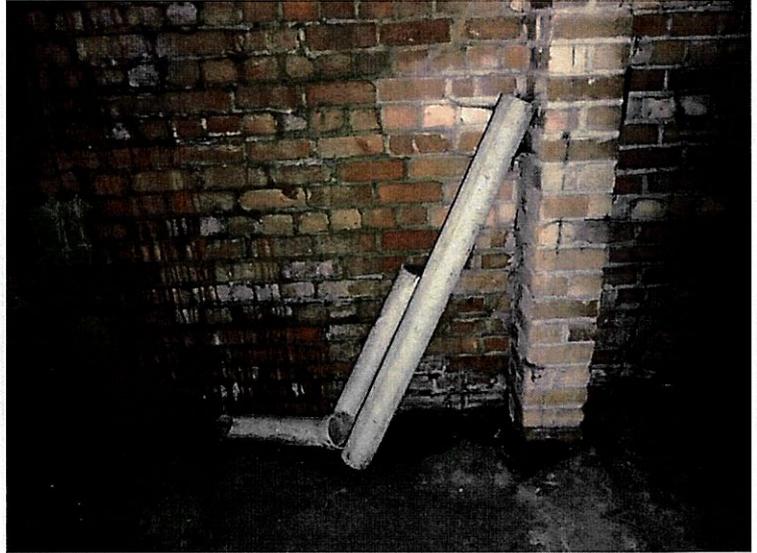
Cement debris to floor

Product Type	Debris	3
Condition	High damage	3
Surface Treatment	Debris	3
Asbestos Type	Chrysotile	1
Material Assessment Total		10

Recommendation: **Remove**

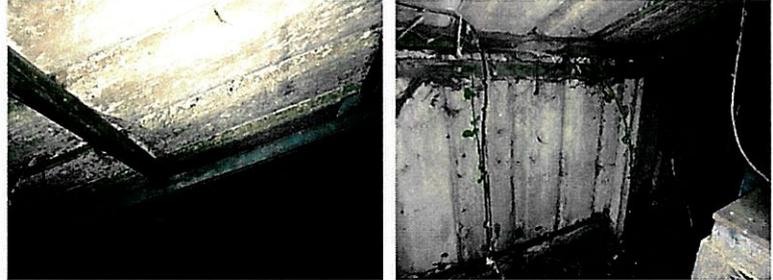
Corrugated cement sheet as ceiling/roof and gable walls

Product Type	Cement	1
Condition	High damage	3
Surface Treatment	Cement	1
Asbestos Type	Chrysotile	1
Material Assessment Total		6

Additional Notes: Materials are generally of low damage with areas of high damage internally. Externally – extensive moss covering materials.

Recommendation: **Repair, Encapsulate or Enclose**

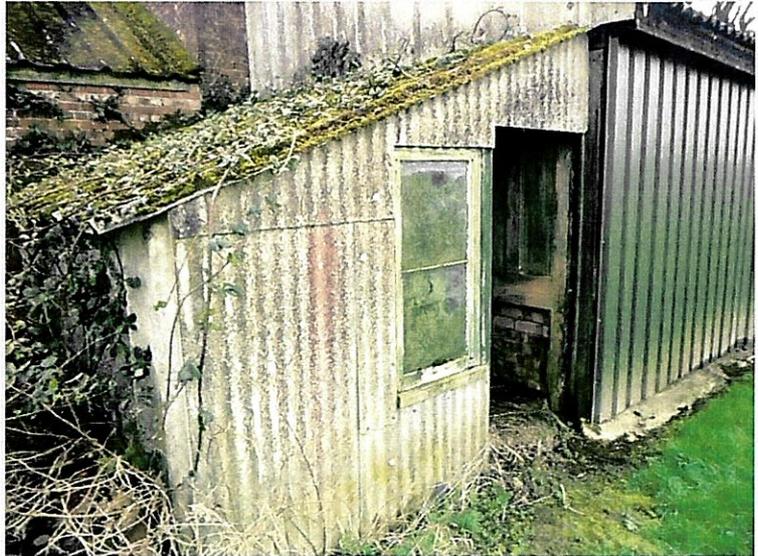
Corrugated cement wall sheets

Product Type	Cement	1
Condition	Low damage	1
Surface Treatment	Cement	1
Asbestos Type	Chrysotile	1
Material Assessment Total		4

Recommendation: **Label and Manage**

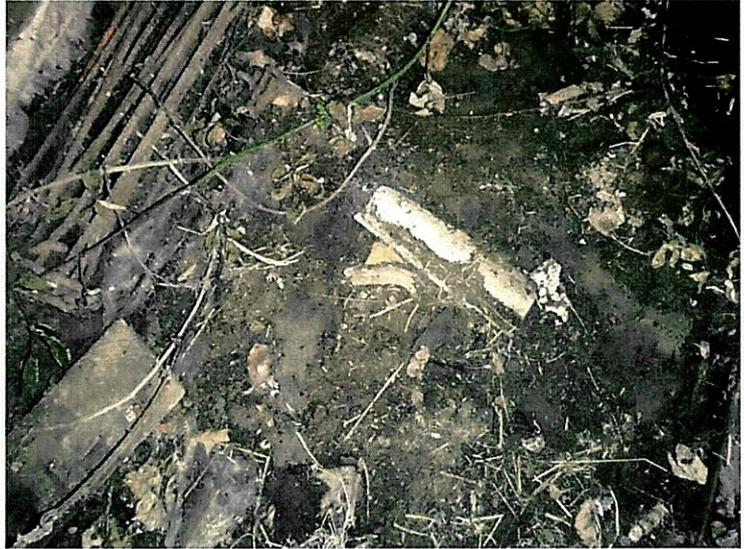
Cement debris to floor

Product Type	Debris	3
Condition	High damage	3
Surface Treatment	Debris	3
Asbestos Type	Chrysotile	1
Material Assessment Total		10

Recommendation: **Remove**

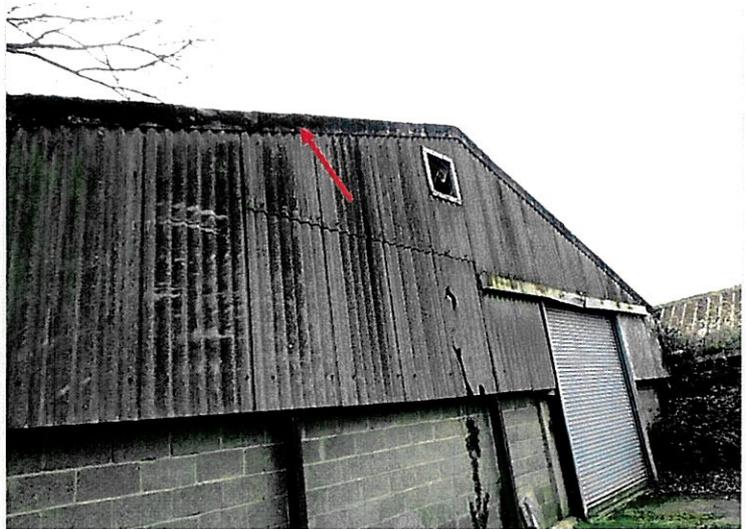
Cement edge capping

Product Type	Cement	1
Condition	Low damage	1
Surface Treatment	Cement	1
Asbestos Type	Chrysotile	1
Material Assessment Total		4

Recommendation: **Label and Manage**

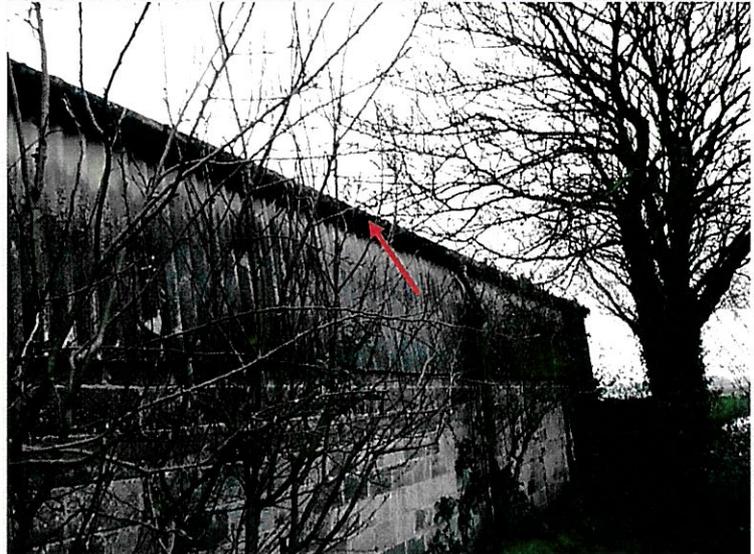
Cement guttering

Product Type	Cement	1
Condition	High damage	3
Surface Treatment	Cement	1
Asbestos Type	Chrysotile	1
Material Assessment Total		6

Recommendation: **Remove**

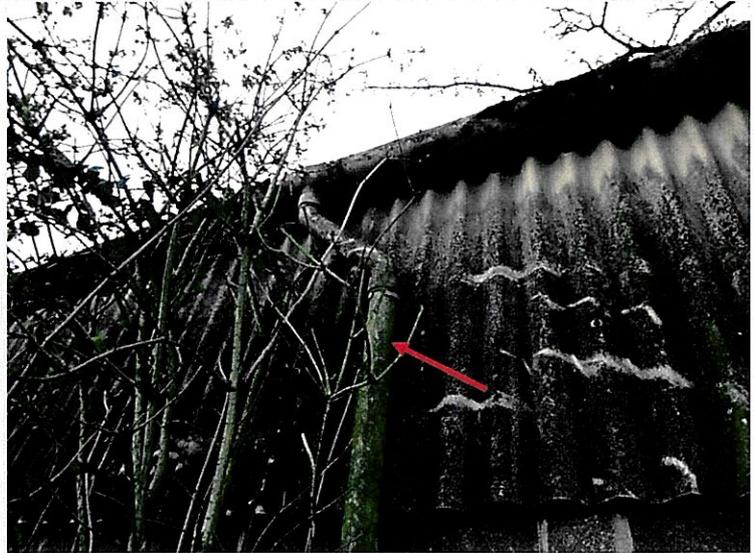
Cement downpipe

Product Type	Cement	1
Condition	High damage	3
Surface Treatment	Cement	1
Asbestos Type	Chrysotile	1
Material Assessment Total		6

Recommendation: **Remove**

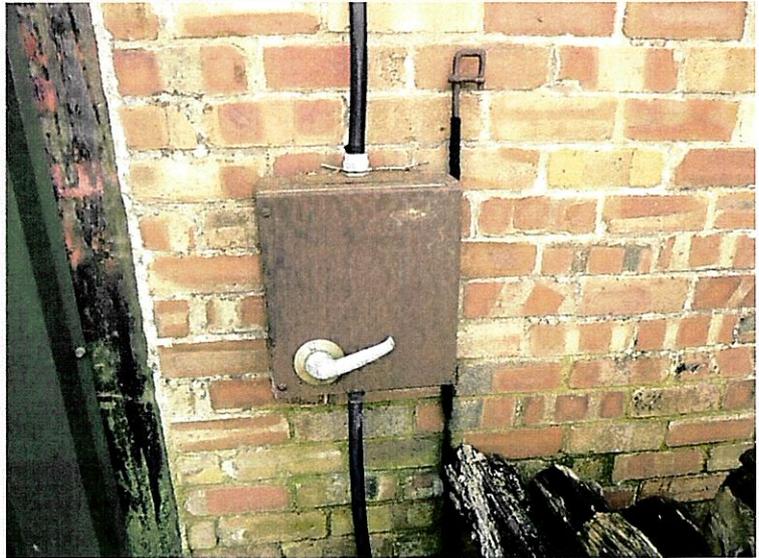
Level of ID: Presumed
 Bulk Cert No.: -
 Extent: 1 Item
 Accessibility: Hard

Product Type	Textile	2
Condition	Low damage	1
Surface Treatment	Enclosed	1
Asbestos Type	Chrysotile	1
Material Assessment Total		5

Recommendation: **Label and Manage**

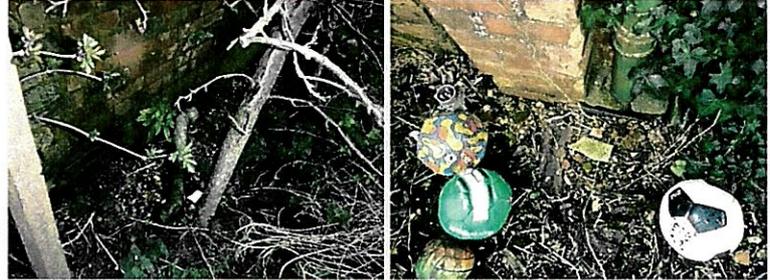
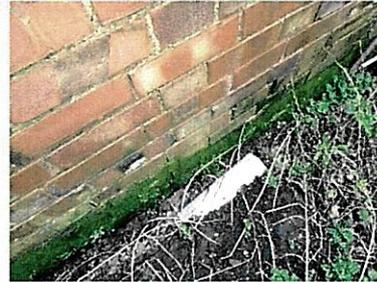
Various cement debris to floor

Product Type	Debris	3
Condition	High damage	3
Surface Treatment	Debris	3
Asbestos Type	Chrysotile	1
Material Assessment Total		10

Recommendation: **Remove**

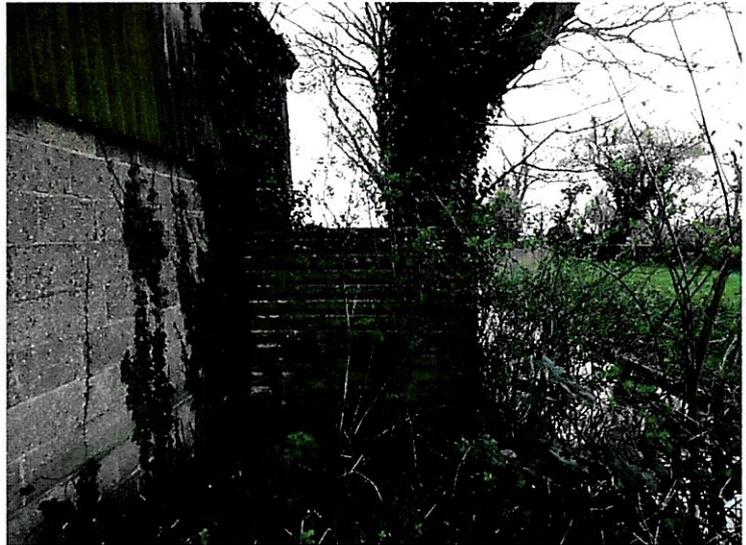
Corrugated cement sheet as wall

Product Type	Cement	1
Condition	High damage	3
Surface Treatment	Cement	1
Asbestos Type	Chrysotile	1
Material Assessment Total		6

Recommendation: **Remove**
