Contract  
**WEB/10A GREEN LANE  
FOOTBRIDGE  
92m 1144yds (52ch)**

Title  
**DEFECTS AND  
PROPOSED REPAIRS**

| Drawing No.<br>CC0946-AMD-01-XX-DR-C-0003 | Issue<br>P02 |

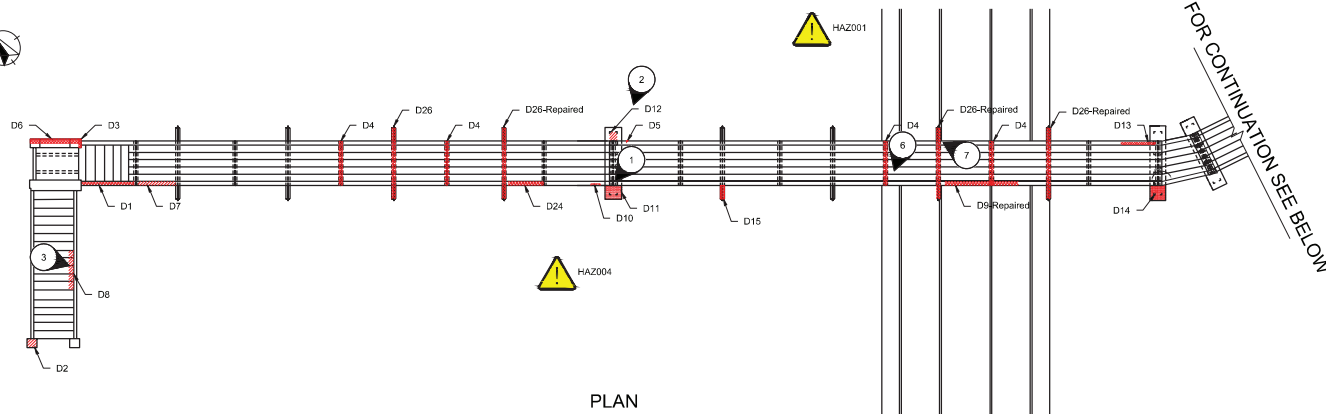
PLAN  
Scale 1:100

| DEFECTS AND REPAIR SCHEDULE | | |
|---|---|---|
| D1 | Staircase support angles corrosion 6-12mm deep, approx 0.5m <sup>2</sup> total | Angles to be replaced when the stair tread is replaced. Refer to drawing CC0946-AMD-01-XX-DR-C-0005 for details |
| D2 | End post LOS | Break out ground, overplate angle. Refer to drawing CC0946-AMD-01-XX-DR-C-0005 for details |
| D3 | Staircase supports corrosion 1-5mm & LOS to diagonal bracing | Replacement of lattice bracing |
| D4 | Under Slung T braces corrosion 4-6mm; Top flanges corrosion 1-3mm | Strengthening underslung T-brace or replacement by new element. Refer to drawing CC0946-AMD-01-XX-DR-C-0005 for details |
| D5 | Section of MG TF cut out 50x30mm | Do nothing. Subject to assessment result of this element. |
| D6 | Pier legs and diagonal bracing corrosion 1-5mm | Replacement of defective lattice bracing |
| D7 | LOS to MG BF approx 500x30mm | To be inspected following mechanical preparation to determine LOS thickness. Likely do nothing. |
| D8 | Staircase stringers corrosion 3-6mm deep. Loss to edges of steps | To be inspected following mechanical preparation to determine LOS thickness. Likely do nothing for surface LOS. Replacement of decks for severe LOS during the replacement of the stair treads. Refer to drawings CC0946-AMD-01-XX-DR-C-0005 & 0006 for details |
| D9 | MG BF corrosion 1-5mm. Joint plates LOS 5-15mm and corrosion 4-8mm. | To be inspected following mechanical preparation. If the LOS is severe, it is proposed to strengthen with an overplate fixed with TCBs. Refer to drawing CC0946-AMD-01-XX-DR-C-0005 for details |
| D10 | Lattice bracing LOS 15x20mm | No repair proposed |
| D11 | Ivy growing up high mileage end pier | Clear vegetation |
| D12 | To pier legs, isolated lattices LOS 30x40mm. Internal bracing corrosion 1-5mm With LOS 100x20mm | Replacement of defective lattice bracing. |
| D13 | Corrosion to support plates 3-6mm | To be inspected further. Information is not clear from the Detailed Examination. |
| D14 | Vegetation growing up to and all around pier | Clear vegetation |
| D15 | T bracing corrosion 1-3mm to all bolts | No repair proposed |
| D16 | Staircase MG LOS 200x30mm with surrounding 200x400mm area corrosion 3-5mm | Overlapping stair stringer subject to inspection of LOS thickness. |
| D17 | Vegetation growing up around staircase | Clear vegetation |
| D18 | Staircase MG 2 No. missing bolts/nuts | Reinstall new bolts |
| D19 | Lattice bracing isolated LOS 30x20mm | Replacement of defective lattice bracing |
| D20 | MG BF LOS 2mx10mm | To be inspected following mechanical preparation. If the LOS is severe, overplating bottom flange of main girder. If it is surface LOS, do nothing. |
| D21 | 2No. Aress MG BF LOS 900x10mm with repair plates fitted | To be inspected following mechanical preparation. If the LOS is severe, it is proposed to replace the T-brace. If it is surface LOS, do nothing. |
| D22 | Staircase MG LOS 5-15mm on bottom edge | Overlapping stair stringer subject to inspection of LOS thickness (similar to D16) |
| D23 | Plate below cleat treads corrosion 3-6mm | To be inspected further. All cleats might be replaced subject to condition. |
| D24 | 1-6mm LOS & pitting to underside of bottom flange | To be inspected following mechanical preparation. If the LOS is severe, it is proposed to strengthen with an overplate fixed with TCBs. |
| D25 | LOS to bottom flange of MG. Approx. 30-50mm x 1m length full loss of section along internal flange | Defect to be repaired with overplate. Refer to drawing CC0946-AMD-01-XX-DR-C-0005 for details. |
| D26 | Under Slung Outrigger braces corrosion 4-6mm. Top flange corrosion 1-3mm | Strengthening underslung outrigger brace or replacement by new element |
