BS5837 Tree Survey  
Land to the east of Coalbeach Lane  
Surfleet  
Lincolnshire  
NGR TF262 289

Survey by  
Christopher Barker CEnv dipHort ACIEEM

# **BS5837 Tree Survey, Land at Coalbeach Lane, Surfleet**

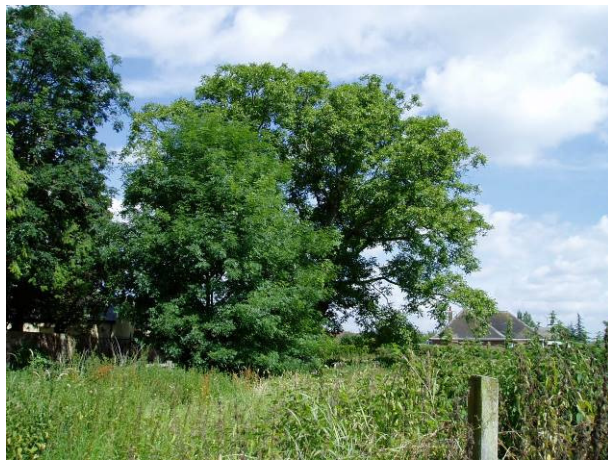
Walnut T1 on Coalbeach Lane (TPO)

Walnut T1 is protected under TPO 017/10/1996. This is a veteran tree with a single trunk dividing into four trunks at 3m supporting a very large broad headed open balanced canopy. It has no obvious structural faults evident from ground level. This tree is of very high visual amenity value positioned along Coalbeach Lane in a highly visible position. The retention and protection of this tree within any development proposals should be a priority.

| Tree | Category | Recommendation |
|---|---|---|
| Walnut T1 | A1 | RPA and canopy can be contained within a garden area and protected by fencing during any construction work. The canopy will not over shadow any proposed house. |

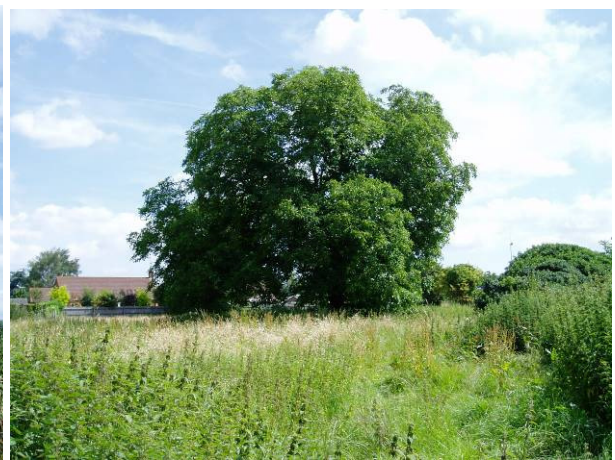
Walnut T3 within site (TPO)

Walnut T3 is also protected under TPO 017/10/1996. This is another veteran tree with a single trunk dividing into a coarsely branching large open canopy. It has no obvious structural faults evident from ground level. This tree is of very high visual amenity value positioned near the south boundary of the site area in full view of nearby houses. The retention and protection of this tree within any development proposals should be a priority.

| Tree | Category | Recommendation |
|---|---|---|
| Walnut T3 | A1 | RPA and canopy can be contained within a garden area and protected by fencing during any construction work. The canopy will not over shadow any proposed house but will have greatest impact on the proposed garage. |

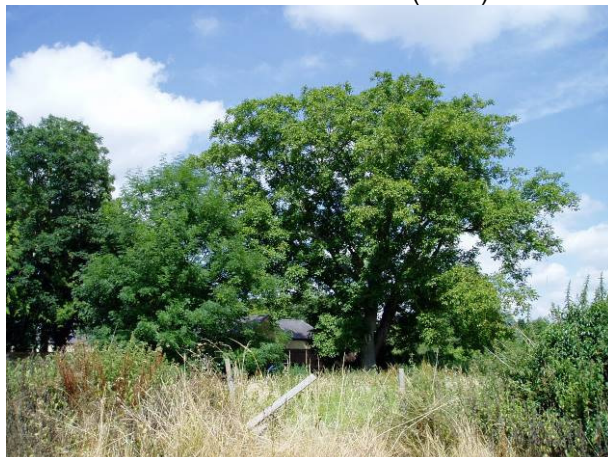
Walnut T1 and Ash T2 Coalbeach Lane

Ash T2 is a smaller tree with a single trunk positioned adjacent to the boundary close to T1. It has an openly ascending canopy but is not of high visual amenity value positioned within the boundary hedgerow. It is protected within scope of the RPA of T1 and can be retained. As it matures it may begin to crowd T1 but it will make an ideal replacement in the long term.

| Tree | Category | Recommendation |
|---|---|---|
| Ash T2 | C1 | Small tree close to T1. No impact on the RPA or canopy of this tree will result from the proposed development. |

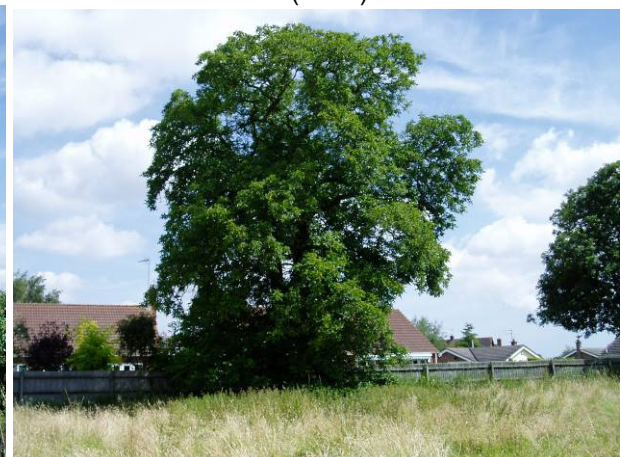
Walnut T4 on north boundary

Walnut T4 is not protected under TPO 017/10/1996. This is a veteran tree with a single trunk dividing into two leaders supporting a broad headed open balanced canopy. There is minor ivy growth on the trunk which should be removed and some minor regeneration at the base that should also be trimmed. This tree is of high visual amenity value positioned on the north boundary in a position highly visible from nearby houses. Part of the RPA of this tree will fall under a proposed access drive and ground protection measures will be required. The round protection measures are specified in section 4.3. The RPA and canopy extremities will need to be protected by fencing during any construction work.

| Tree | Category | Recommendation |
|---|---|---|
| Walnut T4 | A1 | The majority of the RPA and all of the canopy can be contained within a garden area and protected by fencing during any construction work. The southern section (approximately 15%) will be under the proposed driveway to one property. A 'no-dig' construction method utilising ground protection geotextile will be require to construct this driveway. The canopy will not over shadow any proposed house. |

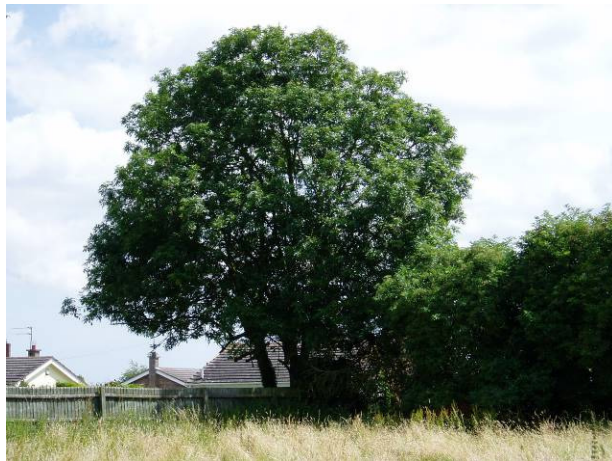
Ash T5 near north east corner

Ash T5 is a large tree with two main trunks positioned within the adjacent garden. This is of high visual amenity value. Whilst the canopy extends over the site boundary it does so at sufficient height to pose no constraint to any development. The RPA is contained within the adjacent garden.

| Tree | Category | Recommendation |
|---|---|---|
| Ash T5 | B1 | There will be no impact on the RPA or canopy of this tree and it will not over shadow any of the proposed houses. |

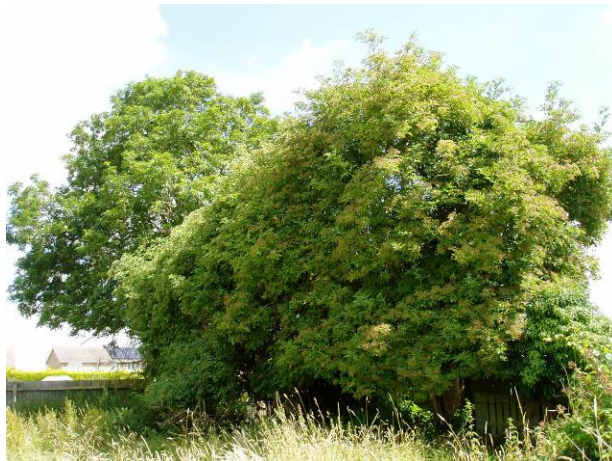
Hedgerow on east boundary

Hedgerow not impact, Trimming recommended

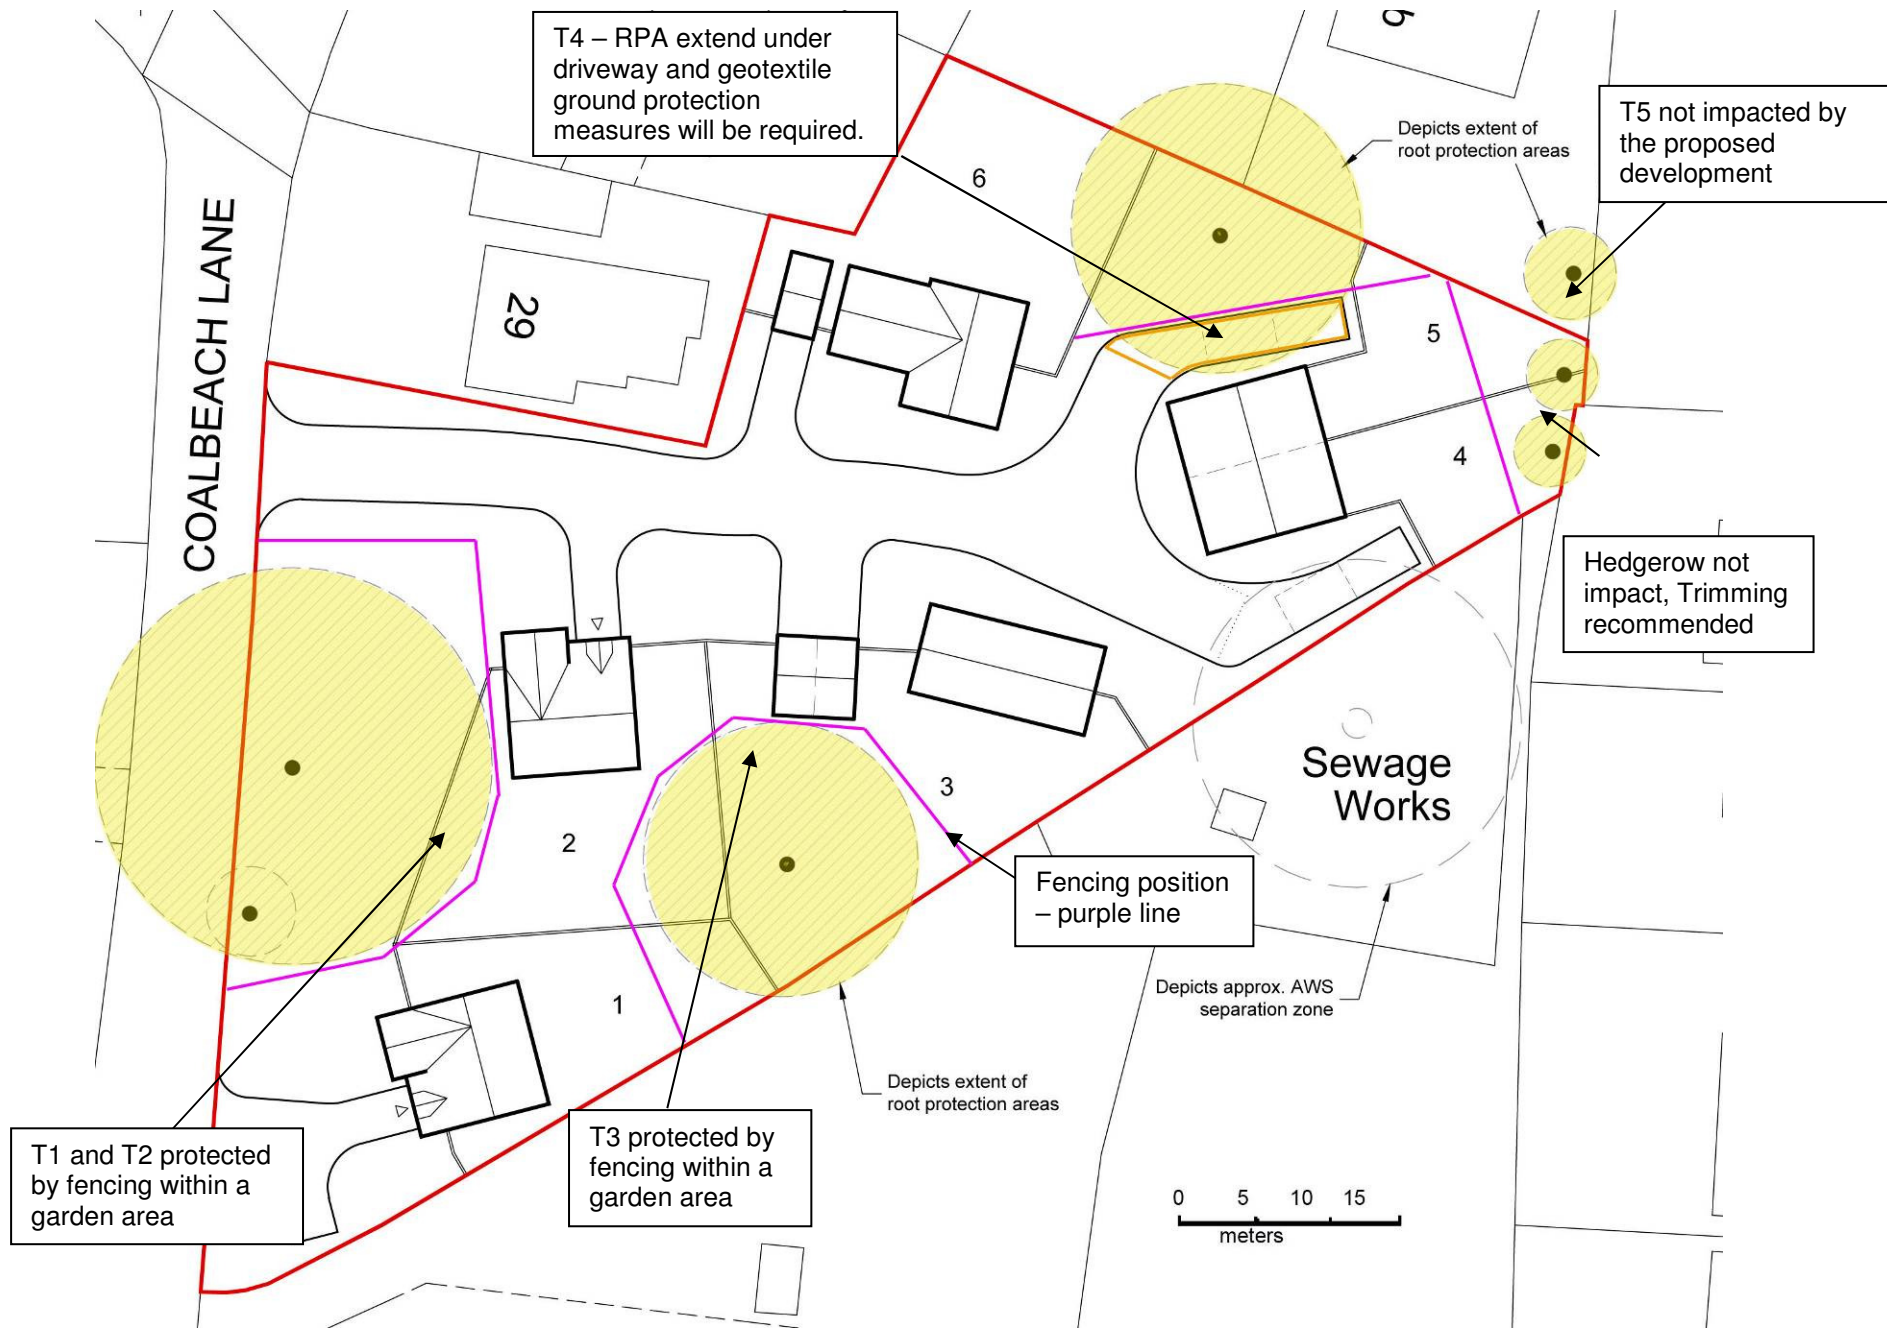
T4 – RPA extend under driveway and geotextile ground protection measures will be required.

T5 not impacted by the proposed development

T1 and T2 protected by fencing within a garden area

T3 protected by fencing within a garden area
