**REPORT:** REMEDIAL METHOD STATEMENT FOR LAND  
TO NORTH OF STATION ROAD, SURFLEET

**CLIENT:** M. FODEN, T. LAUD AND J. BAILEY-SCOTT

Project No: E23109  
Ref No: E23109/3/0

# REMEDIAL METHOD STATEMENT: LAND TO NORTH OF STATION ROAD, SURFLEET

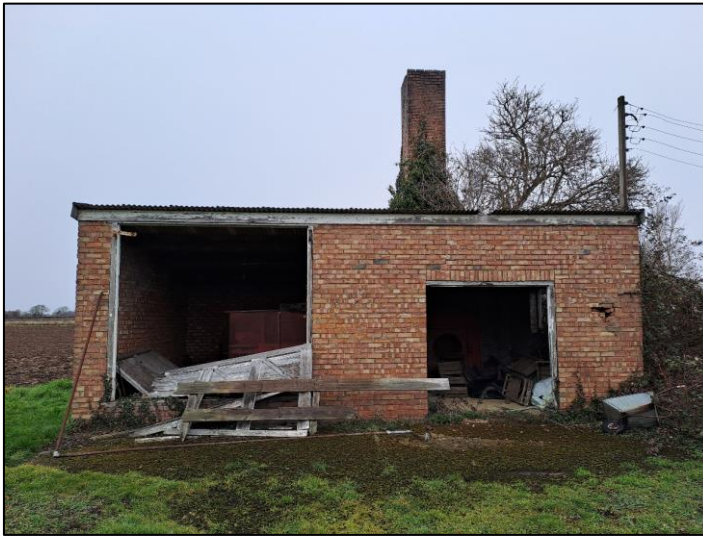
- The southernmost building was not accessible at the time of our investigation but appeared to have been used for general storage. The buildings to the north of this structure appear to be dilapidated former barns, and the remaining building to the north-west supports a large disused 'gas oil' tank and bulb drying equipment;

Photo 1 - Photo of 'Bulb Drier' and Tank Building

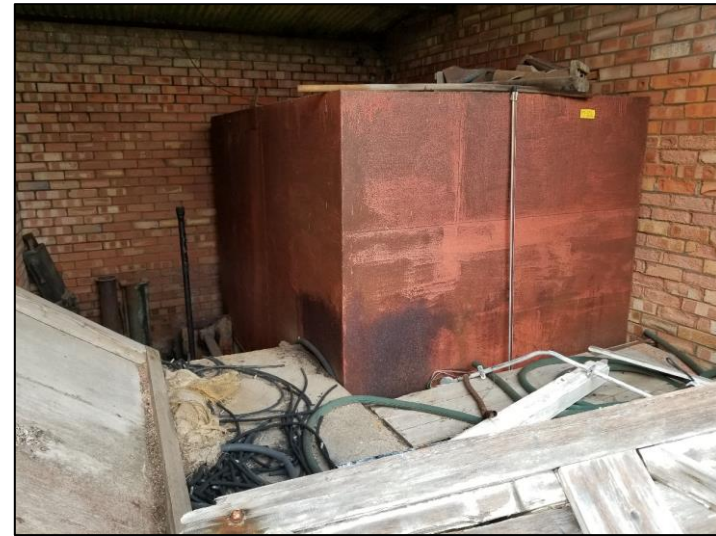
- No evidence of spillages etc. was noted in the area of the tank although slight hydrocarbon odours were noted locally within the building;
- A full inspection of the buildings was not undertaken due to their dilapidated nature;

Photo 2 - Above Ground 'Gas Oil' Tank

- **IMPORTANT:** Fuel storage containers may contain hazardous substances including vapours. The decommissioning, dismantling and removal of all such containers (including the tank) must be undertaken by a suitably licensed / experienced contractor in accordance with all guidelines / regulations and should include works such as cold-cutting, degassing etc. as necessary.

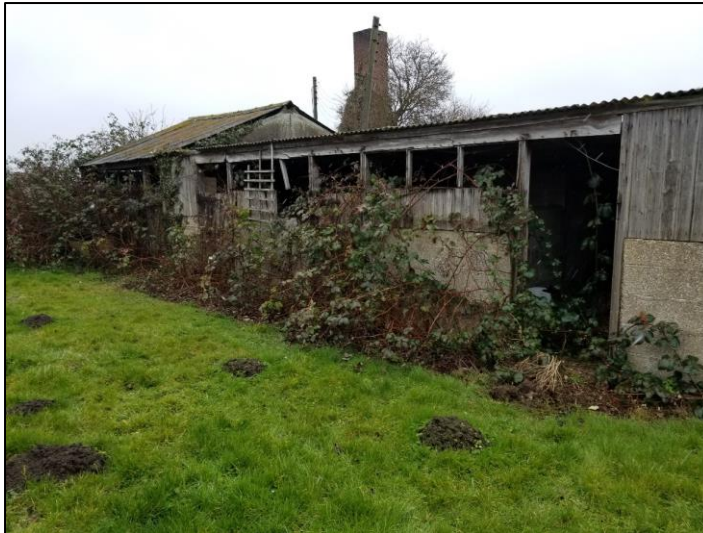
- The 3 No. disused former agricultural structures are of variable construction but mainly comprise single-storey brick buildings. Some suspected asbestos containing building materials were noted as part of these structures;

Photo 3 - Barns / Animal Shelters

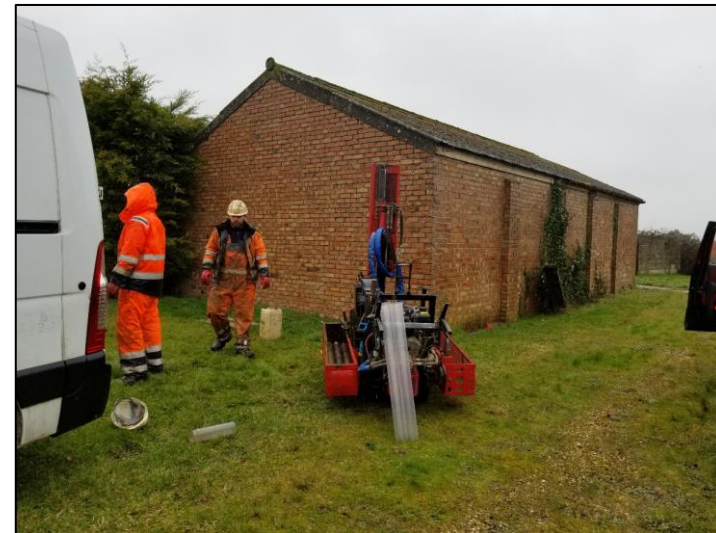
Photo 4 - Southern Storage Building

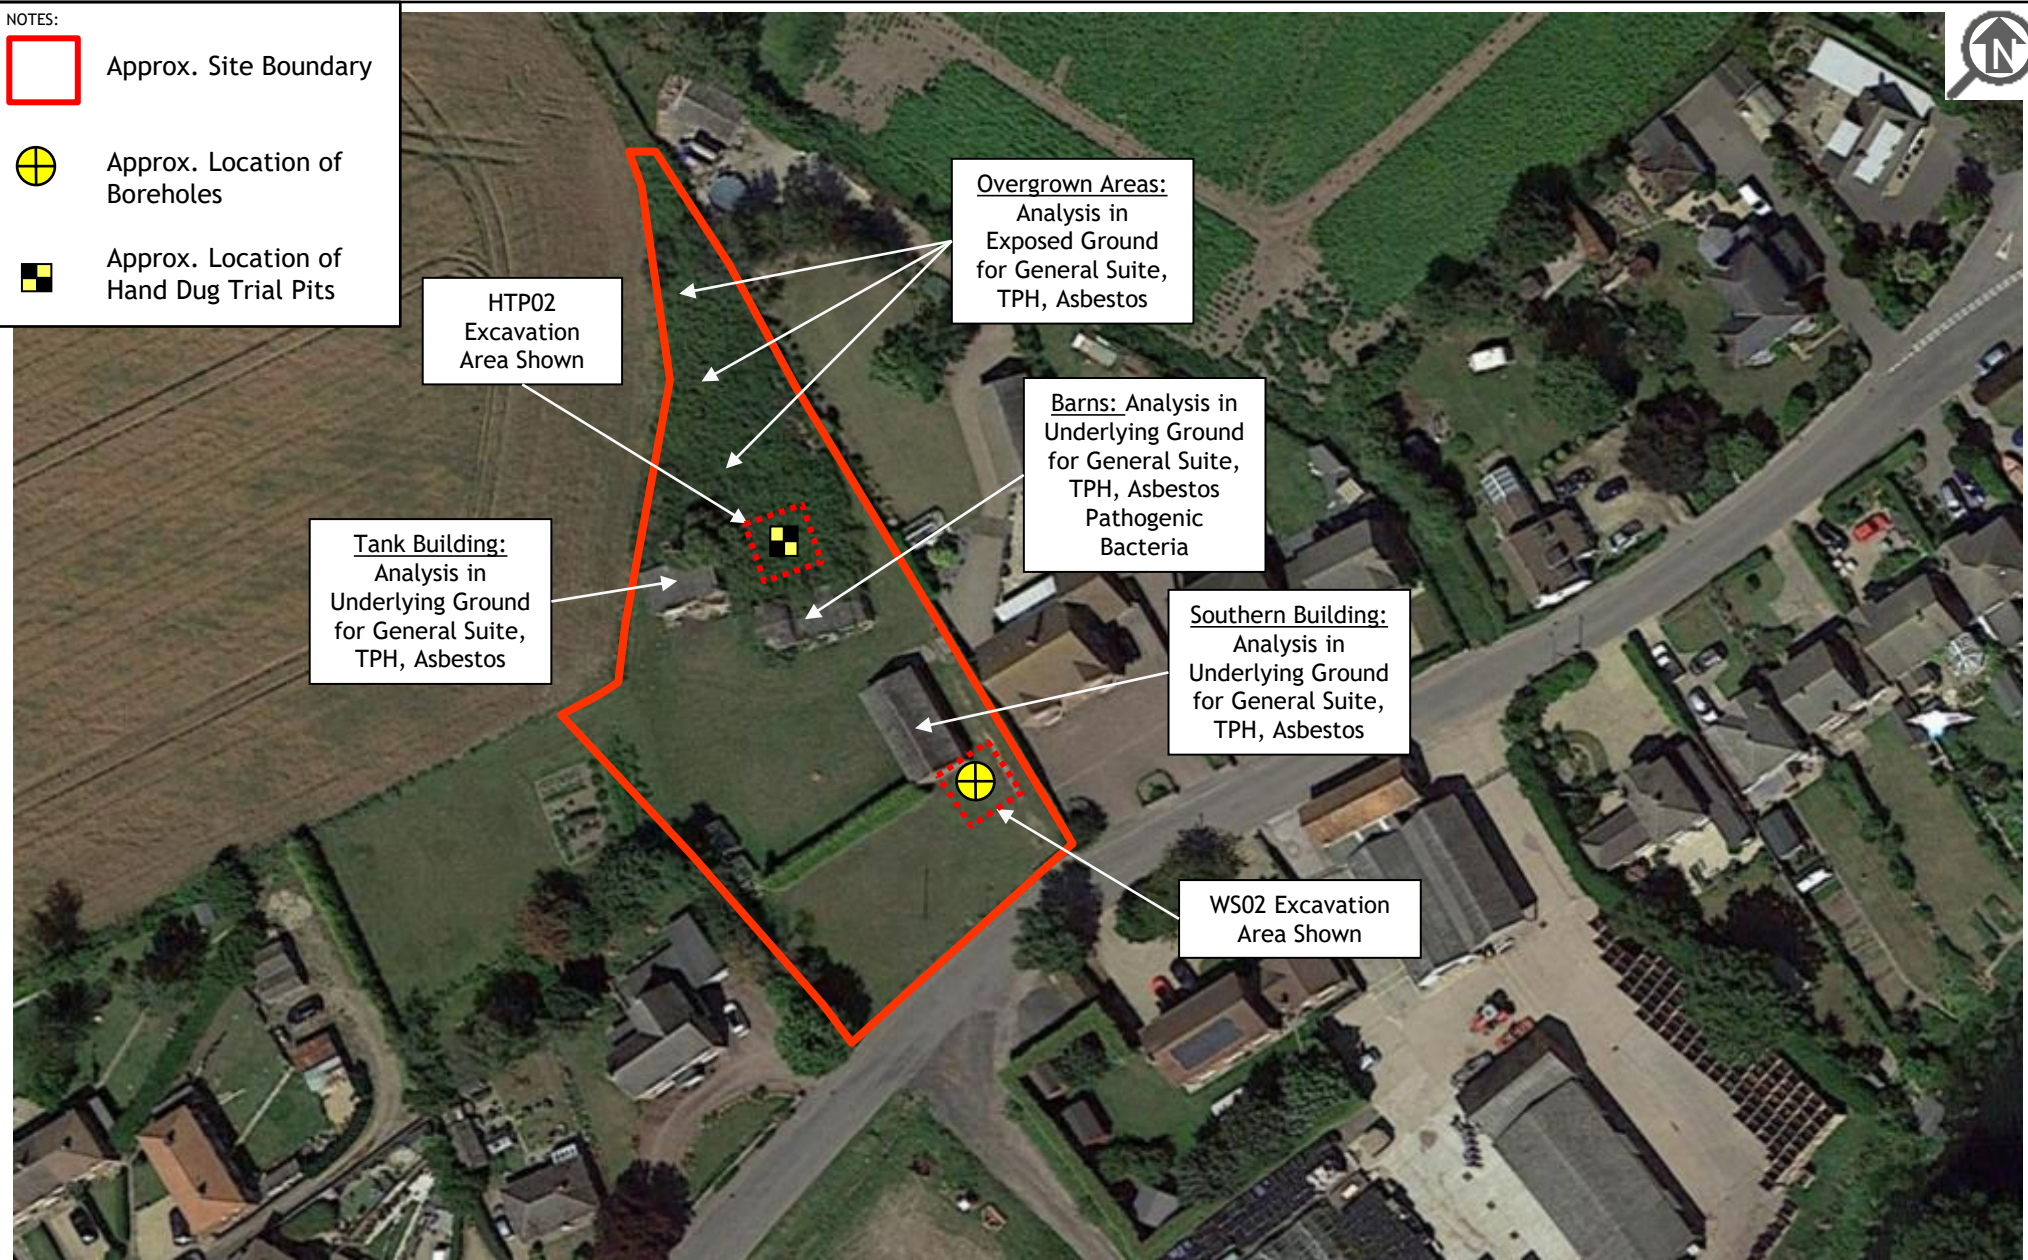
- 1 No. exceedance of mercury:
  - Samples from HTP02 of made ground / topsoil at 0.1m begl.
- 1 No. exceedance of benzo(a)pyrene:
  - Samples from WS02 of made ground at 0.2m begl.

The following validation steps are recommended for each of the impacted areas. At the time of writing this comprises the 2 No. hotspots (WS02 and HTP02), but these steps should also be followed if / when further contamination is encountered following demolition and removal of the tank and related pipework etc. Where further contamination is encountered then these steps should be repeated in full until no further contamination is recorded (to be reviewed by Supervising Engineer).
