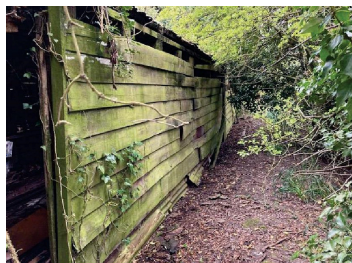
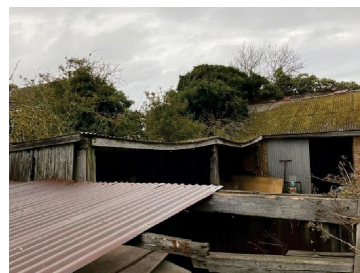
2.3.1. The outbuildings generally were built largely of timber and profiled metal construction as depicted in the photographs below, and the materials themselves appear to be more in need of replacement than maintenance.

- 2.3.4. Corrugated metal vertical sheeting to some rear walls is also nearing the end of its expected lifespan and is recommended that this be replaced to give a longer lifespan. The horizontal timber cladding boards as shown on the photographs above should also be replaced for the same reason if required for incorporation in the new construction.
