# ***Structural Appraisal Report***

**Former agricultural/nursery buildings at :  
Birds Drove, Surfleet, Lincolnshire PE11 4BE.  
Between Fairview and Mala Willa**

Report Reference: 0001

Date: March 2021

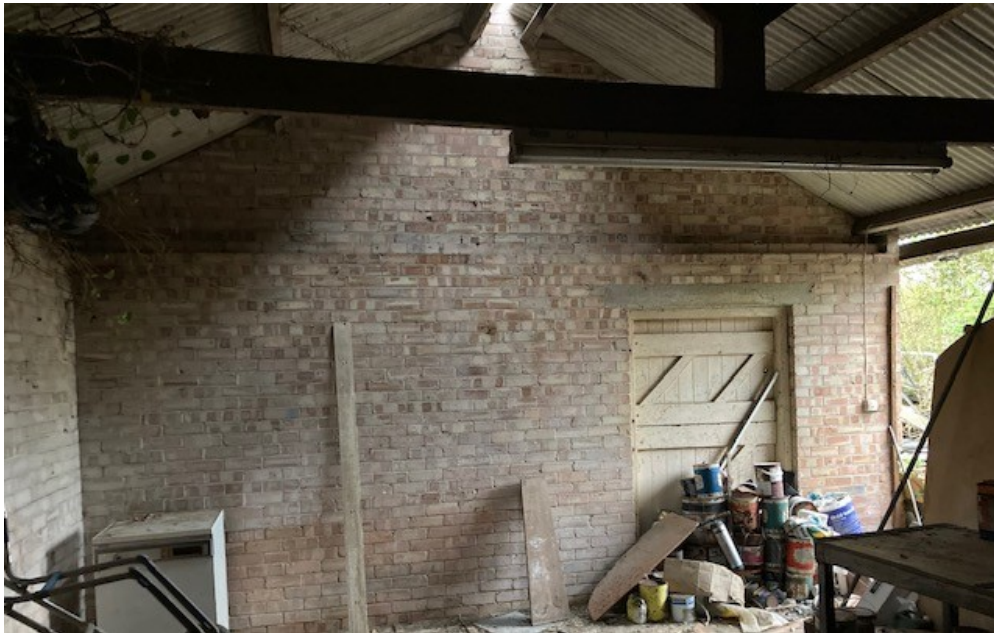
*Stable door in masonry walls - looking onto workshop*

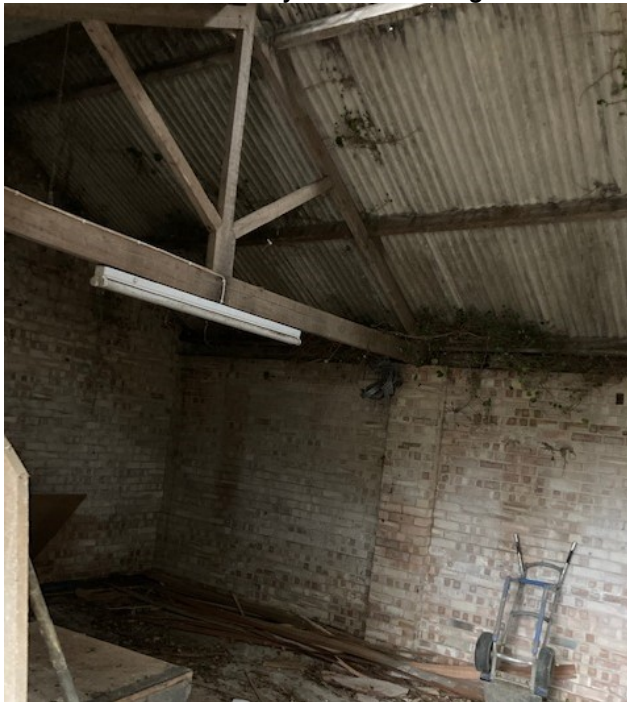
- 3.7** The king post roof trusses and purlins seem solid.
- 3.8** Rainwater goods were existent in part but generally in poor condition, there had been replacement white upvc gutters to the workshop at some point in time but are still in a poor state of repair.

*King post roof structure in stables/stores*

- 4.11** Roof – The king post trusses within the roof can be retained.
- 4.12** Other works will be purely a subdivision of space with internal walls.

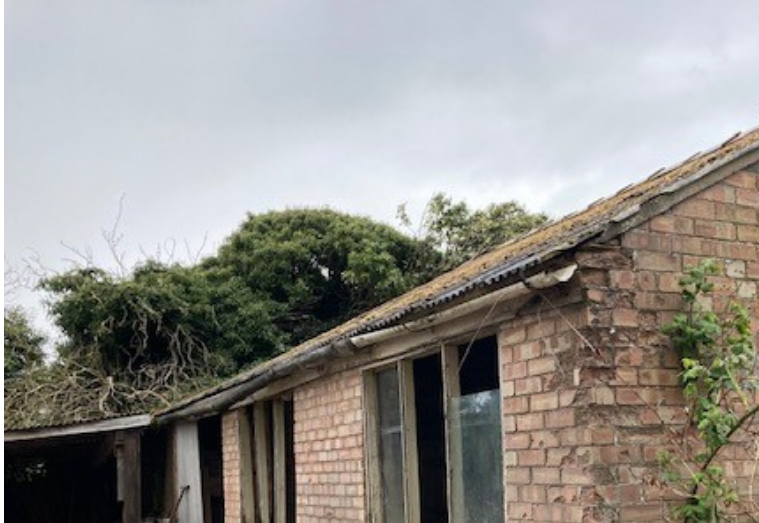
*Dilapidated rainwater goods*

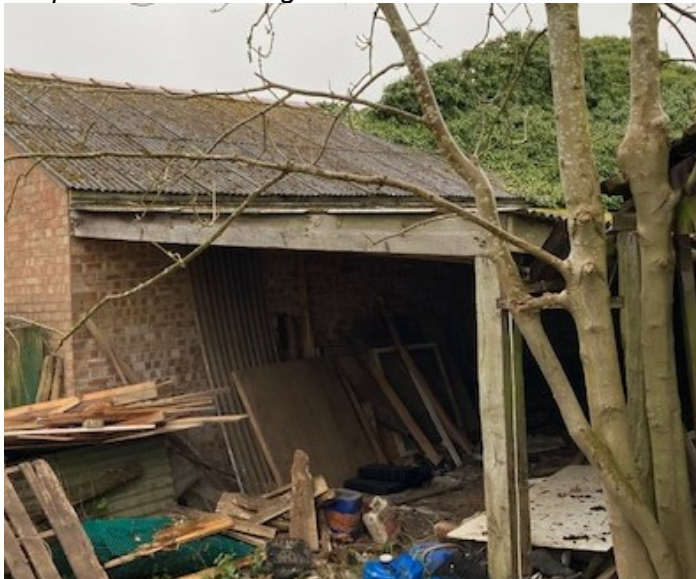
- 3.1** The condition of all supporting timber posts and rafters generally are in solid condition.
- 3.2** The timber rafters are deep profiled timber generally and hence have little movement. It was noted in the lean-to implement store one rafter had broken.

*Supporting posts/rafters in implement store*

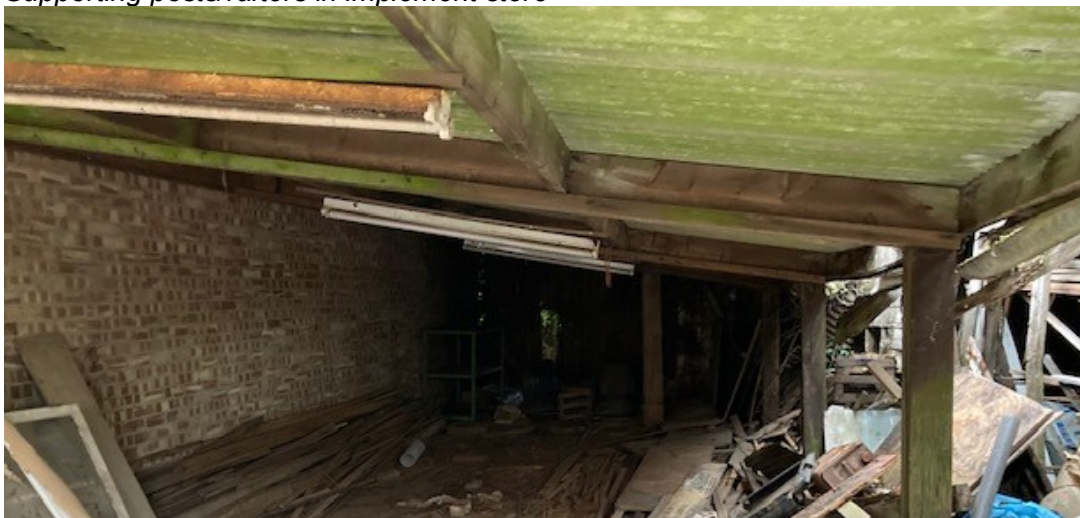
*Roof structure in lean-to implement store*

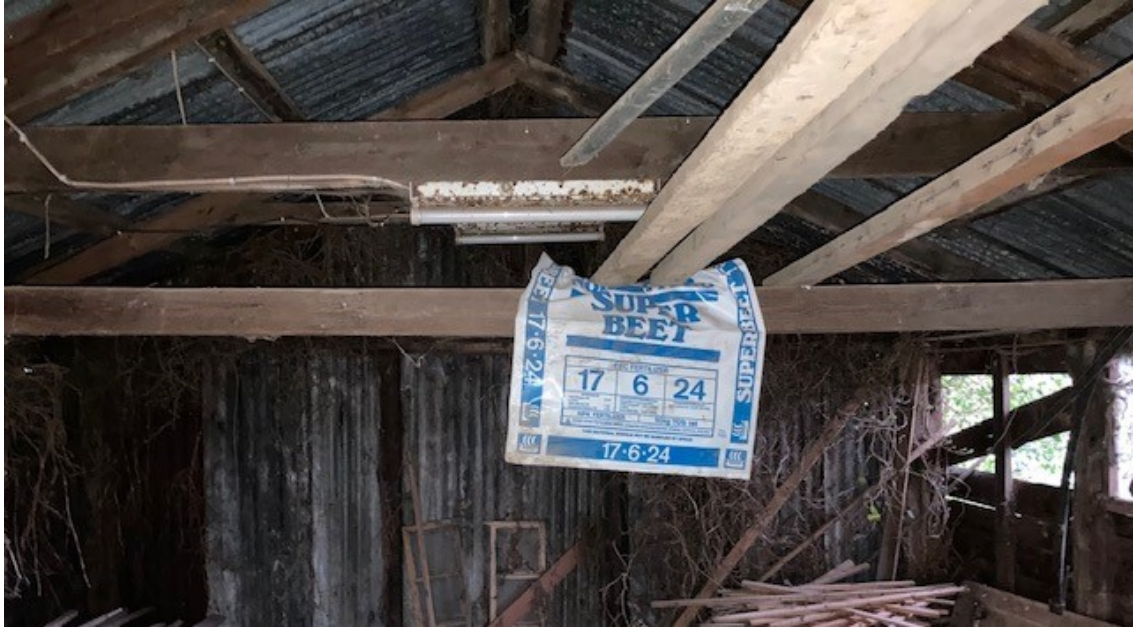
*Roof structure in tractor shed*

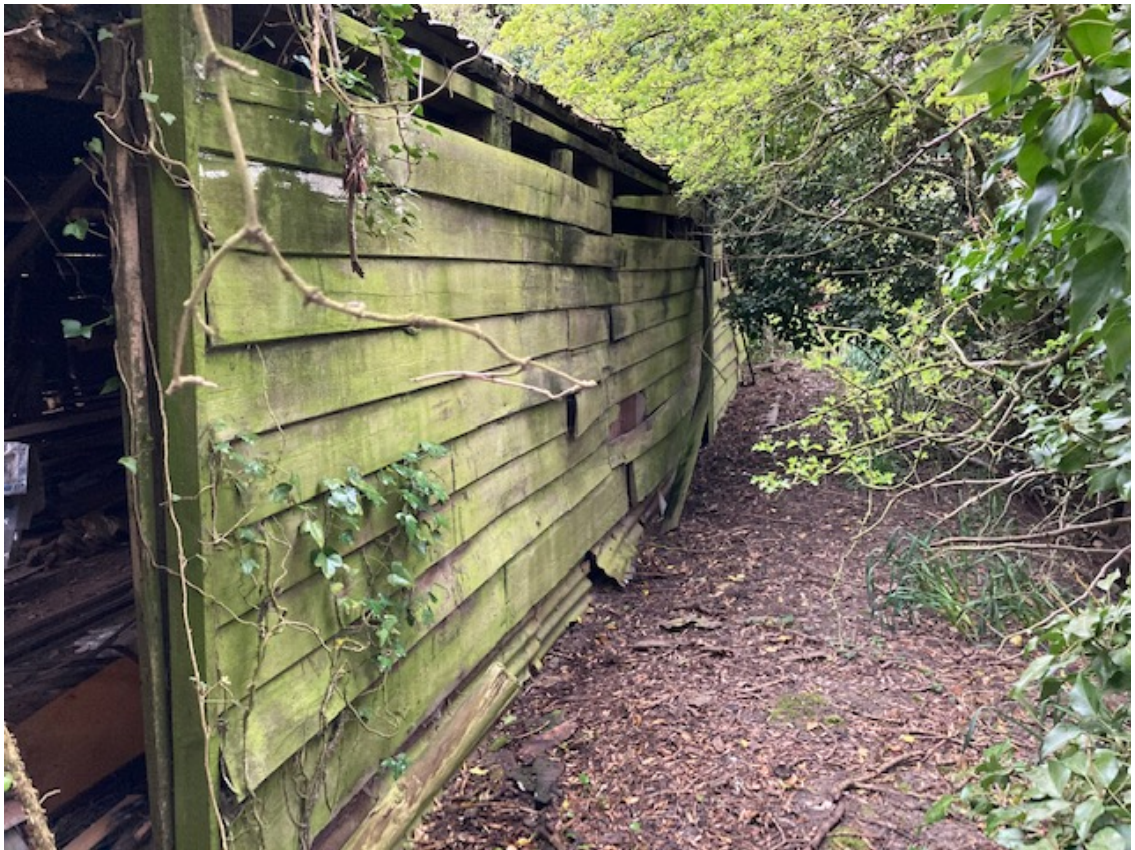
*Cladded wall along front elevation*

cladding boards would also be replaced too to the front elevation of the proposed garage (former tractor shed).

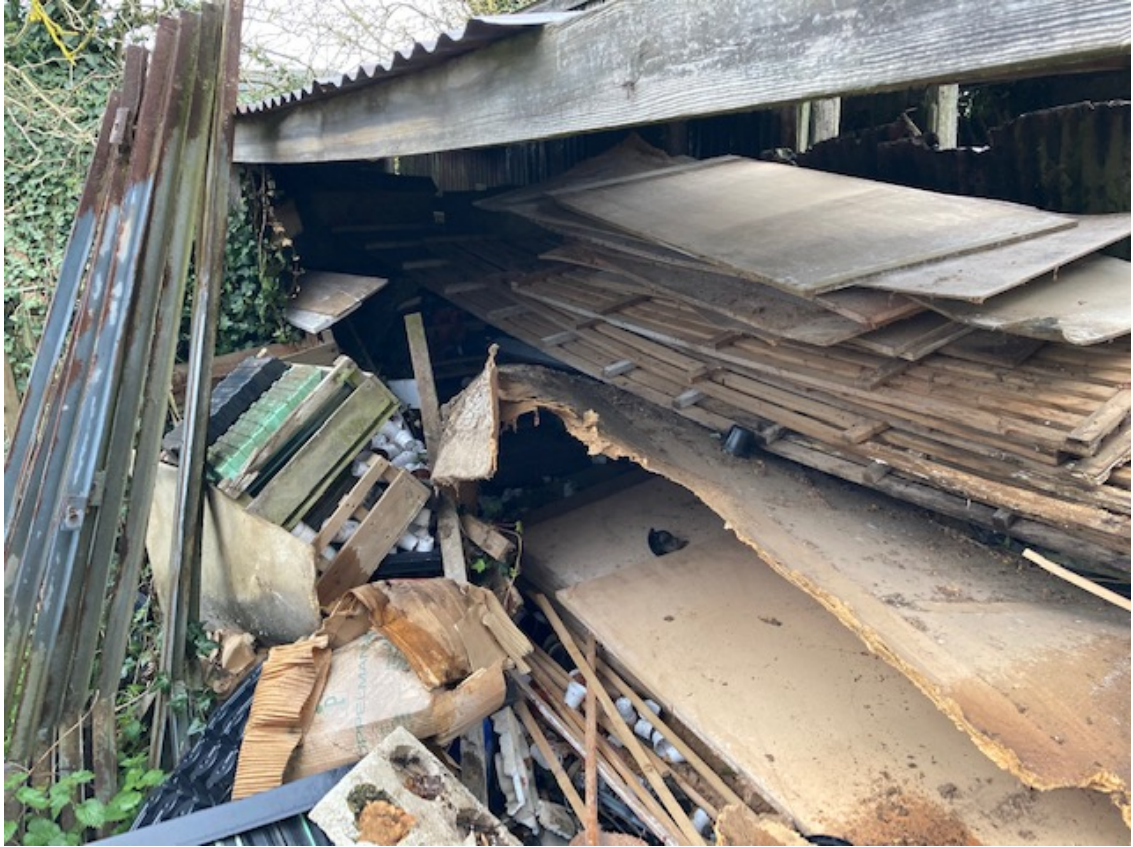
*Former pots/seed trays and shelving within potting shed*

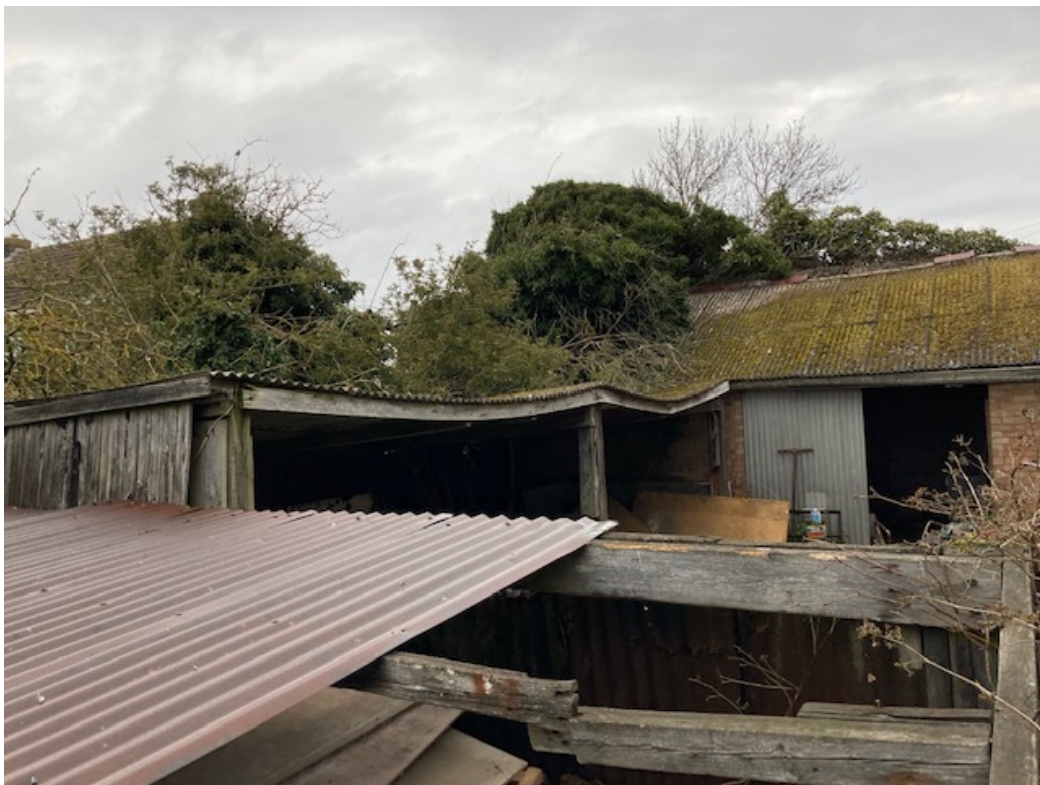
*View over potting shed looking back towards main building*

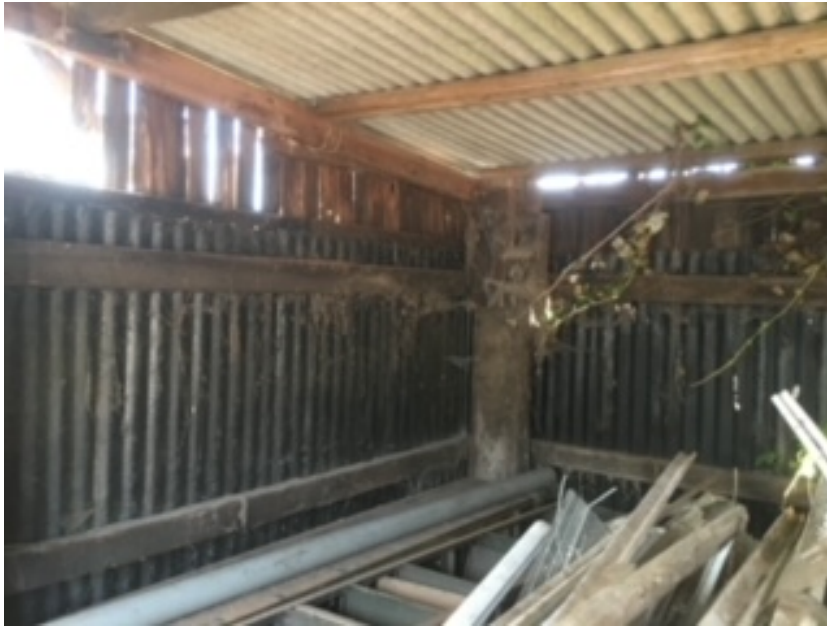
- 3.4** The rear corrugated tin wall is generally covered in ivy therefore hard to fully assess.
- 3.5** The masonry brickwork within the main building is in good order with no cracking noted.

*Corrugated walls on rear of cart hovel on solid supporting posts*

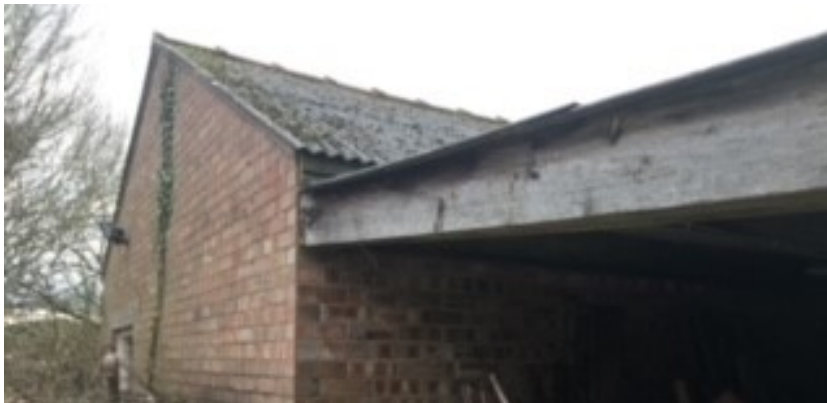
*Solid rafters of lean-to implement store*

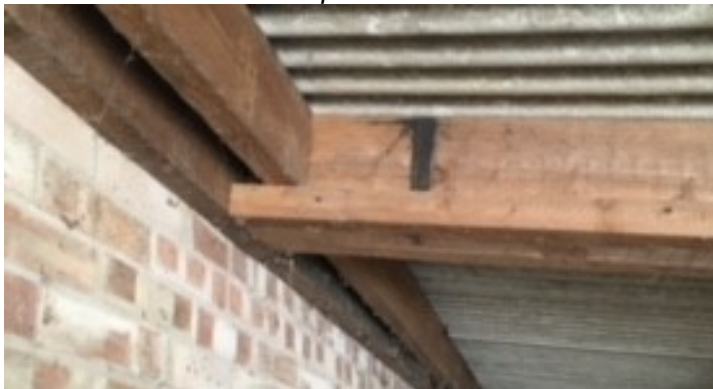
*Rafters onto bearer in lean-to*

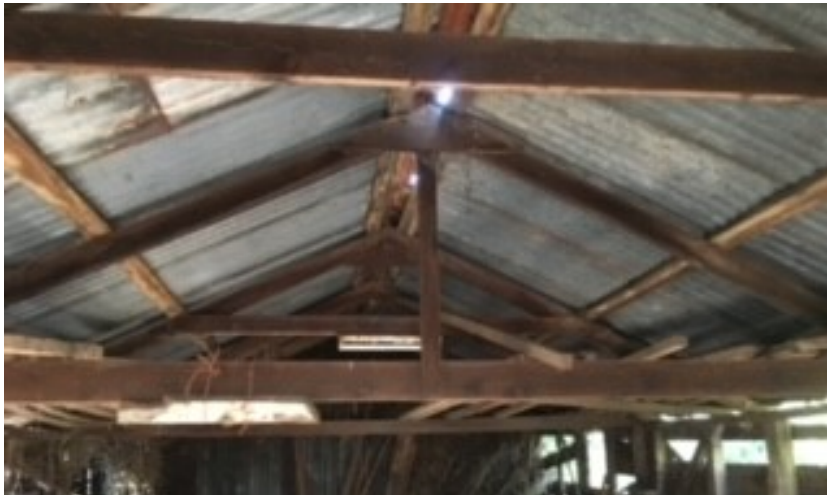
*Timber trussed roof in tractor shed*

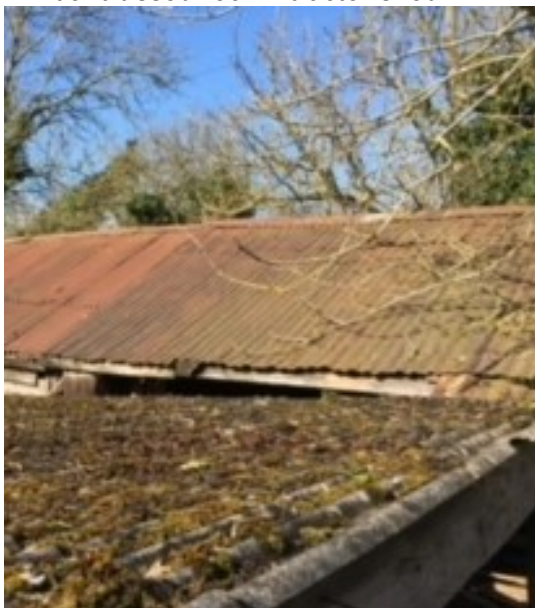
- 3.3** The corrugated roof sheeting across all buildings is in reasonable condition and buildings are generally watertight, except for the potting shed (which is proposed to be entirely demolished anyway).

*Corrugated roofs of outbuildings*

- 4.8** New roof coverings shall be proposed to replace the current corrugated and fibre cement roofs. Ridge tiles can be re-used off the workshop building.

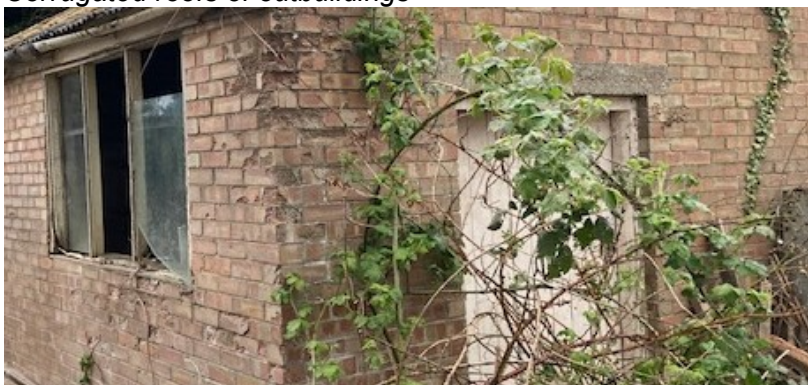
- 3.9** It was noted there are some existing services to the buildings.
- 3.10** The timber windows and doors are in poor condition.

*Timber doors and windows*

- 4.9** The concrete floor within the workshop will be assessed to ensure adequacy to allow an overlay of insulation & screed.
- 4.10** Windows and doors will be replaced with new timber style.
