**A PHASE I DESK STUDY TO ADDRESS CONDITION 4 OF PLANNING PERMISSION REFERENCE  
H17-0798-15 FOR A RESIDENTIAL REDEVELOPMENT AT:**

## **LAND ADJACENT TO 72 STATION ROAD, SURFLEET**

**CLIENT:** Mr J W & Mrs G M Needham  
**AGENT:** Cooper Architectural Design Limited  
**REFERENCE:** DIM/17.041/Phase I  
**DATE:** 28 February 2017

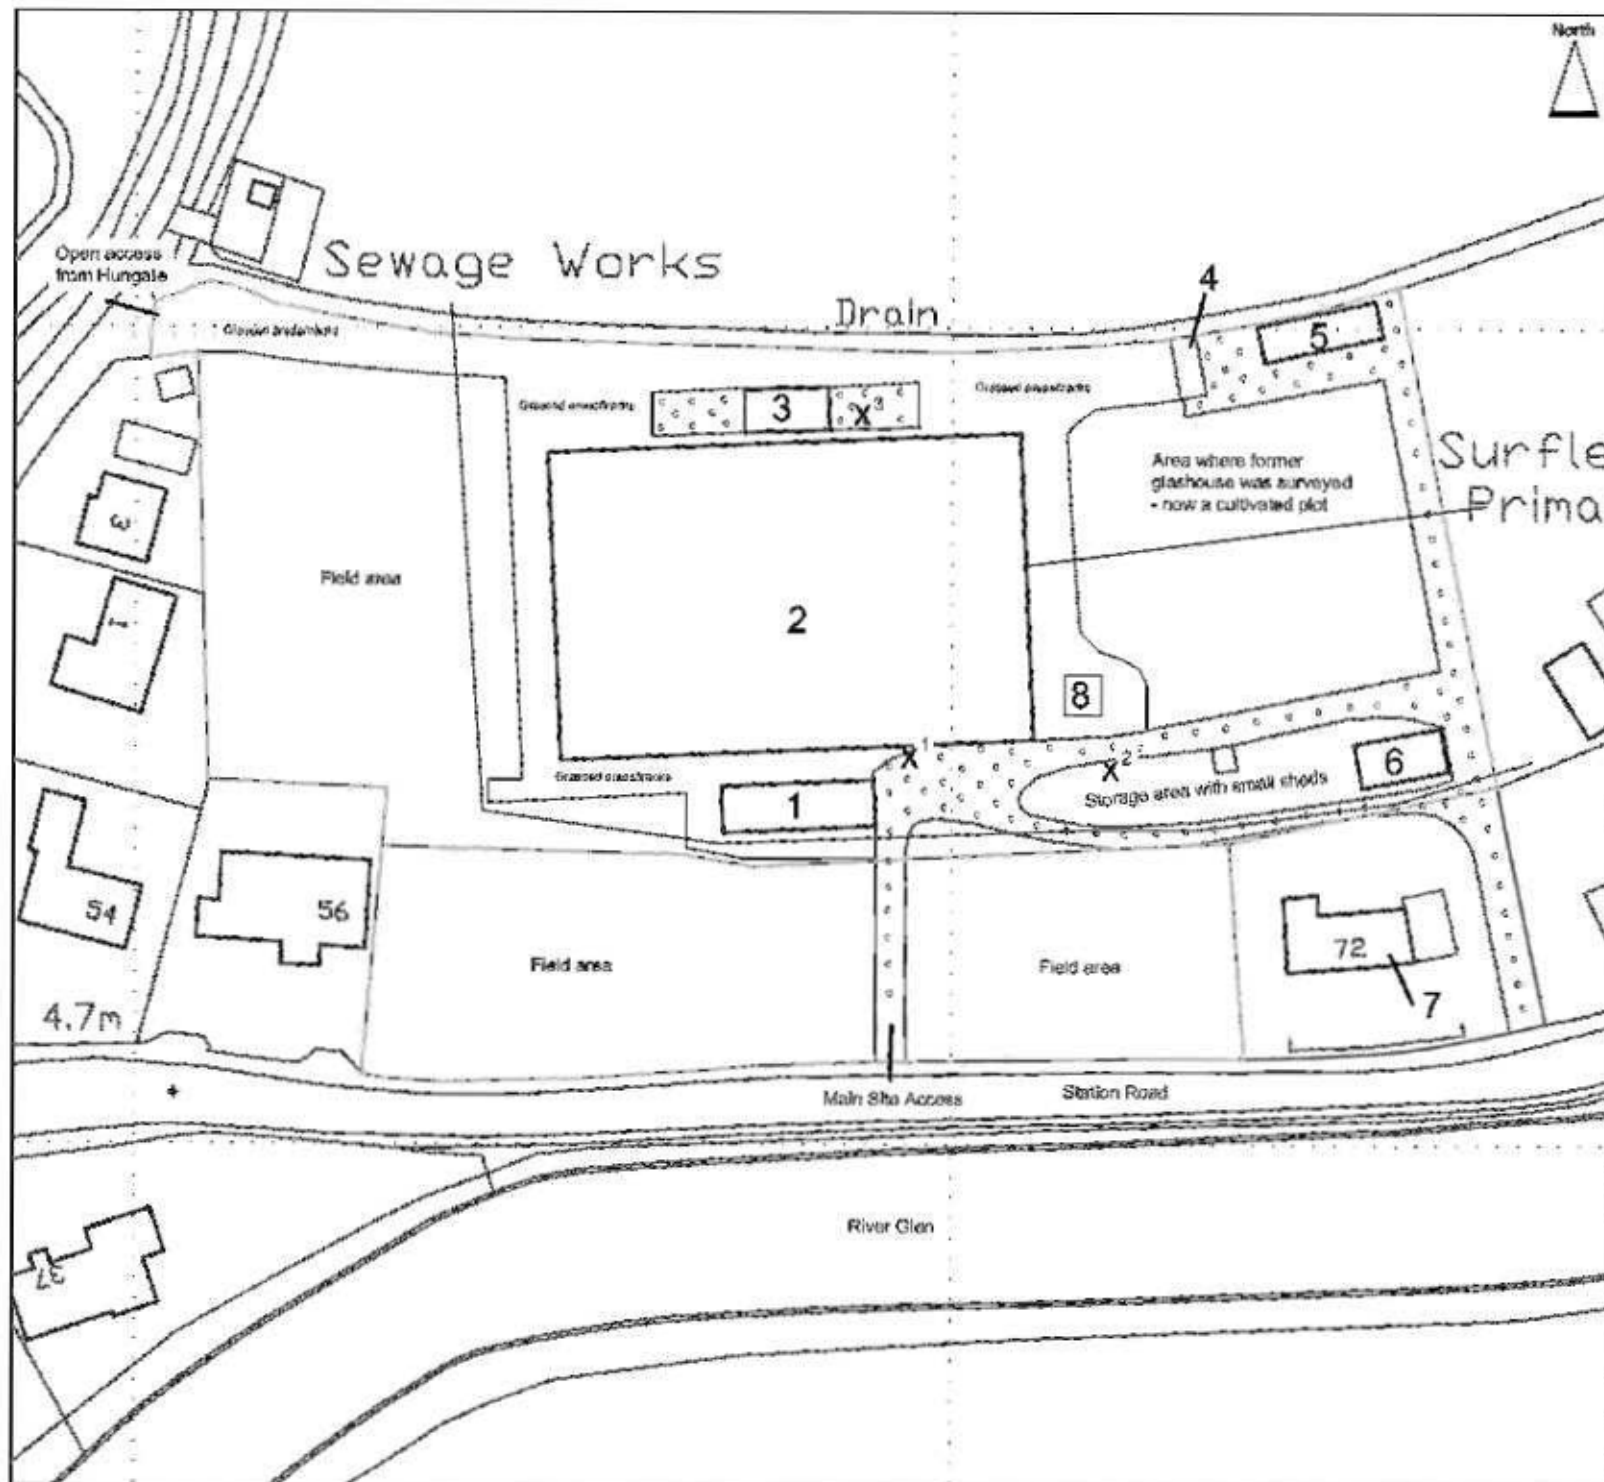
During the walkover there were hardstanding tracks leading from Station Road to the glasshouse (structure 2) and the packing shed (structure 1), and then around the former glasshouse (no surface expression remains) in the east of the site, leading to structures 4 and 5 in the north eastern corner.

Between structures 2 and 6, and adjacent to the tanks located at X<sup>2</sup>, there was an area which was used for general storage. There were also three small timber sheds in various states of repair, including one which was partially collapsed. All three sheds had corrugated cement board roofs (possible ACM). The sheds housed various pieces of agricultural equipment. In this area there were also mounds of soil, as well as sporadically dispersed items of furniture, agricultural and horticultural equipment, and

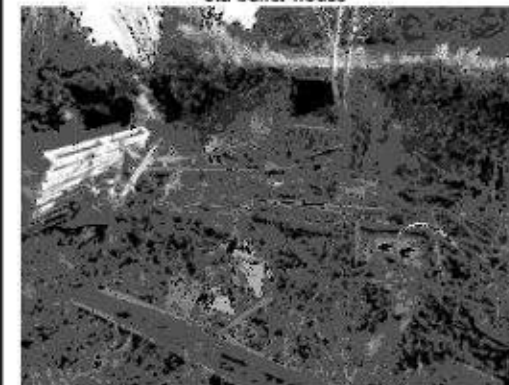
Photo 9 – Looking east at discarded material adjacent to old boiler house

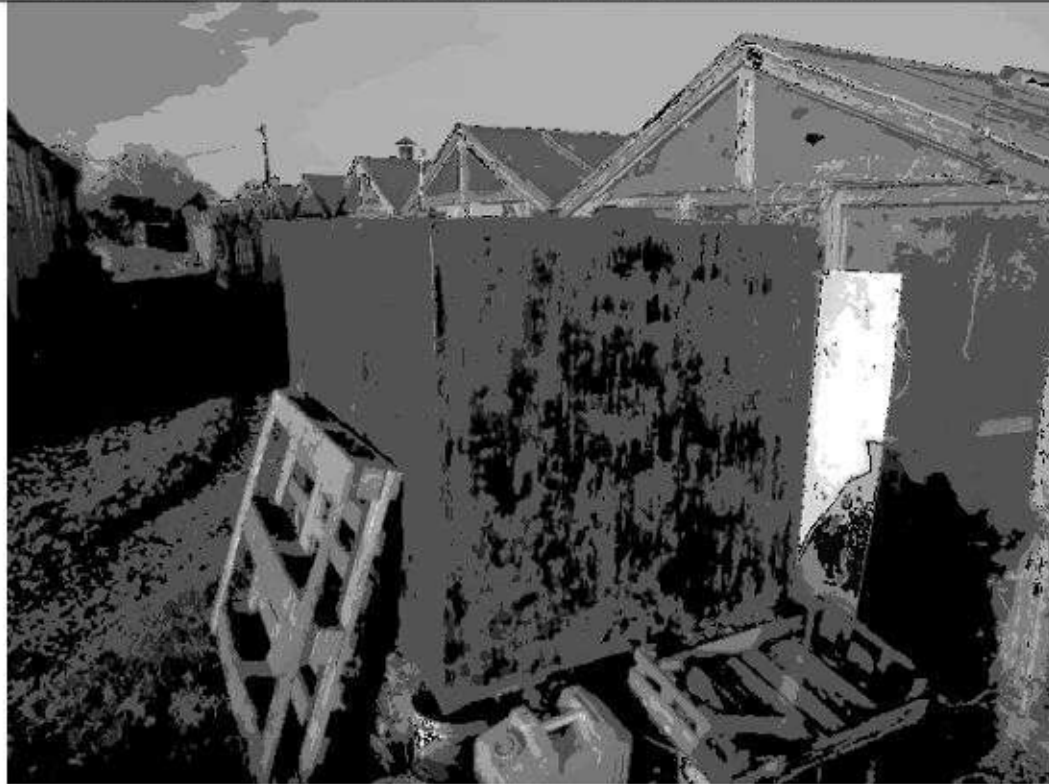
| Structure Reference | Description and Suggested Usage |
|---|---|
| X <sup>1</sup> | A single-skin metal diesel tank raised off the ground on concrete blocks, with soft ground beneath. The tank showed signs of rust, with a small plastic container beneath one of the corners indicating potential signs of leakages and spillages. Anecdotal evidence suggests the pipe connecting it to the fan heaters inside the glasshouse was changed when one of the fan heaters became defunct. |

3. Single skin steel diesel tank, labelled X<sup>1</sup> on drawing 17.041/Phase1/2

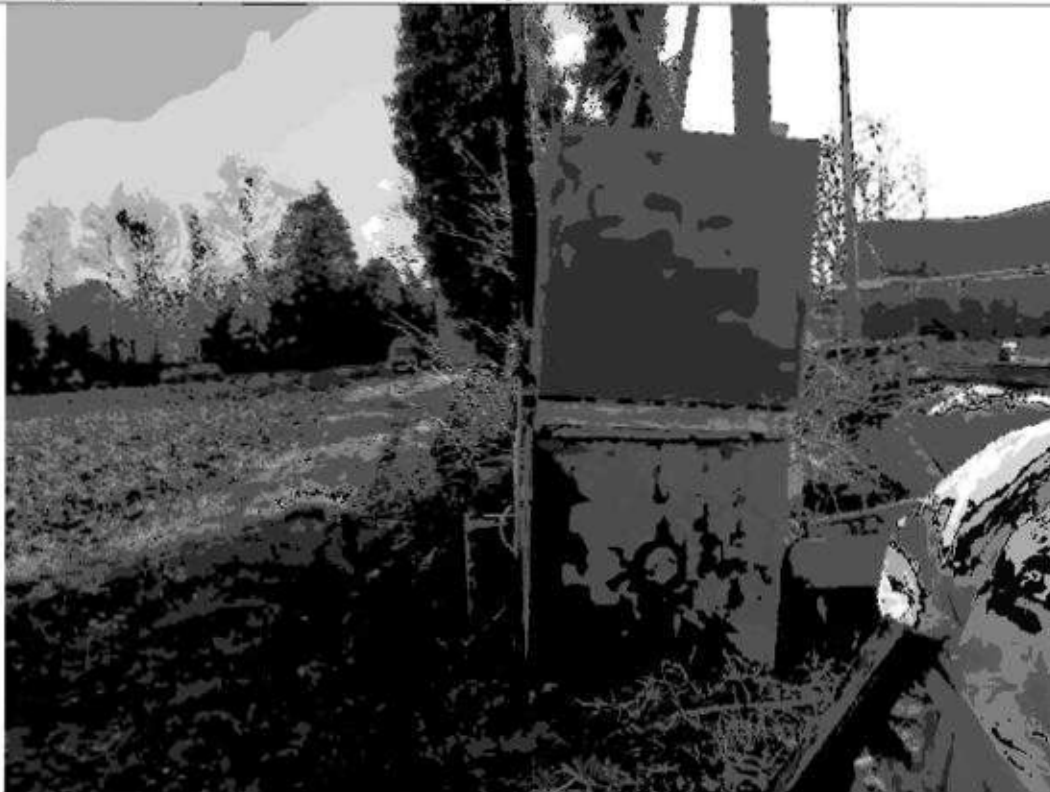
| Structure Reference | Description and Suggested Usage |
|---|---|
| X <sup>2</sup> | There were three tanks in this area. A single skin metal water tank was raised off the ground by approximately 8 m. This was supported on a steel frame attached to a concrete plinth at ground level. The tank showed signs of potential leakage with occasional drips from the base and it was rusty.<br>Adjacent to the concrete plinth were two single skin metal tanks which were not in use and were being stored. They were in a rusty condition and it is understood that they have been used to store diesel. |

8. Single skin steel diesel tanks stored adjcant to water tank, at X<sup>2</sup>

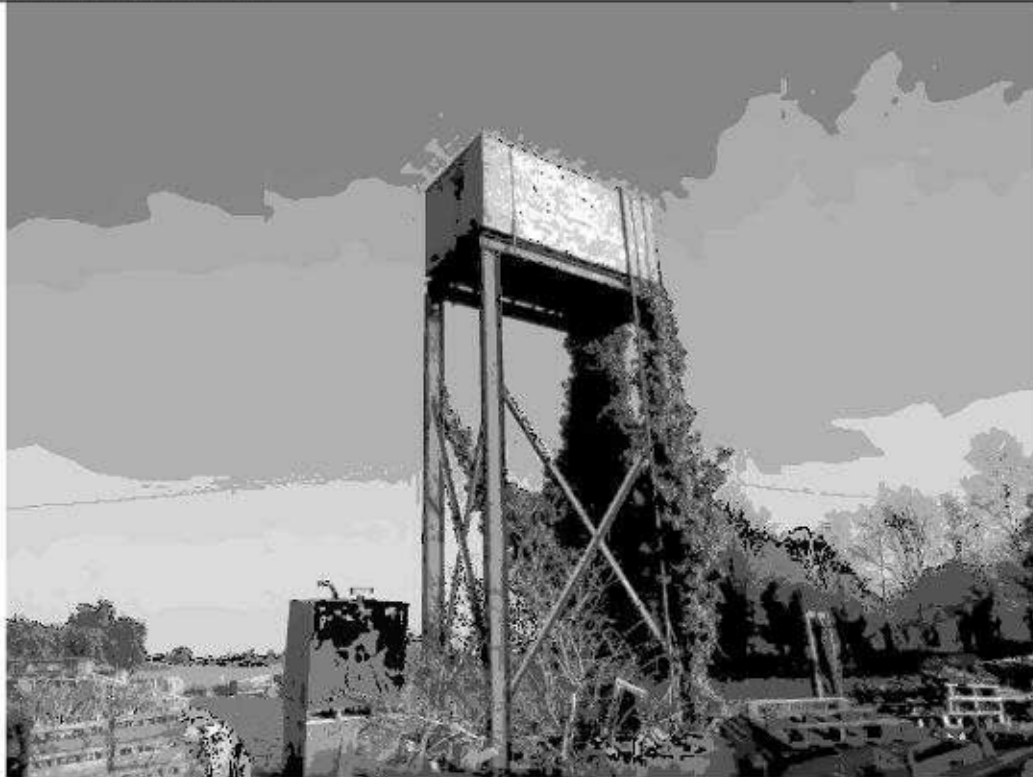
9. Raised water tank, X<sup>2</sup>

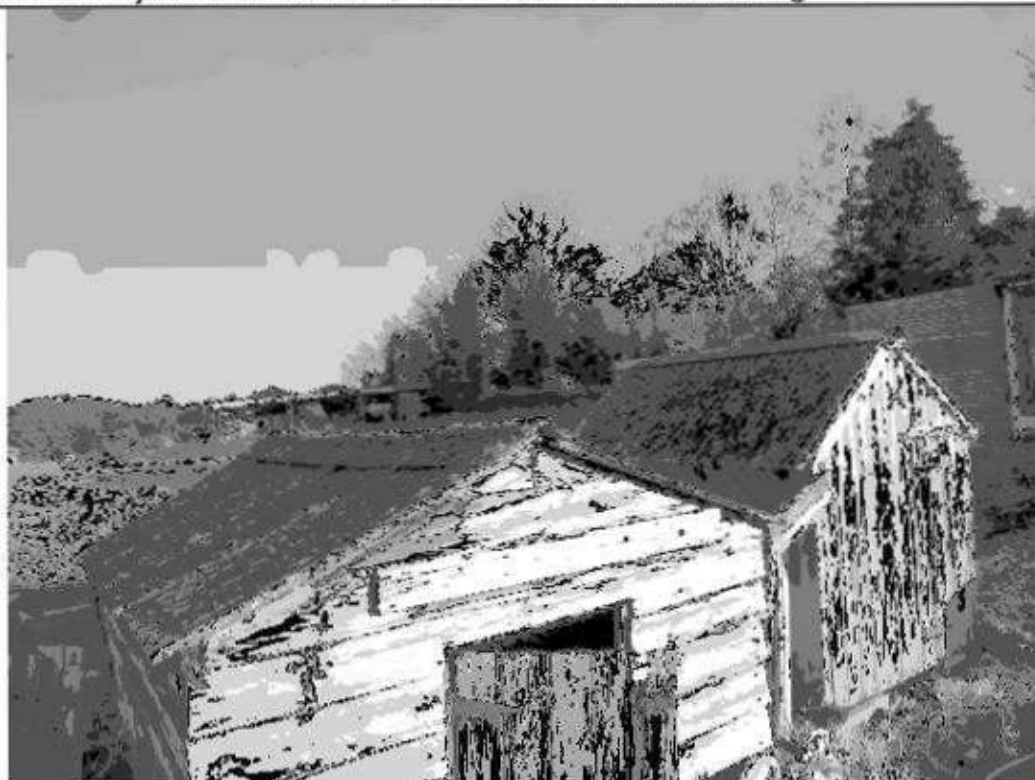
11. Sheds adjacent to Structure 6 and tanks X<sup>2</sup> with ACM roofing

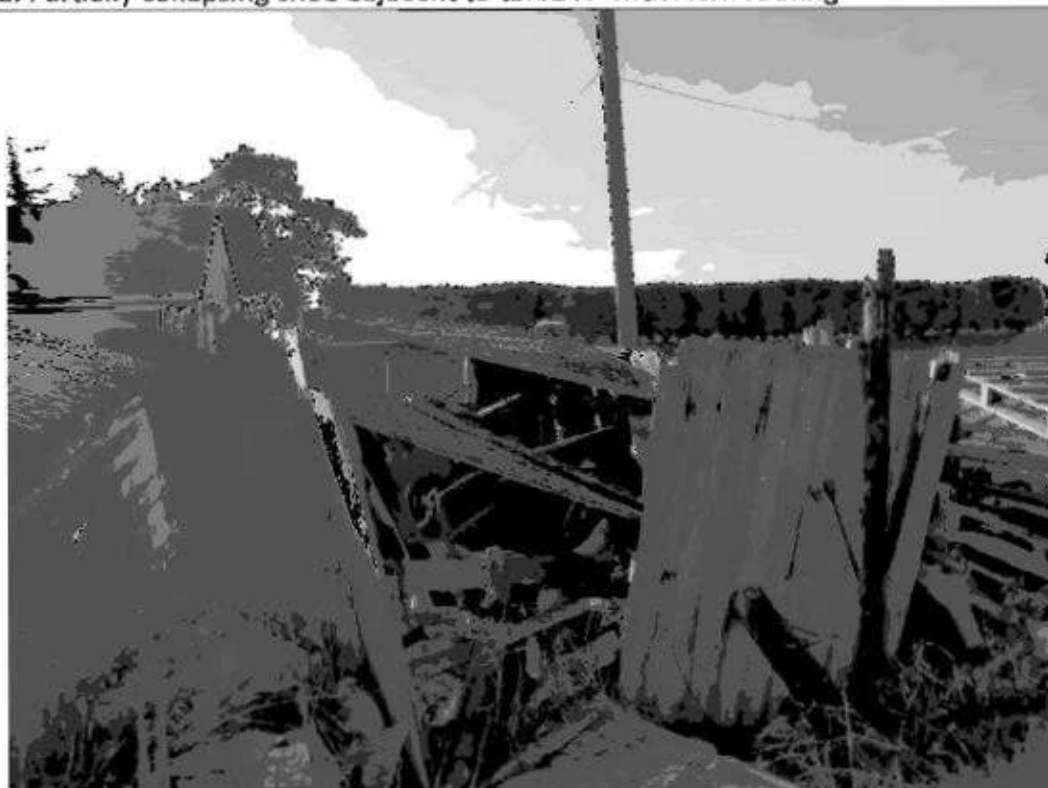
12. Partially collapsing shed adjacent to tanks X<sup>2</sup> with ACM roofing

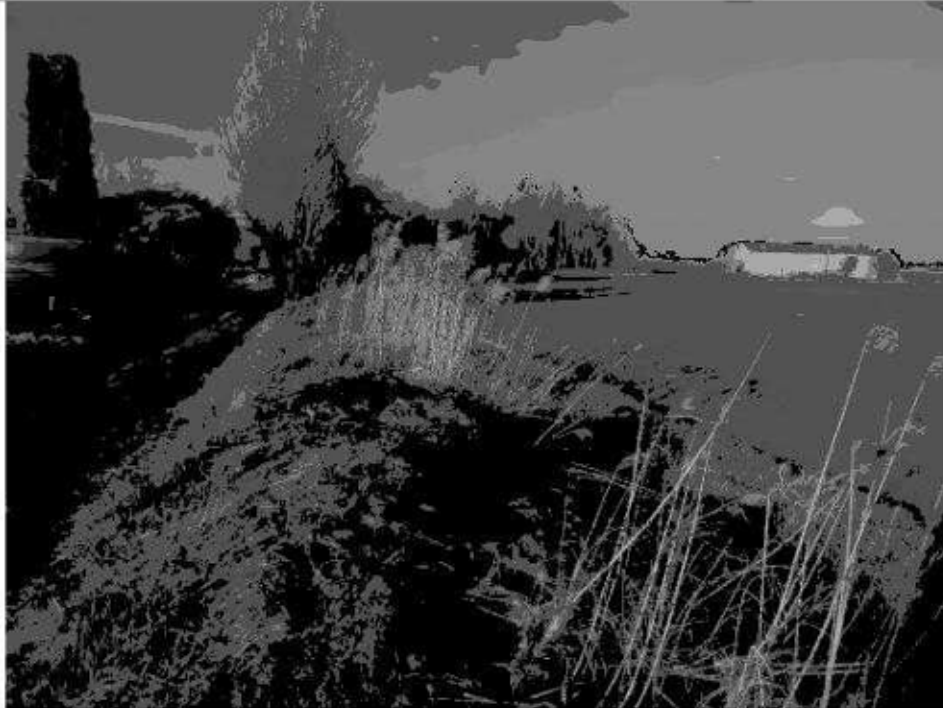
A slightly raised area of discarded soil and ash was located on the northern boundary with a drainage ditch immediately beyond. Mature trees were present along the western part of this boundary. The north western corner of the site was open to Hungate. The western boundary was demarcated by timber fencing with residential properties and gardens immediately adjacent and the southern boundary was lined with mature coniferous hedging. The eastern boundary was shared with a school and was defined by a low concrete wall and mature trees which were located within the school site.

15. Discarded material adjacent to drainage ditch on northern boundary including ash

14. It is recommended that the burnt material adjacent to the drainage ditch should be removed prior to redevelopment and its removal documented and validated.

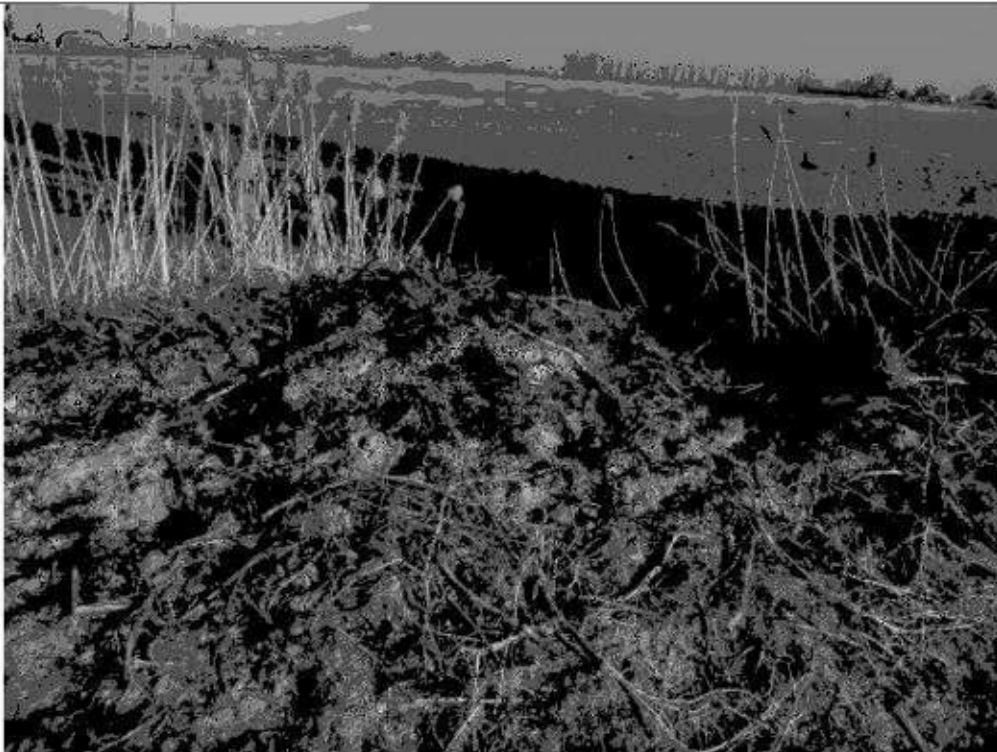
16. Discarded material adjacent to drainage ditch on northern boundary including ash

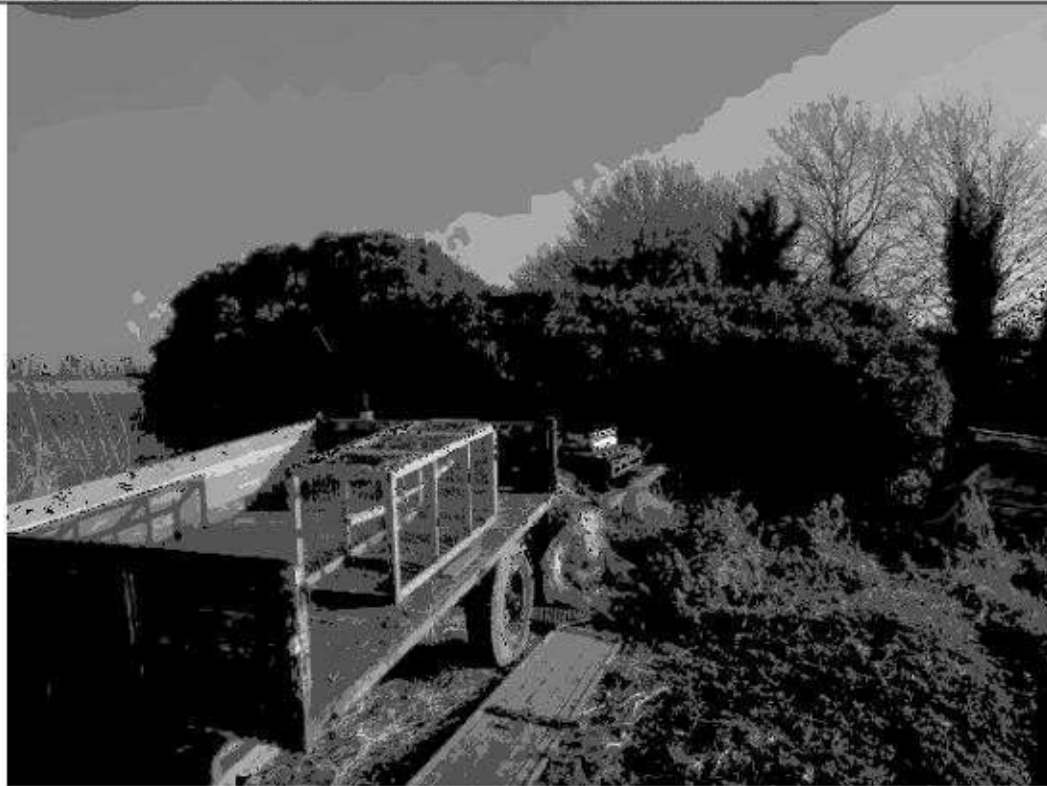
| Structure Reference | Description and Suggested Usage |
|---|---|
| 4 | This structure was partially collapsed and overgrown with ivy and internal access was not possible. The roof was of a corrugated cement board construction (possible ACM) which was clearly fractured due to the collapse. Anecdotal evidence suggests this building was of a similar configuration to structure 3 and used to contain a coal fired boiler for heating the former glasshouse immediately to the south. It was understood that a chimney was removed prior to the Client occupying the site. |

17. Ivy-clad partially collapsed structure 4, viewed from the west

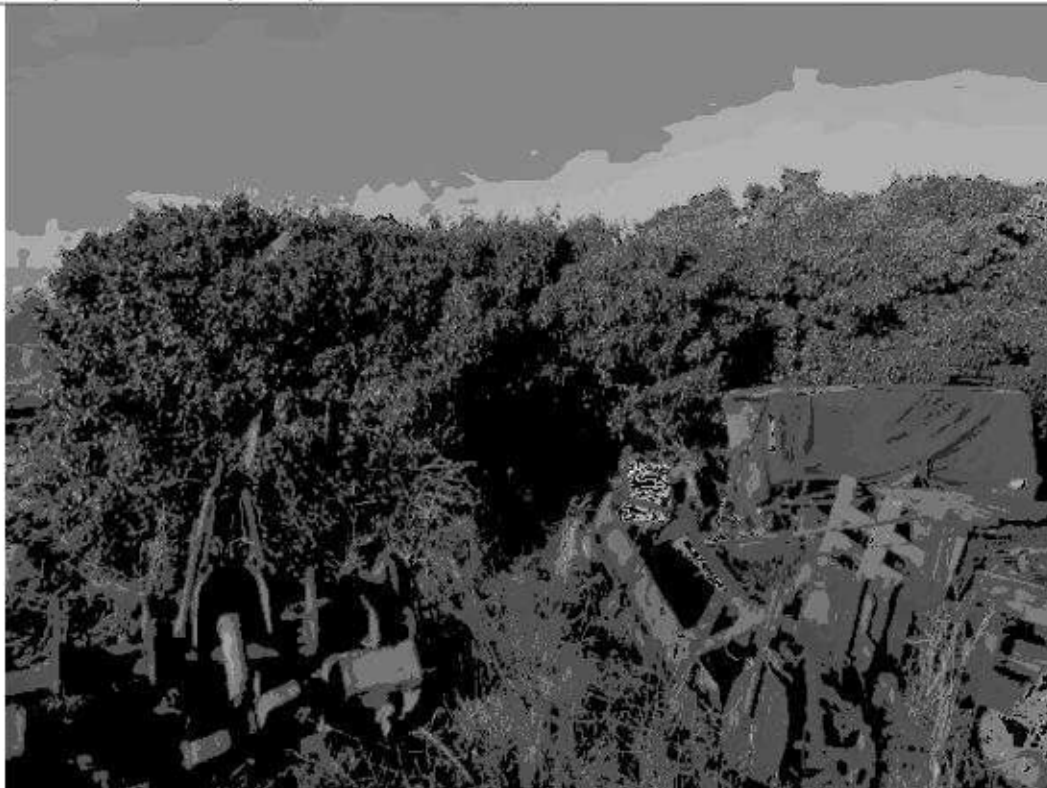
18. Ivy-clad partially collapsed structure 4, viewed from the east

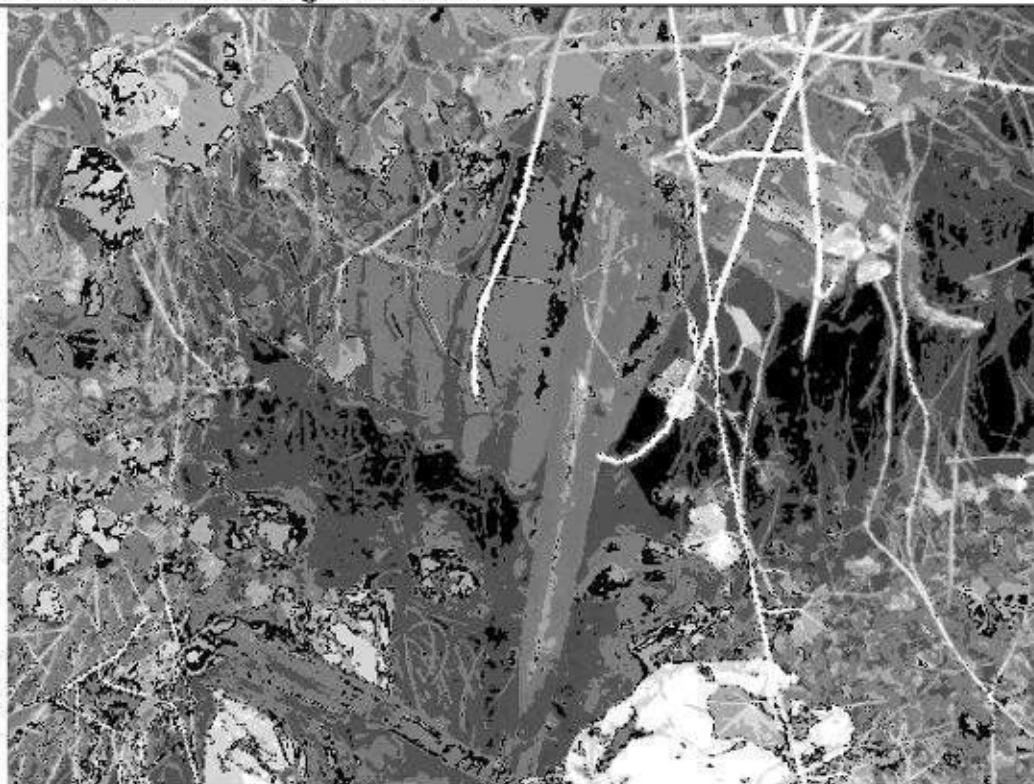
19. Fractured ACM roofing of structure 4
