Our Ref: SW21-192-L01

**RE: SW 21-192 – Cottage Building, Birds Drove, Surfleet, Lincolnshire**

Following our attendance on site on 09 August 2021 to undertake a visual inspection of the existing cottage property, please see our brief letter style report following.

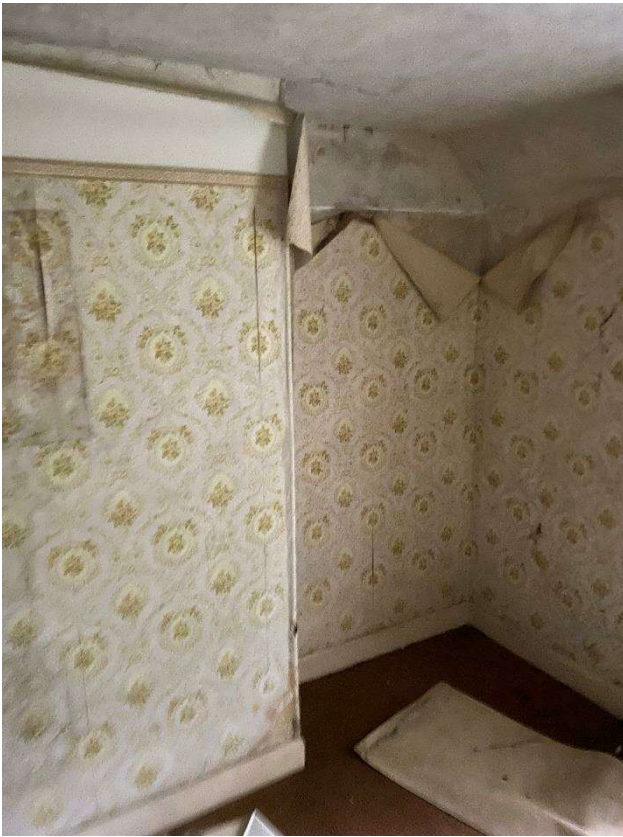
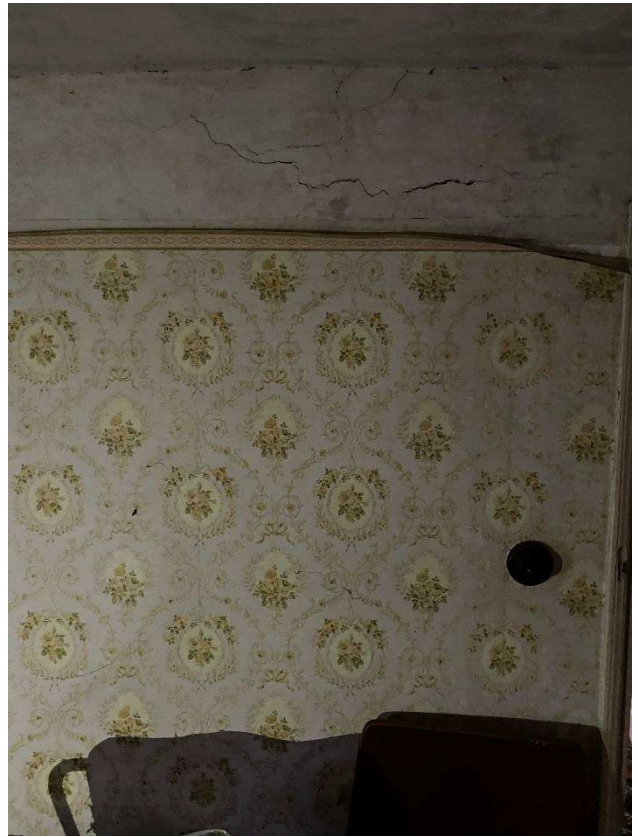
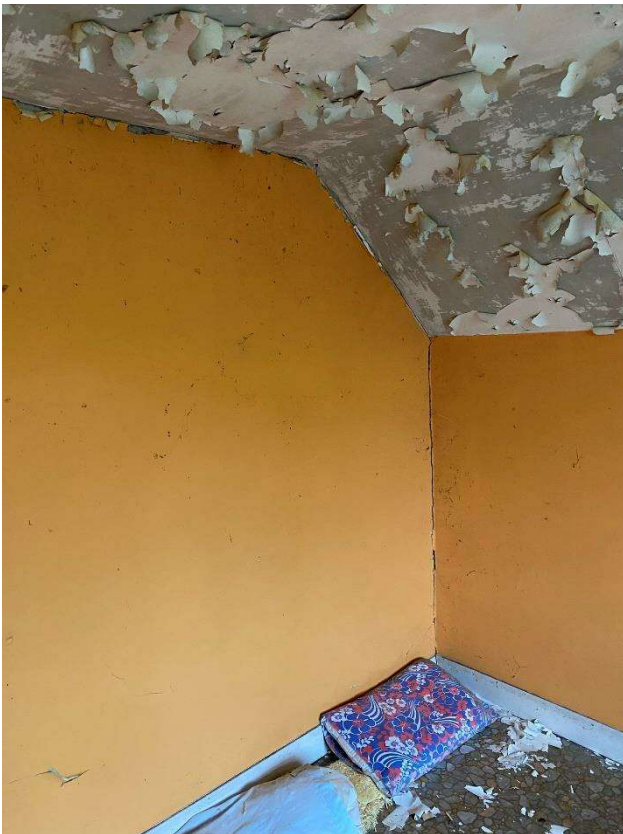
There are a few photos illustrating the structural defects appended to this letter.

The property is illustrating some signs of distress which is indicative of a historic foundation movement.

Internally there is an external wall crack and a crack to internal load bearing wall.

The crack patterns seem to indicate that the rear wall has suffered a differential movement in the past.

We anticipate repair works to take the form of removing the existing ground floor, which is on various levels so assumed beneficial to replace anyway, and replace with a new structural raft slab floor which can be tied into the existing walls and structure providing ongoing and long time foundation stability too.

We would also recommend crack stitching repairs as required to stitch the internal cross wall back to the long elevation external wall.
