## Conditional Survey

27<sup>th</sup> July 2024 – Version V2

LINKED ENGINEERING LIMITED  
83 New Road,  
Sutton Bridge,  
Lincolnshire, PE12 9RQ

The following report is a Non-Intrusive Condition Survey to provide a review of the current state/condition of the existing Sutton Bridge United Football Club changing facilities building located in Memorial Park within Sutton Bridge, Lincolnshire.

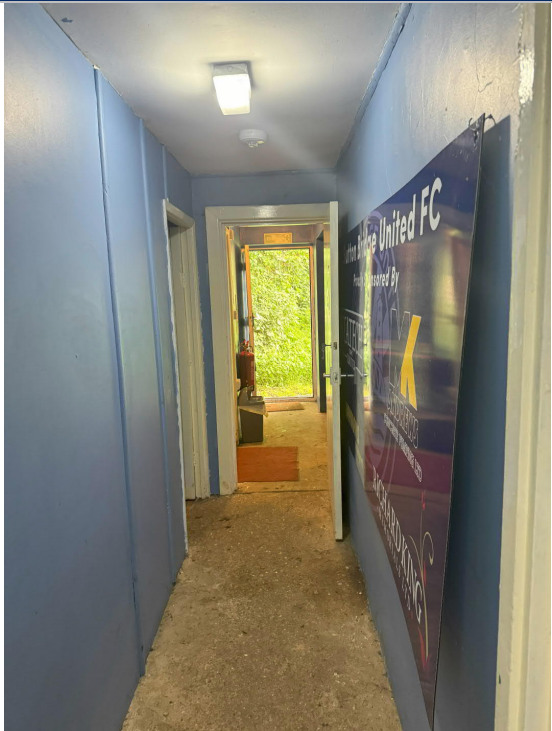
| ITEM | PHOTOGRAPH | DESCRIPTION / ISSUE |
|---|---|---|
| 1 | | <p><b>MAIN CORRIDOR</b></p> <p>The main corridor links the two ends of the building which contains the home and away changing rooms/showers.</p> <p>General construction is concrete floor and fabricated thin wooden walls with minimal insulation.</p> <p>The lighting is generally sufficient, and the area includes smoke detection.</p> <p>Corridor is narrow and does not sufficiently support disabled access.</p> |

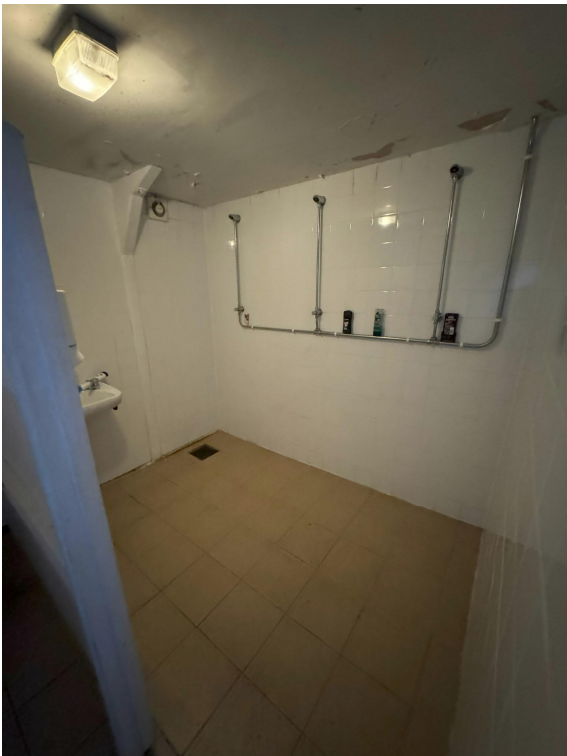
| ITEM | PHOTOGRAPH | DESCRIPTION / ISSUE |
|---|---|---|
| 2 | | <p><b>SHOWERS (HOME TEAM)</b></p> <p>The current showers need to be upgraded and there are signs of damp and paint is peeling off of the ceilings and the ventilation is inadequate.</p> <p>There is no facility for female/unisex showers, toilets and/or for disabled accessibility.</p> <p>Showers need to be upgraded to meet current regulations and standards.</p> |

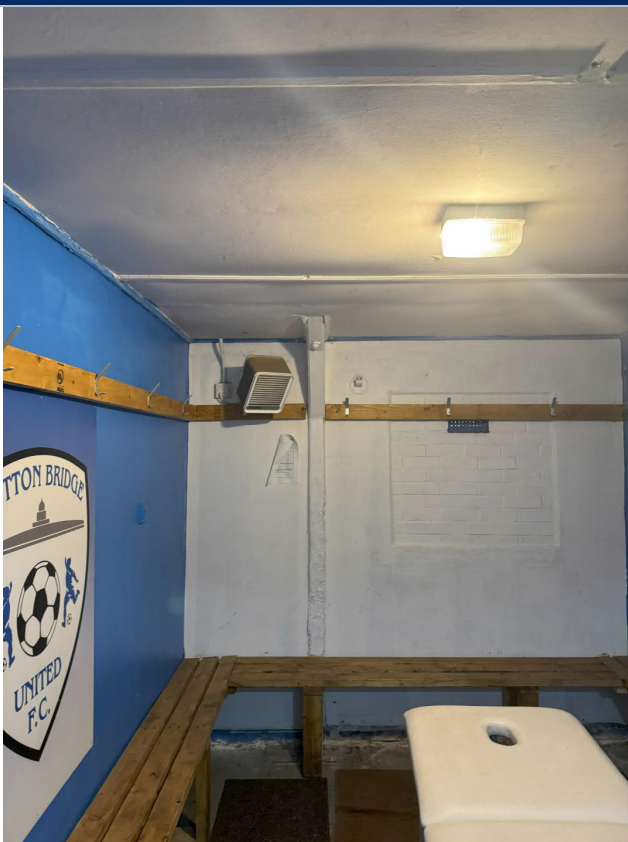
| ITEM | PHOTOGRAPH | DESCRIPTION / ISSUE |
|---|---|---|
| 3 | | <p><b>CHANGING ROOM (HOME TEAM)</b></p> <p>The changing rooms are in a state of disrepair and does not have sufficient lighting, heating and ventilation.</p> <p>There is also no facility for female changing areas.</p> |

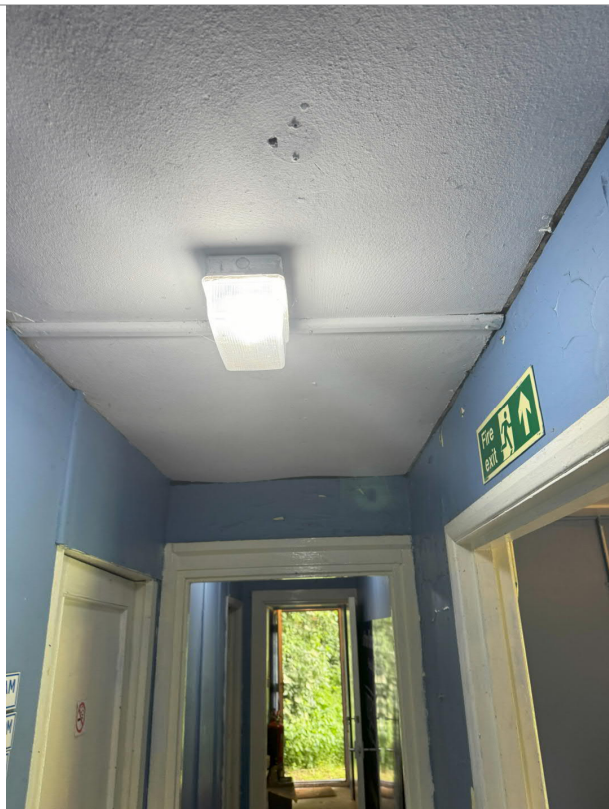
| ITEM | PHOTOGRAPH | DESCRIPTION / ISSUE |
|---|---|---|
| 4 | | <p><b>EMERGENCY LIGHTING</b></p> <p>Emergency lighting throughout the Pavilion needs to be tested, checked and were required provided / upgraded.</p> |

The emergency lighting system does not appear to be maintained and we would recommend the installation is upgraded to meet the required lux levels and current standards.

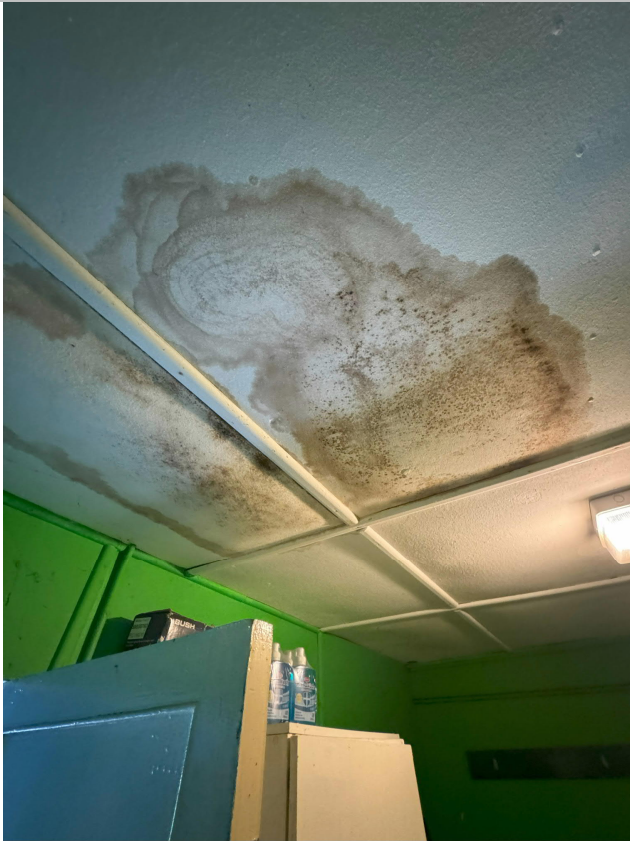
| ITEM | PHOTOGRAPH | DESCRIPTION / ISSUE |
|---|---|---|
| 5 | | <p><b>WATER INGRESS</b></p> <p>Significant water ingress within the storeroom suggests the roof needs repairing / replacing.</p> |

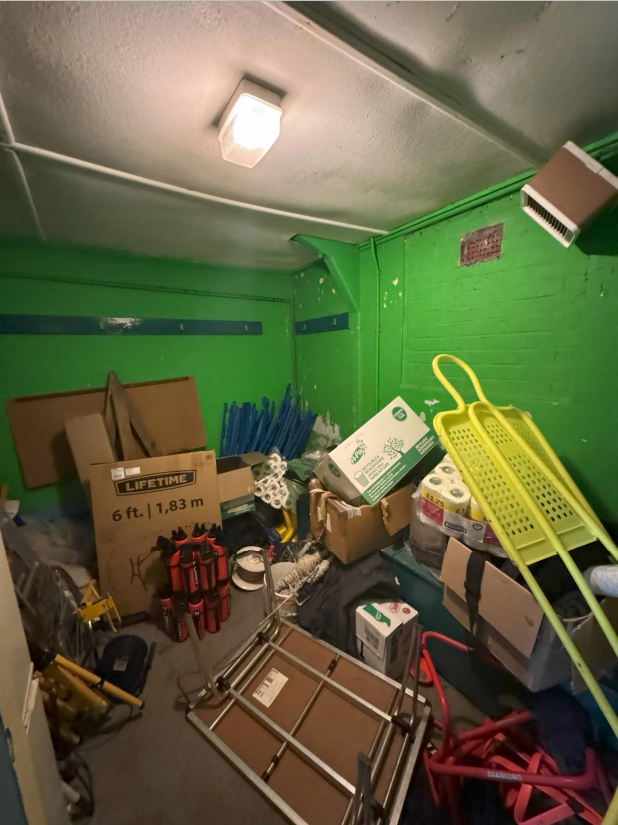
| ITEM | PHOTOGRAPH | DESCRIPTION / ISSUE |
|---|---|---|
| 6 | | <p><b>STOREROOM</b></p> <p>The storerooms sufficient lighting, heating and ventilation.</p> <p>Also requires smoke detection due to items being stored</p> <p>Also recommend racking is provided to store items safely and remove potential trip hazards etc.</p> |

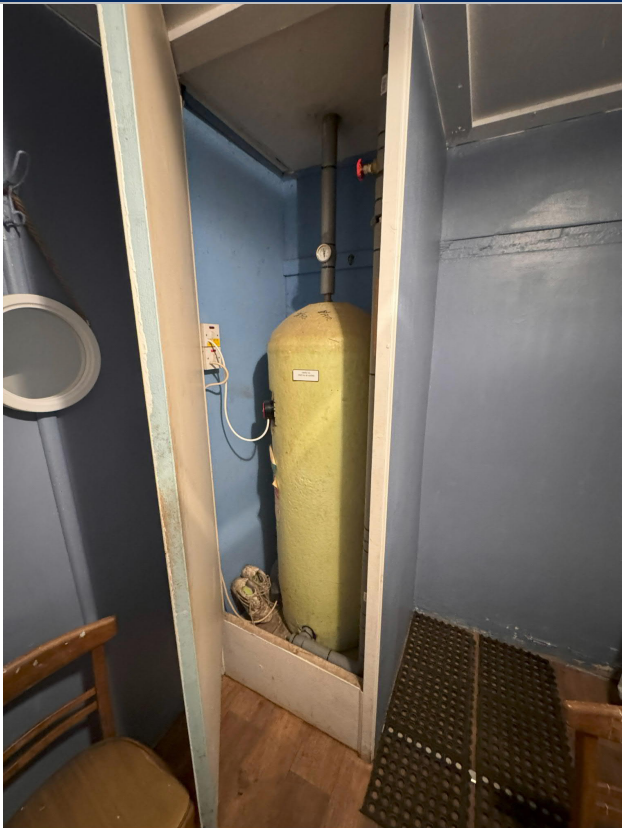
| ITEM | PHOTOGRAPH | DESCRIPTION / ISSUE |
|---|---|---|
| 7 | | <p><b>HOT WATER</b></p> <p>Hot water generation is via an electric cylinder which has no time clock control.</p> <p>This method of hot water generation is not economical and should be replaced and upgraded to an ASHP and / or solar PV generating systems.</p> <p>Also, as more showers will be required to meet current regulations and standards the amount of required hot water storage would need to be increased to meet this peak demand.</p> |

These units need to be replaced they are far past their economic life expectancy. We would recommend plate heat exchangers are utilised to generate the required hot water utilising buffer vessels for storage.

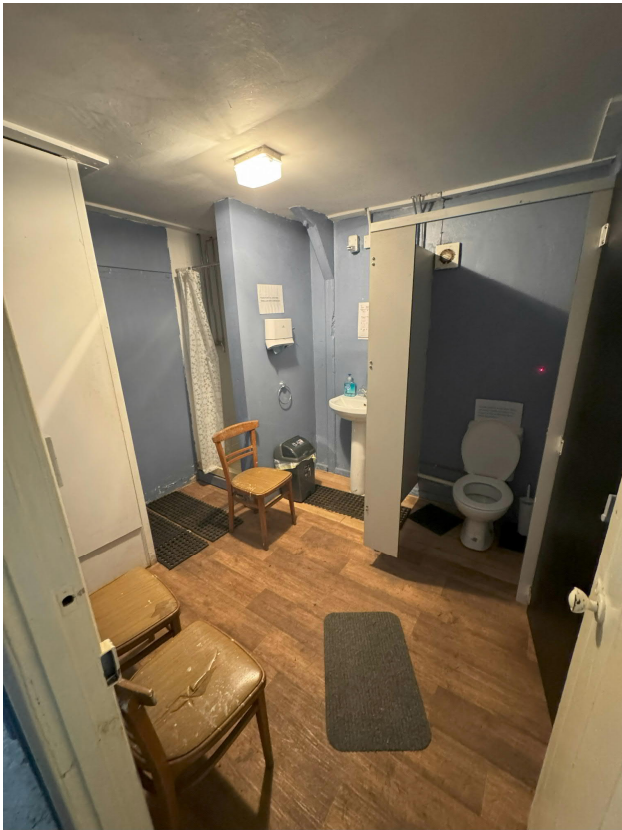
| ITEM | PHOTOGRAPH | DESCRIPTION / ISSUE |
|---|---|---|
| 8 | | <p><b>MATCH OFFICIAL CHANGING ROOMS</b></p> <p>The match official changing rooms are in a state of disrepair and does not have sufficient lighting, heating and ventilation.</p> <p>There is also no facility for female changing areas, showers and toilets.</p> |

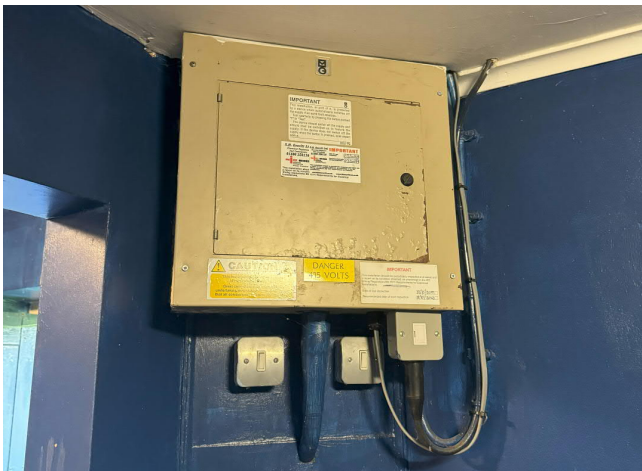
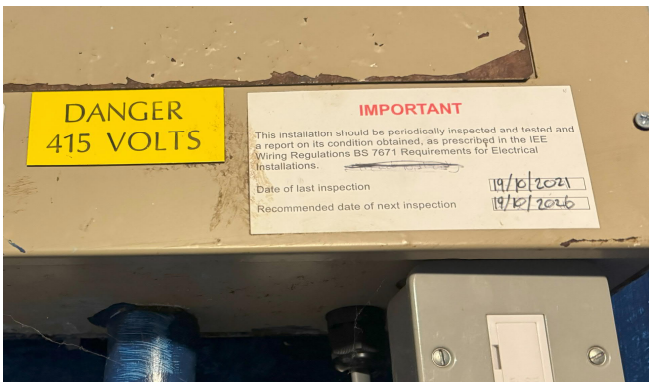
| ITEM | PHOTOGRAPH | DESCRIPTION / ISSUE |
|---|---|---|
| 9 | <br> | <p><b>ELECTRICAL INSTALLATION</b></p> <p>The current distribution board needs to be upgraded to meet current regulations.</p> <p>The last inspection and test was undertaken in 2021 with the next due in 2026.</p> <p>PAT testing also needs to be undertaken throughout the facility.</p> |

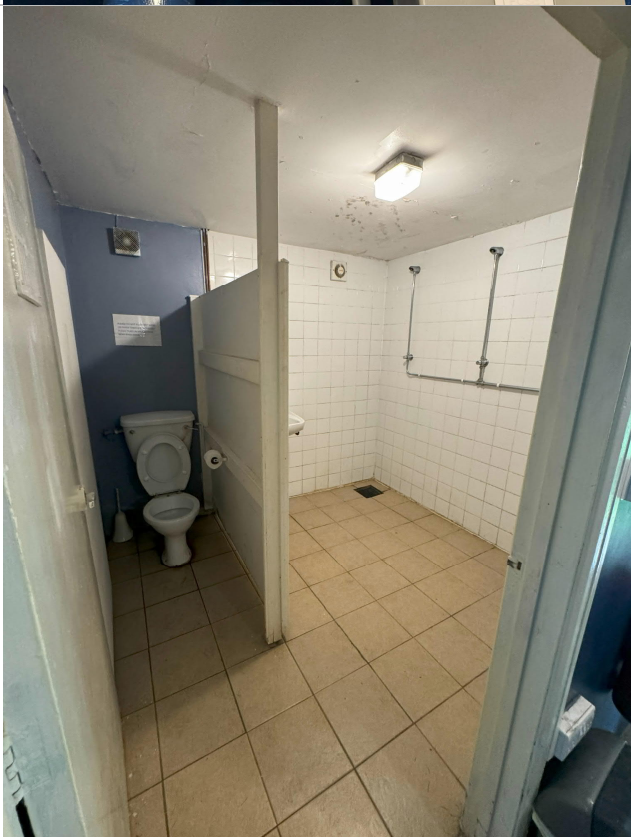
| ITEM | PHOTOGRAPH | DESCRIPTION / ISSUE |
|---|---|---|
| 10 | | <p><b>SHOWERS (AWAY TEAM)</b></p> <p>The current showers need to be upgraded and there are signs of damp and paint is peeling off of the ceilings and the ventilation is inadequate.</p> <p>There is no facility for female/unisex showers, toilets and/or for disabled accessibility.</p> <p>Showers need to be upgraded to meet current regulations and standards.</p> |

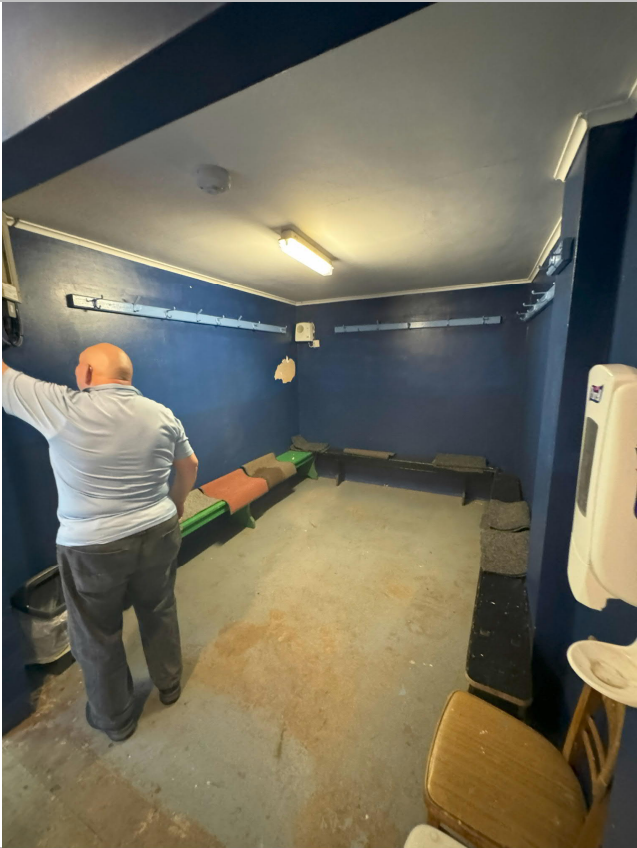
| ITEM | PHOTOGRAPH | DESCRIPTION / ISSUE |
|---|---|---|
| 11 | | <p><b>CHANGING ROOM (HOME TEAM)</b></p> <p>The changing rooms are in a state of disrepair and does not have sufficient lighting, heating and ventilation.</p> <p>There is also no facility for female changing areas.</p> |

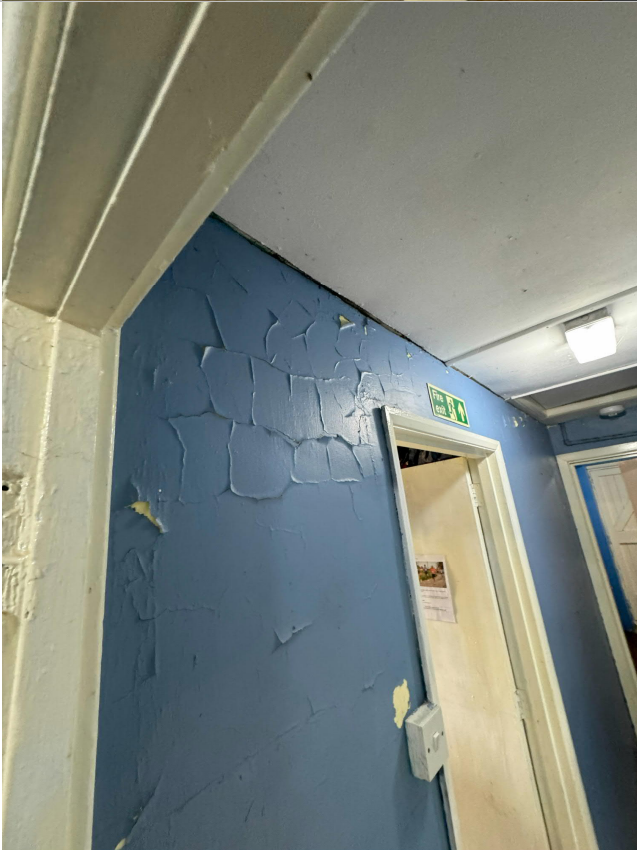
| ITEM | PHOTOGRAPH | DESCRIPTION / ISSUE |
|---|---|---|
| 12 | | <p><b>DETERIORATION</b></p> <p>Throughout the building there are significant signs of deterioration of the fabric, paint and services.</p> <p>This is generally due to the age of the building, poor/no insulation, lack of ventilation and heating.</p> |

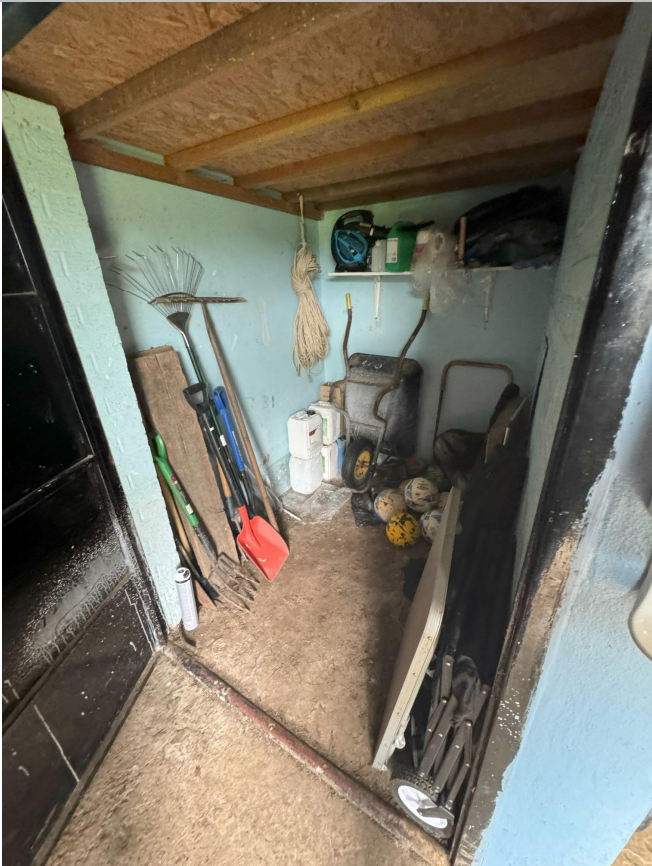
| ITEM | PHOTOGRAPH | DESCRIPTION / ISSUE |
|---|---|---|
| 13 | | <p><b>INTERNAL SECURE STORE</b></p> <p>This room within the front entrance / seating area has not lighting or smoke detection.</p> |

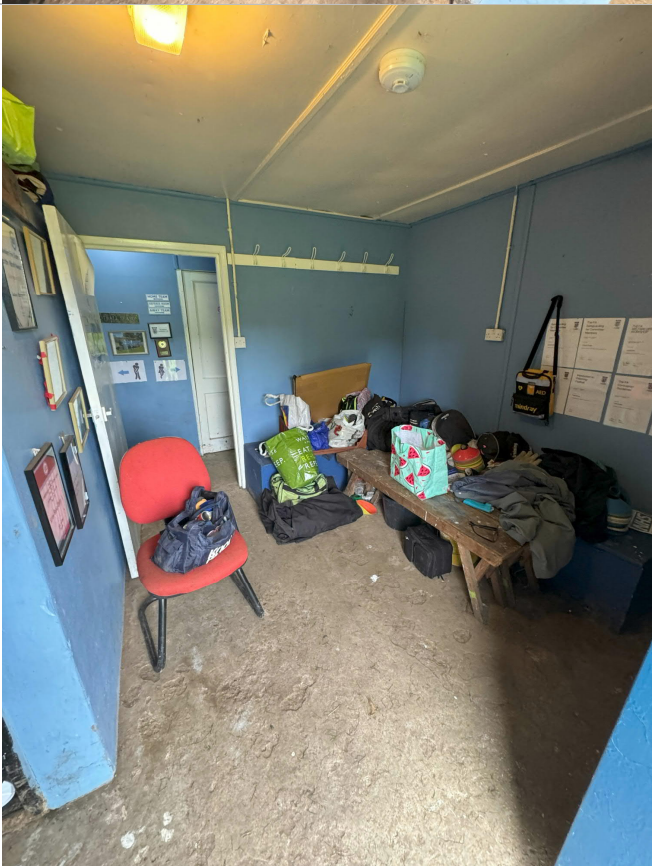
| ITEM | PHOTOGRAPH | DESCRIPTION / ISSUE |
|---|---|---|
| 14 | | <p><b>ENTRANCE / SEATING AREA</b></p> <p>This area is again in a state of disrepair and does not have sufficient lighting and heating.</p> |

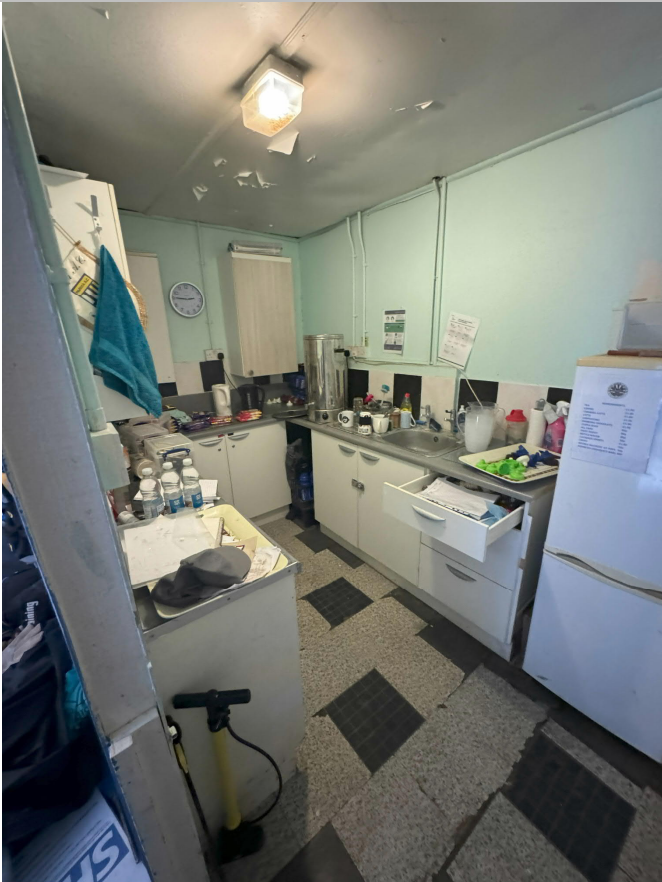
| ITEM | PHOTOGRAPH | DESCRIPTION / ISSUE |
|---|---|---|
| 15 | | <p><b>KITCHENETTE / TEA ROOM</b></p> <p>This area is again in a state of disrepair and does not have sufficient lighting and heating.</p> <p>Recommend heat detector is also installed. Hygiene issues are also likely due to the dis-repair within the room.</p> |

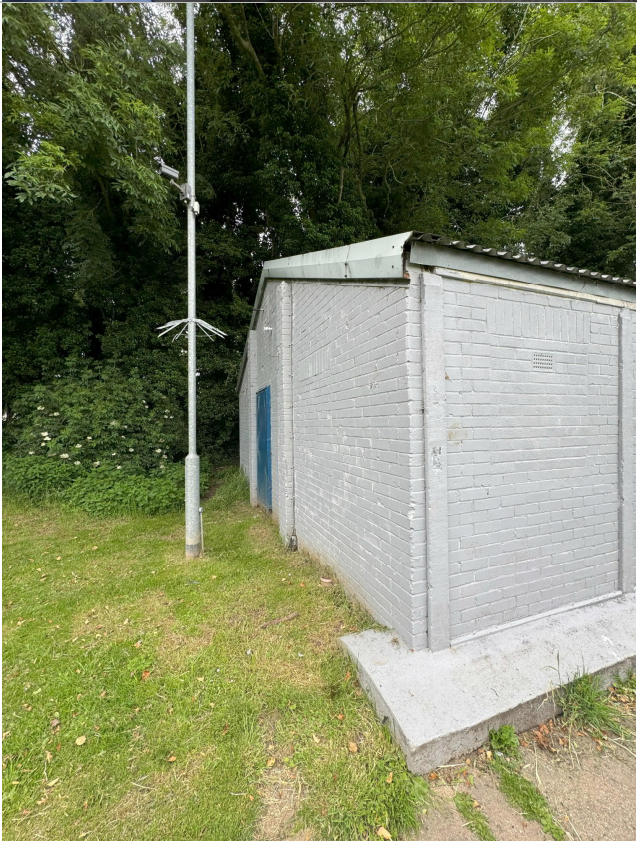
| ITEM | PHOTOGRAPH | DESCRIPTION / ISSUE |
|---|---|---|
| 16 | | <p><b>EXTERNAL</b></p> <p>No natural light provided due to windows being bricked up for security reasons.</p> <p>Roof in general needs replacing and upgrading.</p> |

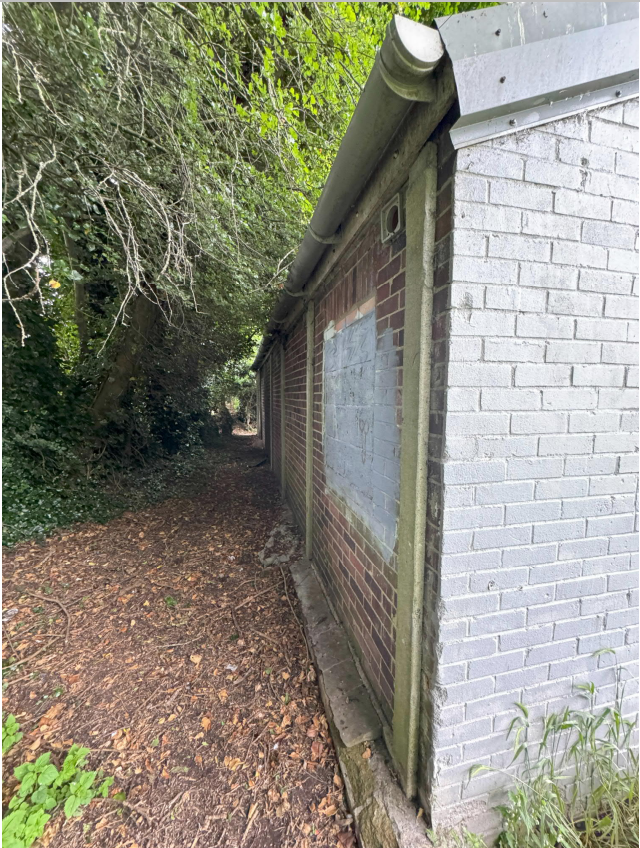
| ITEM | PHOTOGRAPH | DESCRIPTION / ISSUE |
|---|---|---|
| 17 | | <p>EXTERNAL</p> <p>No natural light provided due to windows being bricked up for security reasons.</p> <p>Roof in general needs replacing and upgrading.</p> |

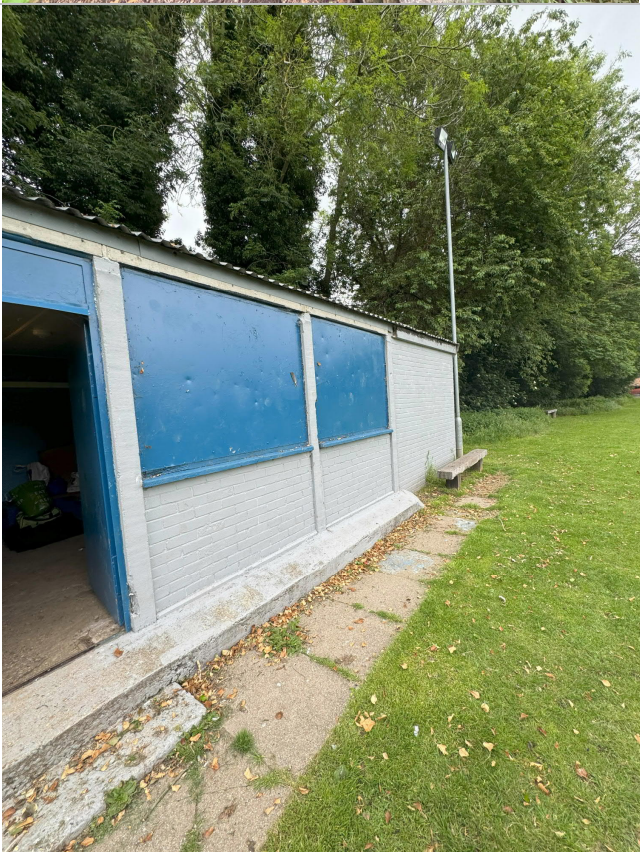
| ITEM | PHOTOGRAPH | DESCRIPTION / ISSUE |
|---|---|---|
| 18 | | <p>EXTERNAL</p> <p>No natural light provided due to windows being bricked up for security reasons.</p> <p>Roof in general needs replacing and upgrading.</p> <p>Insufficient external / security lighting.</p> |

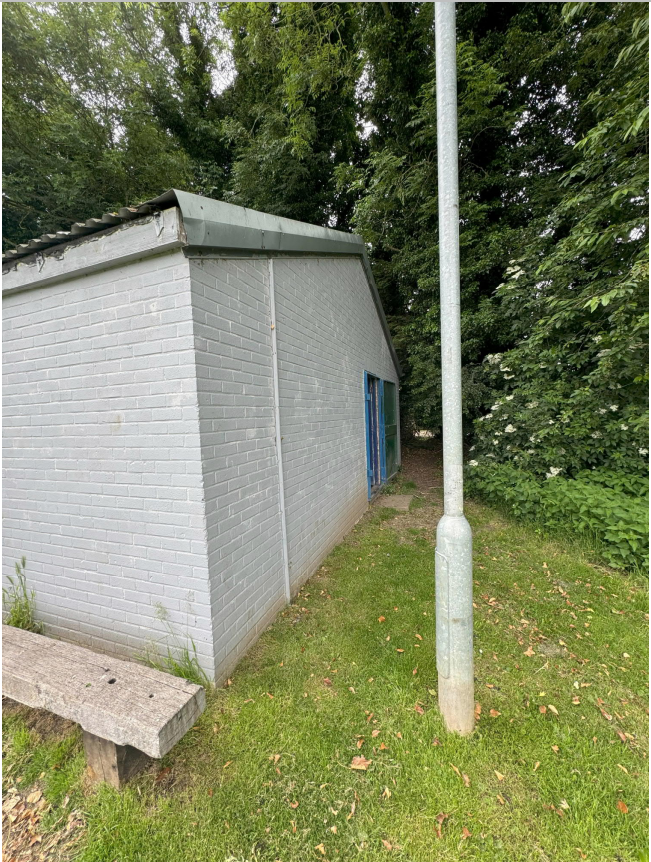
| ITEM | PHOTOGRAPH | DESCRIPTION / ISSUE |
|---|---|---|
| 19 | | <p>EXTERNAL</p> <p>No natural light provided due to windows being bricked up for security reasons.</p> <p>Roof in general needs replacing and upgrading.</p> |
