# Historic Building Record

*The Coach House, Avenue Farm House, Sutton Bridge.*

A programme of historic building recording was undertaken prior to the renovation and conversion of an outbuilding at Avenue Farm House, Avenue Farm Road, Sutton Bridge, Lincolnshire.

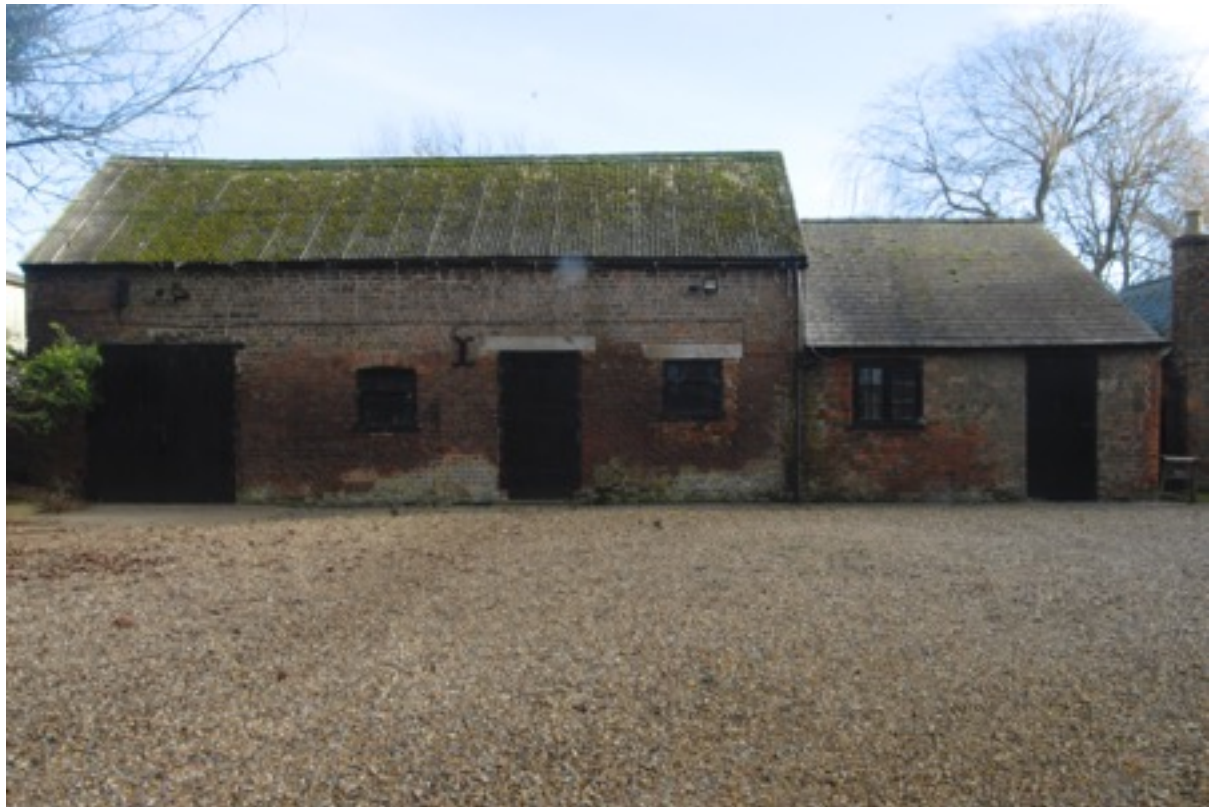
Plate 1.

| Plate 1 | General view of the front facade of the outbuilding showing the western elevation. |

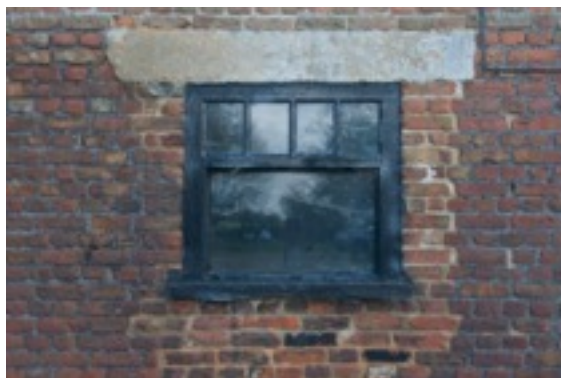
Plate 6 - Window detail showing historic changes

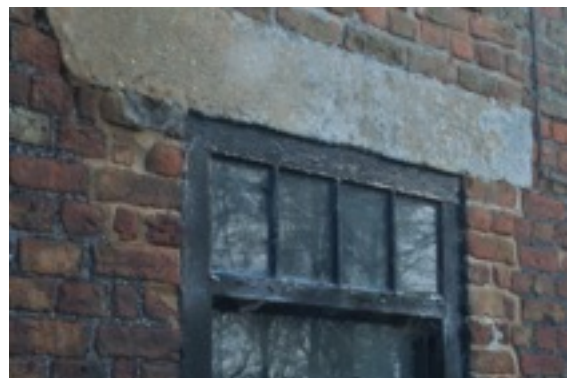
Plate 7 - Mortar and bond differences when window was fitted. Timber frames are no longer original.

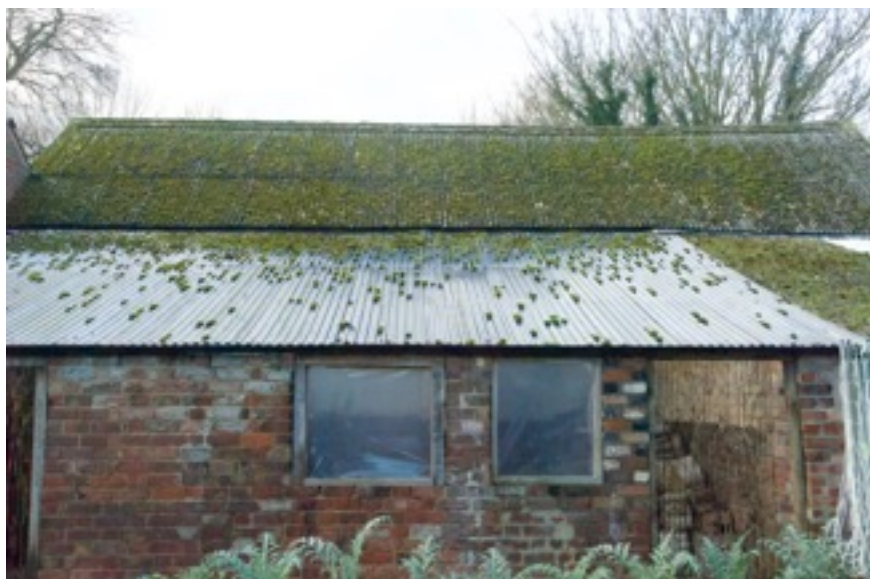
elevation is currently covered by a corrugated plastic roof, (Plate 9) with the roof members supported with wooden beams, most of which are not original. The original roof would have been slate to compliment with the main roofing materials. The open fronted shelter as also noted on the the 1991 and 1995 site plans is no longer present. Whilst most of the partition walls are still in place a few have been removed by the different owners over the years to suit their needs. The difference in both bond and mortars highlight the mix of styles throughout the building.

**Plate 9 - View of Rear Elevation (B)**

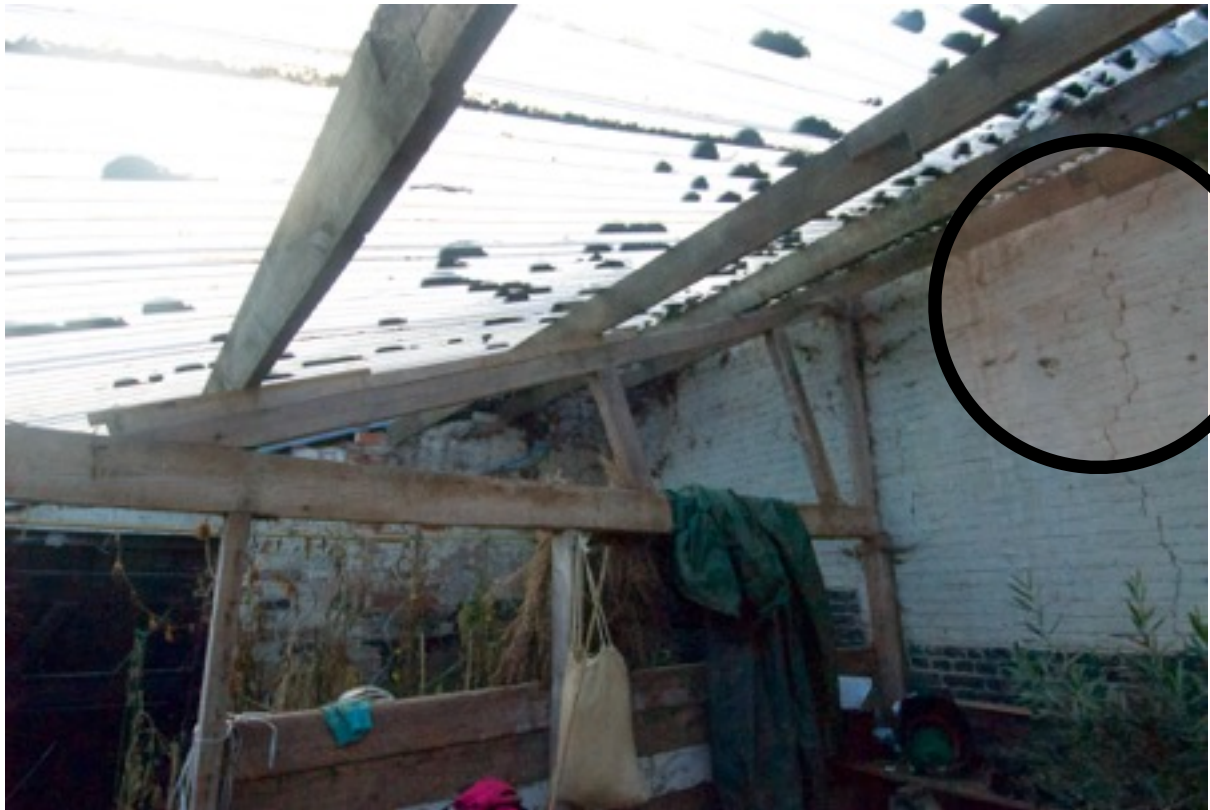
**Plate 10 - Very simple timber rafters to support temporary roof.**

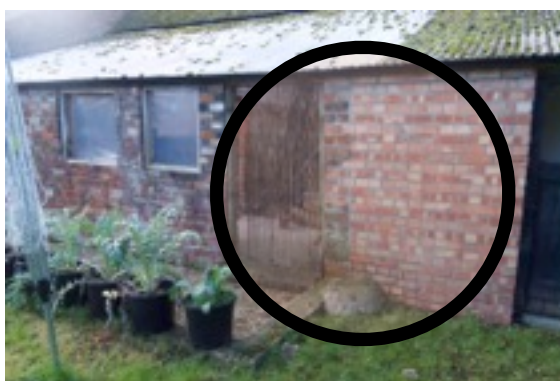
**Plate 11 - Window detail showing historic changes**

The previous foundation is evident and it is clear the a newer wall built in English Garden Wall Bond with much newer bricks (Plate 11). Structural integrity is most probably compromised with evidence of cracking on the partition walls. Modern machinery has been

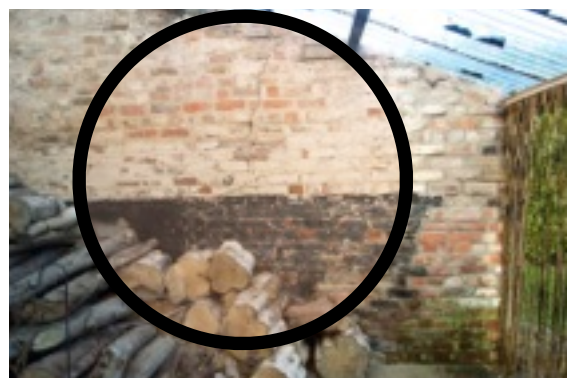
**Plate 12 - Log Store.**

| Plate 12 | Log Store - view detailing crack in roof support. |

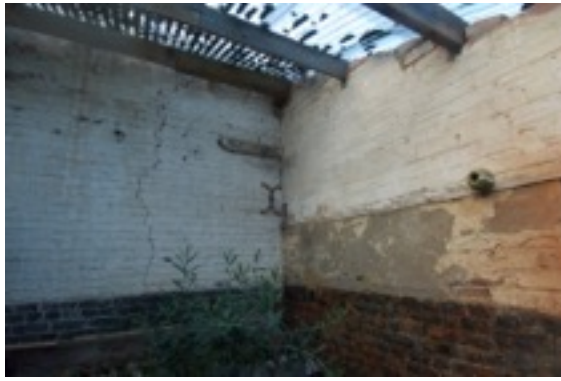
**Plate 13 - Window detail showing historic changes**

used to carve a doorway here without proper consideration of the weight above and cracking is evident. The building has been pinned over the years (plate 13), and the roof supports have clearly been designed to be temporary.

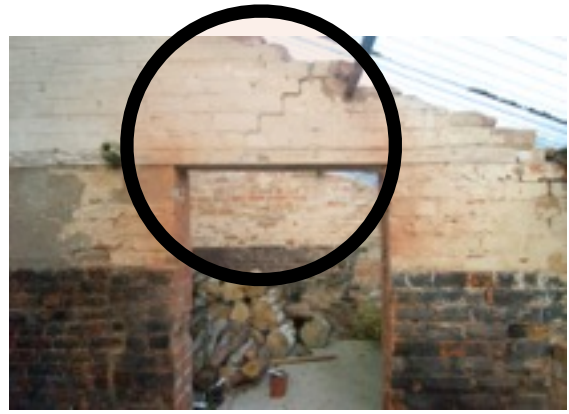
**Plate 14 - Log Store.**

| Plate 14 | Log Store - view detailing crack in roof support. |

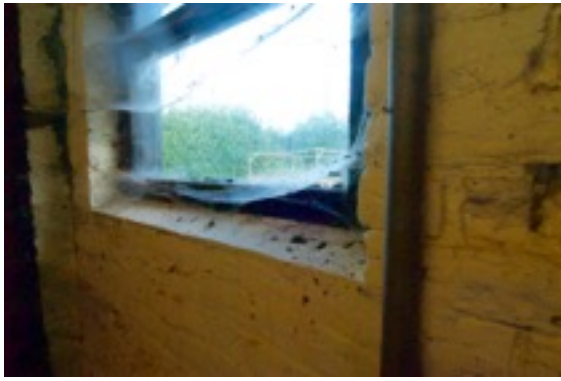
**Plate 16 - Window detail showing historic changes**

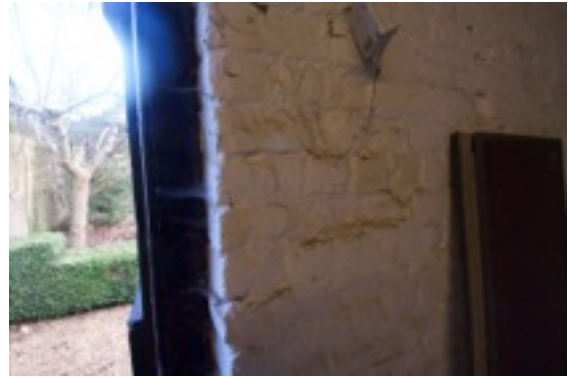
**Plate 17 - Walls showing whitewashing for protection from decay.**

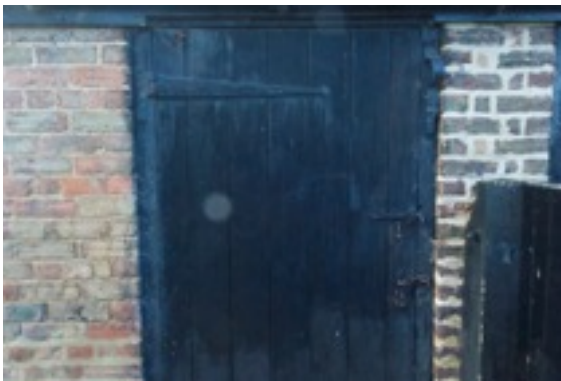
**Plate 18 - Door and different rendering techniques**
