## Structural Survey Report

for  
Proposed Barn Conversion

at  
185 Avenue Farm Road  
Sutton Bridge  
Spalding

Job reference: WECE-24-500

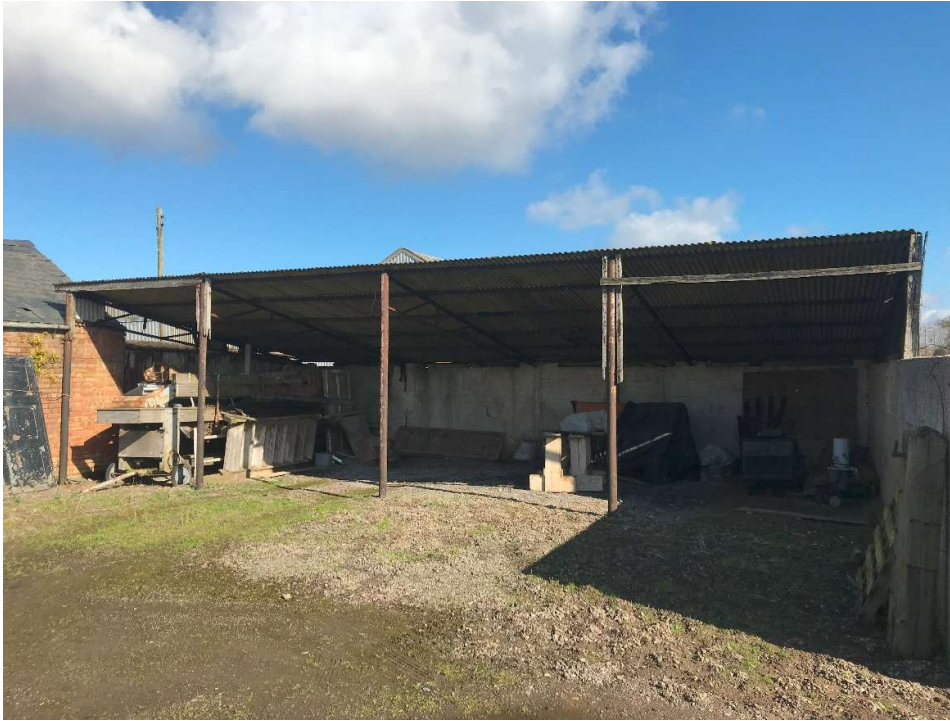
- 4.19. The structural components of Store 5 appear to have performed satisfactorily to date. However, we noted evidence of surface corrosion to the exposed steelwork and some areas of spalled concrete revealing reinforcement at some locations of the reinforced concrete walls.

Photo 10. Courtyard Store 5 open side elevation

- 5.10. Any steelwork with surface corrosion will need to be prepared appropriately and repainted to guarantee its condition for the foreseeable future. Some patch repairs to the steel members may be required following close inspection during the preparation for painting.

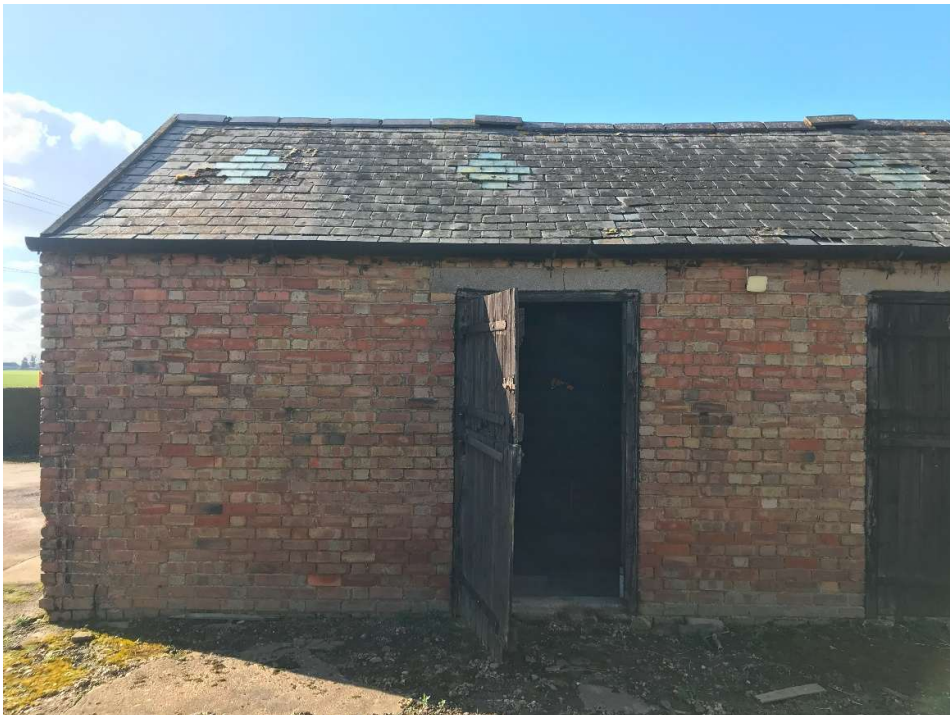
- 4.11. Concrete lintels were provided at the head of all doors and windows supporting masonry and roof structures over on the original barns. However, we comment that most contained vertical cracks at mid-span indicating these lintels have failed. At these locations, the timber header of the door frame appeared to be providing necessary support the structure over.

Photo 11. Store 1 cracked lintel from outside

- 5.08. When undertaking the conversion works, proprietary lintels (pre-cast concrete or steel), or appropriately sized timber sections where no masonry is to be supported over, should be installed to manufacturers or designers' specifications over all door or window openings.

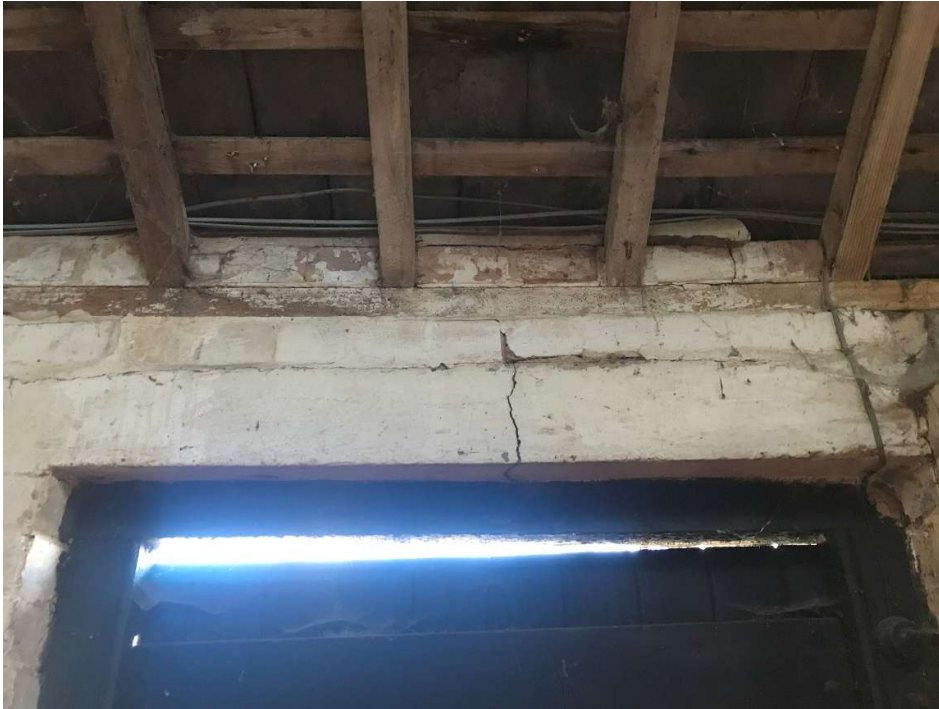
Photo 12. Store 1 cracked lintel from inside

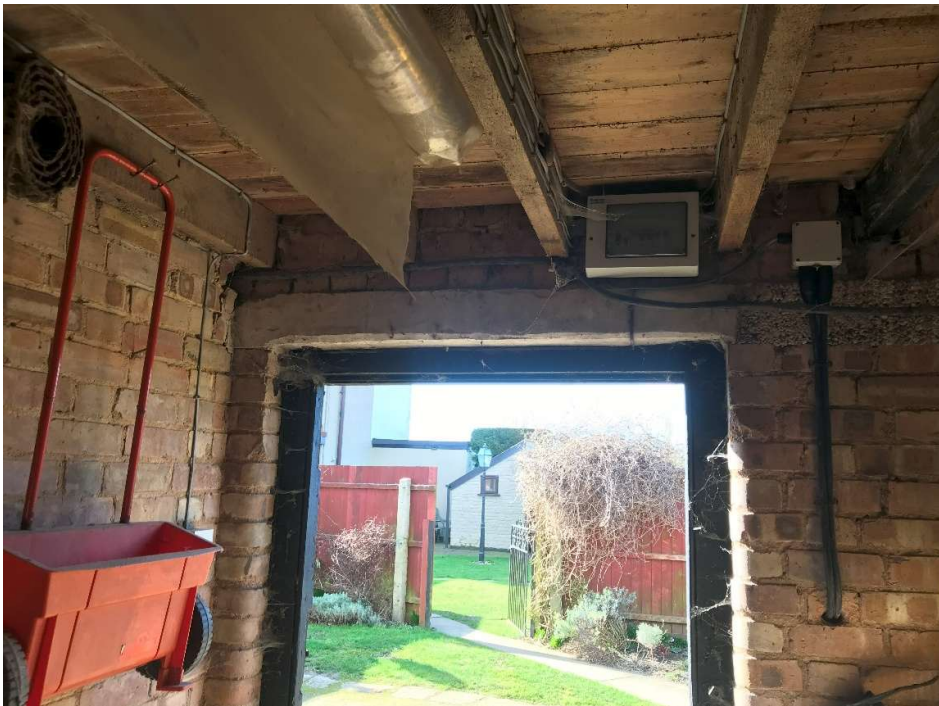
Photo 13. Store 2 lintel with minimal end bearing on RHS

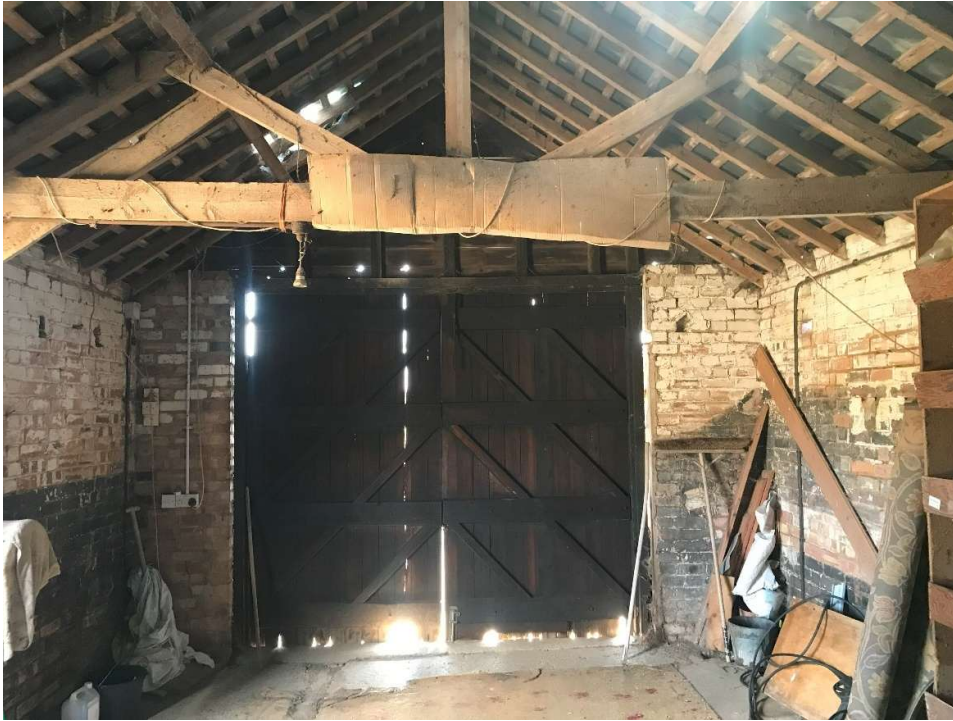
- 4.06. The original barns duo pitch gable end roofs comprise a traditional slate tile on a cut roof formed with common rafters at regular 300-450mm centres on purlins supported by timber king post roof trusses spaced at mid-span, third or quarter points in the case of the single storey stores. The two-storey building has a central truss which is propped from the first-floor structure with two queen posts set beneath each purlin position. The timber purlins are founded directly in the masonry gable end walls. We did not note any protection from moisture transfer from the masonry at gable ends or any roof plan bracing members.

Photo 14. Store 1 king post roof truss

- 5.02. Most of the roof structure (rafters, purlins, and trusses) appear to be currently performing satisfactorily. In converting the barn for domestic use there are likely to be additional loads by adding insulation and roofs. As such all existing roof structures should be confirmed suitable, strengthened, or new roof timbers installed appropriately, all designed by a suitably qualified person.

- 5.03. Should it be confirmed appropriate to retain existing timber members based in their size and spacing, the condition of the members should be confirmed in serviceable condition while undertaking works on the roof structure when the members are clearly visible all around. Any members confirmed to be adversely affected by insect infestation or rot should be treated or replaced as necessary. Any timber member bearing into the existing solid masonry walls should be protected from moisture transfer from the wall.

- 5.04. The addition of roof plan bracing, or ceiling diaphragms, would benefit the existing barns structural elements by providing an effective means of transferring roof level lateral loads to shear walls and adding strength and stability to the existing masonry envelope walls.

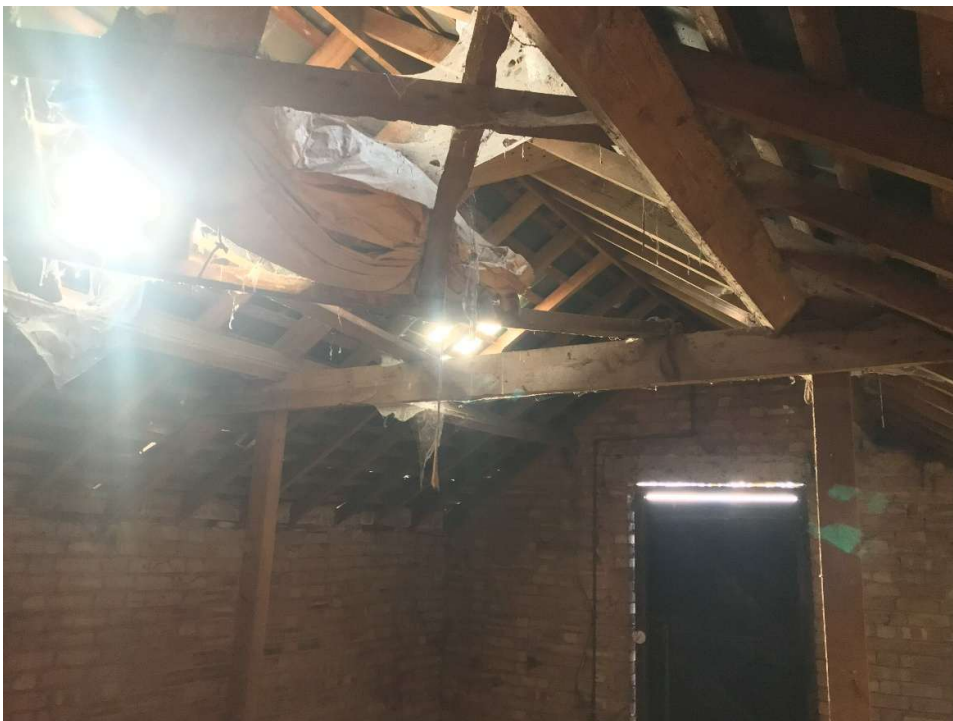
Photo 15. Store 2 king post roof truss

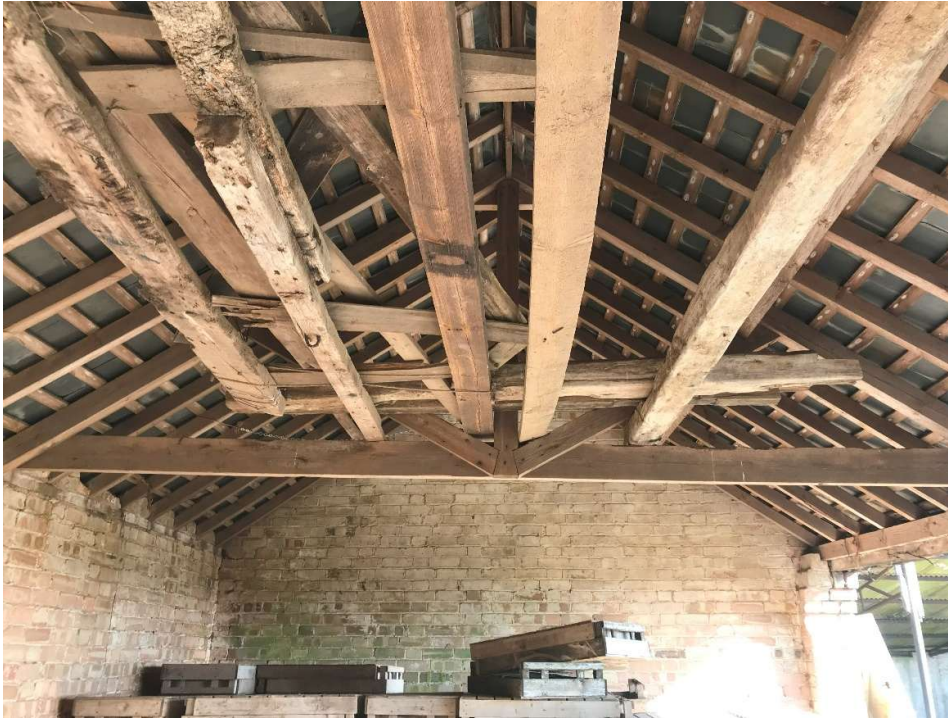
- 4.14. The shelter roof structure of Store 3 is supported by masonry walls along the three enclosed elevations—north, east, and west. On the open south-facing elevation, which faces the courtyard, vertical support to the roof trusses is provided by timber posts in lieu of masonry walls. These timber posts are founded on concrete piers raised approximately 0.70 m above ground level. The structural timber members appear to have performed to structural requirements to date.

Photo 16. Store 3 king post roof truss

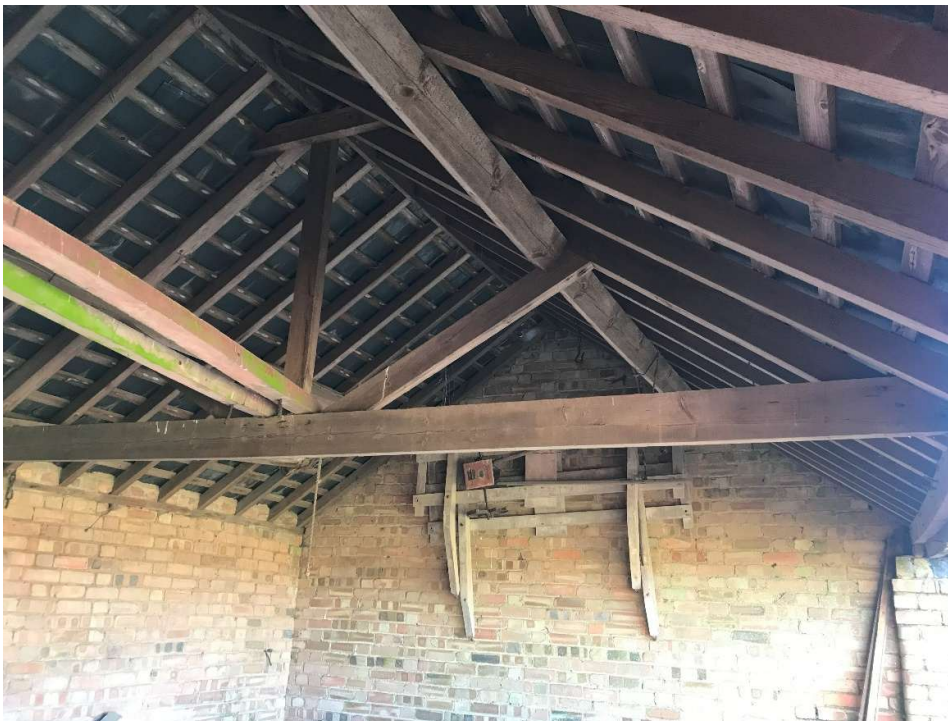
- 4.15. The shelter roof structure of Store 4 is supported by masonry walls along the three enclosed elevations—east, south, and west. On the open south-facing elevation, which faces the fields at the rear of the property, vertical support to the roof truss is provided by timber eaves beam in lieu of masonry walls. The structural timber members appear to have performed to structural requirements to date.

Photo 17. Store 4 king post roof truss

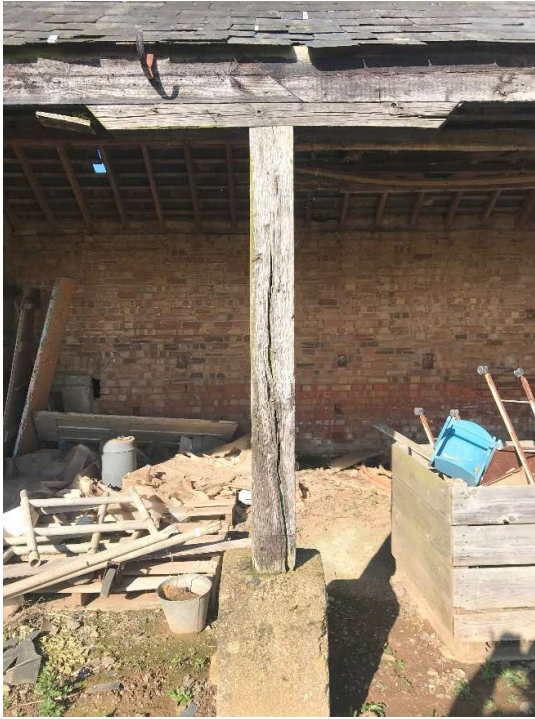
Photo 18. Store 3 timber post supporting eaves beam

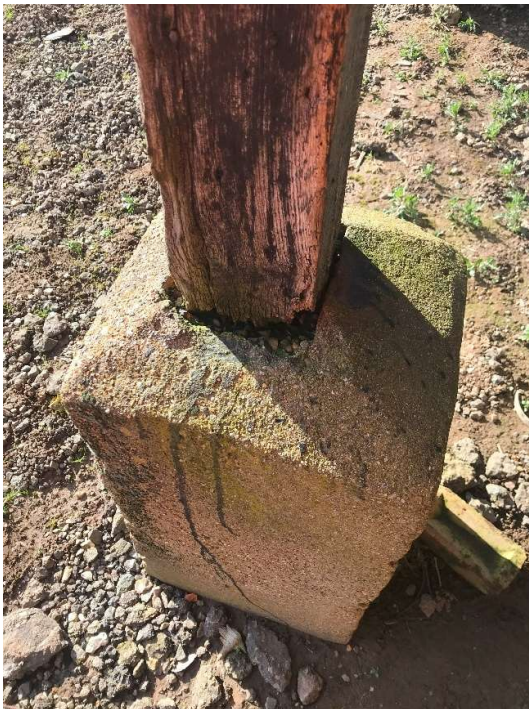
Photo 19. Store 3 timber post base detail

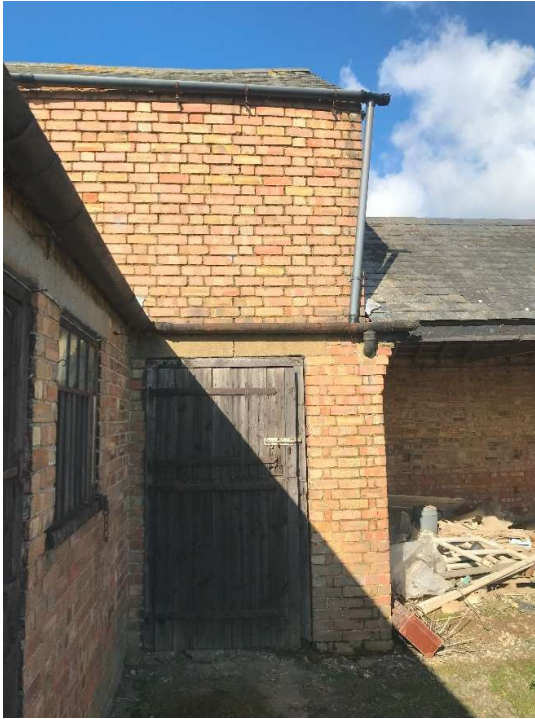
Photo 20. Store 2 stormwater goods

- 5.07. The existing above ground drainage goods were observed to be in a variety of conditions around the barns. At the time of the survey, we were not provided with survey information for the below ground drainage and as such cannot comment on its present condition. If it is proposed to use the existing underground system, we suggest getting a survey undertaken to confirm the pipes are suitably sized and serviceable for the proposed development or confirmed otherwise. As a minimum we would expect all guttering to be free from debris, fixed to an appropriate fall to correctly connected and installed downpipes, which in turn should be suitably connected to the underground drainage network to transfer surface water a safe distance away from any building foundations in accordance with modern standards and regulations to soakaways or similar as necessary.

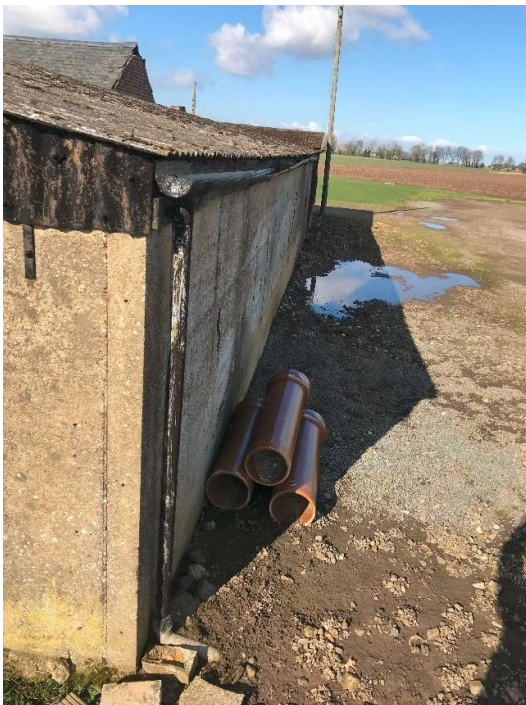
- 4.20. Rainwater goods have been provided along the low eaves of Store 5. However, they were considered non-functioning and in need of repair.
- 4.21. Store 6 is a small timber framed rectangular, approximately 6.00m x 3.00m on plan and 2.70m to low eaves, lean-to structure off the north side of Store 2. Again, this structure is considered a more recent addition.

Photo 21. Store 5 east side elevation stormwater goods

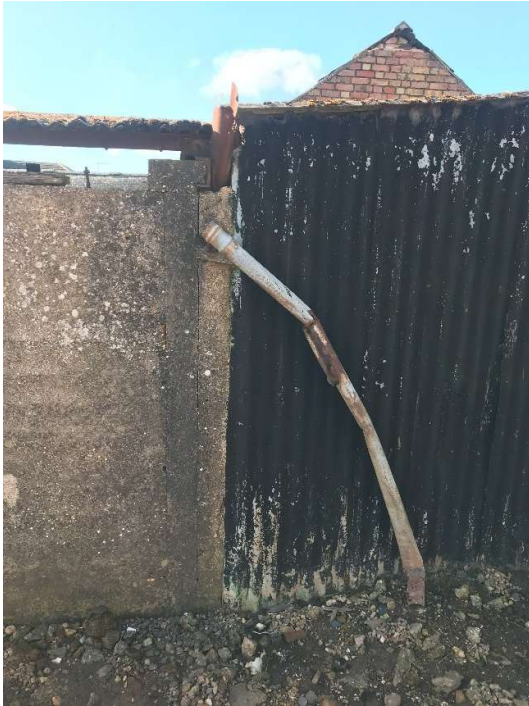
Photo 22. Store 5 north end stormwater goods

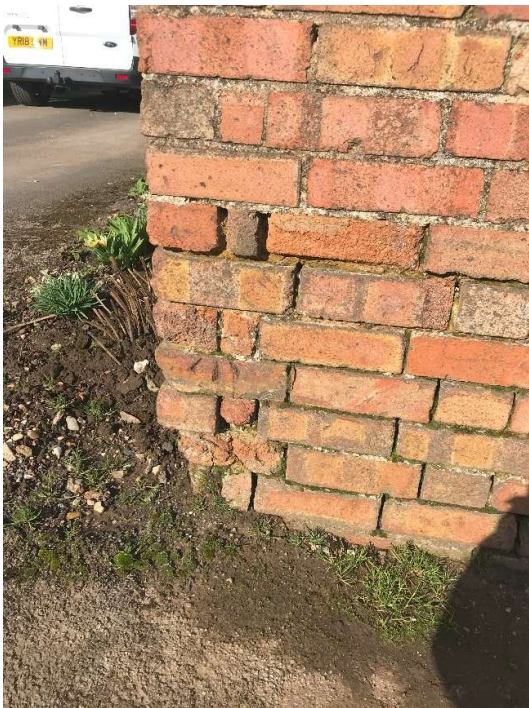
- 4.10. The original barns load bearing walls, considering their age, generally appeared to be in good structural condition with little signs of movement or settlement. We noted some weathering, particularly of the mortar joints at a few locations, and some small areas at corners containing damaged brick units

Photo 23. Weathered masonry

- 5.05. Any repairs to the masonry walls bonded with lime mortar should be undertaken using traditional methods. Any historical repairs, if applicable - locations to be confirmed on site, undertaken using ordinary portland cement-based mortar should be removed and replaced with lime mortar as required.

- 5.06. Any minor cracks in masonry walls should be repaired with proprietary crack stitching kits by Helifix, or similar approved. All cracked or overly weathered masonry units are to be replaced, and mortar joints repointed. All locations to be confirmed on site following close inspection.

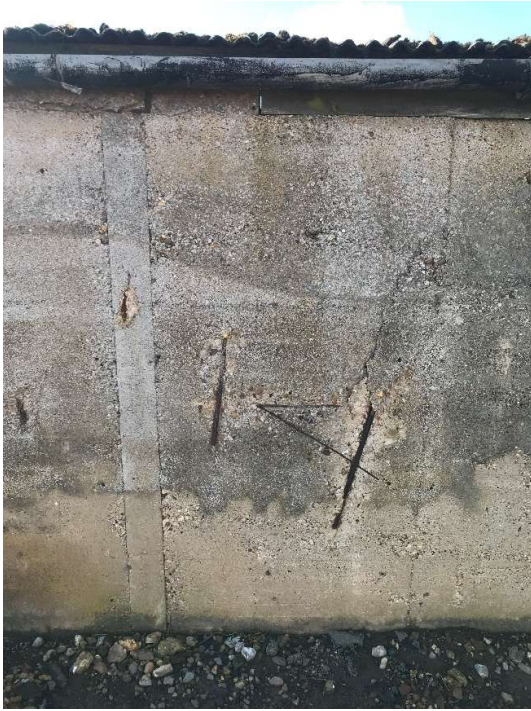
Photo 24. Store 5 load bearing RC wall with exposed reinforcement

- 5.11. Any reinforced concrete with exposed reinforcement will need to be prepared appropriately and repaired with concrete to guarantee its condition for the foreseeable future.

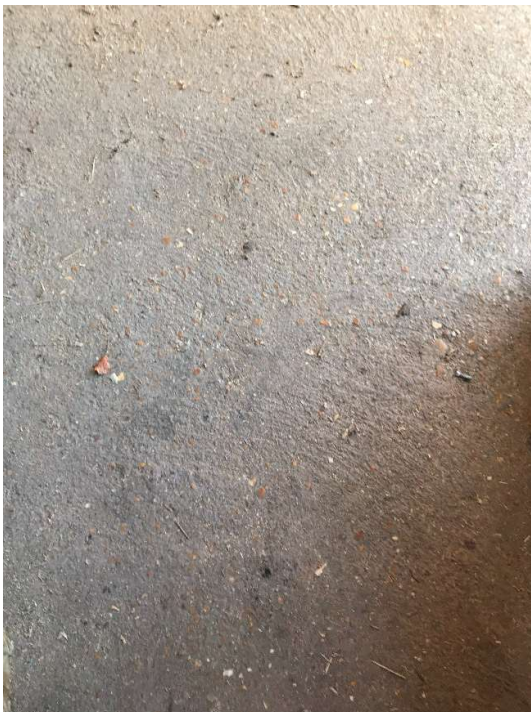
- 4.29. The ground floor of Store 1 and 2 was observed to be concrete which appeared to be in reasonable structural condition with no evidence of significant cracks or settlement. We noted the formed gutter and sloping surfaces in Store 1, evidence of its assumed historical stable use. There were no concrete slabs to any of the shelter structures of Stores 3, 4, 5, 6 or 7.

Photo 25. Store 2 concrete floor slab
