# ANTHONY-JOHNSON

Wingland Farm,  
Walpole Marsh,  
PE14 7JH

## Overview:

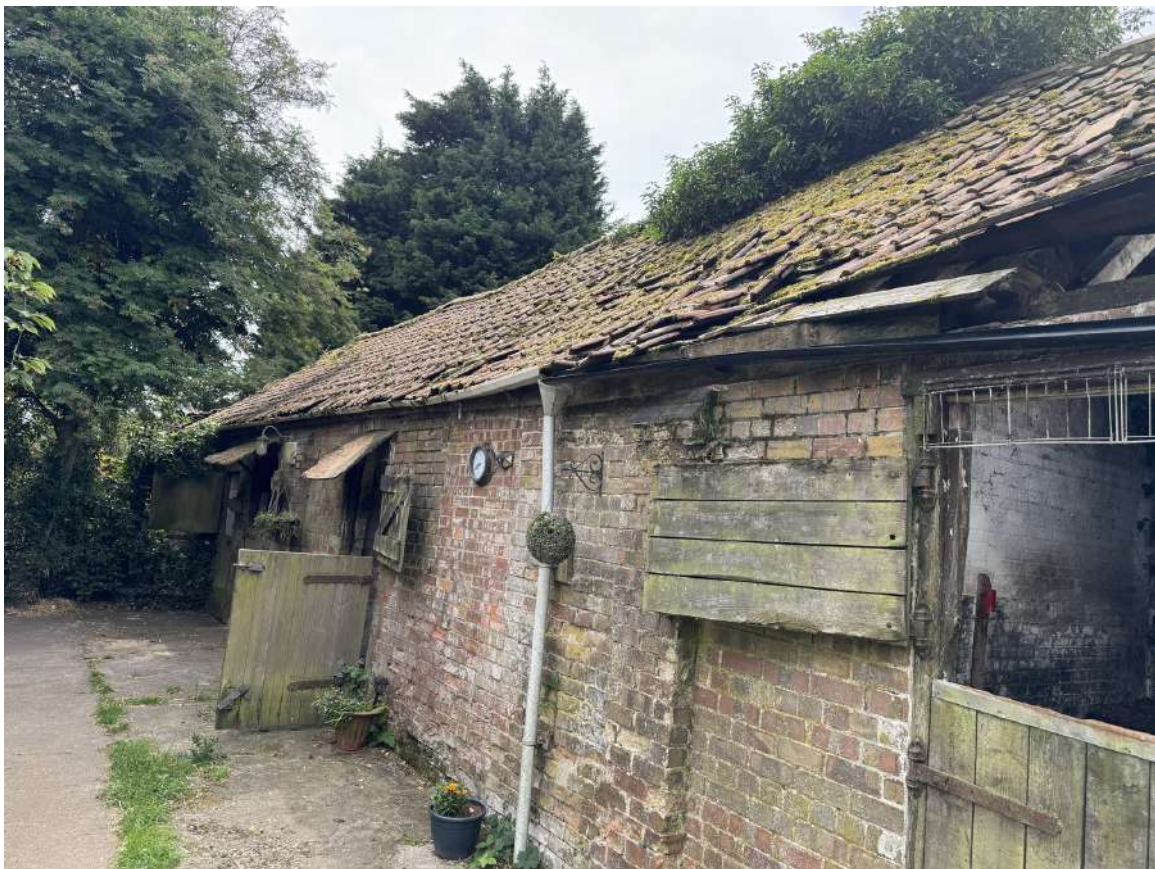
Image 1.0: Exterior view of barn complex showing open bay section with plain tile roof

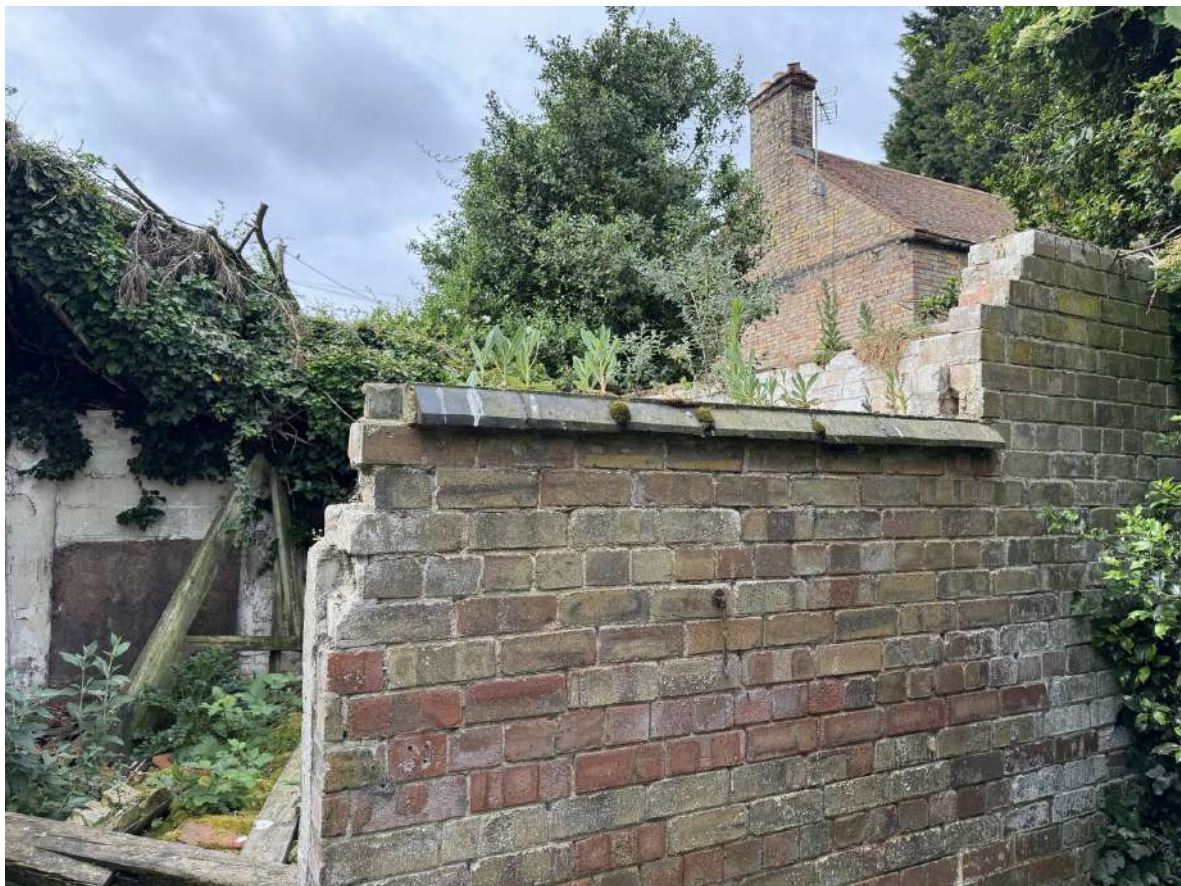
Commencing close to the main residential property, the roof structure to this section has fully collapsed, leaving the masonry end and side elevations standing. The end was clearly formed with a hip roof with the wall plate still present. The wall panel remains intact and functioning as originally intended. The external wall to the front elevation has rotated outward toward the head, with some loss of masonry to the upper courses. The wall to the rear is fully concealed by ivy and could not be visually examined. The finished floor to this section is covered in broken roof tiles and was considered too dangerous to access.

A crack has developed at the front elevation along the juncture with the internal wall, indicating a rotation of the front wall panel in the outward direction. The panel would require reinstatement, tying brickwork back in to the buttressing internal partition.

Image 3.0: Collapsed section adjacent to main residential property, gable and side walls standing

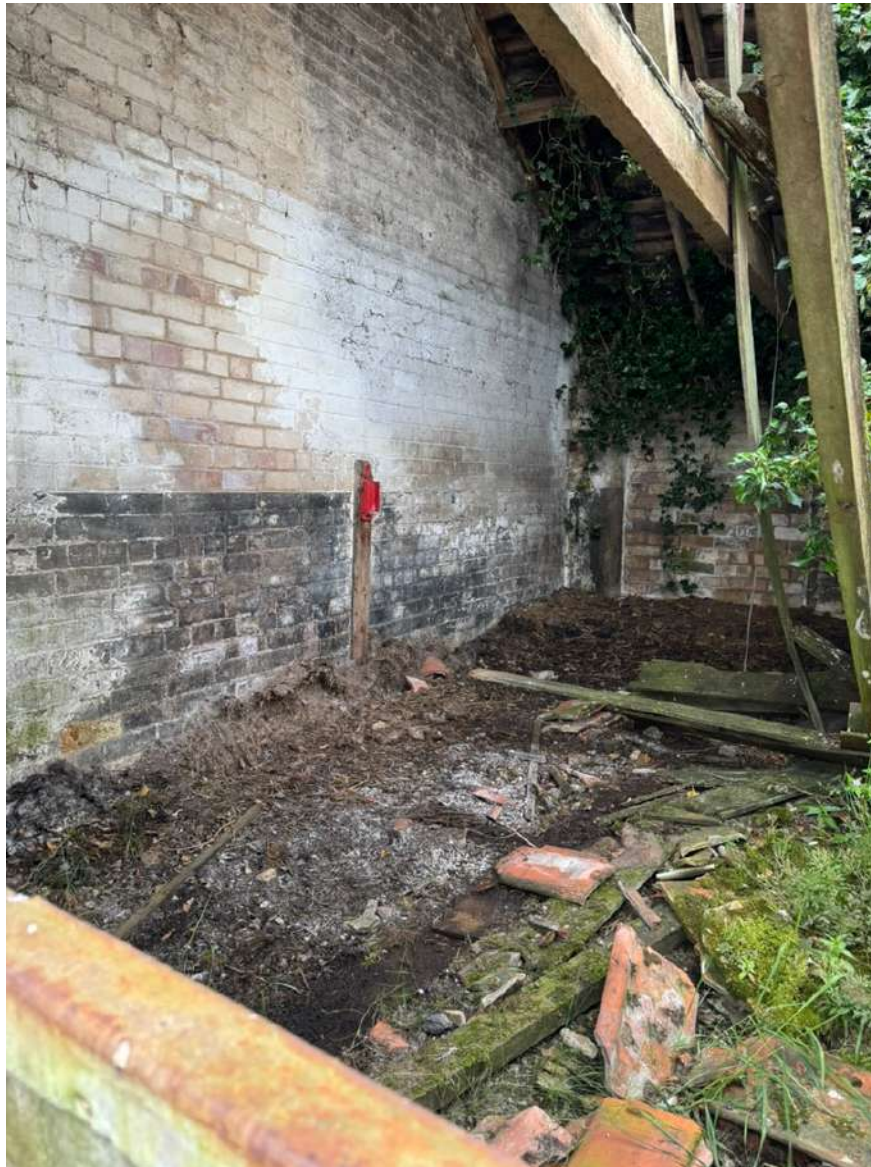
Heading toward the car park area, a stable door is hung off masonry that appears to have bellied in an outward direction with rotation at the head. Reinstatement of the masonry to this section would be required internally, tying the wall back. Horse muck was found to be present to a depth of approximately 1 metre up against the rear elevation, preventing inspection of the finished floor.

Image 4.0: Horse muck, rising to approximately 1 meter above finished floor level.  
Collapsed roof with remaining truss

The roof to this section has fully collapsed with a truss remaining but bowing horizontally. The remaining section of roof has dropped, indicating that the truss has dropped at the far end. The ridgeline has been lost and excessive decay was evident within the remaining timbers.

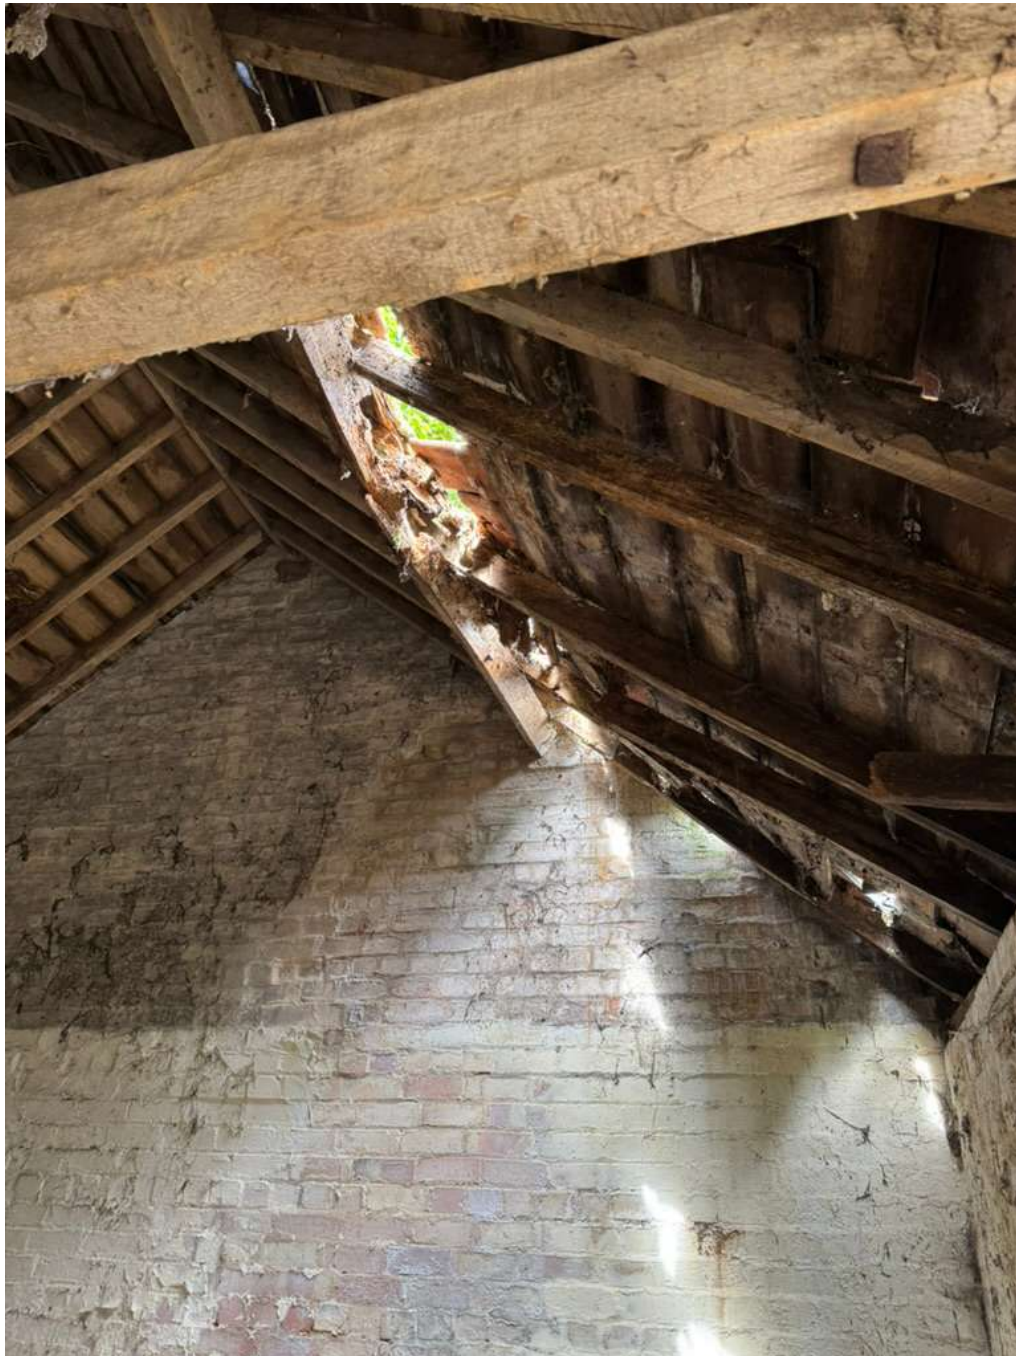
Image 6.0: Failed purlin, with rafters exposed and sarking lost

The next bay is partially intact. A purlin has failed on the front elevation along with the associated rafters and tiles have been lost from the affected area. The sarking board has partially failed. The roof has partially collapsed, although the single truss within this bay remains intact and has partially rotated about its head.

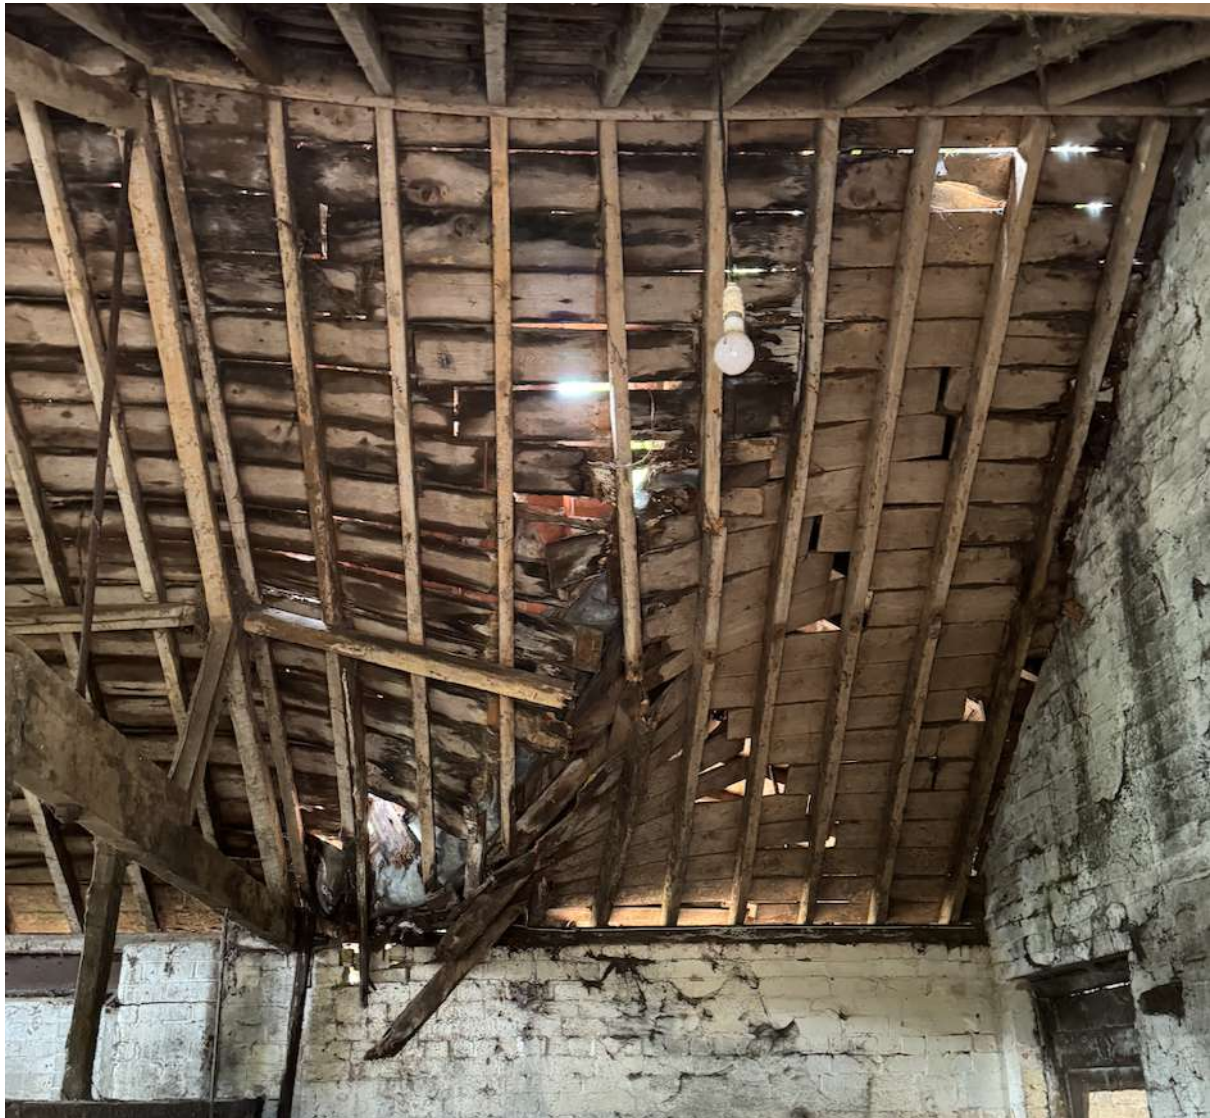
The final section of barn is formed of three open bays. The first bay comprises a roof that has failed with the purlin having snapped and rafters having collapsed. This has resulted in a valley joining an adjacent garage to have also collapsed, and the head of the brick wall to this bay has belled inwards. Masonry separating this bay from the adjacent bay was noted as being intact.

Image 7.0: Failed purlin, rafters, valley to adjacent roof, failed sarking boards and deflecting ridge board.

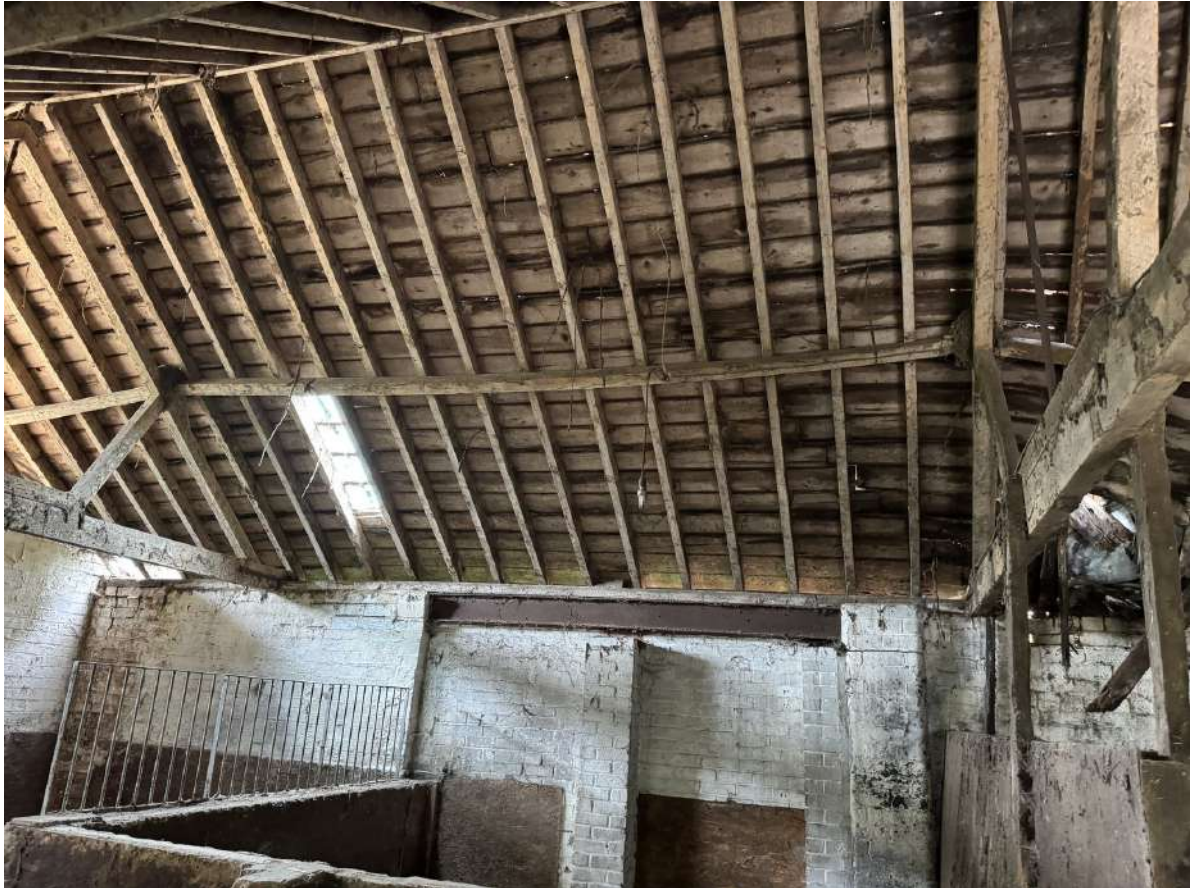
The second bay incorporates a roof that spans a considerable distance between adjacent trusses. The purlin has sagged excessively, indicating that it is overstressed, and this has resulted in the roof sagging with the ridgeline dropping excessively. The span between the existing trusses is excessive for a single purlin; an additional truss should be introduced at mid-bay to reduce the purlin span, support the roof and remove the sag.

Image 8.0: Interior of long span bay showing steel beam to rear elevation and internal stable partitions. Purlin to mid-span of rafters is overstressed and has sagged excessively.

To the long-span bay, the single purlin spans an excessive distance and is overstressed. An additional truss should be introduced at mid-bay to reduce the purlin span and support the roof; the sagged roof can then be re-levelled, arresting the spread that has been imparted to the side elevations. The steel beam to the rear elevation of this bay should be re-bedded so that the outward rotation of the masonry either side of it is removed.

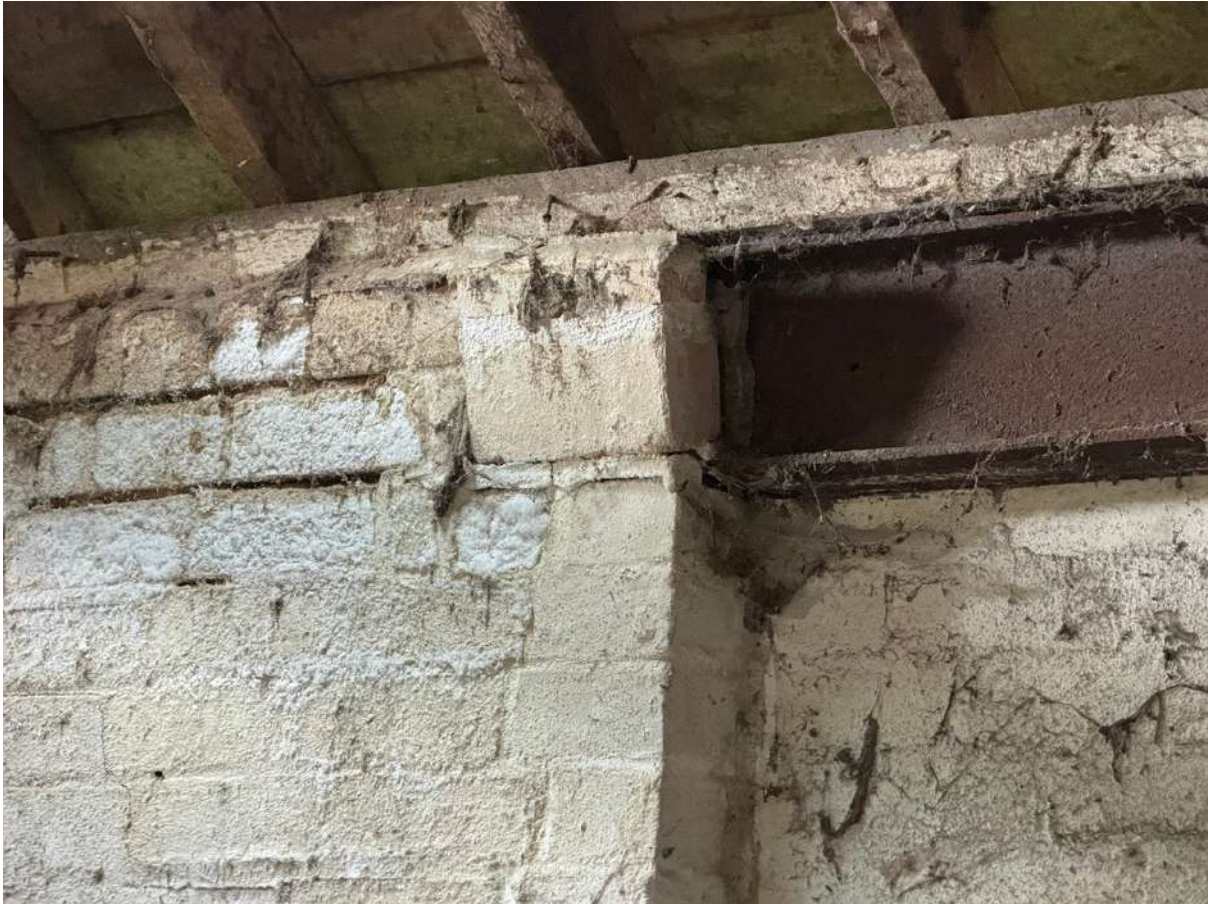
The head of the side elevations has spread as a direct result of the sagging roof, the rafters thrusting the heads of the wall panels outward as the ridge has dropped. The rear elevation to this bay incorporates a steel beam, and the masonry either end of the steel beam has rotated, with a crack developing three courses below wall plate level, indicating that the wall panel has rotated in an outward direction, being pushed by the roof as it drops and attempts to spread.

Image 9.0: Masonry and beam rotating outward due to thrust imparted to head of wall panel by rafters.

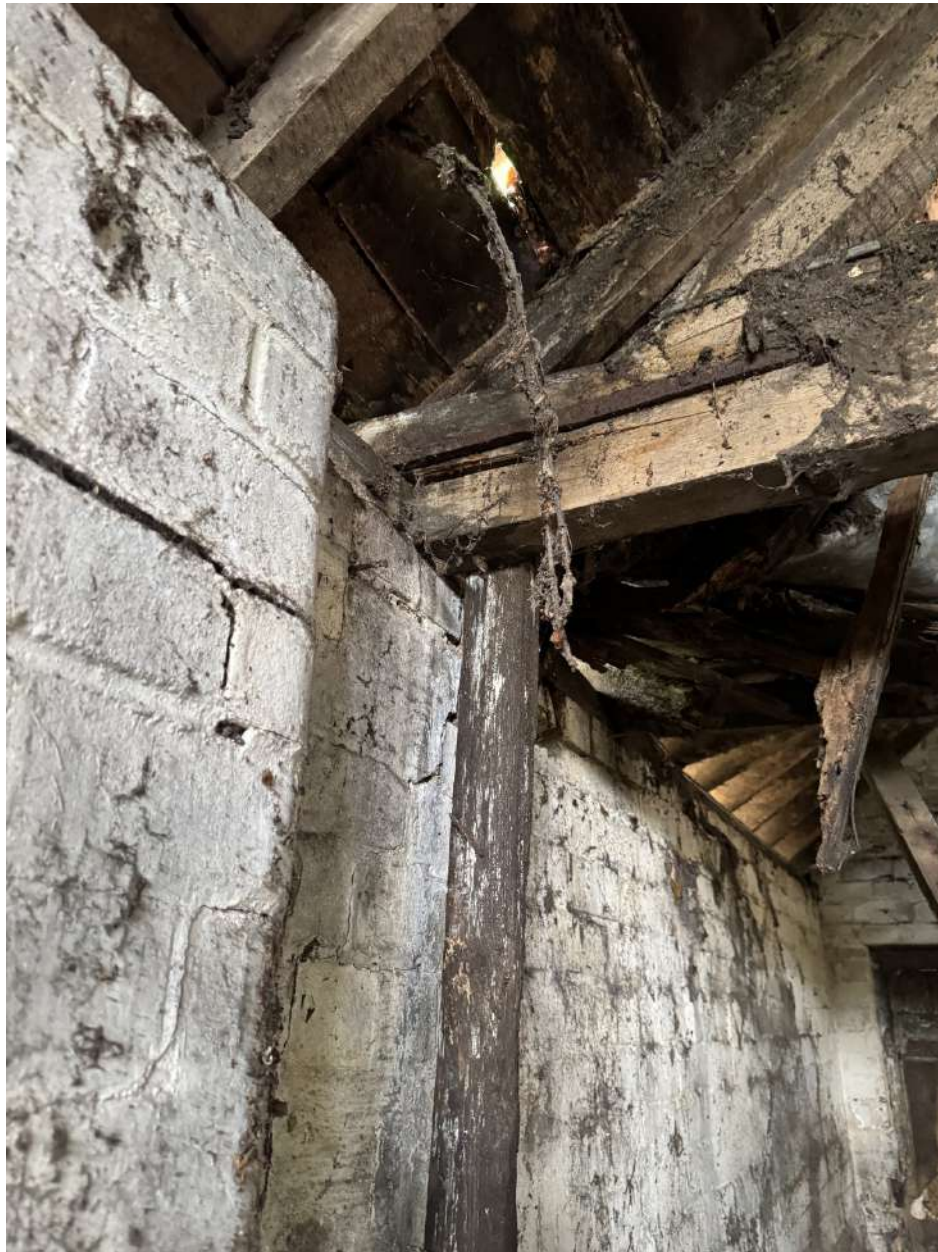
The truss set between the collapsed valley and the long span section has split and is now supported off a timber post set in-board of the masonry. The masonry has moved outward relative to the bearing location of the truss, increasing the bending moment in the bottom chord and this, coinciding with maximum shear forces in the timber has caused the outermost fibres to fail.

Image 10.0: Collapsed valley junction and split truss, now supported on timber post

The roof may be partly repaired and partly rebuilt. The bays in which a truss remains intact and fixed to the wall plate — where bellying of the masonry has been limited by the closely spaced internal partitions — may be retained and locally repaired, replacing failed purlins, rafters, sarking and tiles as required. The collapsed sections, the failed and snapped purlins, the split truss, and the collapsed valley junction with the adjacent garage require rebuilding.

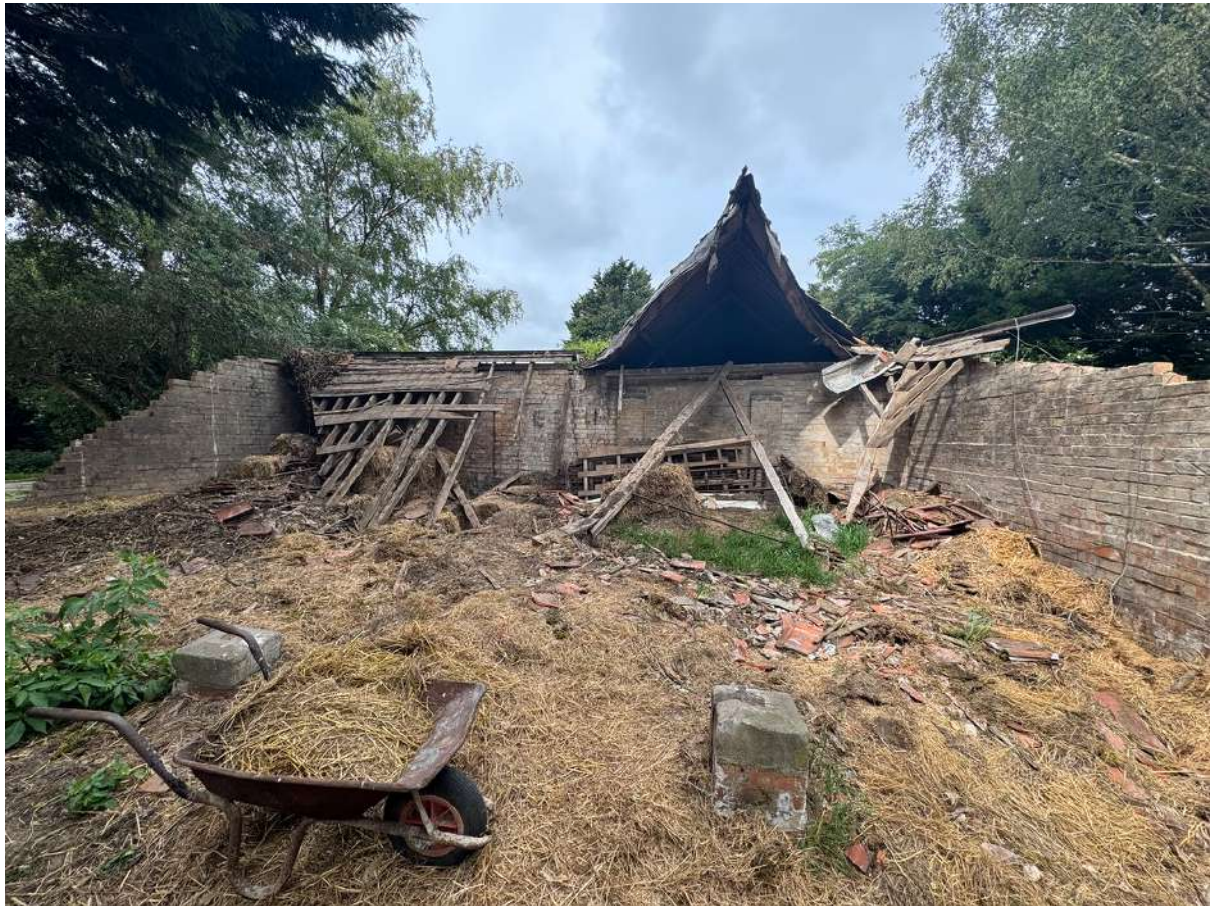
The final bay runs out over a partial height masonry elevation and incorporates a roof structure with hips. The roof structure to this bay has fully collapsed and was being cleared of debris at the time of the survey.

Image 11.0: Collapsed end of barn structure

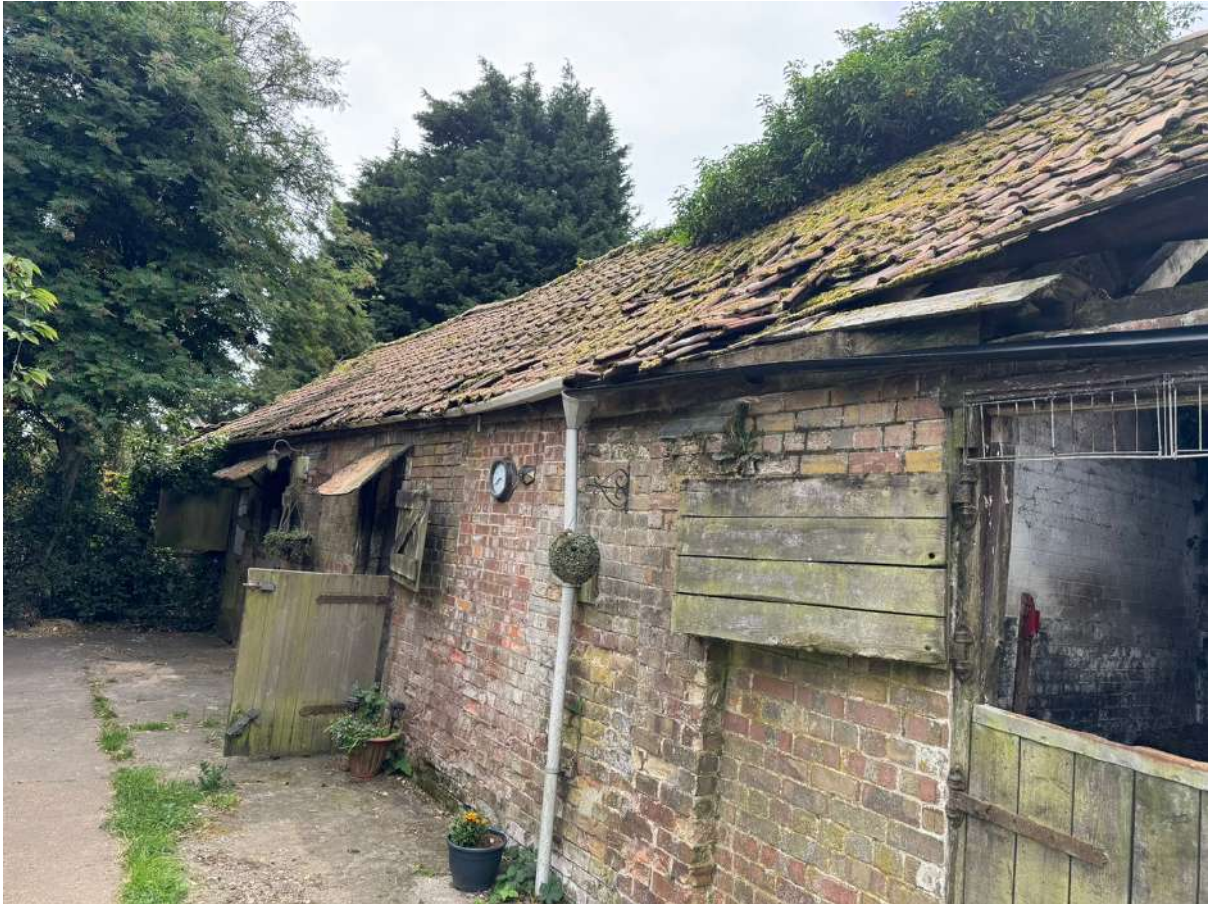
The roof structure has failed in a number of locations. The ridgeline was noted as wandering where the roof structure remained intact. Purlins have been lost or are overstressed throughout much of the remaining roof structure and tiles have been lost in a number of locations, allowing for rapid decay of the underlying timber members.

Image 12.0: Deteriorating roof structure, with tiles lost or dislodged, roofline wandering at ridge due to spread at eaves.
