**HISTORIC BUILDING RECORDING  
CURLEW COURT  
GUYS HEAD ROAD  
SUTTON BRIDGE  
LINCOLNSHIRE  
(SBCC15)**

Work Undertaken For  
Mr and Mrs P. Clery

July 2015

A.P.S. Report No. **66/15**

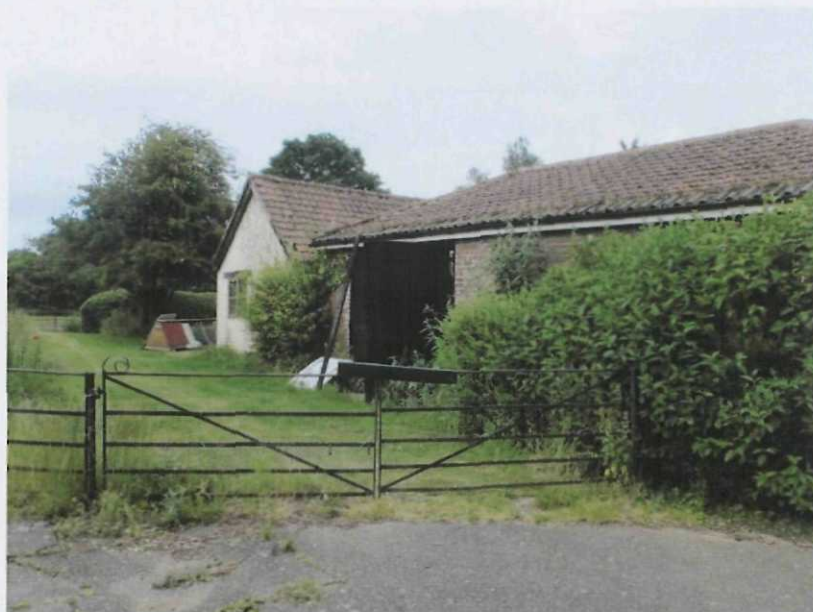
Plate 1. General view of the entrance to the southern range of Curlew Court showing the eastern elevations of divisions A and B (Fig. 4), looking southwest

This part of the southern range extends further north than the remainder of the structure and forms an L shape that is instrumental in enclosing the courtyard. There are several details of note in the external views of Division B. The structure has recently been used as a garage, the access provided by means of large double doors in the eastern elevation. In keeping with the general form of the structure, there would have been a large set of doors present here to allow unloading of feed and provisions. The current doors are not original to the structure. The aperture is also a later alteration as is evidenced by the ragged joins around the doorway with more modern brick and mortar having been used. South of the double doors, most of the eastern elevation is concealed by vegetation (Plate 1).

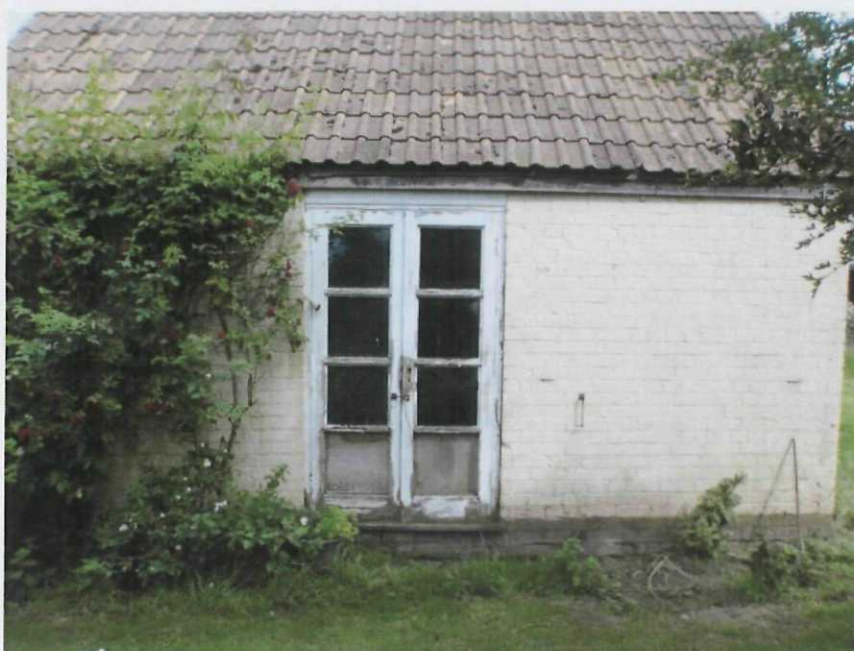
**Plate 2.** The southern elevation of Division A. This is one of the original walls of the latest addition to the structures comprising the southern range. It is constructed in English Garden Wall Bond.

The south, west and north walls appear to be original to the structure, constructed sometime before 1929 when it appears on the Ordnance Survey 6 inch map (Figure 1b). The walls are laid in English Garden Wall Bond.

The aperture for the door, central to the southern elevation, shows no evidence of alteration, and the wooden door itself may also be original.

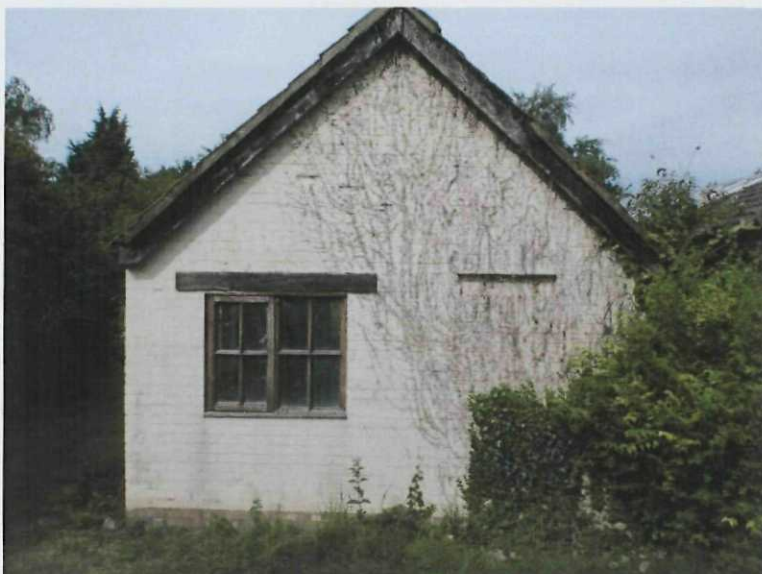
**Plate 3.** The eastern elevation of Division A. Although whitewashed, the bottom three courses show modern brickwork.

The eastern elevation shows differences to the rest of the structure. To the north of the wooden casement window with its oak lintel, there is a recess in the external brickwork that appears to show a removed lintel.

The bond of the entire elevation is also markedly different, being laid in Stretcher Bond. The bottom three courses of this elevation show modern brickwork. Internal examination of the un-whitewashed brickwork showed that the entire east elevation is a recent replacement constructed from modern brick and mortar.

The wooden casement window is older than the brickwork of the east wall and suggests re-use of an older window, either from this structure or elsewhere.

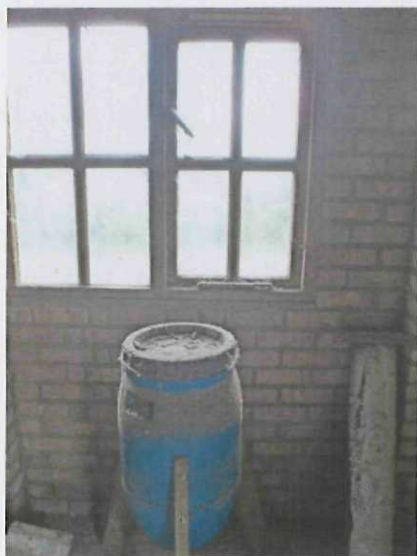
**Plate 4 (Left).** Internal view of the eastern elevation of Division A, showing modern brick and mortar.

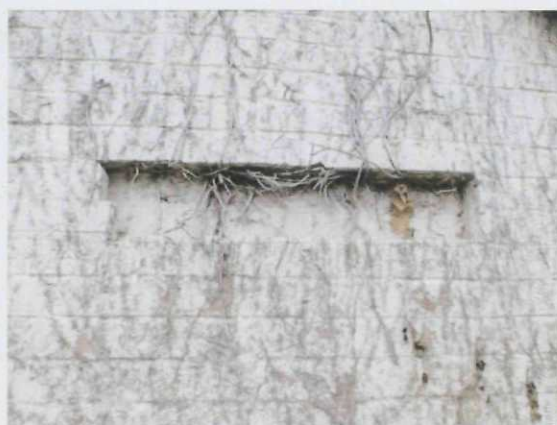
**Plate 5 (Below).** Detail of the recess in the brickwork on the eastern elevation

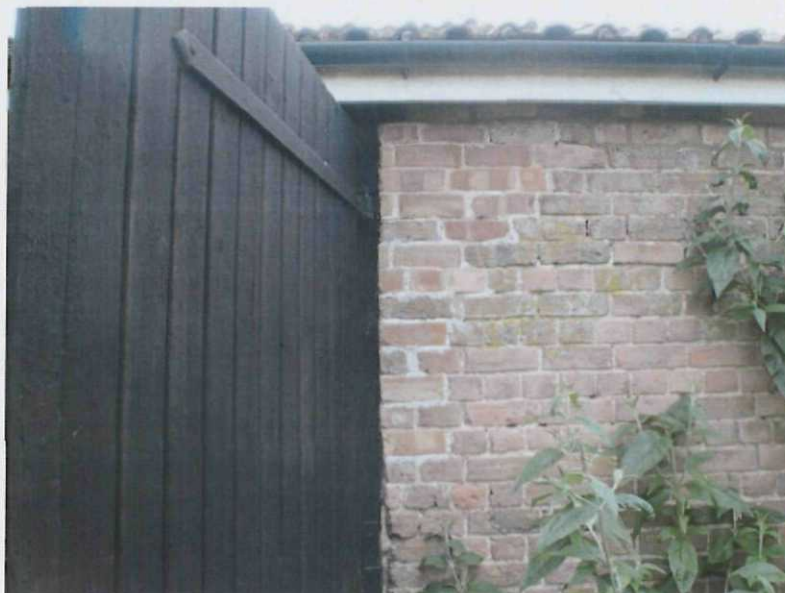
**Plate 6.** Detail of the brickwork on the eastern elevation of Division B. Note the ragged join by the door and the change from English to Stretcher bond in the upper portions of the wall.

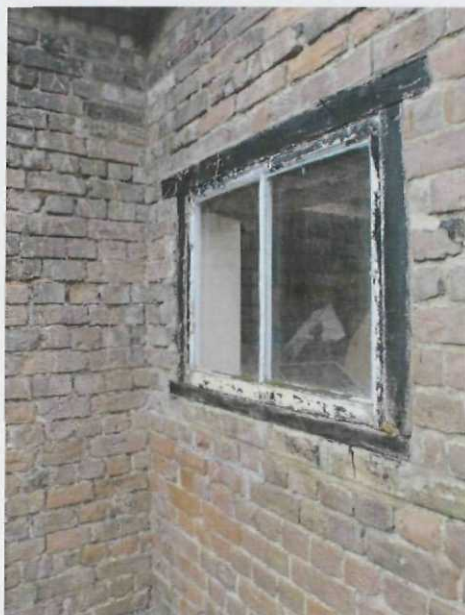
**Plate 7 (Left).** Detail of the wall angle where Division B and C join. The bricks are keyed rather than butted demonstrating the contemporary construction.

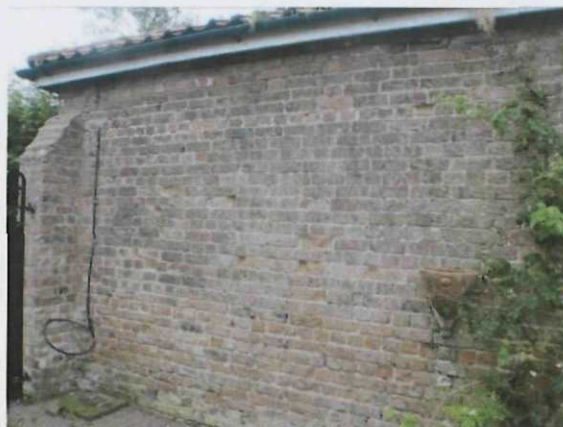
**Plate 8** (above right). The north elevation of Division B, supported by a buttress. In both plates, the upper courses are laid in Stretcher bond where the roof height has been raised

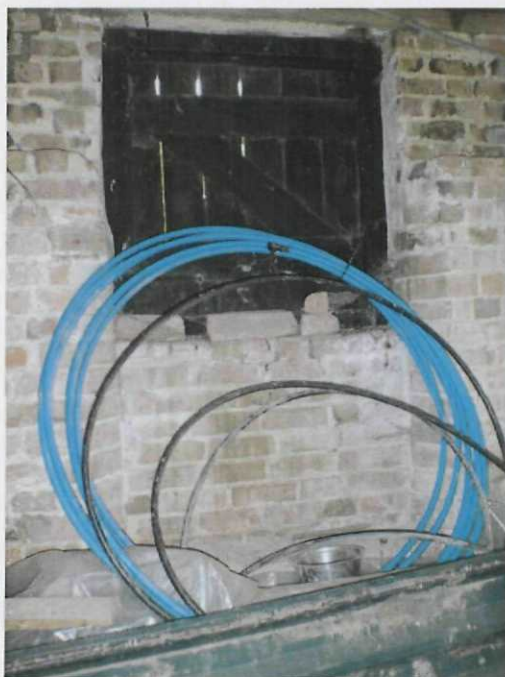
When the roof level was raised, the window in the east elevation was also altered. The aperture for the window shows chamfered brickwork in the lower courses but this has been blocked up using a contemporary brick type and the height of the window has been raised.

**Plate 9 (Left).** The raised window in the eastern elevation showing the chamfered aperture in the original wall. The alterations appear to have taken place when the roof was raised.

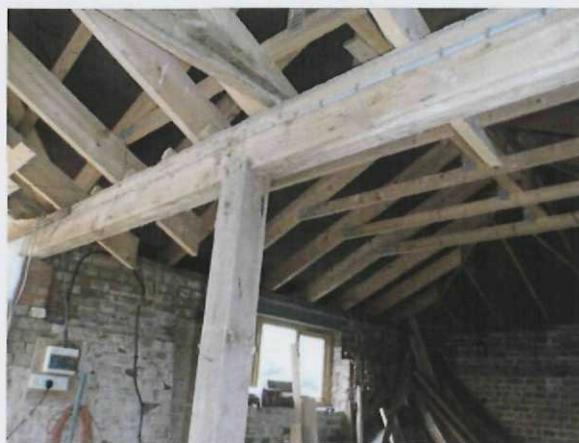
**Plate 10 (Below).** Various phases of roof timbers. The upper timbers are most recent and are attached to an older supporting timber and post

The roof in Division B has undergone recent alteration. The area is divided centrally by a north – south timber supported on a central post (Figure 4). The post and timber appear to be older than the upper timbers that form the roof structure. The structure is open, showing the modern felt material over which the outer pantiles are laid.

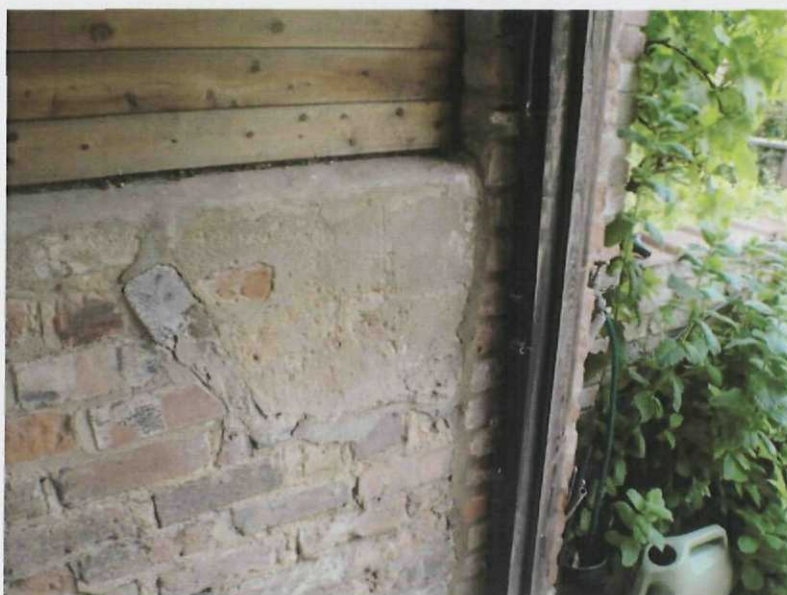
The purpose of this part of the structure is uncertain but it is likely that it provided cattle accommodation. In the main passage into the courtyard at the west of Division C, the remains of an integral manger structure can be observed within the brickwork.

**Plate 11.** Visible in the west wall of Division C (in the entrance passageway to the courtyard) is the blocked remains of an integral manger within the wall. This suggests that Division C was for cattle accommodation

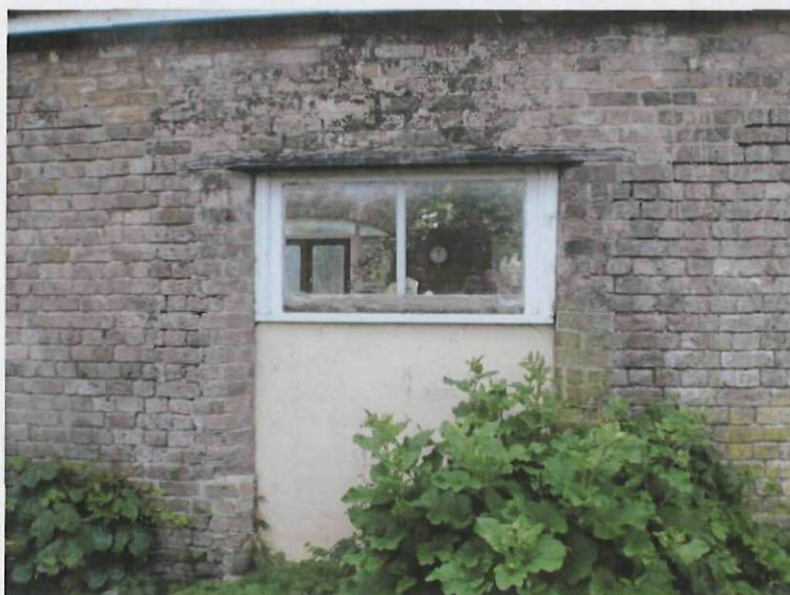
On the northern elevation of Division C, where the wall faces into the courtyard, there is a blocked doorway that may have allowed access and egress for the animals. The chamfered edges to the aperture are in the style of features original to the structure. The brickwork surrounding the doorway is, however bonded with a different mortar than the surrounding wall. There may have been an original doorway in this position, however, this suggests later alteration, or at least repair to the structure.

**Plate 12.** The blocked doorway in the northern elevation of Division C. The upper six courses, laid in stretcher bond show the alteration to the roof height. The brickwork around the chamfered door aperture shows evidence of repair or alteration

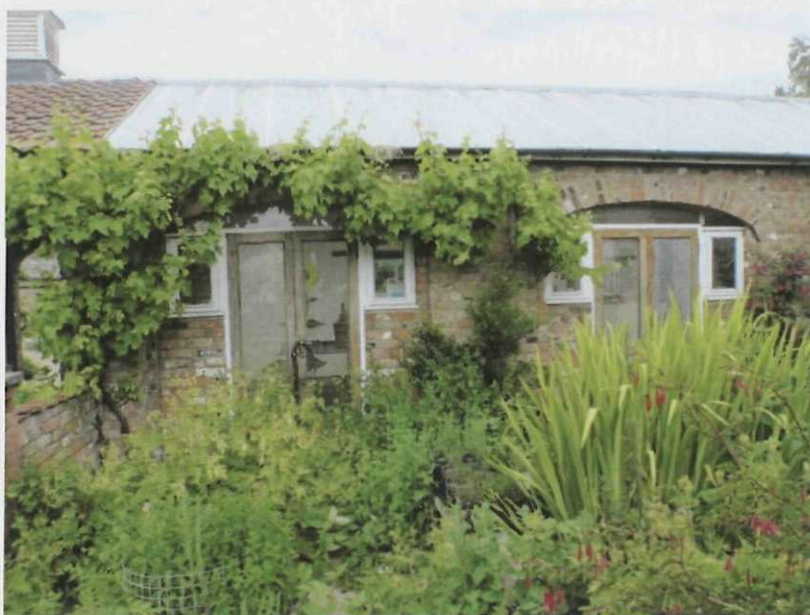
The southern elevation of Division C has also been considerably altered. It is likely that there was an entrance or entrances somewhere within this elevation, despite there being evidence of an integral manger within the wall structure. It has been altered to form decorative arched entranceways. This has been sympathetically produced and re-uses some of the original bricks. Although the outside bricks have weathered around the decorative doorways, internal examination shows the recent nature of the construction.

**Plate 13.** External view of the south elevation of Division C showing the decorative arched entranceways.

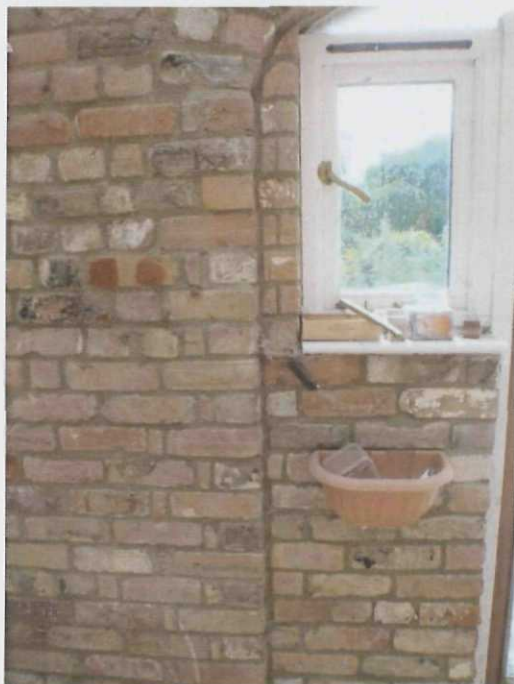
**Plate 14 (Left).** Internal detail of the decorative arched doorways, showing the new mortar and recent construction.

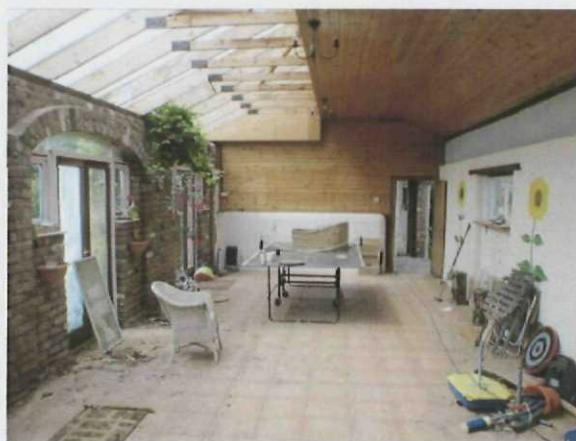
**Plate 15 (below).** Internal view of Division C showing the suspended ceiling and modern roof construction

Internally, the floor has been covered in large ceramic tiles and the modern roof structure is partly covered by a suspended wooden ceiling. The internal wall of the north elevation has been rendered and the change in wall depth where the roof level was previously raised has been retained as a feature.

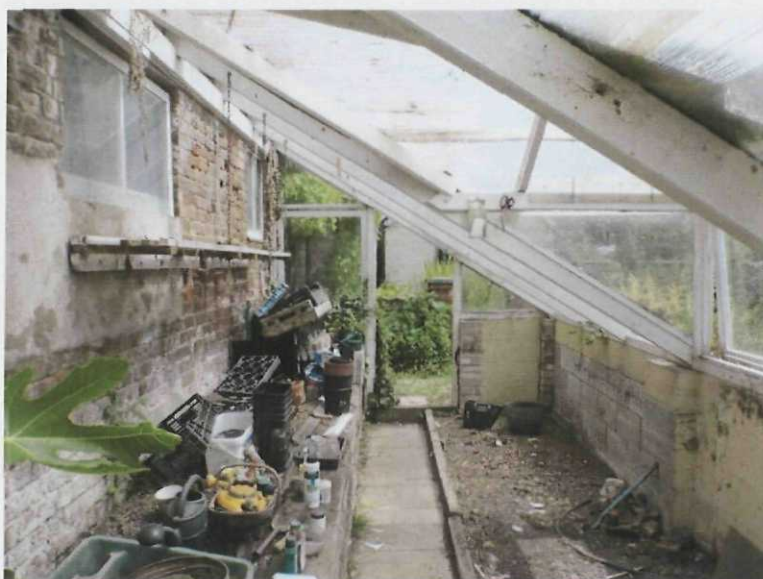
**Plate 16.** Internal view of Division, D, The Greenhouse. The breezeblock wall is attached to the main structure by angled timber joists forming a lean-to structure

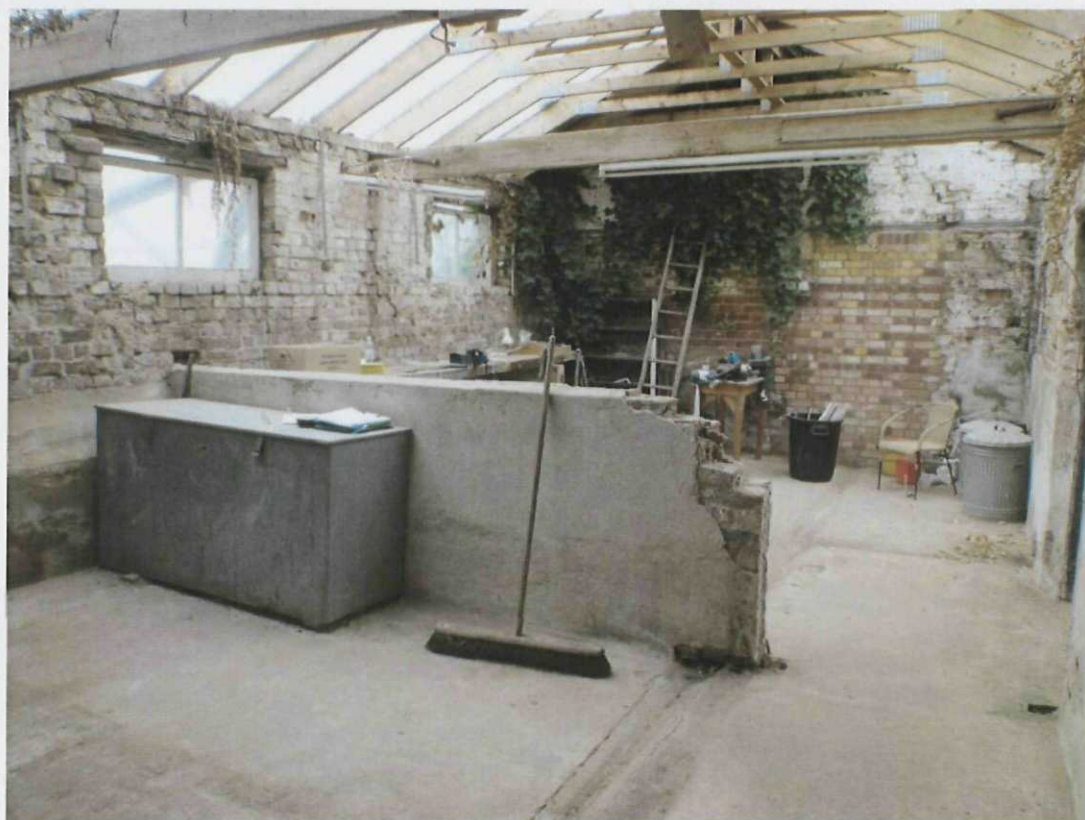
**Plate 17**

General internal view of Division E, The Stable Block. The wall at the rear of the picture is a recent addition. This area of the southern range demonstrates the most features indicative of the intended use.

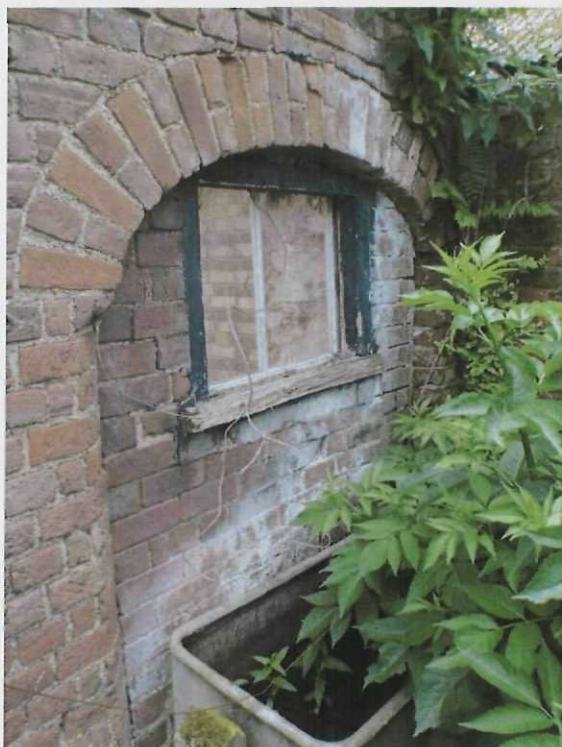
**Plate 18**

The southern entrance to the stables in the north elevation of Division E. The archway is unaltered, retaining original mortar.

The southern, arched entrance (Plate 18), prior to being bricked up, appears to have been unaltered. The brickwork and mortar around the arched entrance is in keeping with the materials constructing the rest of the northern elevation. There is no indication as to when it was bricked up to form the window although the bricks appear to be 19<sup>th</sup> century.

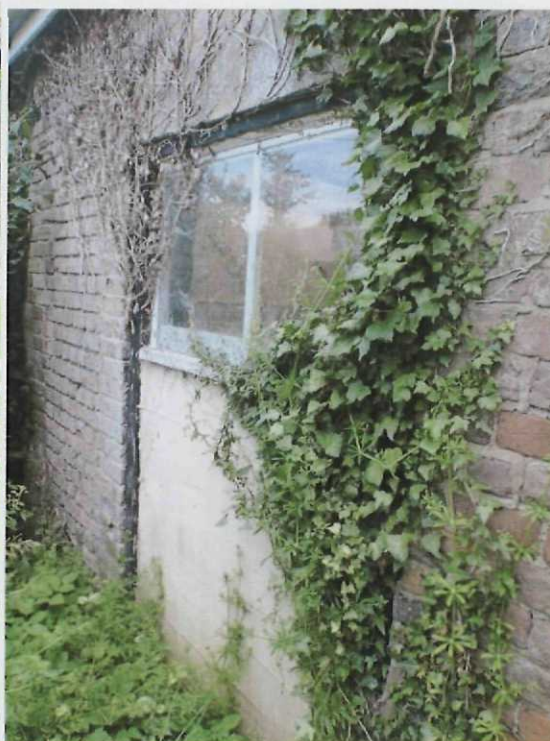
**Plate 19**

The northern entrance to the stables appears to have been added or altered due to the change in mortar

The western entrance (Plate 19) appears to have been either an addition or an alteration to the structure. It is possible that an entrance to the stables was present here, perhaps forming separate access to a loose box. The mortar around the bricked up aperture is more recent than that which bonds the original north wall structure. It appears to have been open until recently as the materials blocking the aperture are modern breeze blocks.

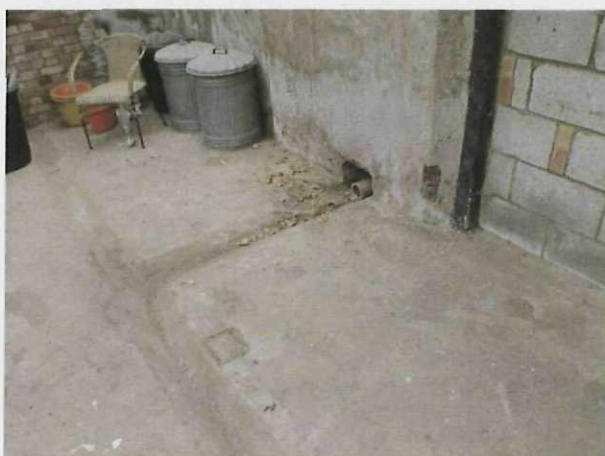
There is remaining evidence for divisions of the stalls on the stable floor. The concrete floor has evenly spaced holes where the stall posts would have sat, just to the north of the manure drain. The outlet for this runs into the central courtyard.

**Plate 20.** Detail of the manure drain with the outlet running into the central courtyard. It continues west, underneath the modern wall at the left of the picture

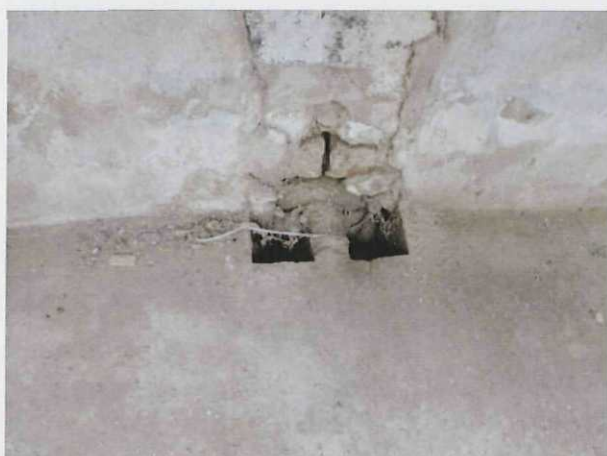
Now used as windows, the apertures in the southern elevation of Division E are most likely to have been apertures used for loading feed into the hay racks above the mangers in each of the stalls. They may also have served as ventilators. In the floor adjacent to this wall, the post holes for the mangers are still visible.

**Plate 21.** Two small holes in the ground abutting the southern wall of the stable indicating the positions of the mangers.

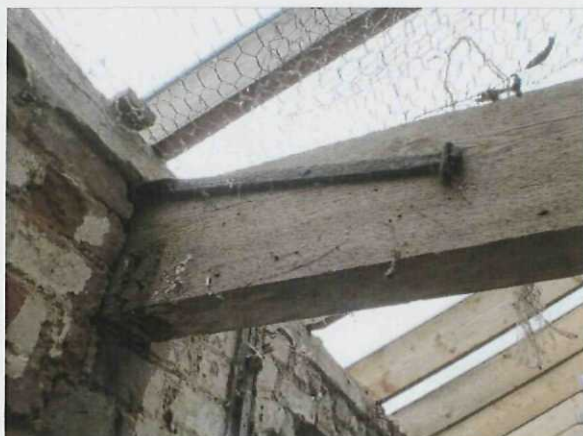
Although the upper roof timbers in Division E are relatively modern, the supporting beams, aligned north to south appear to be contemporary with the original raising of the roof height. The beams are held to the wall by an unusual type of iron tie, where one end hooks over the wall and the other is attached to the beam itself. Two of these remain in this part of the southern range but more may survive in the area further west beyond the modern wall.

**Plate 22.** Detail of the roof timber and iron tie that appear to be contemporary with the original raising of the roof
