*Structural Inspection Report*

**Bridge Hotel,  
4 Bridge Road,  
Sutton Bridge,  
PE12 9UA.  
For Mr Mark  
Andrews Property  
Services Ltd**

Date: 4 November 2016  
Reference: U-C3091.00  
Status: Issue 1

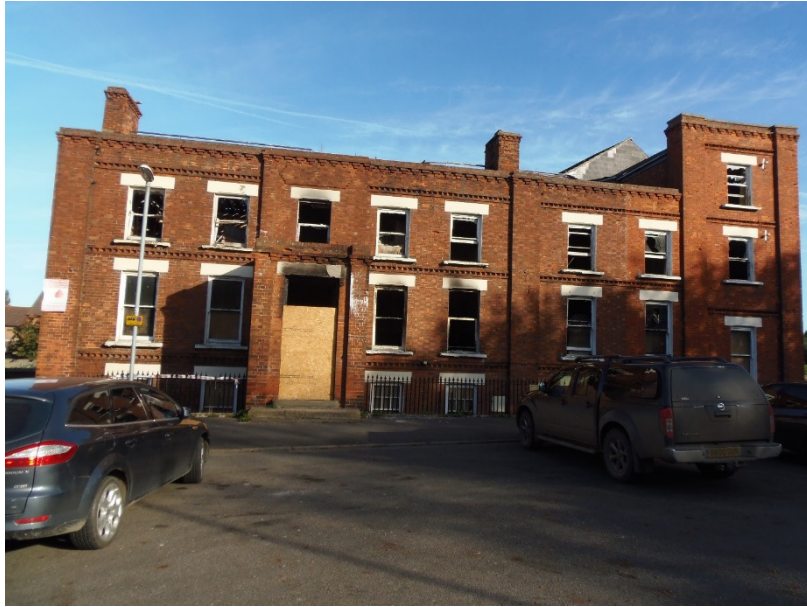
**Front Elevation**

- a) The front elevation wall was finished in facing brickwork.
- b) Vertical cracking (estimated maximum width of 4mm) of brickwork to the lintel ends of the LHS windows (See Photos 02 and 03).
- c) Spalled brickwork and eroded mortar was noted to the elevation at parapet level and to the front porch structure (See photos 05 – 07).
- d) Cracking (estimated width of 2 mm) of brickwork to the basement window surround on the LHS window and spalling of brickwork (See photo 10).
- e) The front wall appeared to be out of plumb to the upper level of the LHS corner (See photo 04).
- f) There was no bulging to the wall at first floor level / eaves level.
- g) There was movement cracking of the lintels.
- h) There was soft, loose and missing pointing to the front elevation.

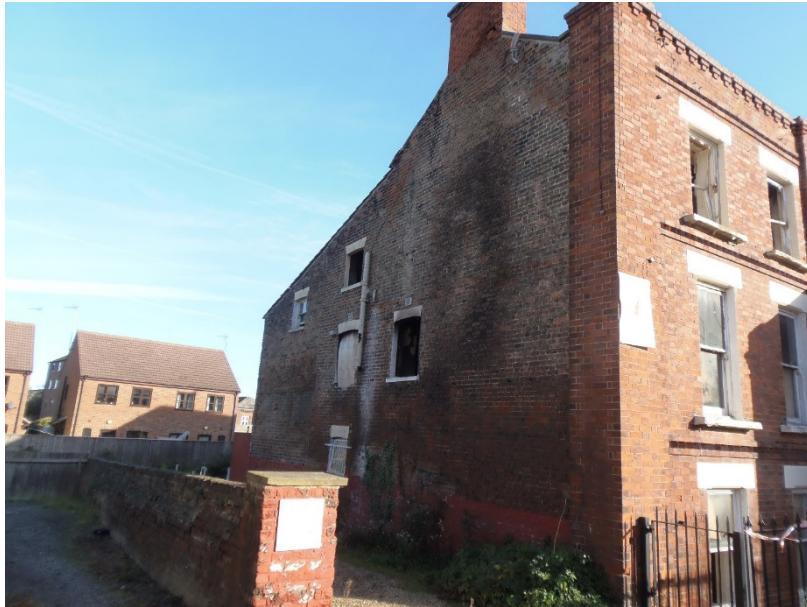
#### LHS Elevation

- a) The LHS elevation wall was finished in common brickwork.
- b) Vertical cracking (estimated maximum width of 30 mm) of brickwork to the façade return feature (See photo 08).
- c) Badly damaged and loose brickwork to the LHS chimney stack (See photo 09).
- d) The LHS elevation wall appeared to be plumb
- e) There was no bulging to the wall at first floor level / eaves level.
- f) There was movement / cracking of the lintels.
- g) There was soft, loose and missing pointing to the LHS elevation.

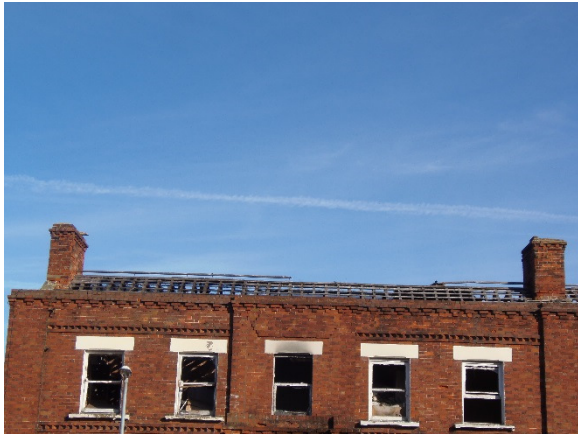
Photo. 01

- 2.3.1 Whilst not strictly the subject of the report the roof structure does provide lateral support to the main structural walls by tying the top of the walls together and forming a diaphragm. The fire had resulted in the roof being damaged beyond repair (See Photo 01) and potentially leaving the upper storeys vulnerable to wind loading and collapse.
