## **Site Address:**

279 Broadgate,  
Sutton St Edmund,  
Cambridgeshire.  
PE12 0LT

## **Purpose of Report:**

The purpose of the survey and associated report is to discern the condition of an existing Structure, located to the land at the above address. The survey aims to further ascertain the general level of works required to convert this structure into a residential building.

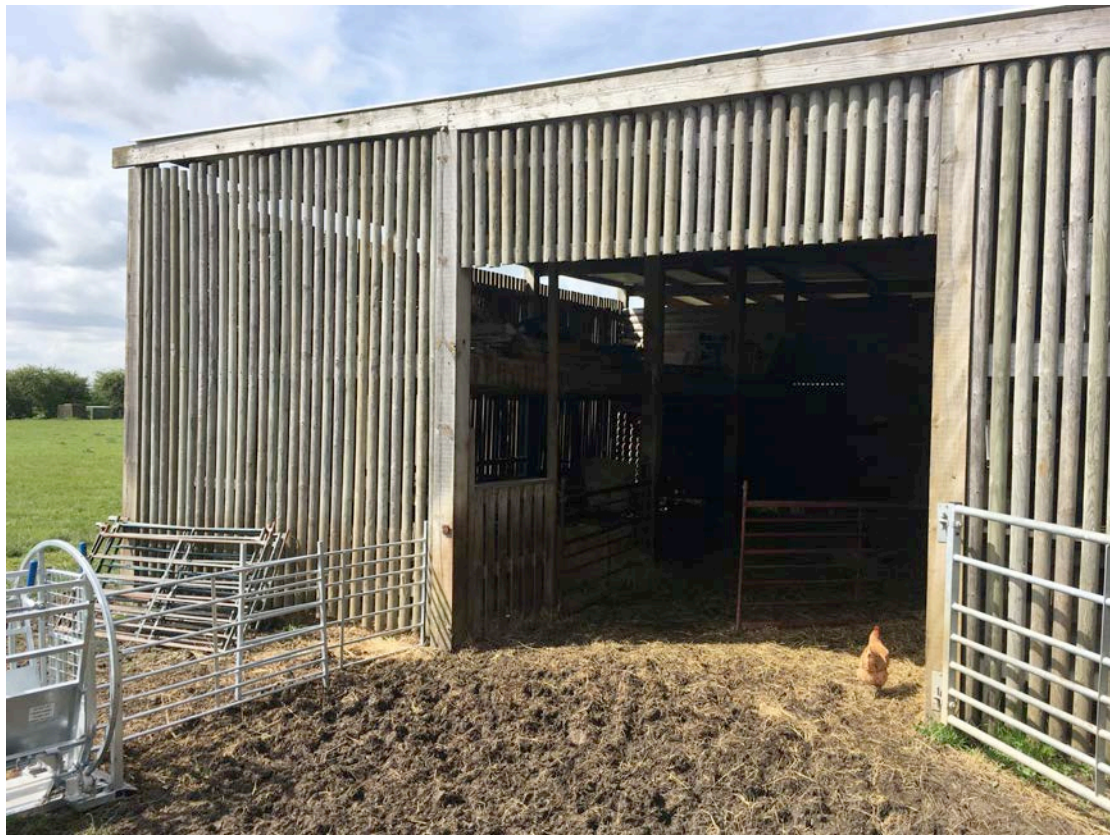
The front consists of an enclosed area, with mezzanine floors running either side of a central aisle. Access is via an opening to the front elevation, with timber posts incorporated into the framing of the entrance.

Image 3.0: Entrance to front of structure.

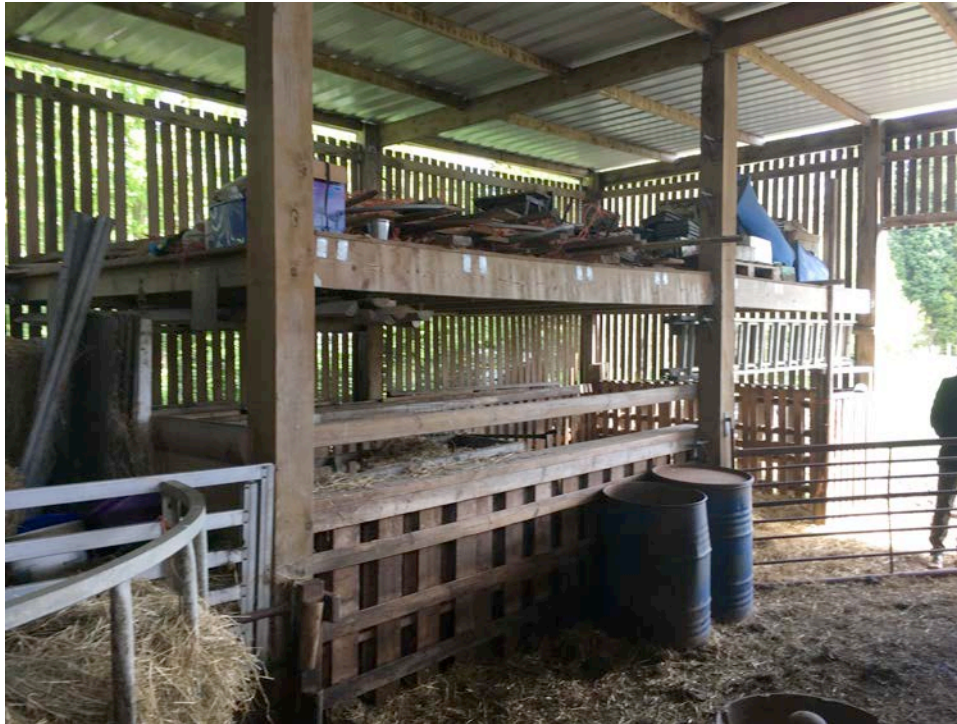
The front and side elevations incorporate horizontal timber side rails, spanning between timber columns. Vertical half rounded timber cladding sections are affixed back to the side rails at suitable centres, forming infill screens.

Image 4.0: View to interior of front half of structure.

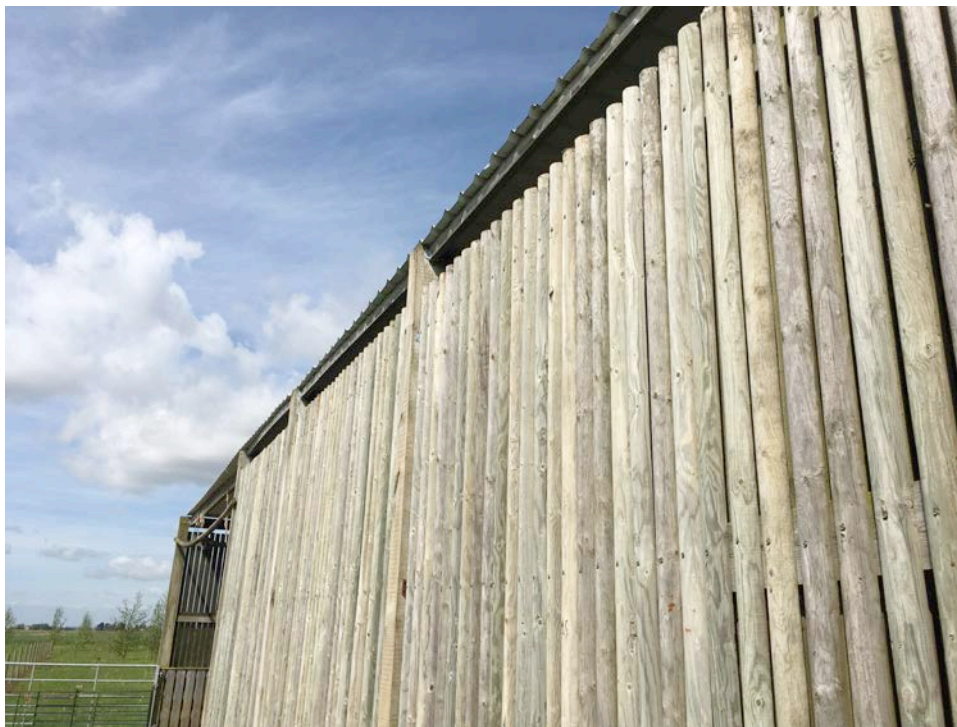
The rear of the structure incorporates a full height store, with side access via a full width, full height opening. The area is enclosed internally on one side by horizontal timber boarding running ground to eaves level, dividing the rear of the structure from the front.

Image 5.0: Side Elevation, with opening to rear section of barn.

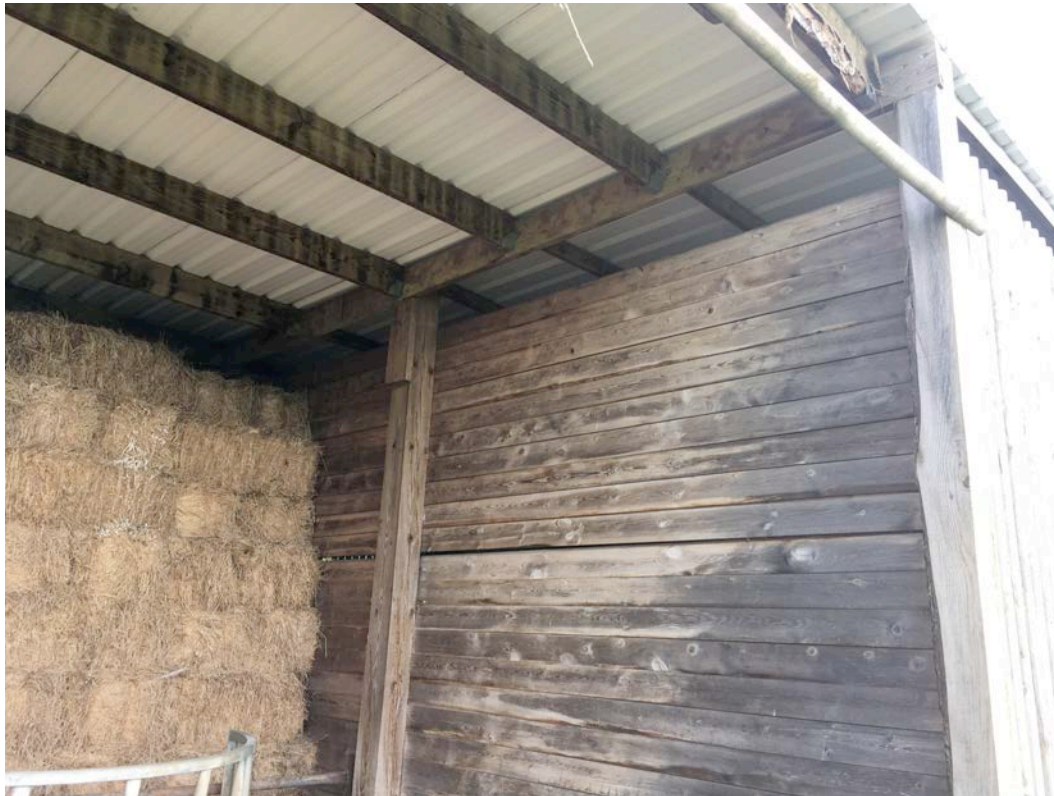
Image 6.0: View of timber columns to existing Barn.

- Timber columns span from pad foundation to Eaves level. Restraint to the columns is provided predominantly along one axis, with the other axis having an effective length equal to  $1.2 \times$  overall length. It is therefore surmised that the full compressive strength of the timber is not being utilized. Timber columns were found to be in good overall condition, with limited deterioration and no signs of stress induced damage. Columns were found to remain straight and true.

- Existing timber columns are considered sufficient for the given task, wherein loads from the roof would be carried in bearing by the columns.
- Replacement of existing infill wall panels would be required, so as to facilitate sufficient insulation, provide a weatherproof finish and provide a suitable finish internal to the structure. In reviewing the existing structure, it is proposed that a solution, similar to that already employed is utilized, wherein wall panels are set between existing columns. These in turn would provide robust bracing to columns, reducing their effective lengths to an extent that facilitates additional loads associated with a heavier roof finish.

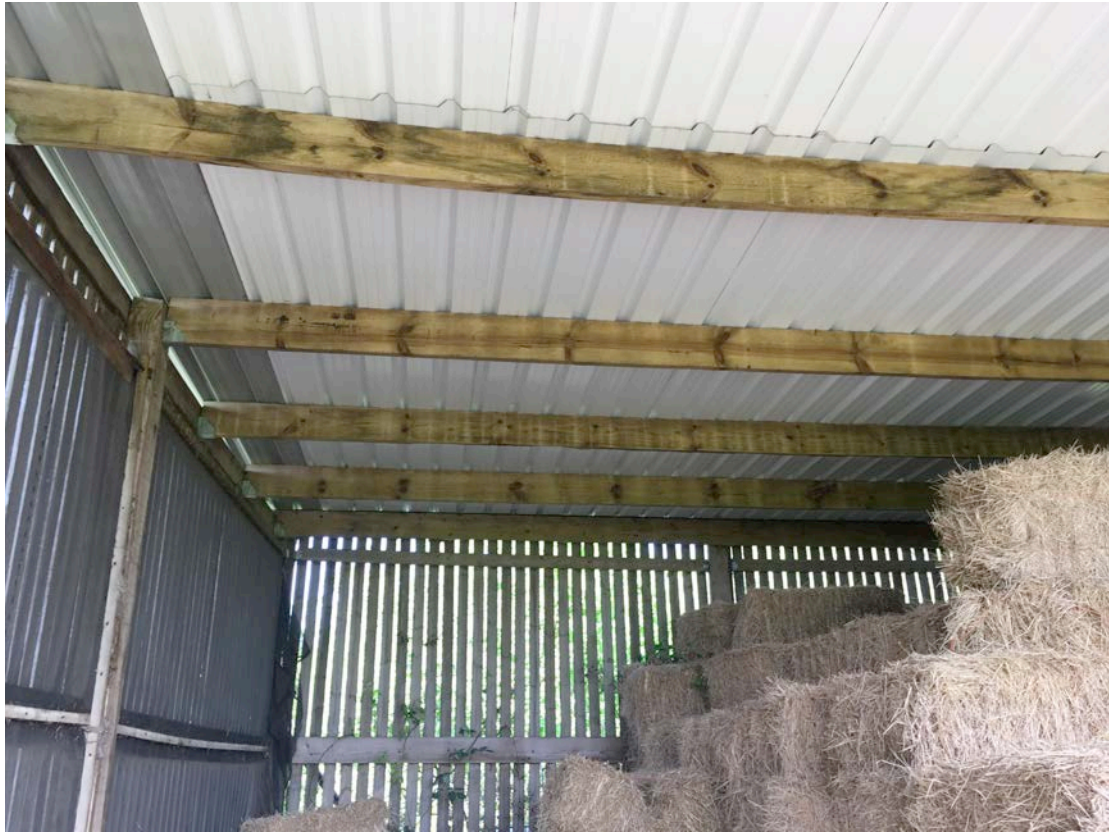
Timber rafters were noted as being supported off primary beams and columns via zinc plated side fixed joist hangers.

Image 7.0: View of rafters to rear half of structure, supported from columns and Primary beams.

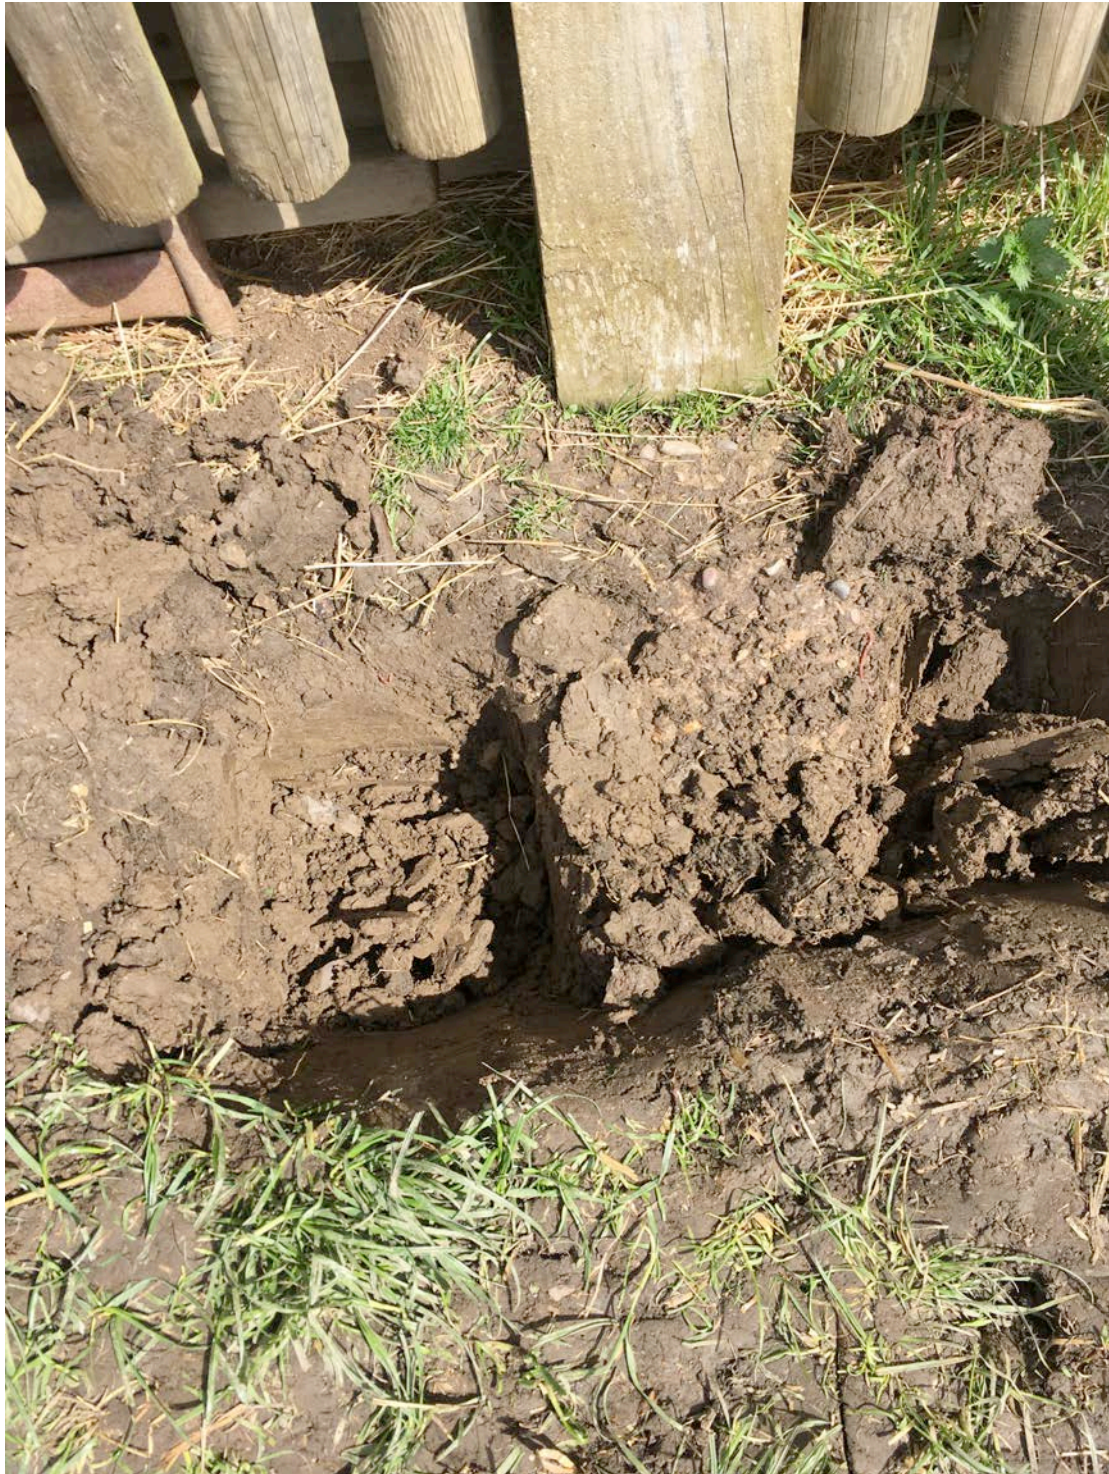
Exposure of a Pad foundation to the centroid of the Southerly elevation revealed a rectangular concrete mass, formed to the perimeter of the timber post. The concrete was found to extend out 600mm from the face of the column, with a width of 400mm and depth of 600mm. Pad foundations were found to be set to firm clay.

Image 8.0: View of Pad foundation to existing column.

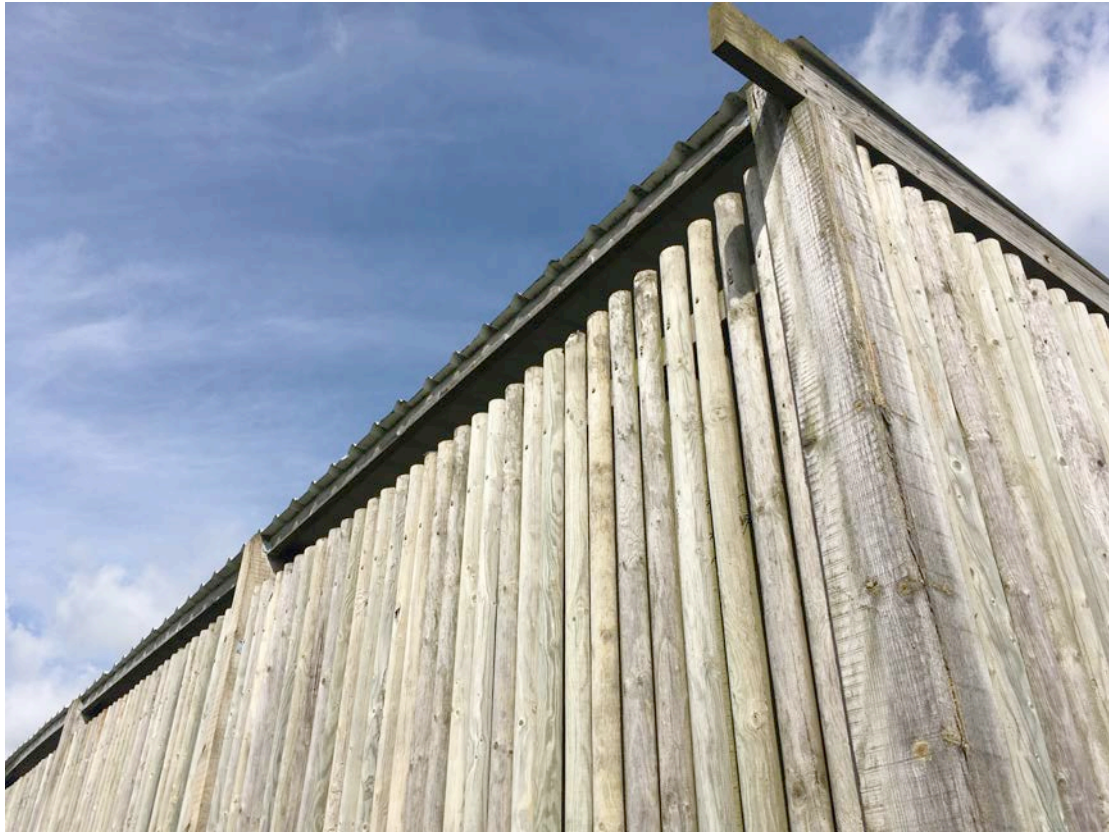
- Primary timber members further transfer vertical loads from rafters back into columns in the form of axial loads, applied eccentrically.
- Infill panels to the external perimeter of the structure are formed from equally spaced half round timber sections. The shape of the sections, coupled with gaps between each individual member yields eddy shedding, reducing overall wind loading on the structure, hence limiting sway due to wind loading. However, horizontal forces due to wind, although limited, are carried by infill panels and transferred back via horizontal members to columns at eaves level and mid span. These loads are carried through shear at pad foundation level and axial loading in rafters/ primary timber members at roof level. Infill panels running perpendicular remove lateral wind loading via racking, converting wind loads into axial loads in columns.

Image 9.0: Infill panel to exterior of structure

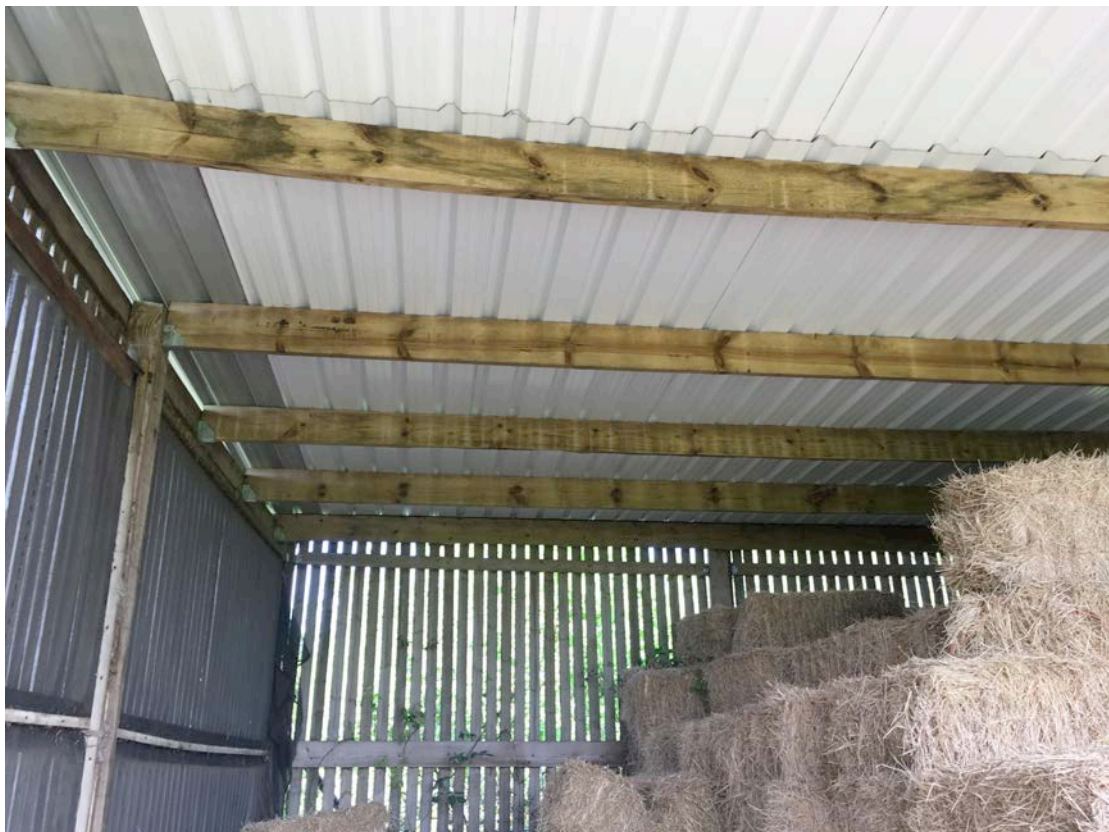
- To the rear section of the barn , rafters were found to be overly stressed, with significant deflection at mid span. This was considered a result of the considerable span of the structural members, as opposed to the magnitude of loading.

Image 10.0: Excess deflection to rafters over rear Section of structure.

- The existing structural elements to the flat roof require remedial works so as to facilitate the formation of an insulated, weatherproof finish, capable of supporting additional loads, without detrimental effects to finishes. To this end, further structural elements would be required, along with upgrading to existing end support conditions.
