## Structural Survey Report

on  
Agricultural Barn for Domestic Conversion

at  
Holly Cottage  
Old Fen Dyke  
Sutton St. James  
Lincs

Job reference: WECE/23/325

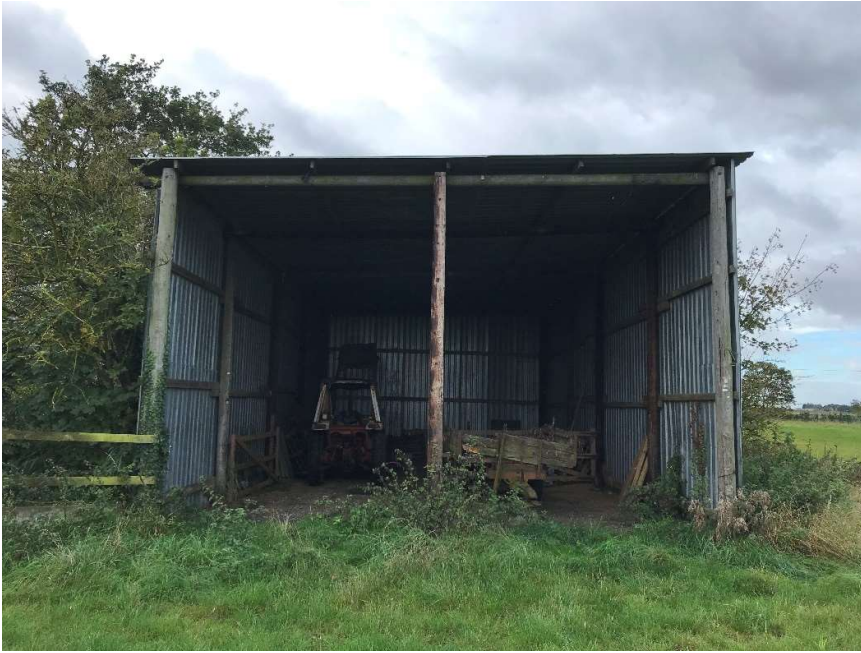
Photo 1. Northeast Elevation

- 3.3. An opening on the northeast facing elevation provides the only access into the barn.
- 3.4. The timber members were typically measured to be:
  - Side rails: 120x38, 150x47, or 95x47. All at around 1.750m centres.

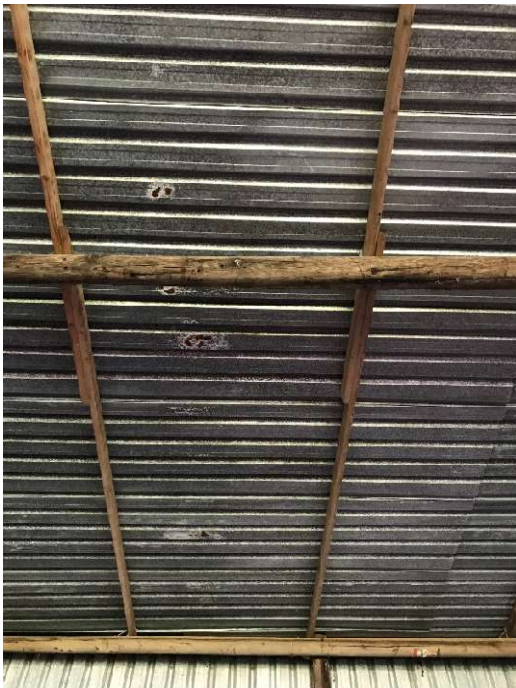
- 3.7. There was no visible excessive deflection or distortion in the roof beam members, and posts were plumb and aligned within normal construction tolerances. There were no signs of structural distress in the primary timber frame members and no visible indication of settlement at any post. However, we did observe that some secondary structural members - roof purlins, show signs of vertical deflection and nominal distortion.

- 3.10. Small areas of localised corrosion were observed to the underside of the roof cladding at a couple of locations. Whilst there did not appear to be any evidence of corrosion on the wall cladding, we did notice a few sporadic dents located around the building.

Photo 6. Roof cladding and supporting structural members

- 4.5. We comment that the minor distortion of the existing roof purlins may be due to missing noggins which does not represent a major structural concern. We would expect noggins to be provided at least at mid-span of the purlins and these noggin members should be installed as part of the domestic conversion. With respect to the observed vertical deflection, the purlin members section size and/or spacing should be reviewed as part of the conversion works. If the existing section or spacing is determined to be inadequate or excessive respectively, we suggest that additional purlin members are provided between the existing to prevent potential issues such as water ponding on the roof. Small areas of roof and wall cladding will need to be repaired or replaced where they are either corroded or damaged/dented as part of the conversion works.

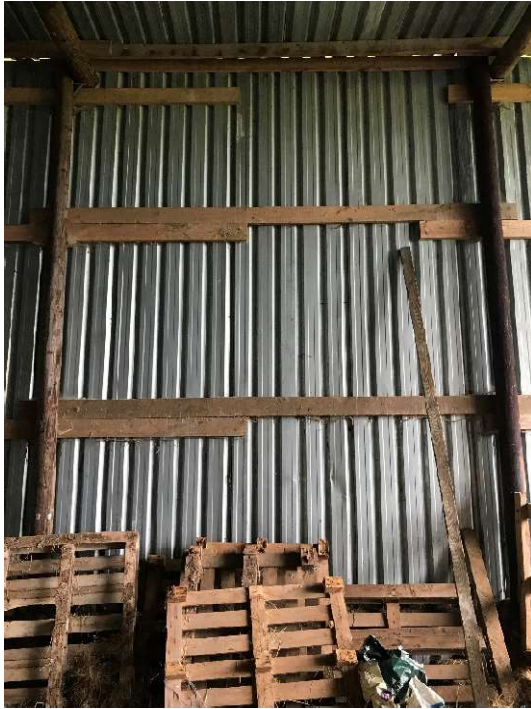
Photo 7. Side cladding and supporting structural members
