# Arboricultural Consultancy for Aviva

| Insured | Mr Mark Campling | Address | The Yews, Jarvis Gate, Spalding, Lincolnshire, PE12 0EP | | |
| Client | Subsidence Management Services | Contact | Cliff Sithole | Claim No. | IFS-AVI-SUB-17-0068560 |
| Report Date | 30/08/2018 | | | | |

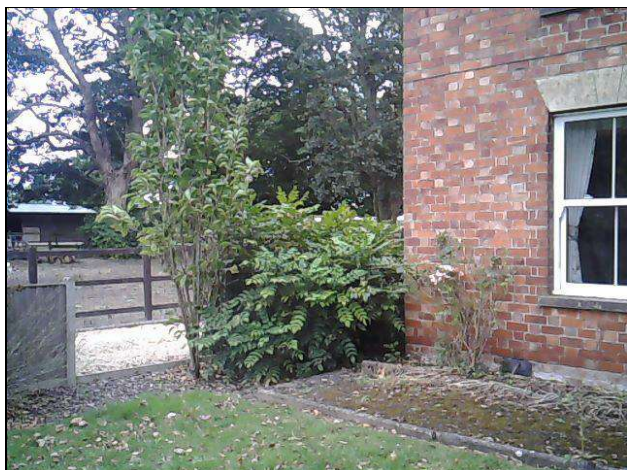
| Tree No. | Species | Age Cat | Approx. Height (m) | Distance to Building (m) * | Ownership | Action | Requirement |
|---|---|---|---|---|---|---|---|
| S1 | Mahonia | 1 | 1.2 | 0.5 | C - Insured | Action to avoid future risk | Do not allow to exceed current dimensions by way of regular pruning. |

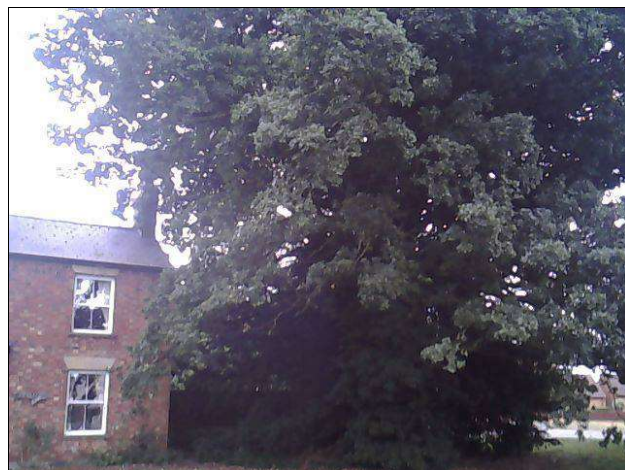
T1 - Oak

Site Investigations revealed the presence of roots in TP/BH1 and TP/BH2 to a maximum depth of 2500mm; samples of these roots were recovered from underside of foundations and throughout the borehole, these roots were identified (using anatomical analysis) as having emanated from probably *Quercus* spp. (Oak) but possibly *Castanea* spp. (Sweet Chestnut).

Our survey of the site identified the Oak (T1), given its position relative to the damage (and the absence of any Sweet Chestnuts on/near site) it is our opinion that the roots identified within TP/BH1 are *Quercus* and will therefore emanate from this tree.

| Tree No. | Species | Age Cat | Approx. Height (m) | Distance to Building (m) * | Ownership | Action | Requirement |
|---|---|---|---|---|---|---|---|
| T1 | Oak | 3 | 17.3 | 5.4 | C - Insured | Remove | Remove close to ground level; do not treat stump due to translocation risk. Where such a risk exists, we advise that any emergent regrowth is removed annually. |

Removal of The Oak (T1) and Yew (T2) will offer the most certain and reliable arboricultural solution likely to restore long-term stability.

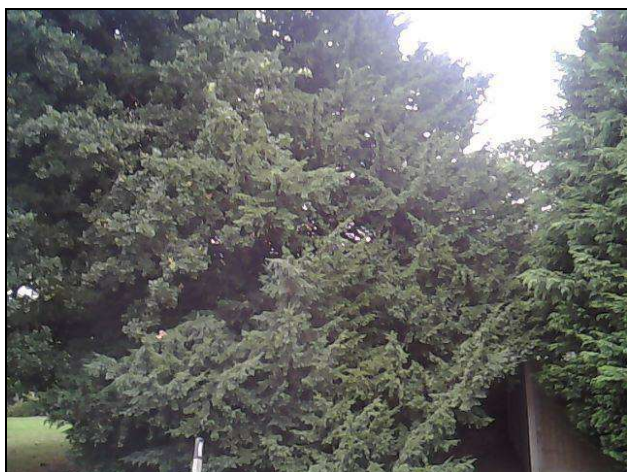
T2 - Yew (Common)

However, whilst not positively implicated, given its size and proximity the Yew (T2) cannot be discounted as contributing to the overall level of soil drying proximate to the area of damage and is therefore also considered to retain a contributory influence, albeit in a secondary capacity when compared to T1.

| Tree No. | Species | Age Cat | Approx. Height (m) | Distance to Building (m) * | Ownership | Action | Requirement |
|---|---|---|---|---|---|---|---|
| T2 | Yew (Common) | 3 | 14.2 | 3.6 | C - Insured | Remove | Remove close to ground level; do not treat stump due to translocation risk. Where such a risk exists, we advise that any emergent regrowth is removed annually. |

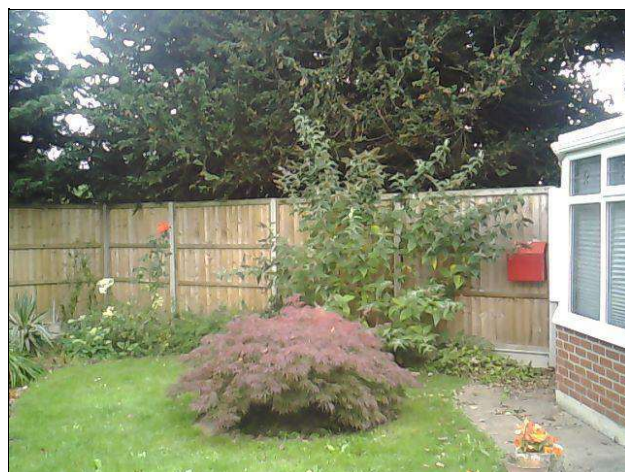
S2 - Buddleia

| Tree No. | Species | Age Cat | Approx. Height (m) | Distance to Building (m) * | Ownership | Action | Requirement |
|---|---|---|---|---|---|---|---|
| S2 | Buddleia | 1 | 2 | 2 | C - Insured | Action to avoid future risk | Do not allow to exceed xm height / spread by way of regular pruning. |

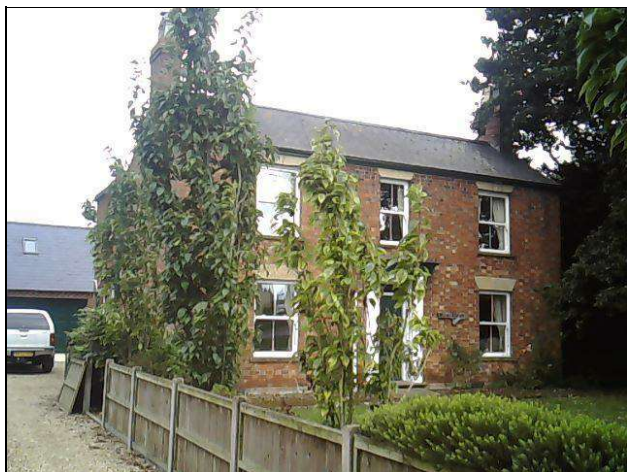
TG1 - Cherry

| Tree No. | Species | Age Cat | Approx. Height (m) | Distance to Building (m) * | Ownership | Action | Requirement |
|---|---|---|---|---|---|---|---|
| TG1 | Cherry | 1 | 6 | 2.3 | C - Insured | Action to avoid future risk | Do not allow to exceed current dimensions by way of regular pruning. |

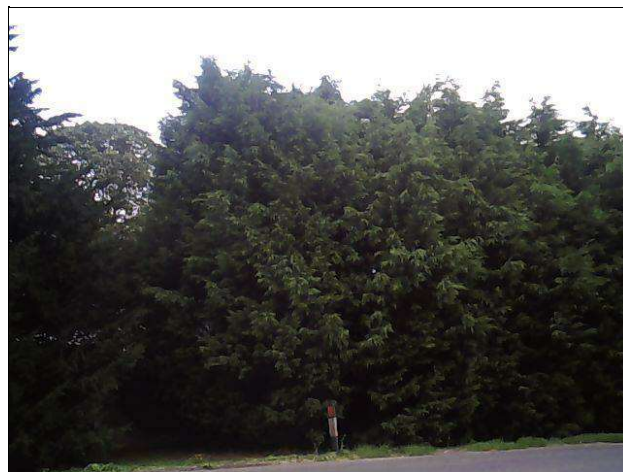
H1 - Cypress

| Tree No. | Species | Age Cat | Approx. Height (m) | Distance to Building (m) * | Ownership | Action | Requirement |
|---|---|---|---|---|---|---|---|
| H1 | Cypress | 1 | 6.3 | 10.5 | C - Insured | Action to avoid future risk | Do not allow to exceed current dimensions by way of regular pruning. |
