# Claim Assessment Report

**Our Reference:** IFS-AVI-SUB-17-0068560

**Risk Address:** The Yews , Spalding, PE12 0EP

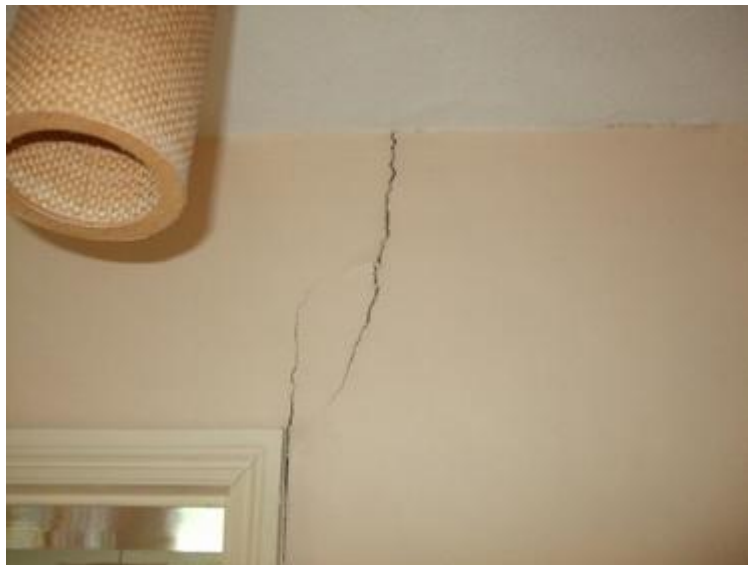
1-3mm wide tapering, diagonal, crack above the rear hall door opening. The crack continues down the junction of the door frame and the wall. 1mm wide cracks are noted above the front of this door head and the adjacent front right bedroom door.

FIGURE 03 Landing - tapering crack above rear door

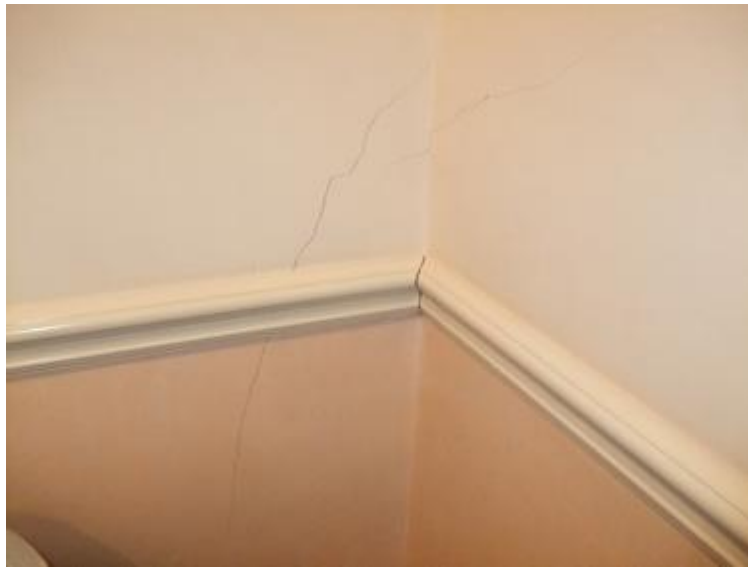
1-2mm wide x 600mm long diagonal, tapering cracks to the internal walls. The cracks end at the front external wall.

2mm wide vertical crack above the front left lounge.

1.5mm wide diagonal cracks above the kitchen door and front right lounge door.

FIGURE 04 Hallway - crack to internal lounge wall

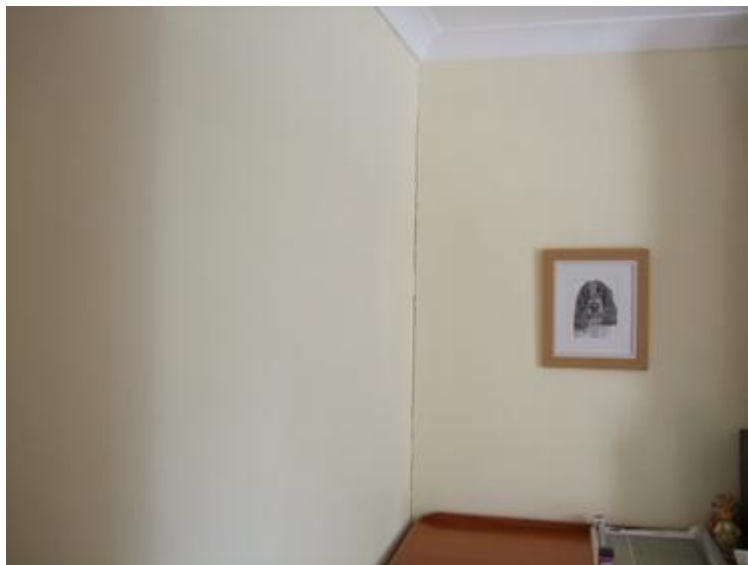
1-2.5mm wide tapering vertical crack at the rear left corner wall junction. (junction of the original house and extension)

FIGURE 05 Rear bedroom - vertical crack at wall junctions.

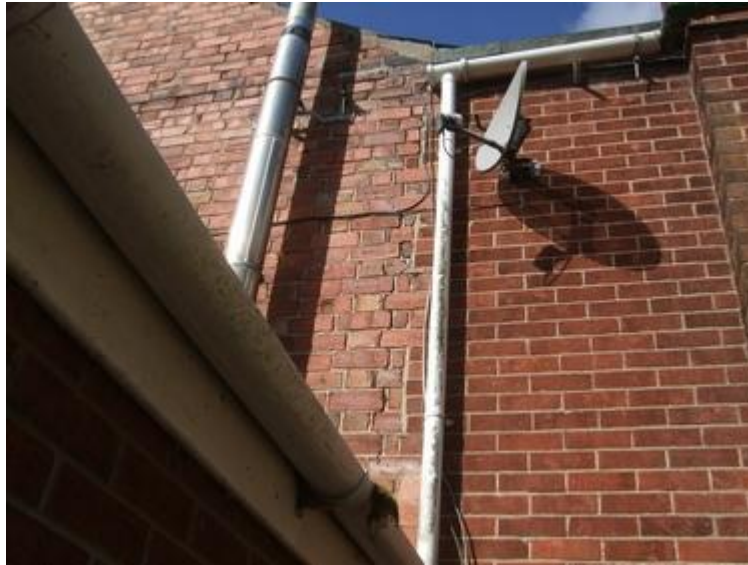
3mm wide x 1500mm long vertical, stepped crack at the junction of the original house and extension.

FIGURE 06 Rear elevation - vertical stepped crack

The tapering nature of the internal cracking is typical of foundation movement. The movement does appear to be concentrated around the internal stair walls and the front external wall around the front door. The cracking at the rear of the house appears to be caused by differential movement between the original house and extension.
