# Parsonage Farm Parsonage Lane Spalding Lincolnshire

*Historic Building Recording*

CA Project: MK0012  
CA Report: MK0012\_1

March 2019

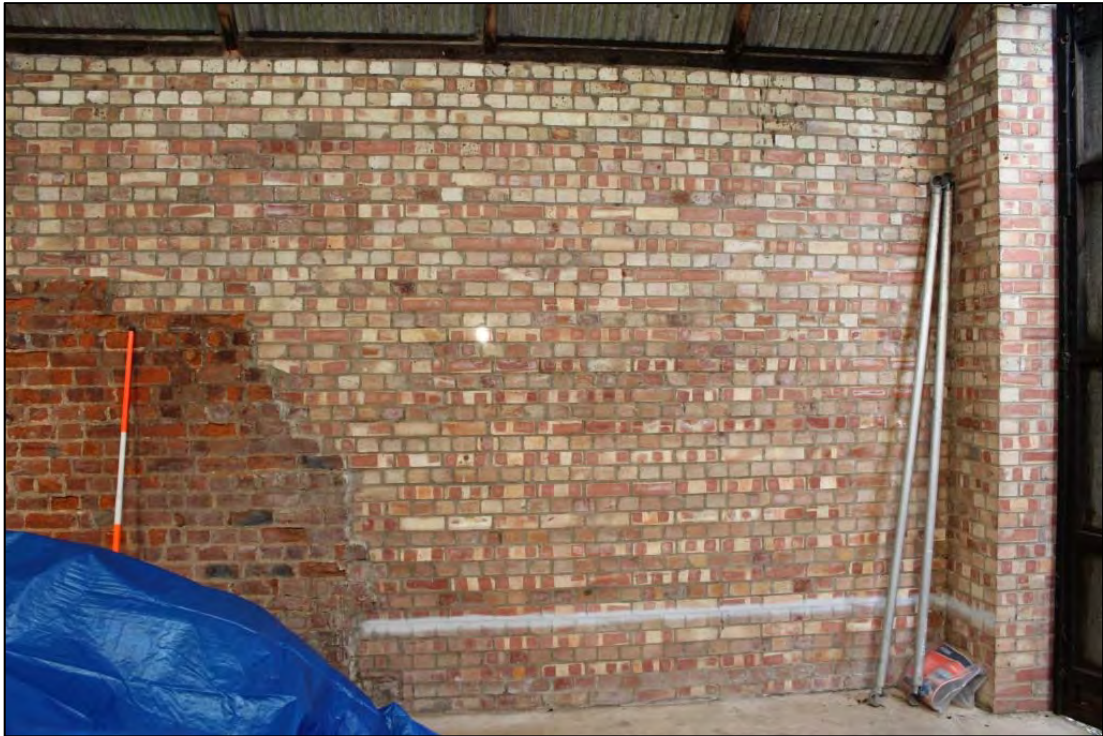
Photo 3: Internal view of north-eastern extent of Building A, showing 20th-century repair and extension works

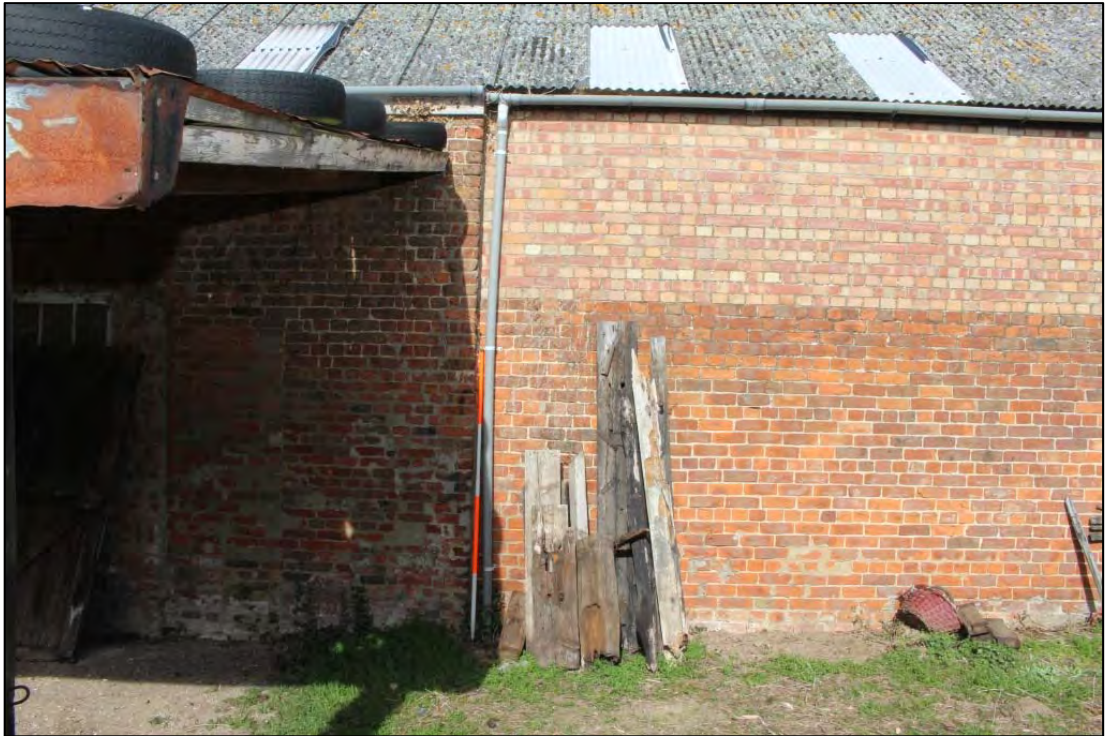
- 4.4. Cartographic evidence suggests that the length of the barn up to the eastern extent was consistent from 1888 until the 20th-century extension, terminating in line with the western elevation of Building E. However, there is evidence of a further phase of alteration to the length of the barn where the presence of butt joints on both southern and northern elevations indicate a previous extension (Photos 4 - 6). The lower courses of brickwork of the apparent extension appear to be hand-made and date to the 19th-century, suggesting that the barn was extended soon after its construction. This would accord with the extension being built prior to 1888 when the building first appears on the OS map apparently incorporating the length of this earlier extension. The pattern of brickwork evident on both the earlier and later extensions (Photo 2, above), suggests that the earlier extension may have been repaired at the time of the later extension using the same type of brickwork. Alternatively, both northern and southern elevations exhibit the same phasing of brickwork, suggesting that the earlier extension may have been originally built to a lower height than the original barn and extended upwards at the time of the 20th-century extension.

Photo 4: Overview of southern elevation showing butt joint between phases of extension/repair

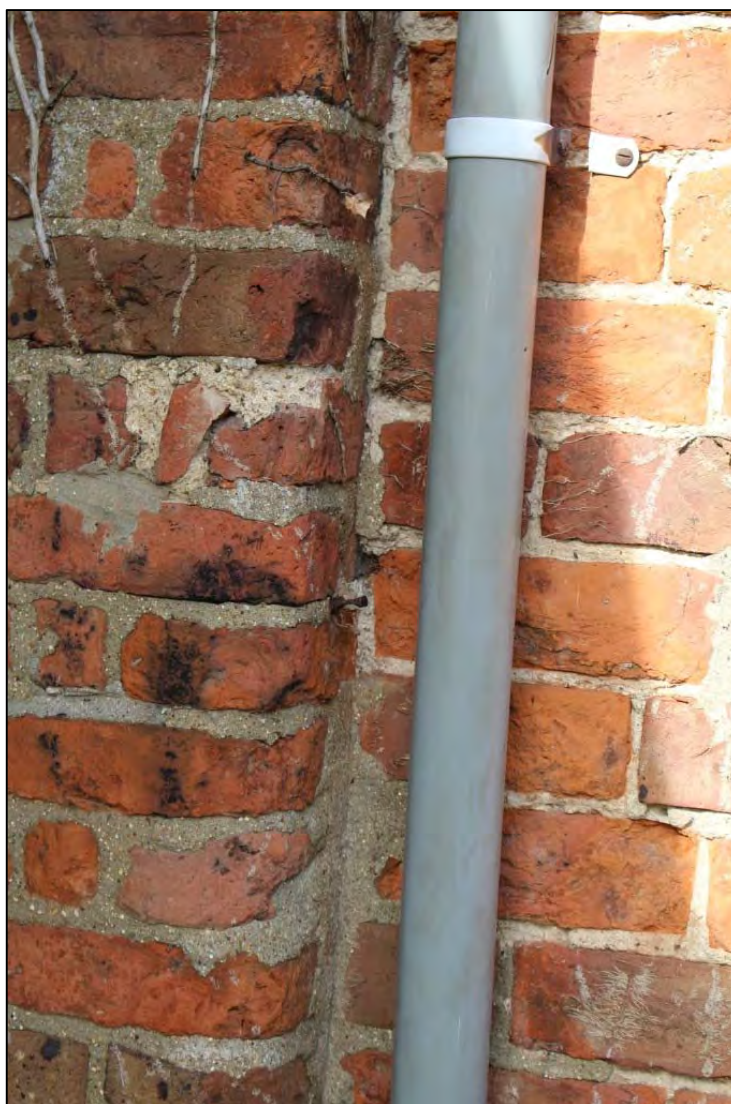
Photo 5: Detail of butt joint within southern elevation. Note the rounded bricks to the western side of the joint

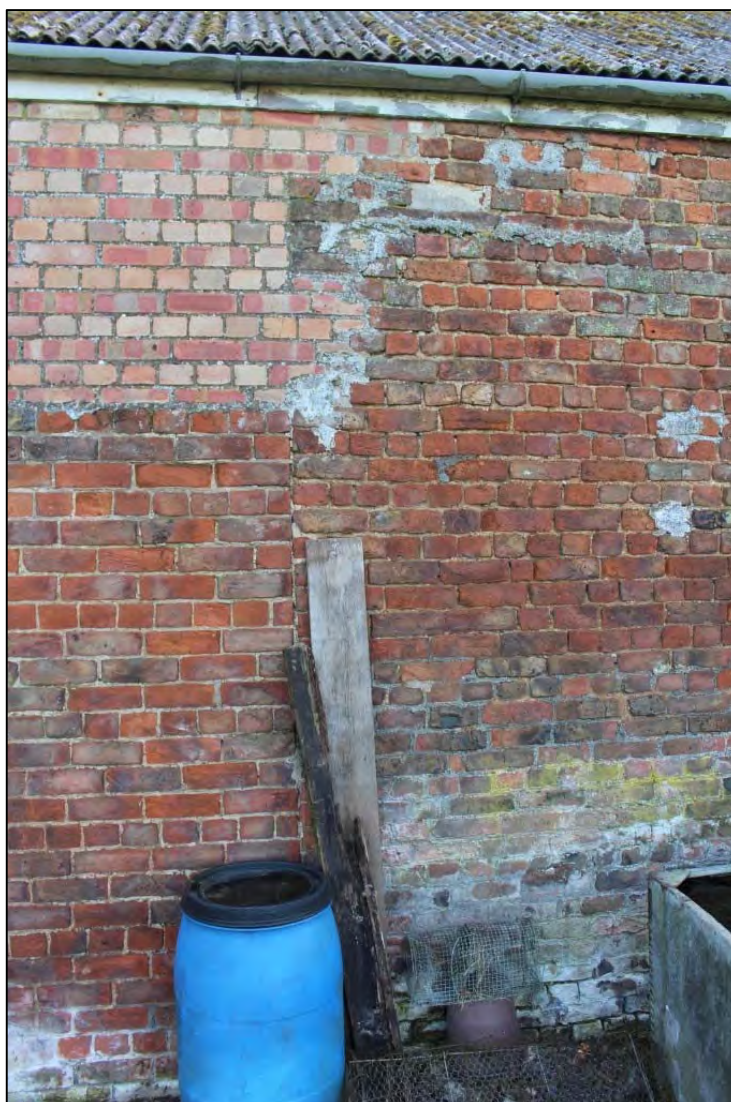
Photo 6: Detail of butt joint on northern elevation. Note the later brickwork to the upper courses, contemporary with the later extension

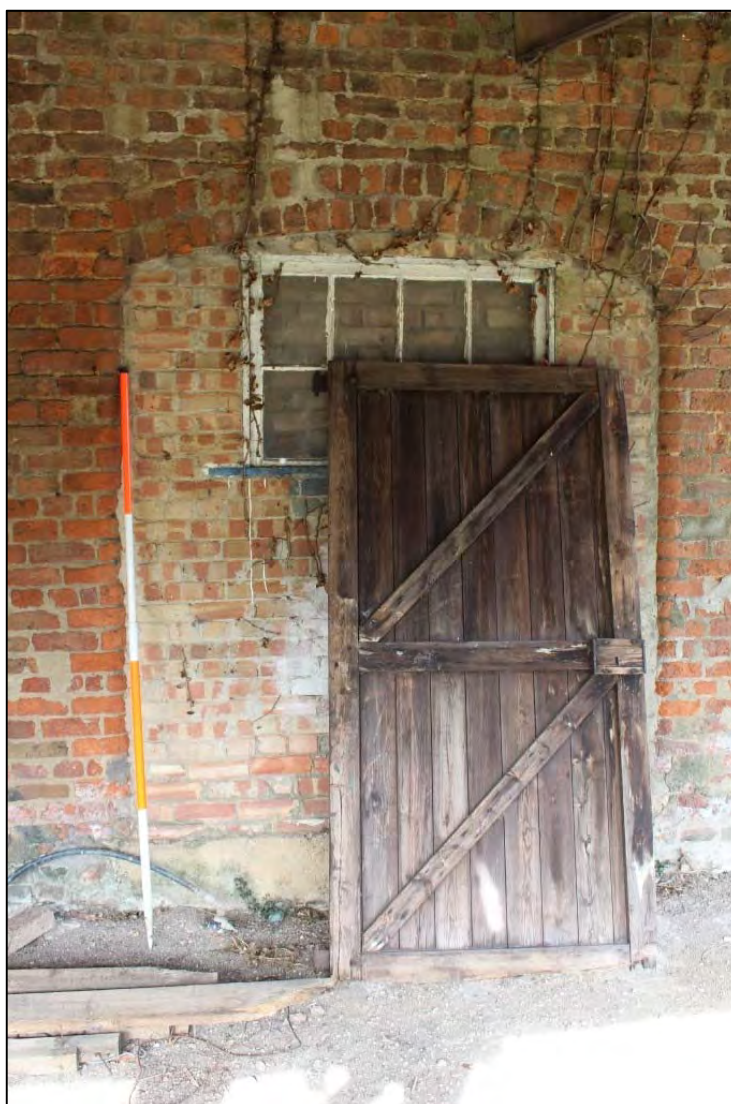
- 4.5. Approximately half way along the southern elevation are a pair of segmental arch headed opening that has been blocked internally and externally (Photo 7). The northernmost arch (see Fig. 7) is very shallow and is not visible internally, the arch head is single course, however taking account of the degree of remodelling of the surrounding brickwork, it is unclear whether the arch was once part of a door or window opening. The southernmost opening is more substantial and externally, the opening appears to have been partially blocked with the incorporation of a window, before being blocked up entirely from within the barn at a later date. The original opening incorporates curved bullnose bricks (Photo 8), possibly to ease the movement of carts or horses through the opening. Immediately above the blocked-up opening, a regularly spaced line of vertically laid bricks suggests that these slots may have previously accommodated timber joists to support a first floor in this part of

Photo 7: Overview of blocked up arch-headed opening within the southern elevation

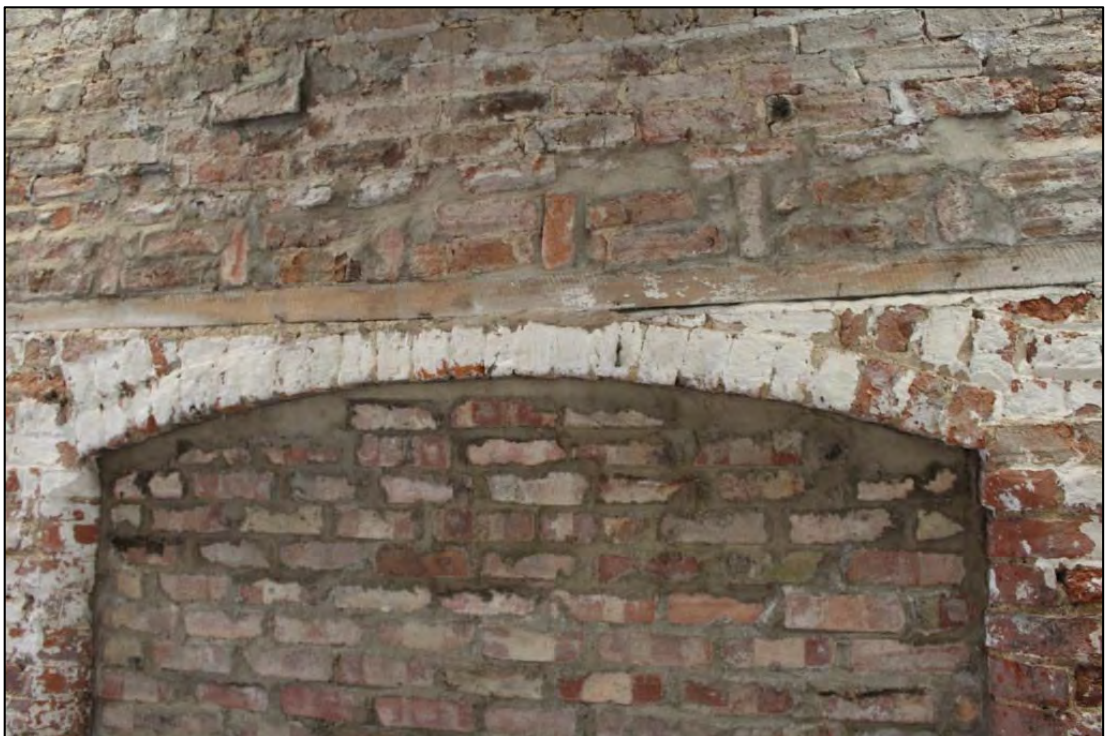
the barn (Photo 9). An extant, machine cut timber remains within the wall, immediately beneath the slots (Photo 10) but this cuts across the top of the brick arch, suggesting that a first floor was inserted as a later alteration. Evidence for the existence of a first floor is replicated on the northern elevation, however the brickwork has been repaired in a way that does not evidence the incorporation of slots for timber joists (Photo 11).

Photo 10: Detail of blocked up slots that may once have supported timber joists. Note the extant timber immediately below

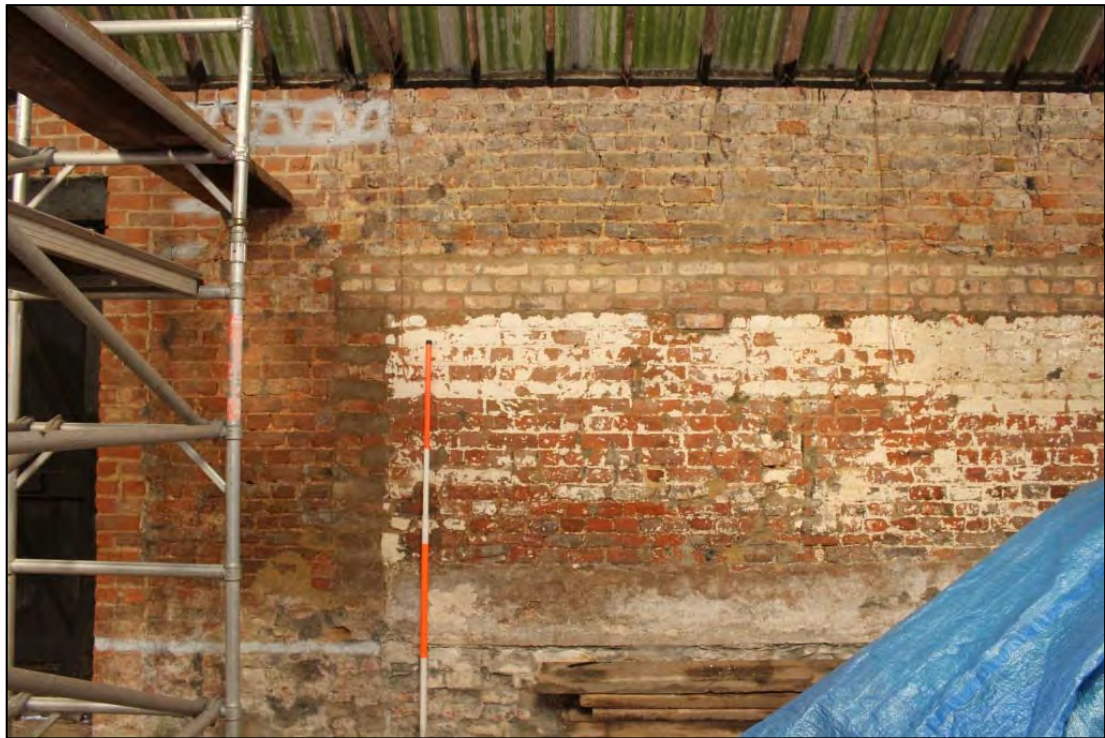
Photo 11: Detail of northern elevation showing evidence of alterations

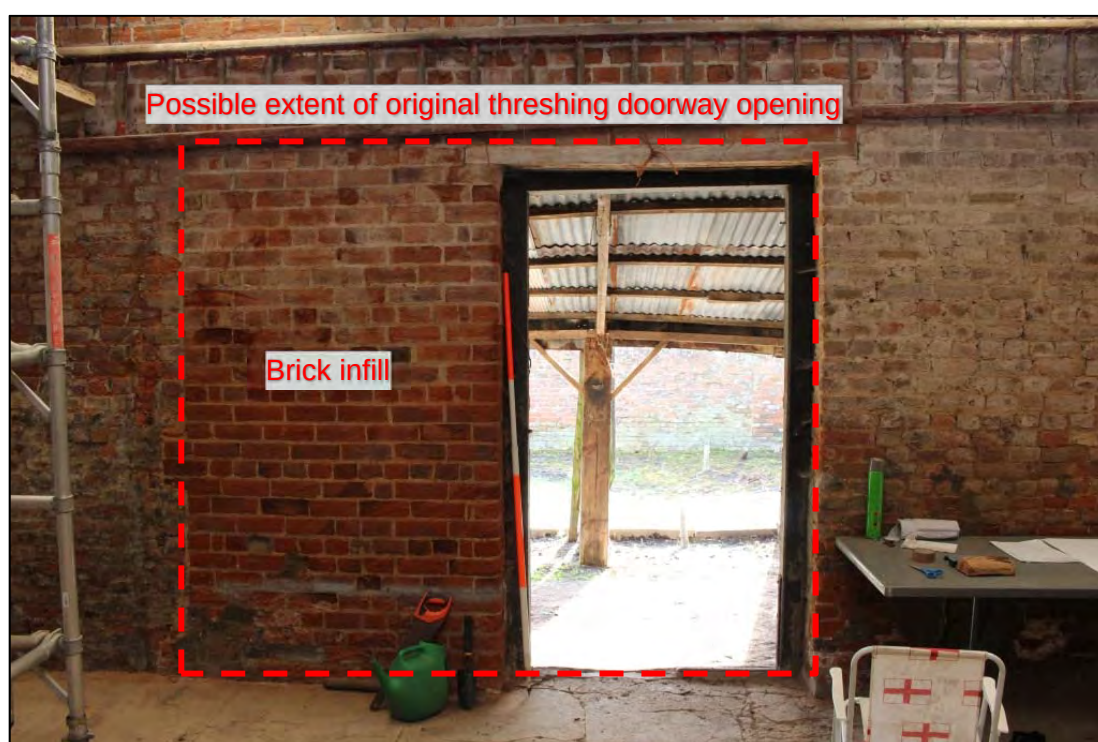
Photo 13: Overview of single doorway within the southern elevation, note the renewed brickwork to the north of the door

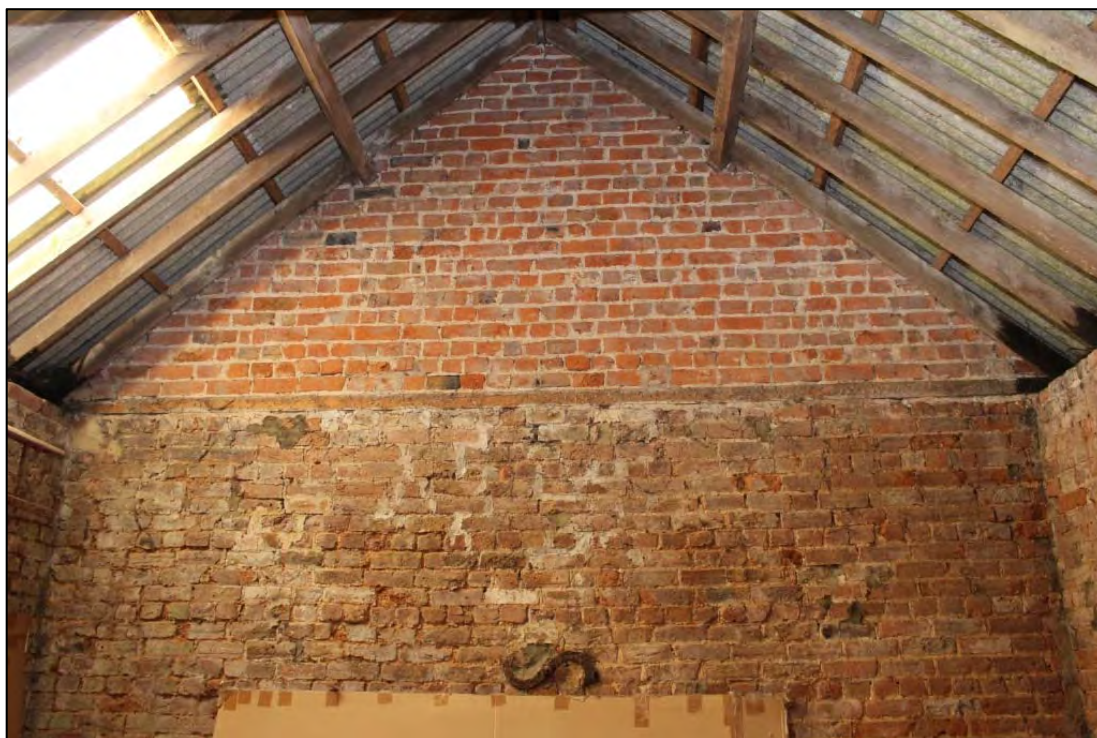
that in the adjacent northern and southern elevations (Photo 14), suggesting that the western extent of the barn may have always terminated in its extant position, or else was subdivided at its western extent where the gable currently sits. Additionally, there is evidence that the upper part of the gable end has been rebuilt in the 19th-century from hand-made bricks, possibly in conjunction with a re-roofing of the barn.

Photo 14: Overview of western gable of the barn, note the change in brickwork and the incorporation of a horizontal roof timber

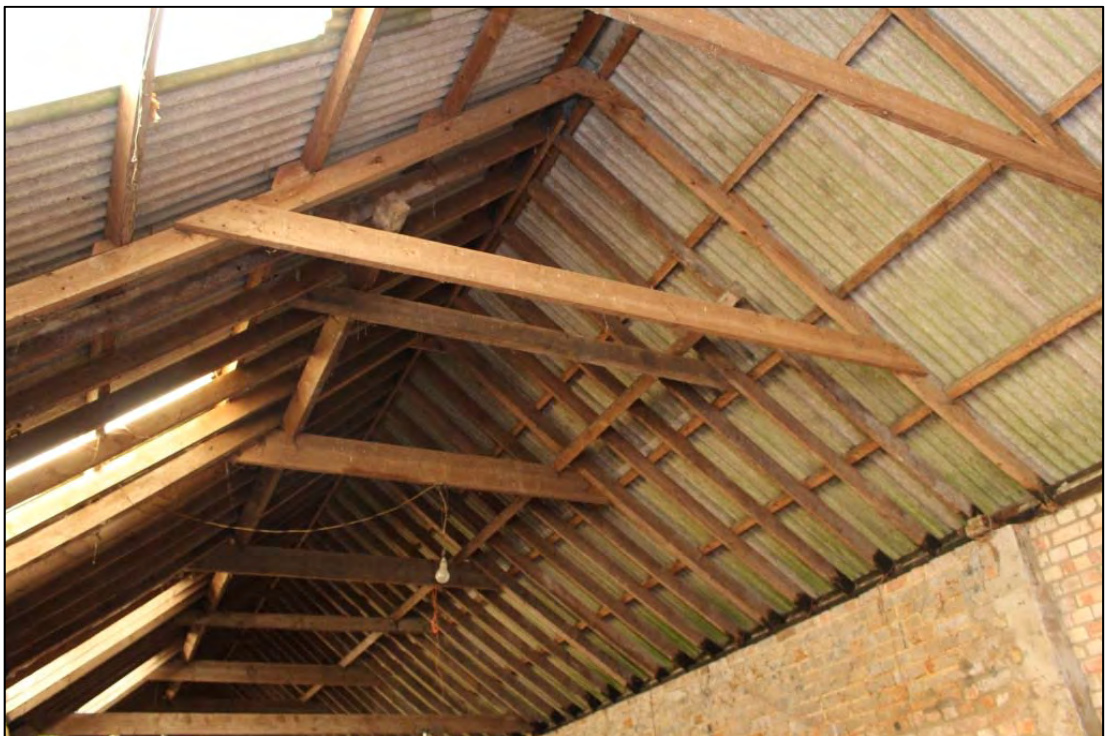
Photo 16: Width and placement of collars changes at the point of the earlier extension, also note the change in rafter spacing and termination of clasped purlins. The butt joint within the northern elevation can be seen in the lower right of the picture

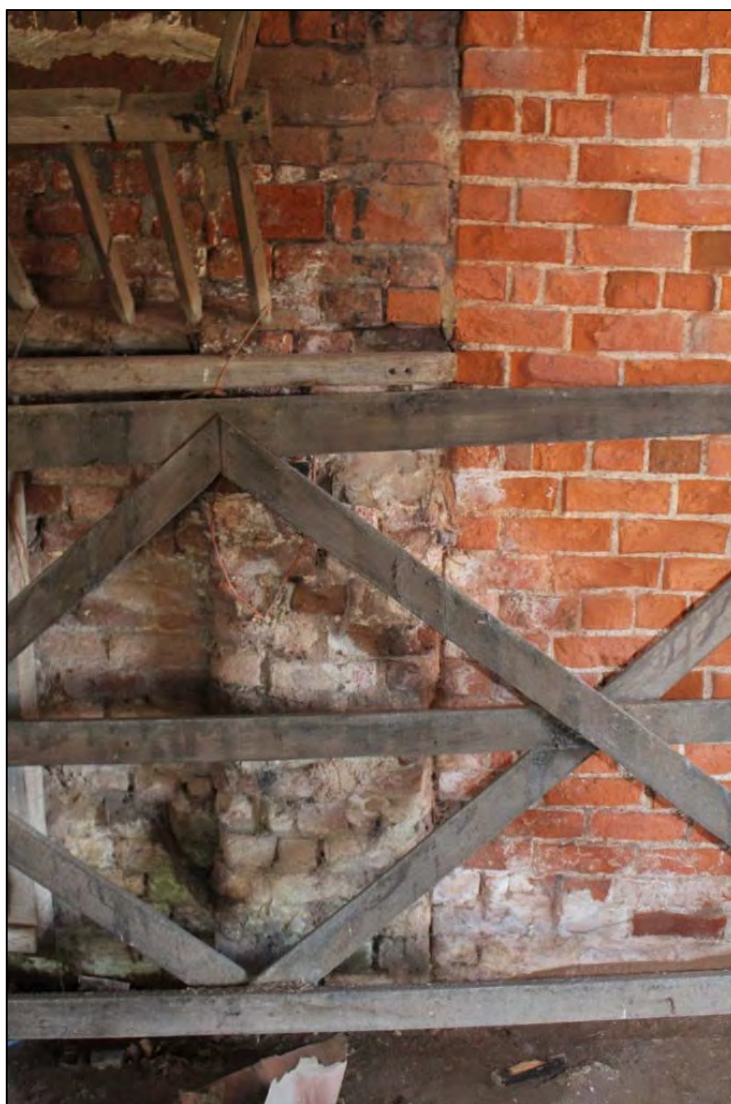
Photo 20: Detail of butt joint within western elevation of Building B. Note the tapering of the buttress as it rises

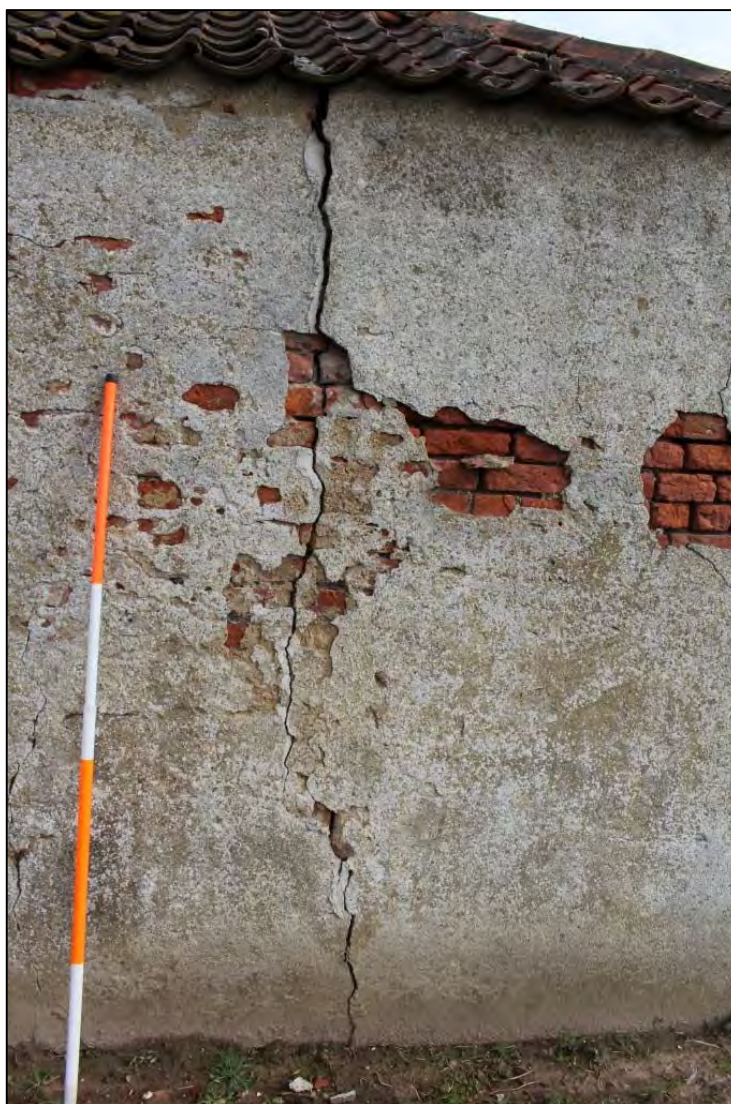
approximately in line with the southern elevation of Building A, perhaps adding weight to the theory that the northern extent of Building B was once part of Building A, as suggested in cartographic evidence. This is further corroborated by 19th-century alterations, including the later wall to the north-western extent of Building B which hint towards a significant reconfiguration of the buildings at this part of the farmstead. The southern extent of the western elevation (Photo 25) retains cement render to the majority of the elevation. This appears to have caused damage to the brickwork beneath, likely through the trapping of moisture (Photo 26).

Photo 26: Evidence of cracking and erosion beneath cement render

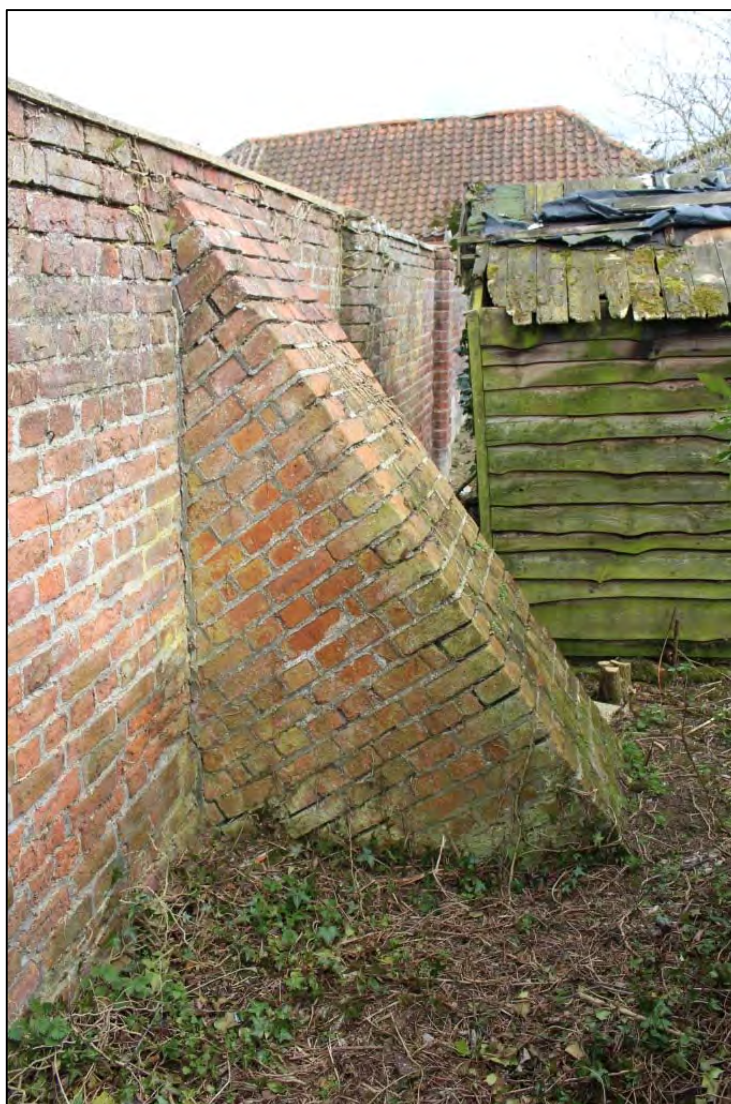
- 4.20. Enclosing the courtyard to the southern extent is a brick wall (Photo 38), approximately 2.2m tall, which extends from the south-eastern corner of Building C to the north-western corner of Building D. The wall comprises red brick, laid predominantly in English Bond and capped in cement. Whilst the northern elevation of the wall is plain, the southern elevation incorporates a series of chamfered buttresses or pilasters, probably included for decoration rather than structural stability. The westernmost buttress, situated where the wall has transitioned to the southern elevation of Building C (Photo 39), tapers into the wall at the top (Photo 40). The three easternmost buttresses also incorporate brick chamfer detail but terminate abruptly at the top of the wall without tapering (Photo 41). This suggests that the wall may have once been taller and was reduced in height in the past, possibly due to damage or stability issues. A large, angled buttress (Photo 42) disrupts the rhythm of the chamfered buttresses and was almost certainly installed at a later date to address a structural deficiency within the wall.

Photo 42: Angled buttress supporting southern wall
