# **NORTH LEVEL DISTRICT INTERNAL DRAINAGE BOARD**

## **Foul Anchor Sluice, Tydd Gote, Wisbech**

**Listed Building Consent Application – September 2020**

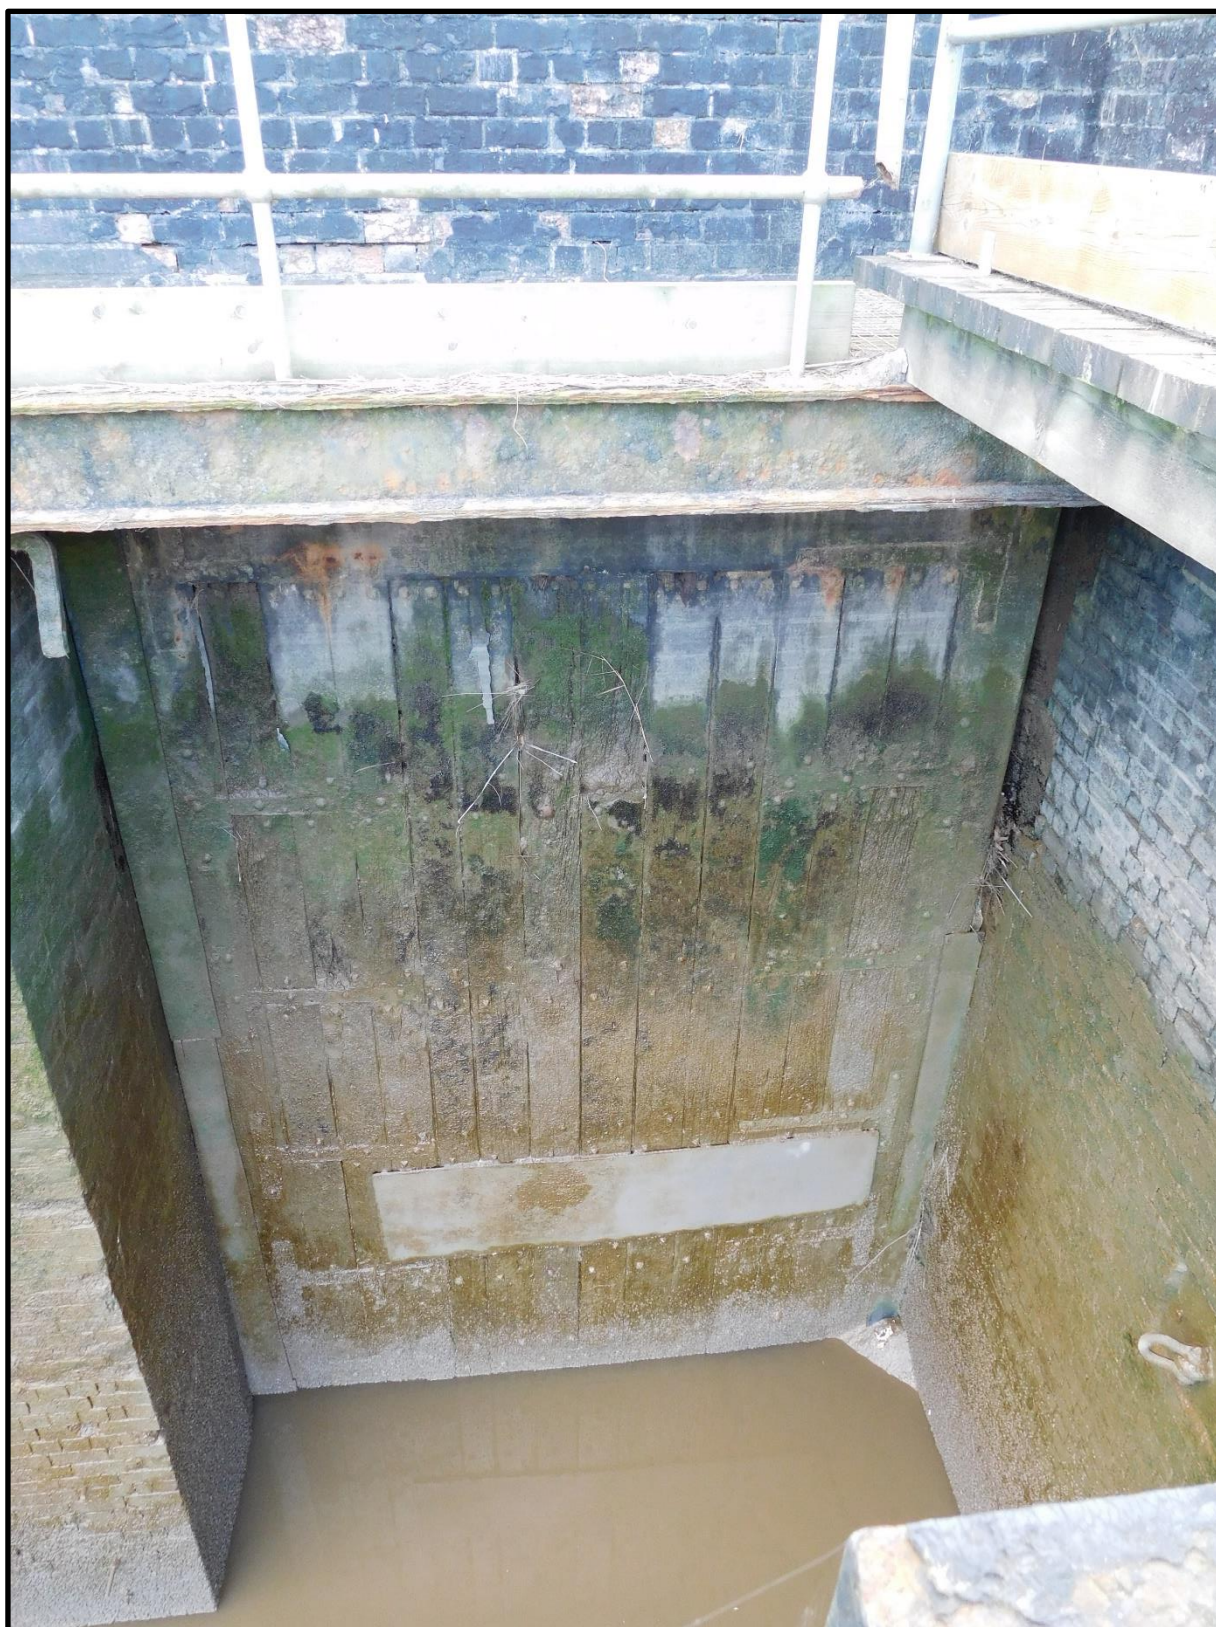
***Outer door (northern)***

- 1.5. The above works included some minor repairs to the two outer doors to try and stop leaks, but those doors are showing significant signs of deterioration and do not seal effectively against the sluice structure, allowing water to flow "the wrong way" on high tides.

- 2.1. In order to address the issues outlined in 1.5 above, it is proposed to replace the two outer sluice doors. Any works required to the sluice structure to ensure effective fixing, sealing and operation of the replacement doors would be undertaken at the same time.

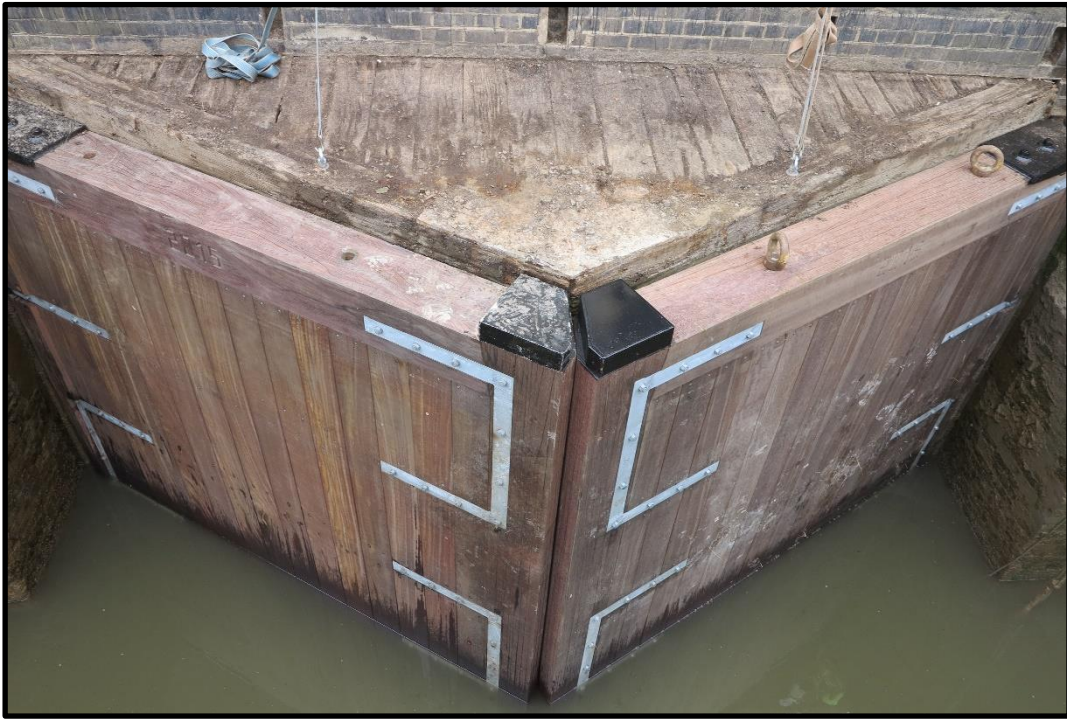
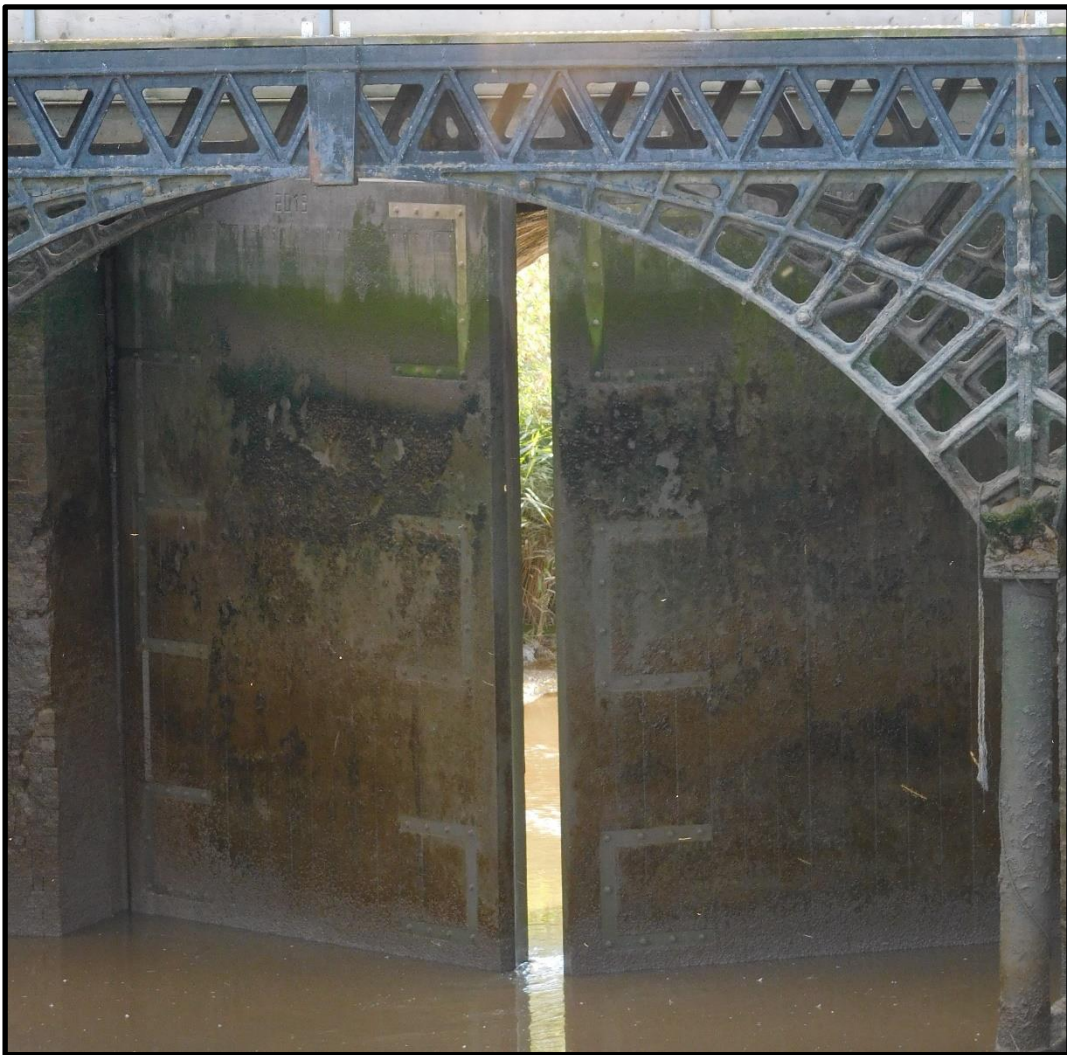
*Change in appearance of central doors from installation in 2015 (top) to present day (bottom)*
