Contract  
Proposed Structural Repair Works to:-  
Roman Lodge, Mill Lane, Tydd St Mary, Lincs.

Draw Title  
Structural Repair - Existing Decayed Joist Ends

Project  
Proposed Alterations & Extension to  
Roman Lodge  
Tydd St. Mary  
Spalding  
Lincolnshire PE13 5SB

Title  
Joist Decay Schedule

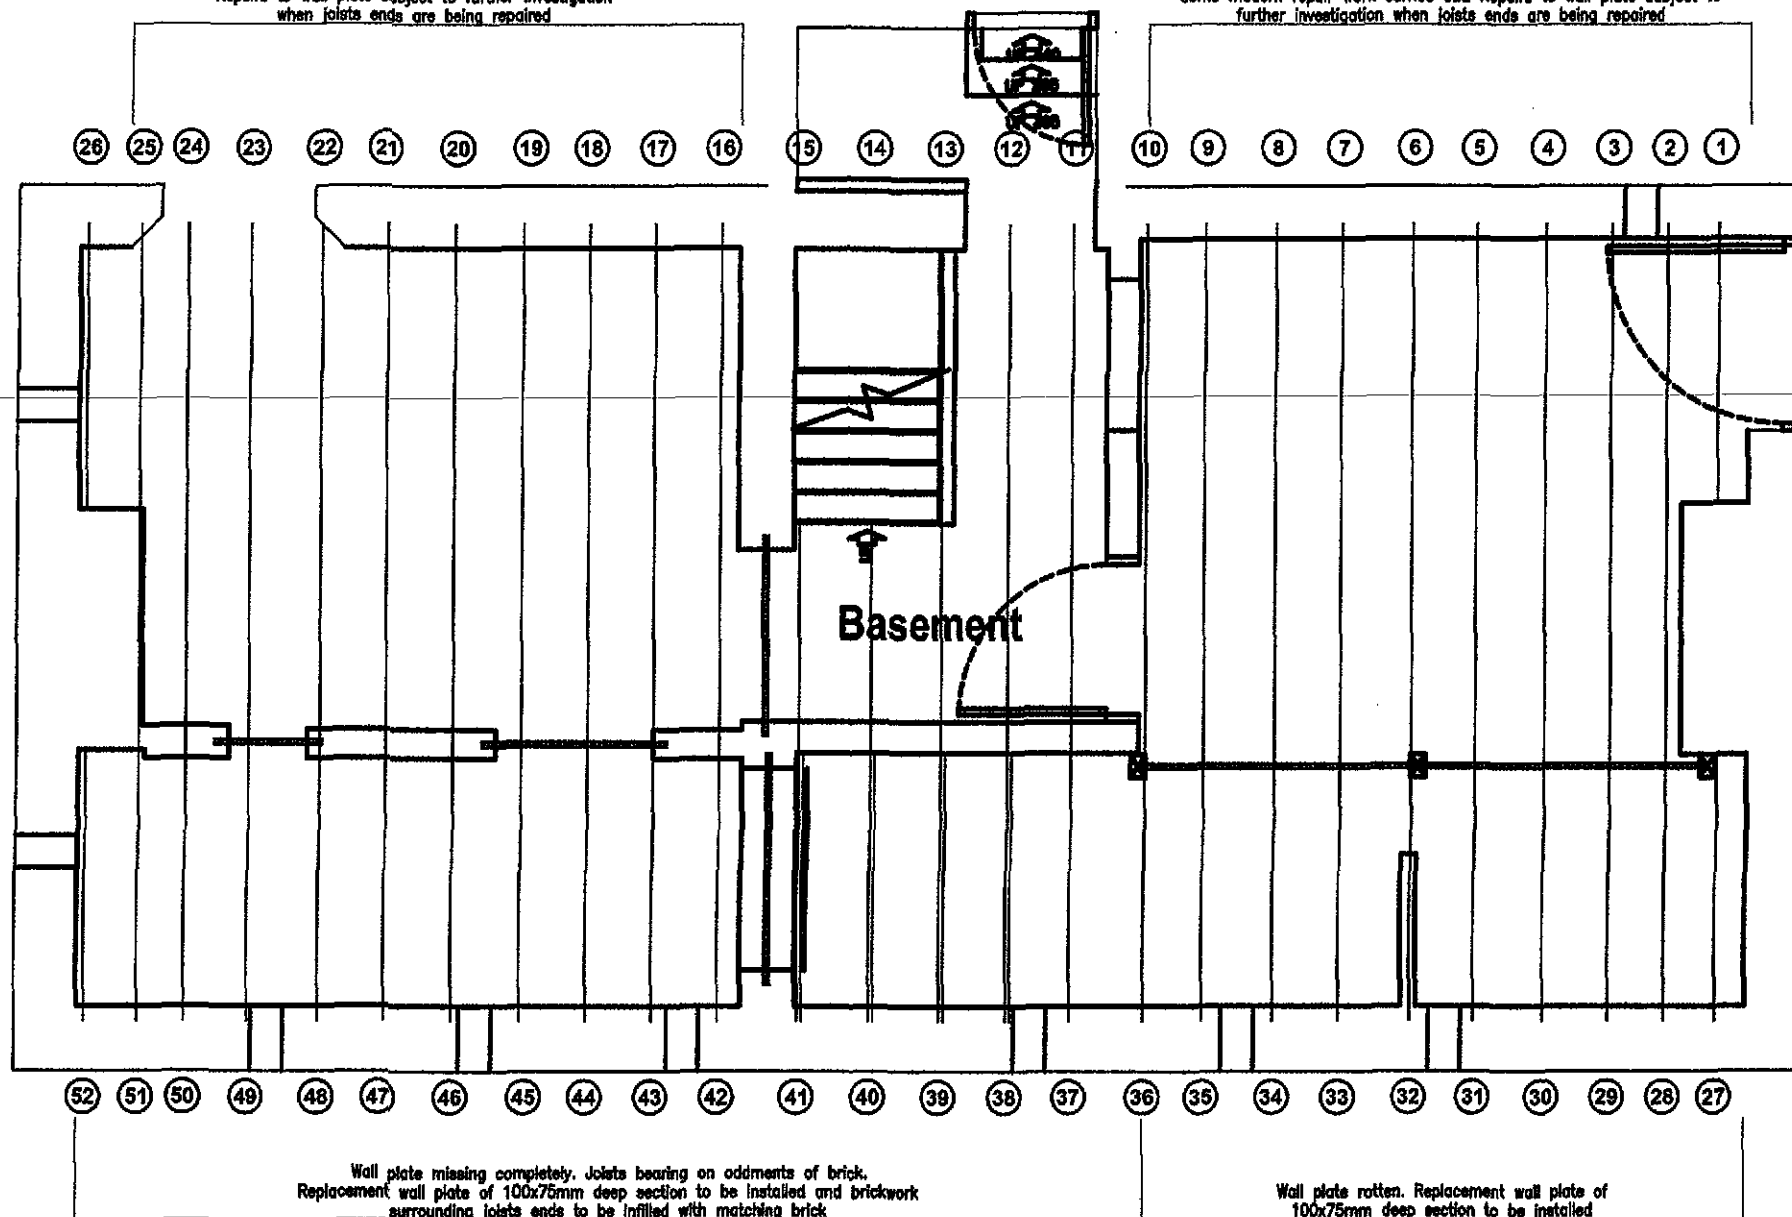
Upon visual inspection wall plate appears fine.  
Repairs to wall plate subject to further investigation  
when joists ends are being repaired

Upon visual inspection wall plate appears fine albeit with  
some modern repair work carried out. Repairs to wall plate subject to  
further investigation when joists ends are being repaired

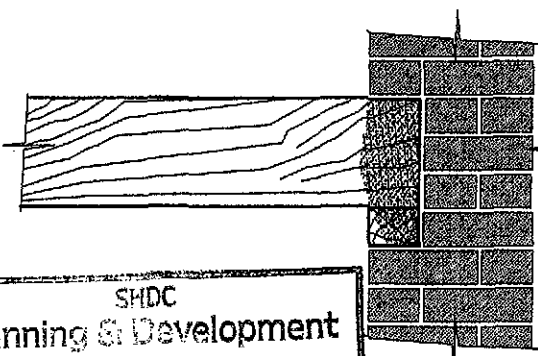
Existing Joist End Detail (1:15)

Decayed timber joist end  
cut back as required  
(min 50mm from  
evidence of last decay)
