CONTAMINATION SCREENING PHOTOGRAPHS

PROPOSED CONVERSION OF AGRICULTURAL BARN TO RESIDENTIAL DWELLING

LOWGATE FARM, LOWGATE, TYDD ST. MARY SPALDING, PE13 5PF

PLANNING APPLICATION ISSUE

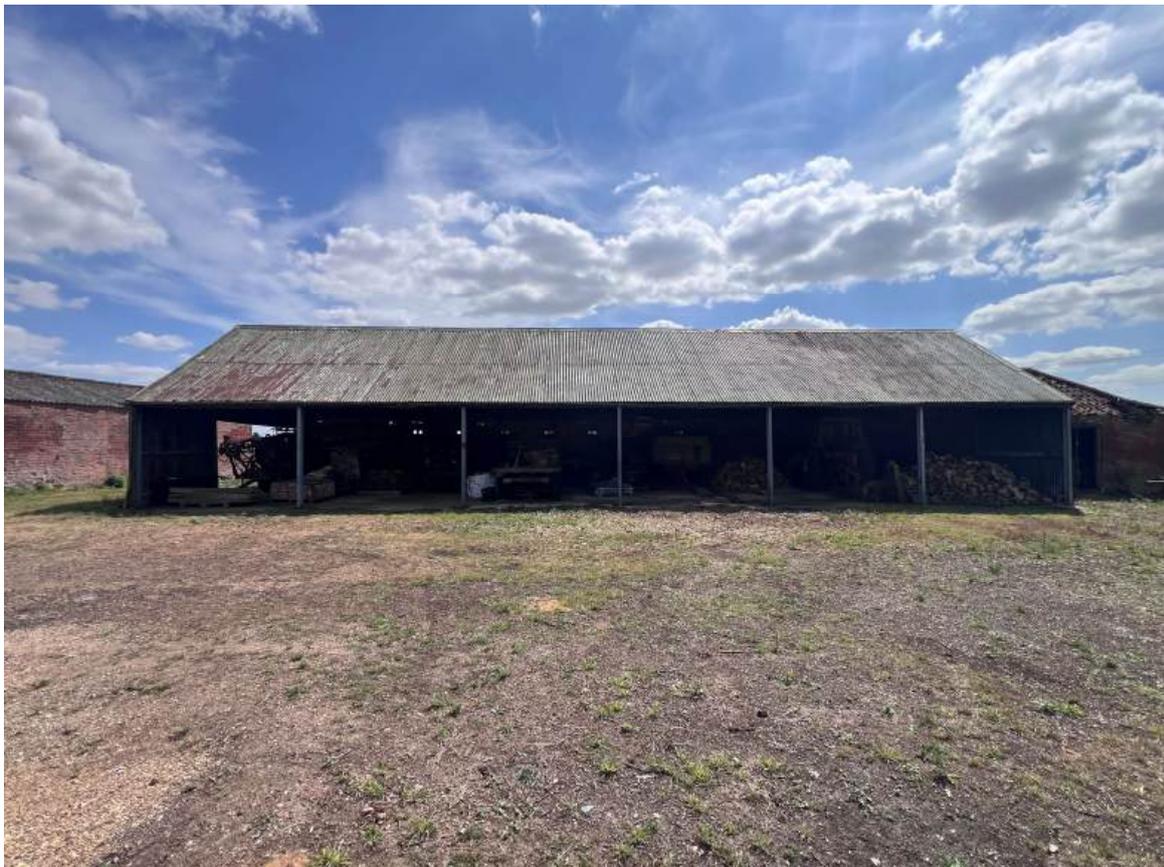
Barn A (see fig 01) is of steel construction and comprises a steel frame of columns topped by timber trusses. The barn has a pitched roof which has a single skin corrugated steel roof cladding over the whole area. The west gable wall is partly brickwork where it adjoins a further brick building and has the same single-skin steel cladding as the roof where exposed, the east gable is partly the same cladding, partly collapsed brickwork and partly open. The south facing side wall is brickwork. The north side of the barn is open. The floor is a simple concrete slab.

Fig. 01 – General image of north elevation of barn A showing steel structure and claddings.

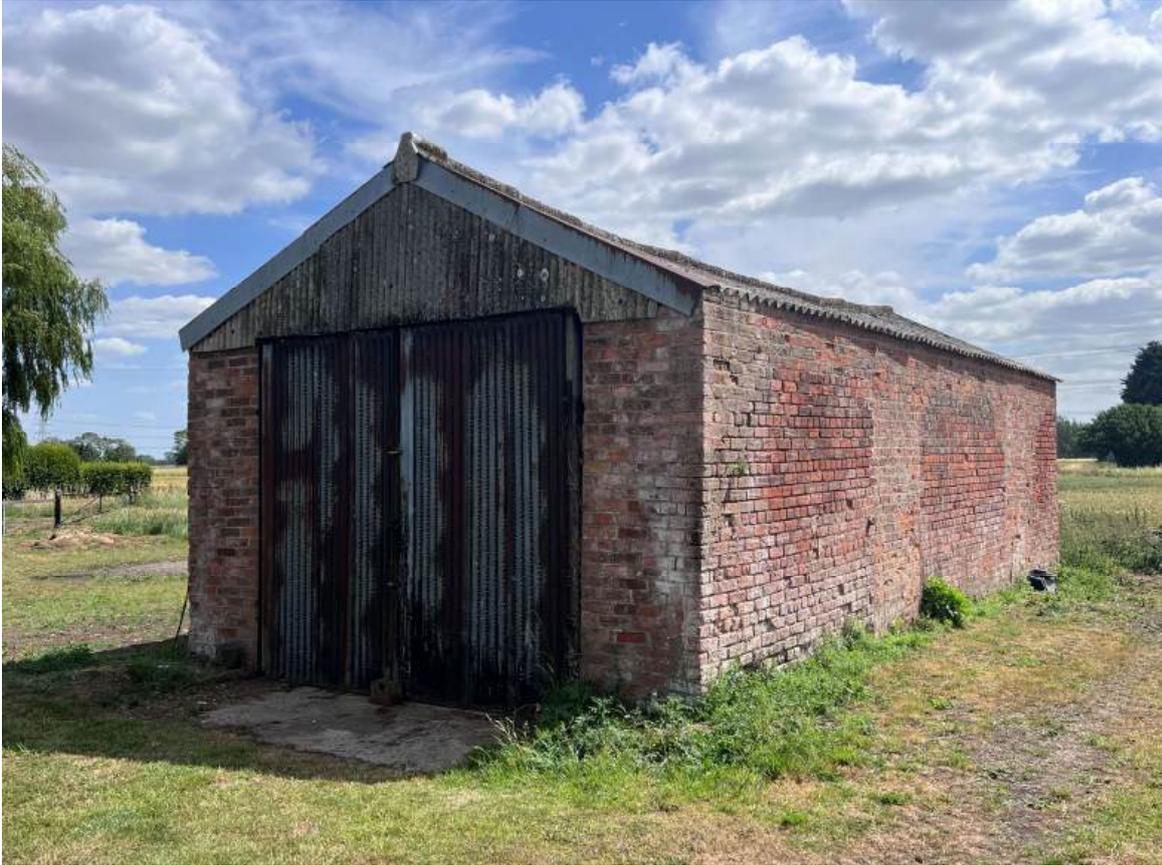
Barn B (see fig 02) is a brick building with partial steel cladding to the north elevation, timber trusses and single skin corrugated asbestos-cement roof cladding. The floor is a simple concrete slab.

Fig. 02 – General image of barn B.

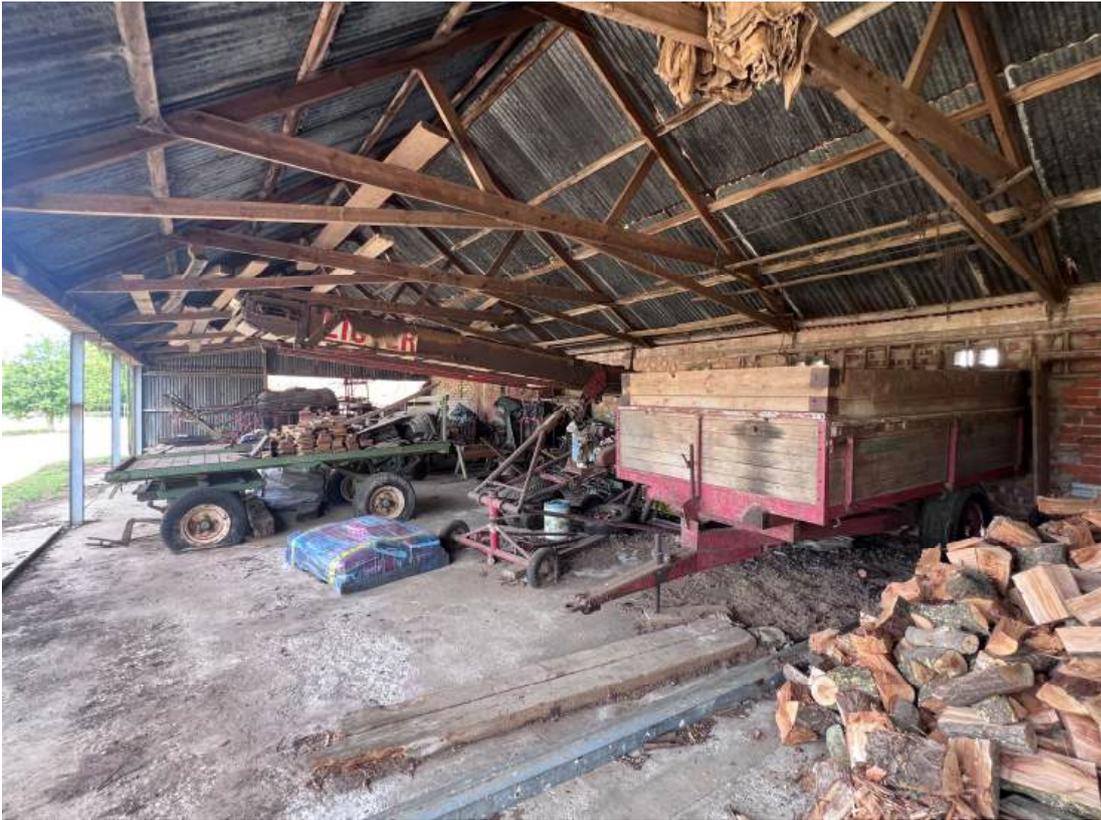
There does not appear to be any visible evidence of staining on either floor.

Fig. 03 – General image showing concrete floor in barn A

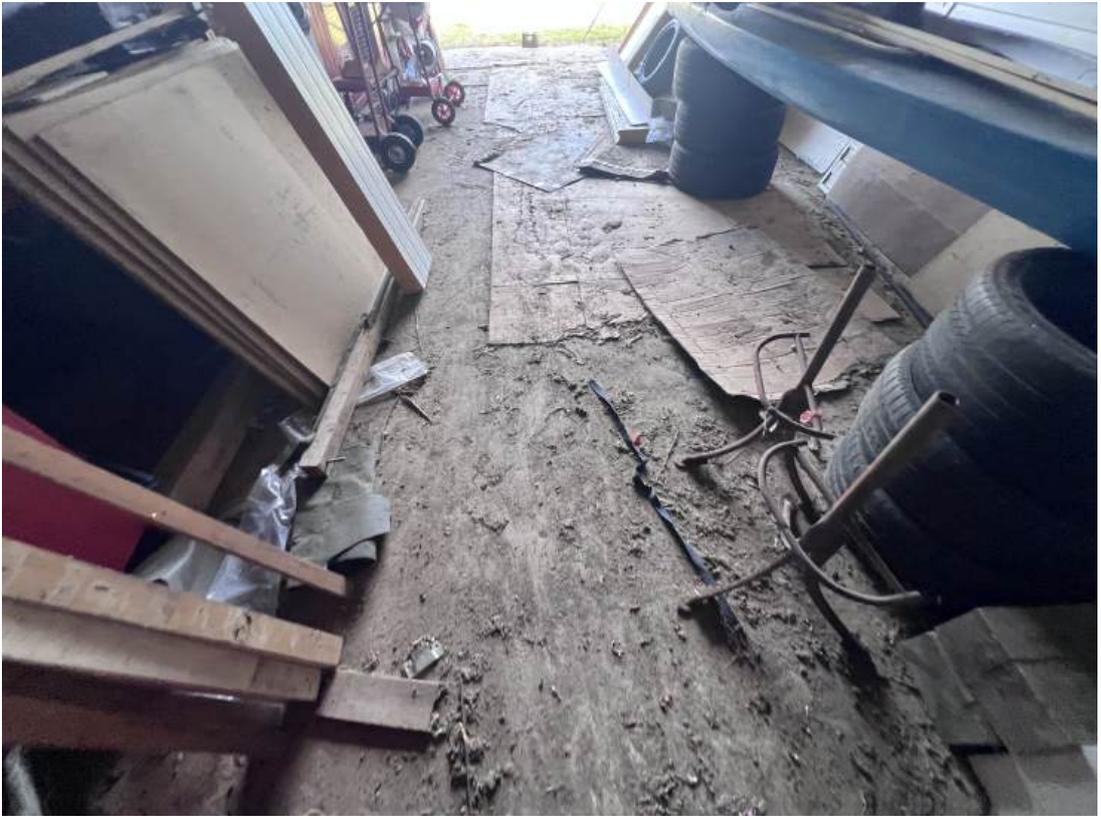
Fig. 04 – General image showing concrete floor in barn B.

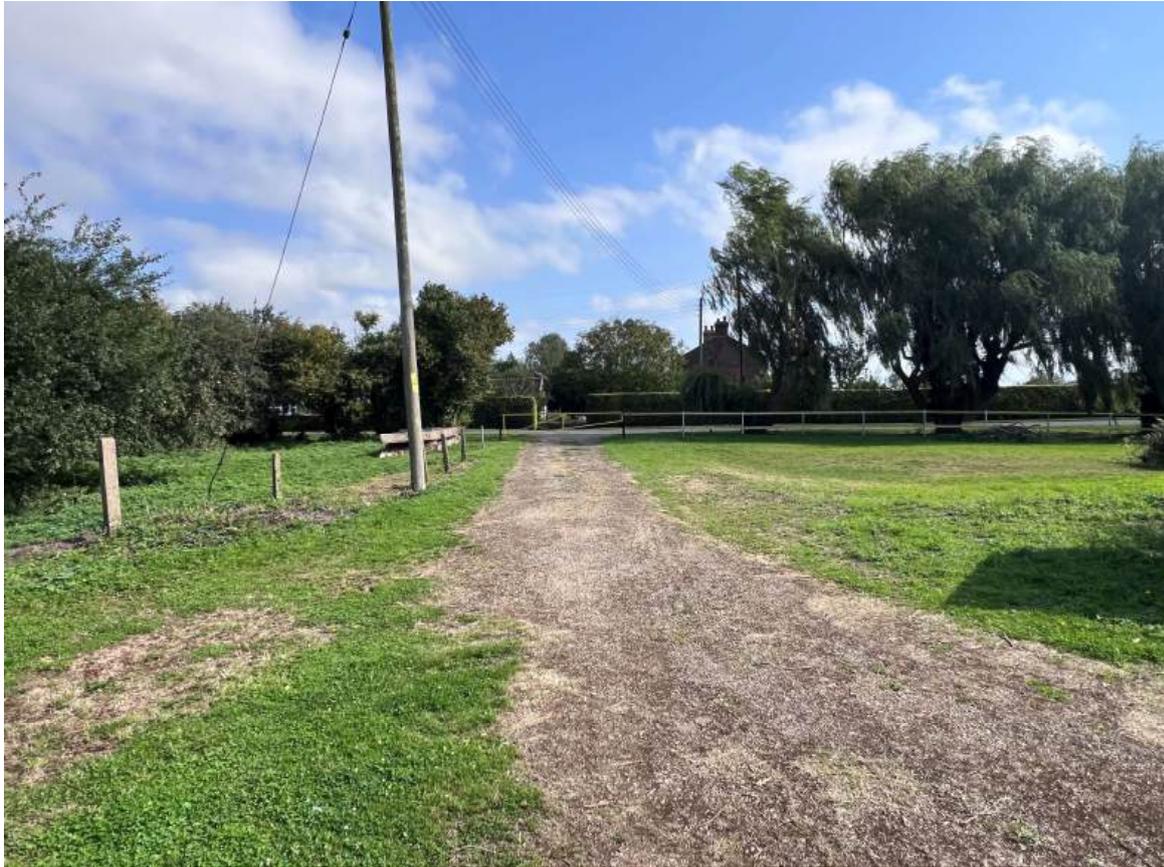
Fig. 05 – General view of the gravel drive looking towards Low Gate.

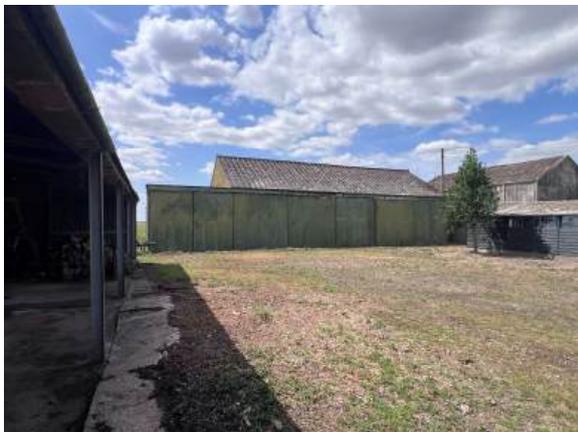
The remainder of the site is grass with substantial plant growth throughout this area, and all appears healthy with no signs of contamination, die-back etc. (figs. 06 to 09).

Fig. 06 – General view of site looking north west,

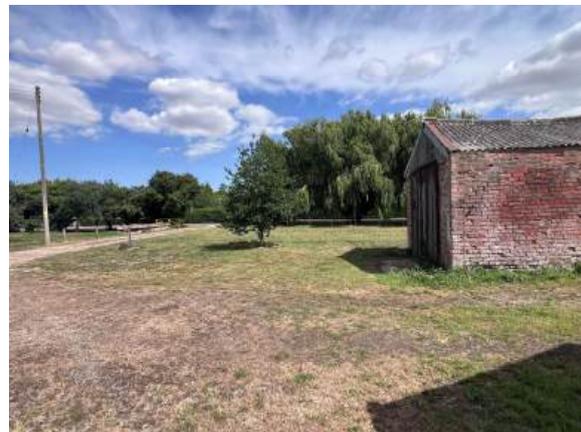
Fig. 07 – General view of site looking east towards entrance

barn A is on the left

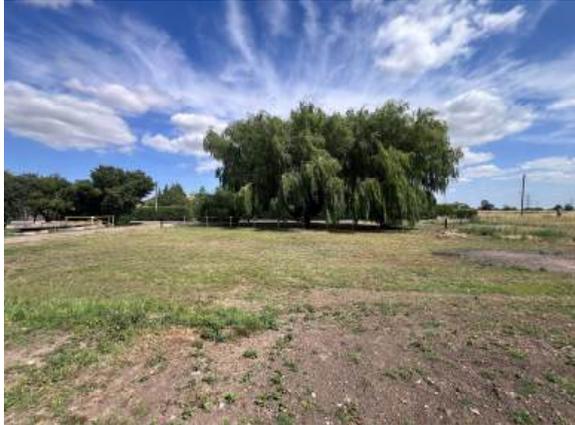
Fig. 08 – General view of site looking east towards Low Gate

including barn B

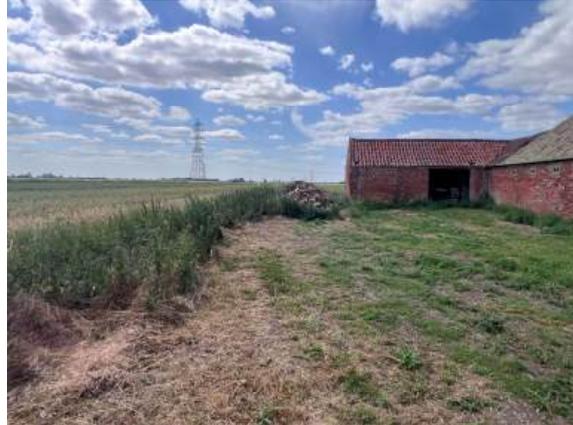
Fig. 09 – General view of site along the south boundary looking west
