**PRELIMINARY STRUCTURAL REPORT  
UPON  
REDUNDANT BARNS  
LOWGATE FARM  
LOWGATE,  
TYDD ST MARY  
PE13 5PF**

**Ref: 25110**

**SEPTEMBER 2025**

At the request of Oglesby & Limb Ltd, on behalf of Mrs E. Dack, a visual inspection only of the property was undertaken, the purpose being to comment upon the structural elements only.

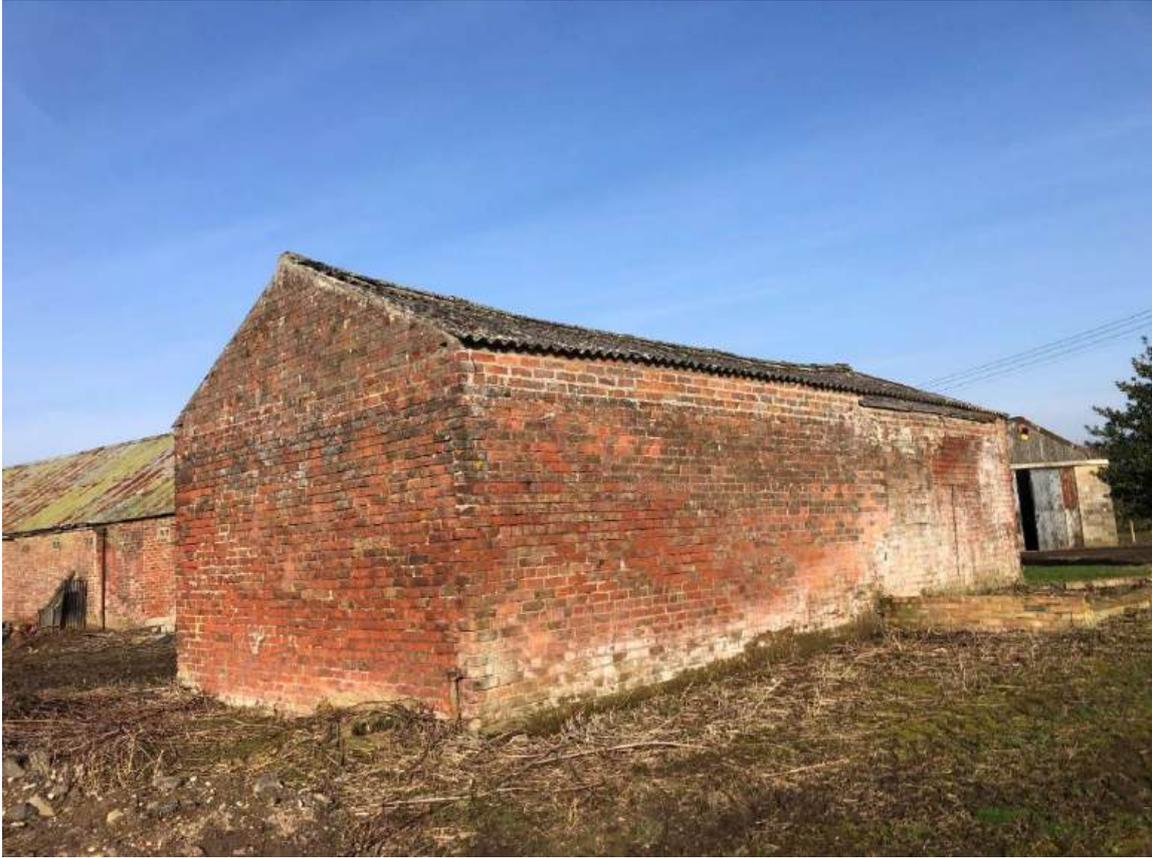
**Photograph 1**

The external appearance of the brickwork exhibits considerable movement and re-pointing throughout – see photograph 1.

As with many agricultural buildings of this age, there is unlikely to be any foundations. This is the likely cause of vertical movements to the structure.

Nevertheless, it would be possible to introduce suitable support to the walls in the form of underpinning and remedial strengthening to the roof, in conjunction with re-pointing and crack repair.

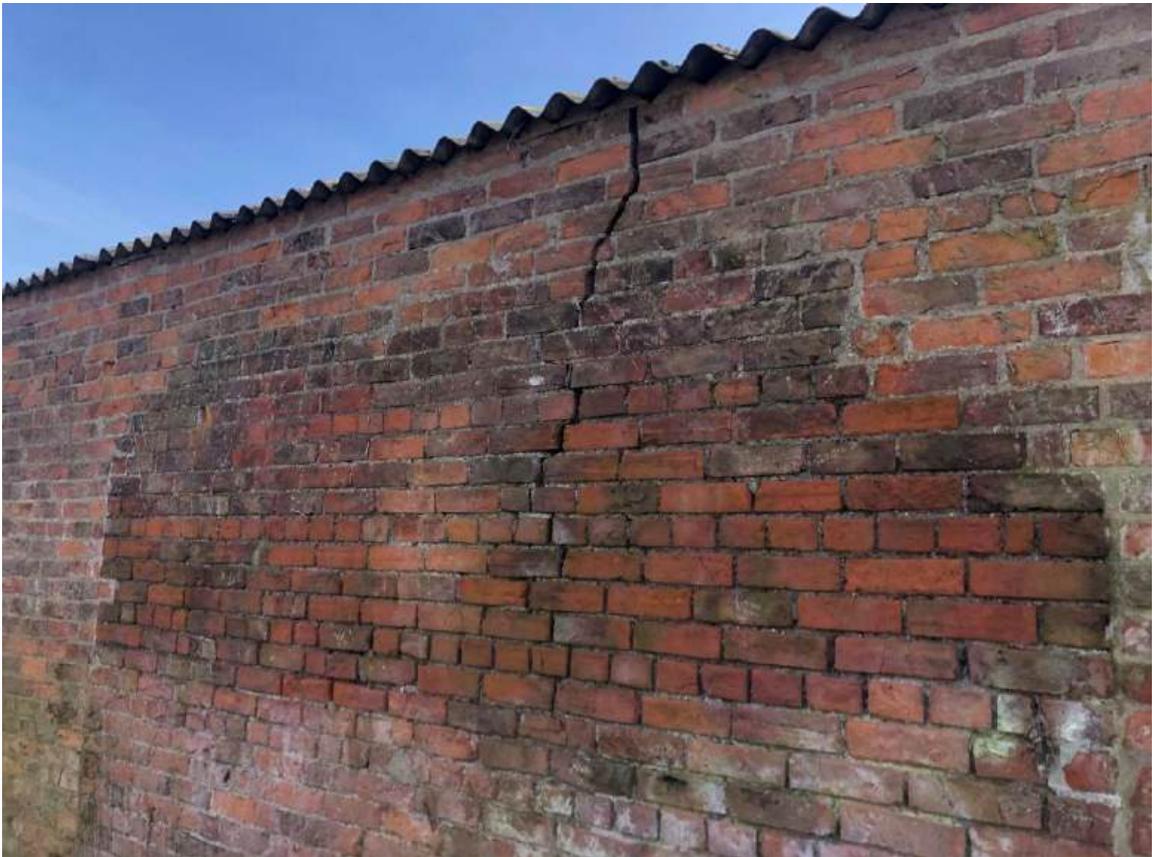
**Photograph 2**

A minor crack was noted at high level in the Eastern flank wall, with a more significant crack present in the Western flank wall – see photograph 2.

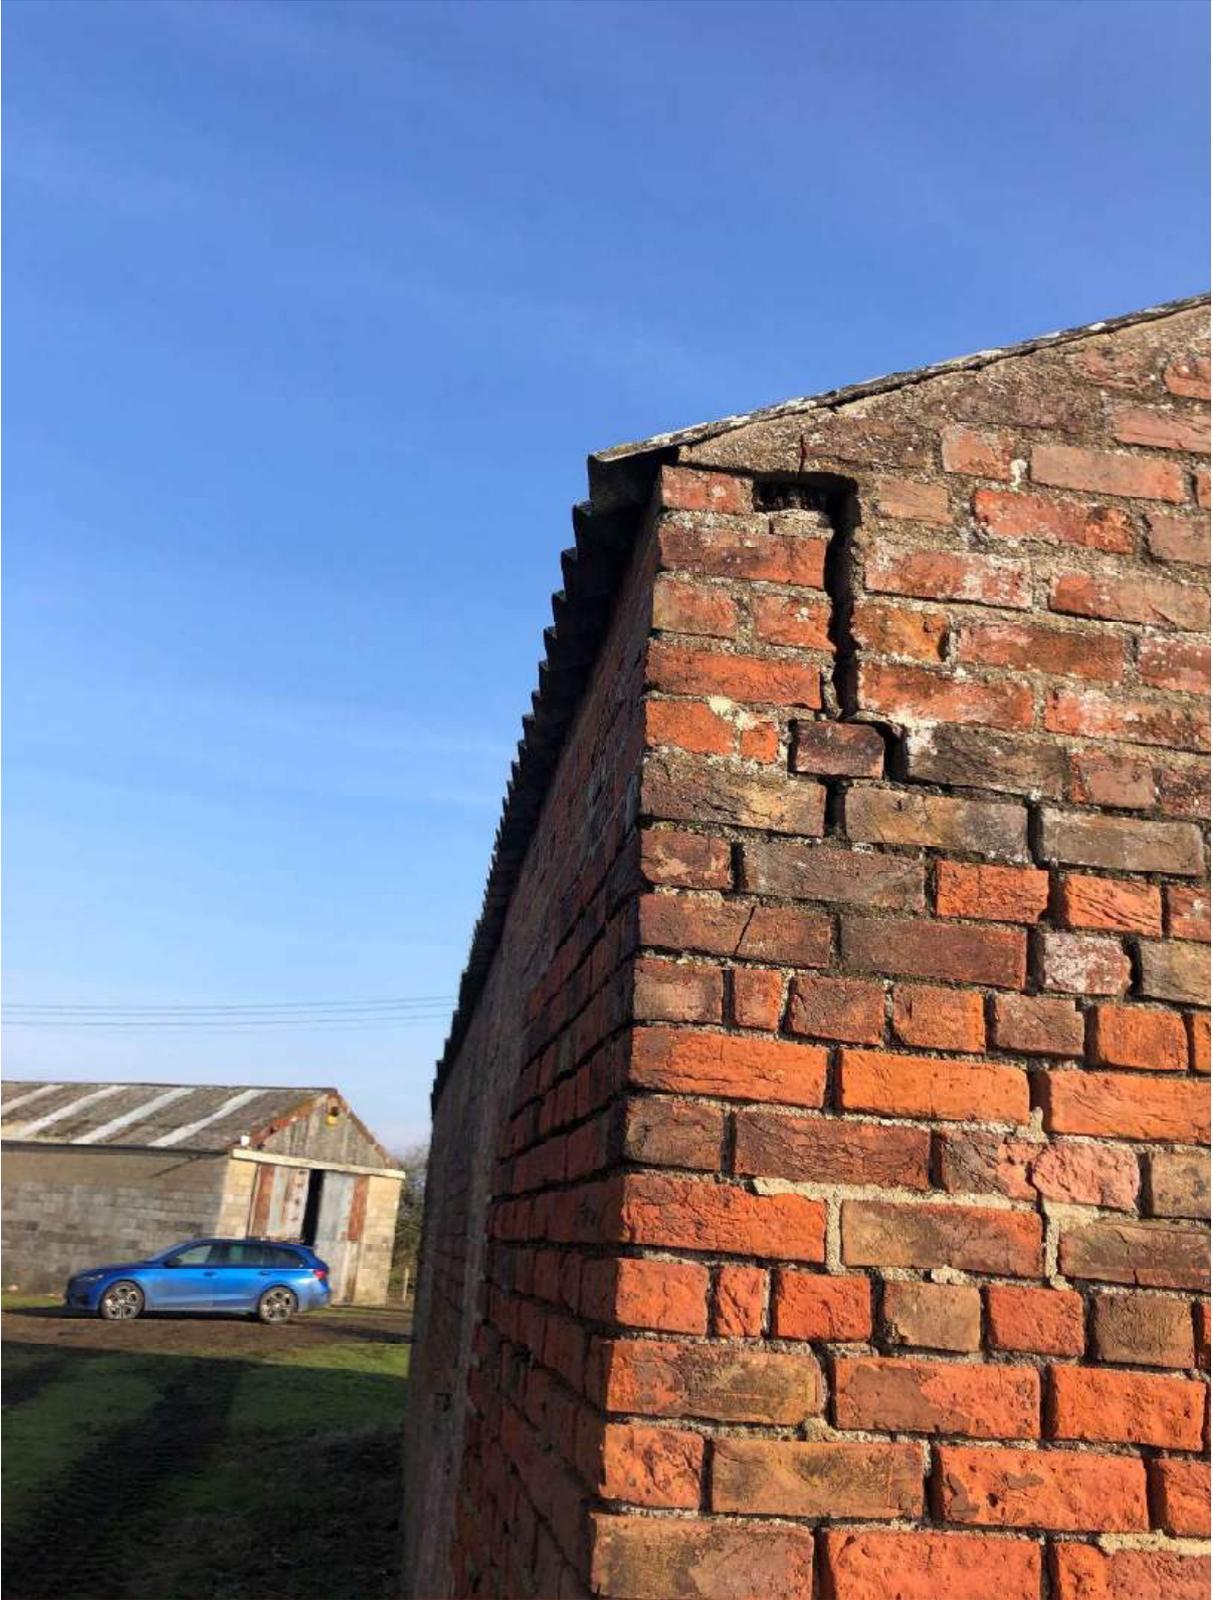
Photograph 3

Further cracking is visible to the South gable at eaves level – see photograph 3.

Although access internally was not possible, the likely cause of outward movement at eaves level, will be due to no effective tie being present at eaves level.

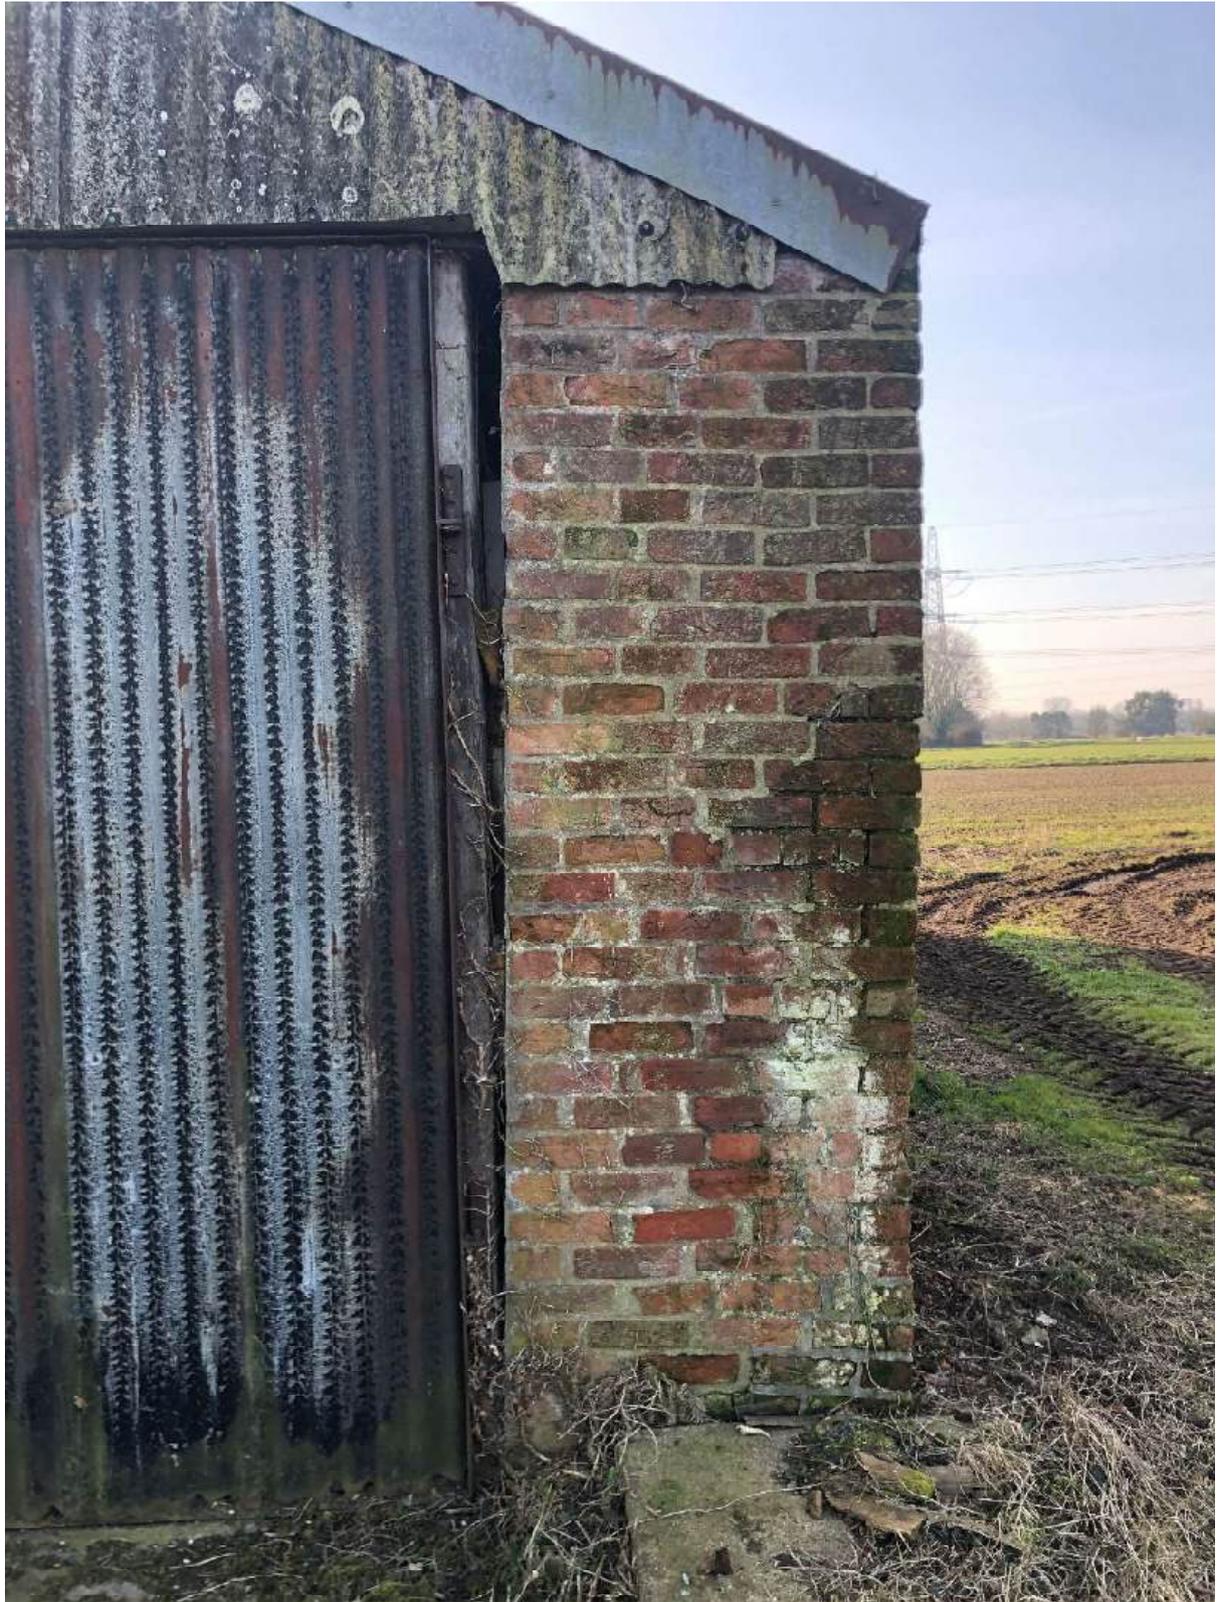
Photograph 4

The flank walls are not plumb and lean outwards, with an inconsistent vertical gap noted where the front door abuts the brickwork – see photograph 4.

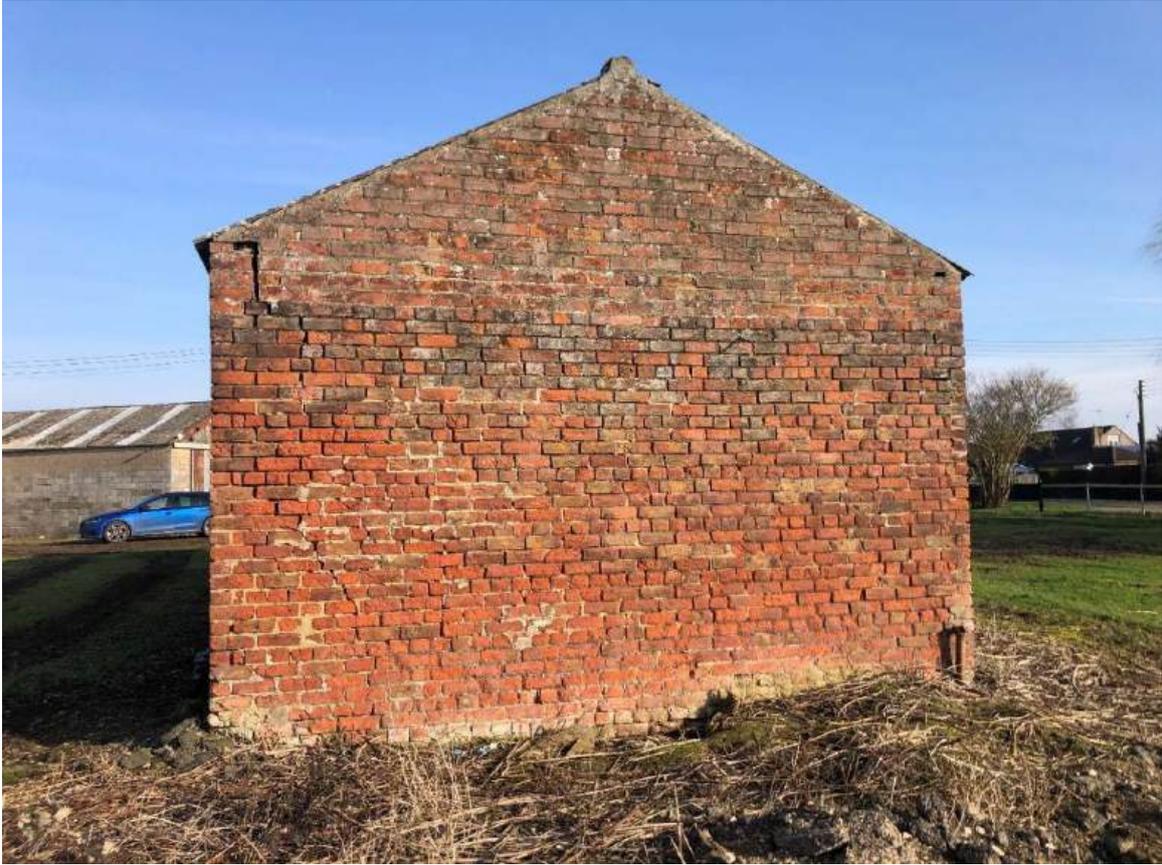
**Photograph 5**

Large areas of the brick walls have washed away mortar joints and random re-pointing – see photograph 5.

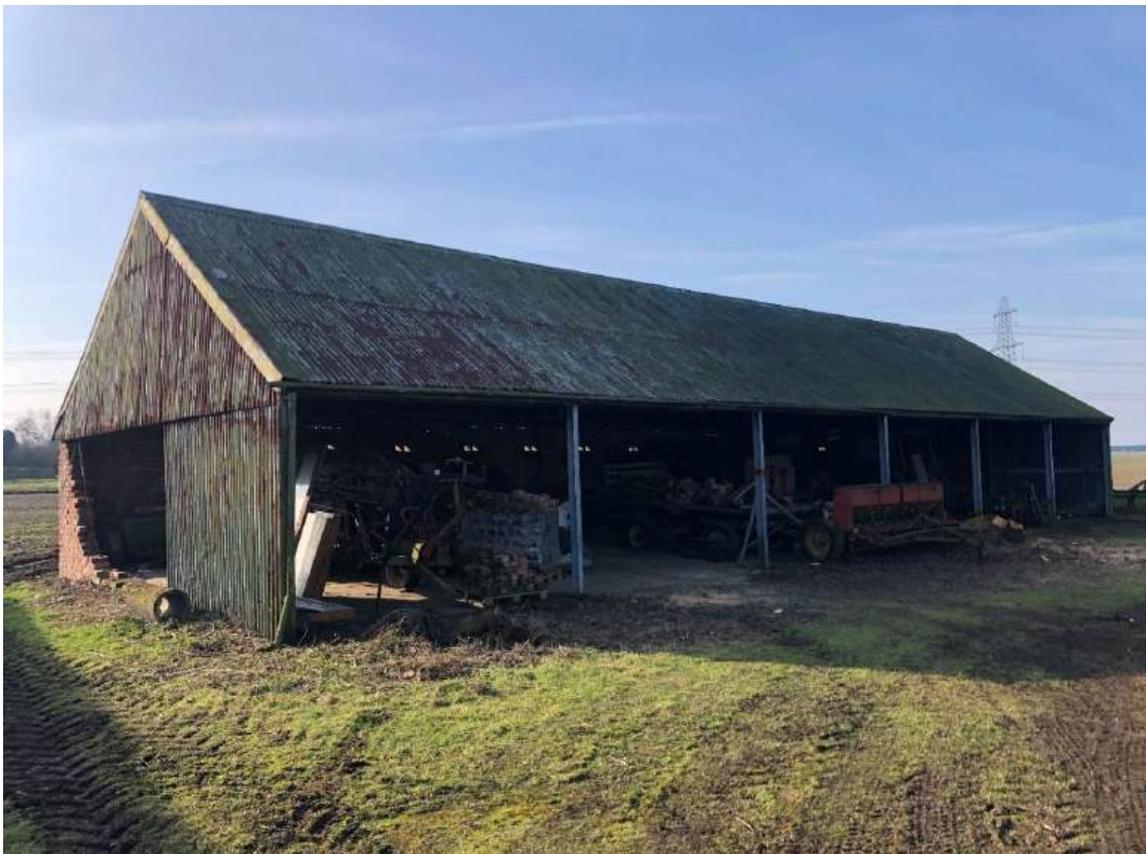
**Photograph 6**

This relatively large open fronted barn, with a rusting corrugated steel roof, appears to have been enlarged to create its present arrangement – see photograph 6.

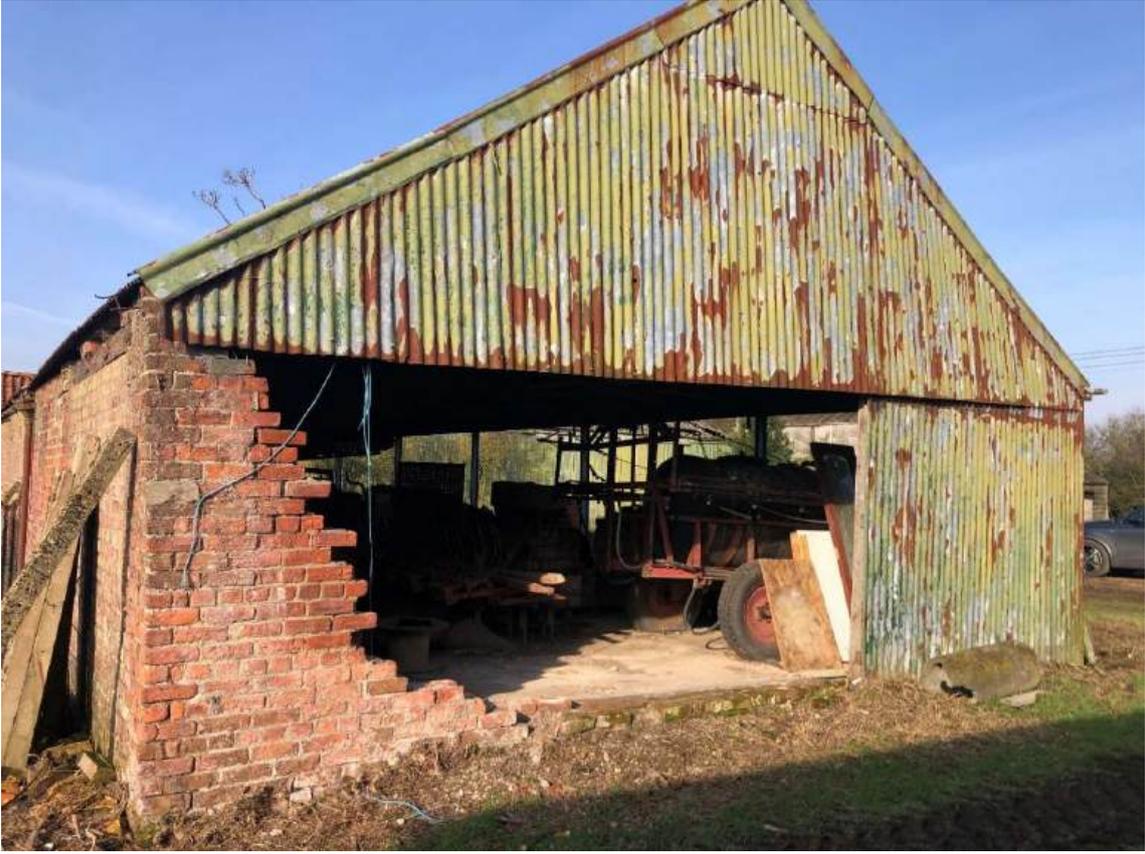
**Photograph 7**

A large area of brickwork has fallen away to the West gable, with loose bricks clearly visible – see photograph 7.

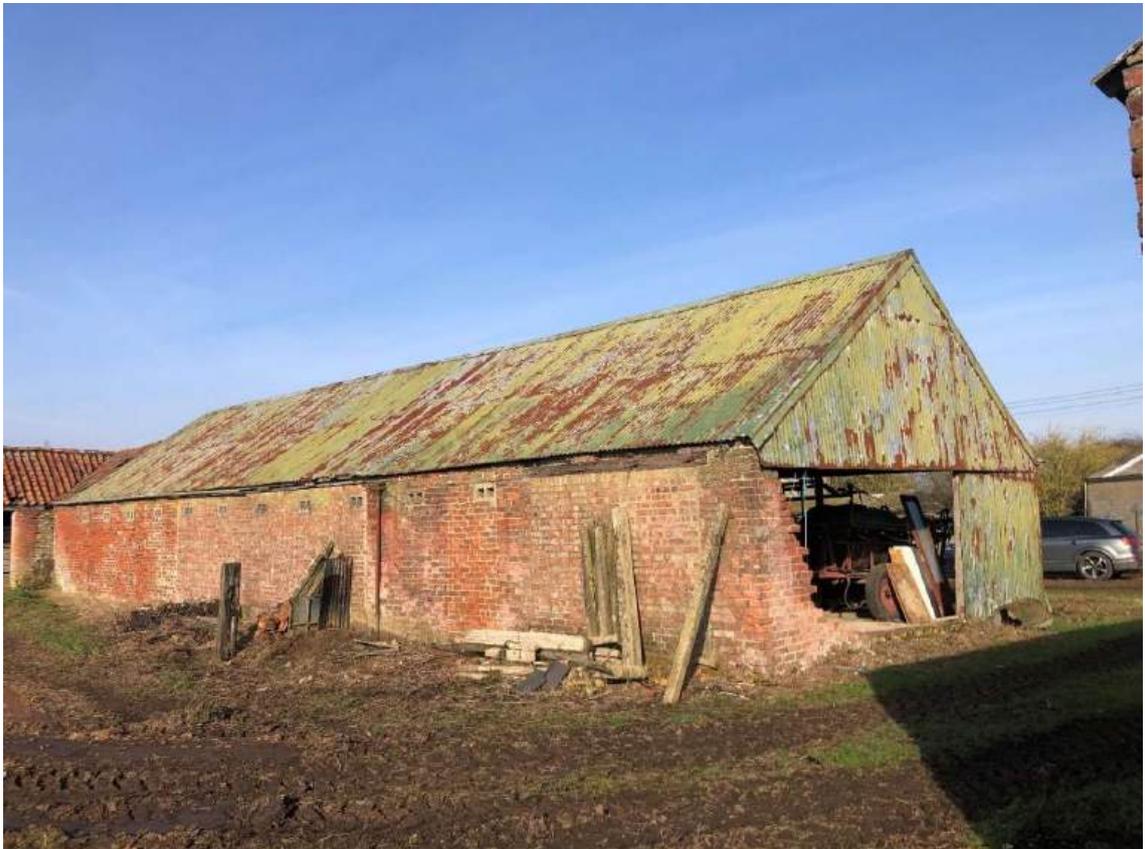
**Photograph 8**

The South elevation shows the brickwork was built at varying stages, with different types of brick and mortar joints visible – see photograph 8.

Since the roof trusses have prevented horizontal loads being transferred to the rear brick wall, although the walls are visually different, the sound areas of the wall are relatively true and vertical.

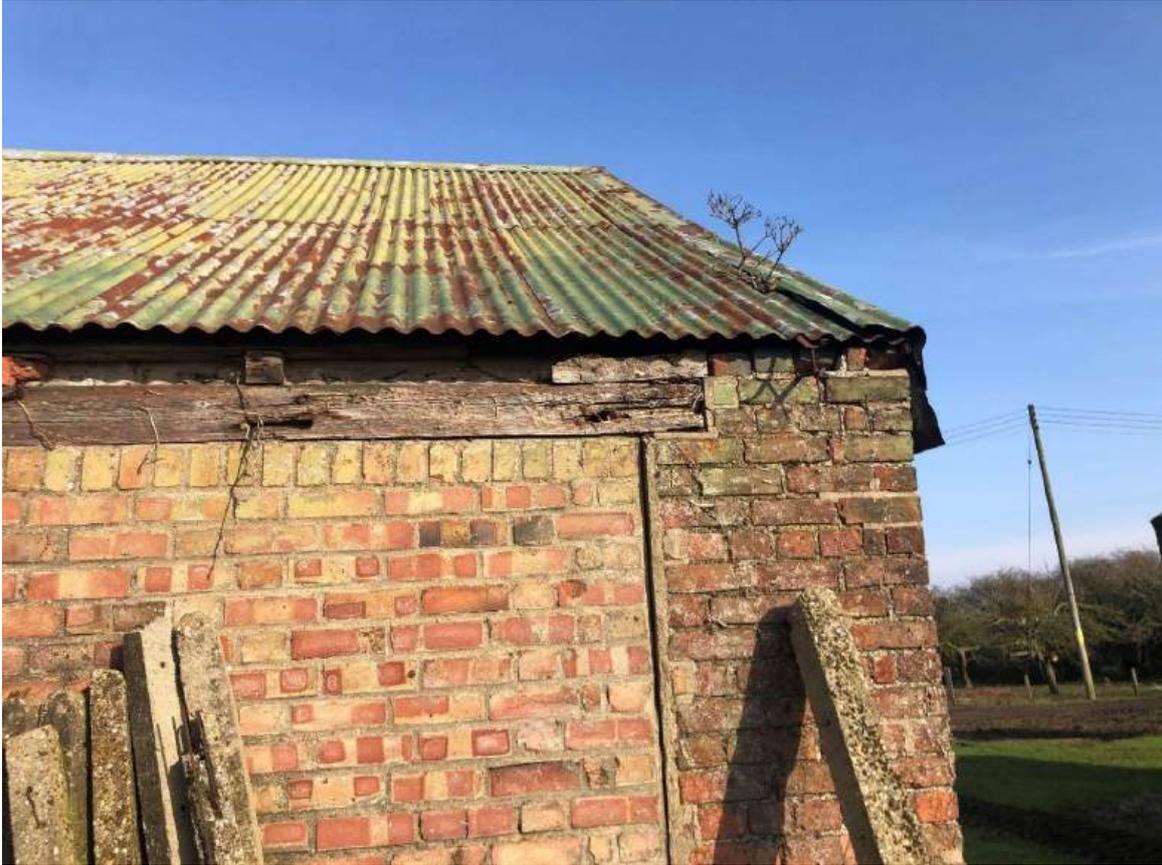
**Photograph 9**

Loose bricks are present at eaves level and above an old doorway where a decaying timber lintel is present – see photograph 9.

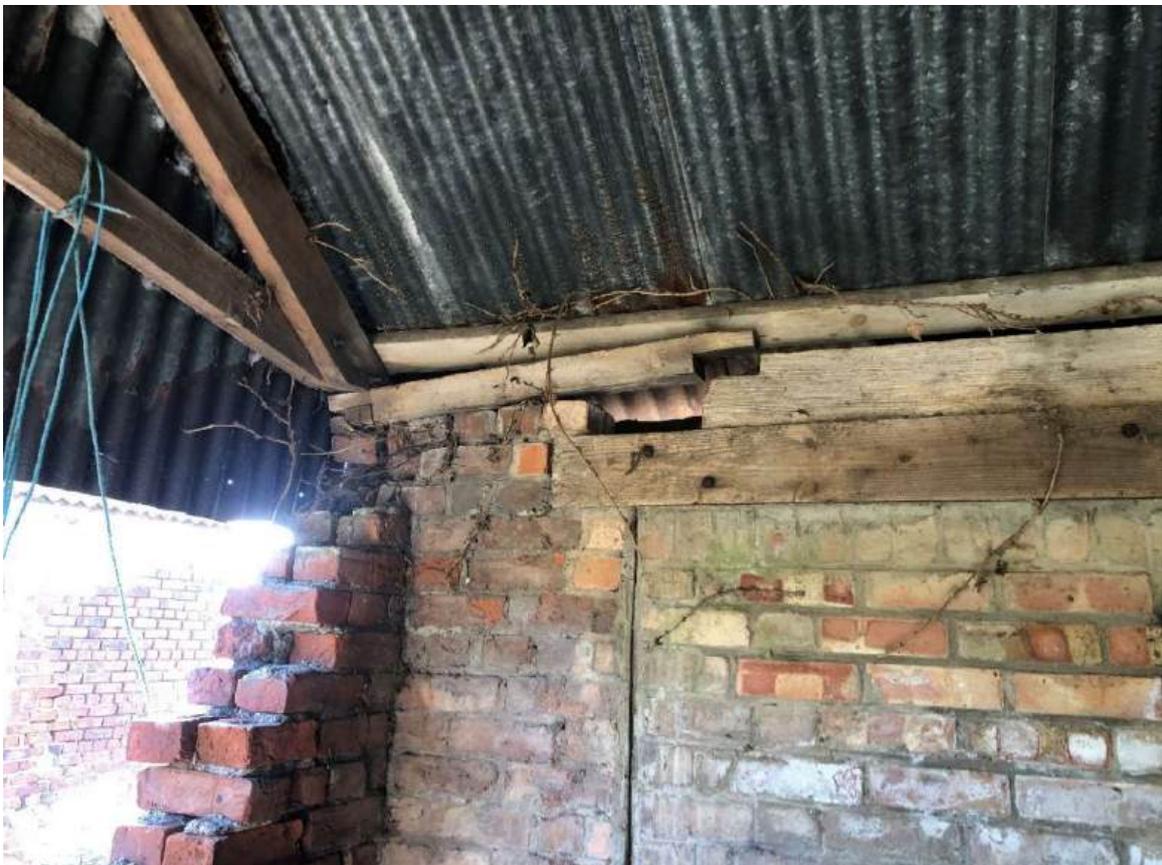
**Photograph 10**

To the rear corner, the support of the gable truss is compromised by the condition of the brickwork and timber wall plate that is displaced – see photograph 10.
