**Stage One Environmental Desk Study of 87, Moulton Chapel Road**

**Moulton Chapel, Spalding, Lincolnshire PE12 0XD**

Report number 20-02-02 Addendum

Date 28<sup>th</sup> April 2020

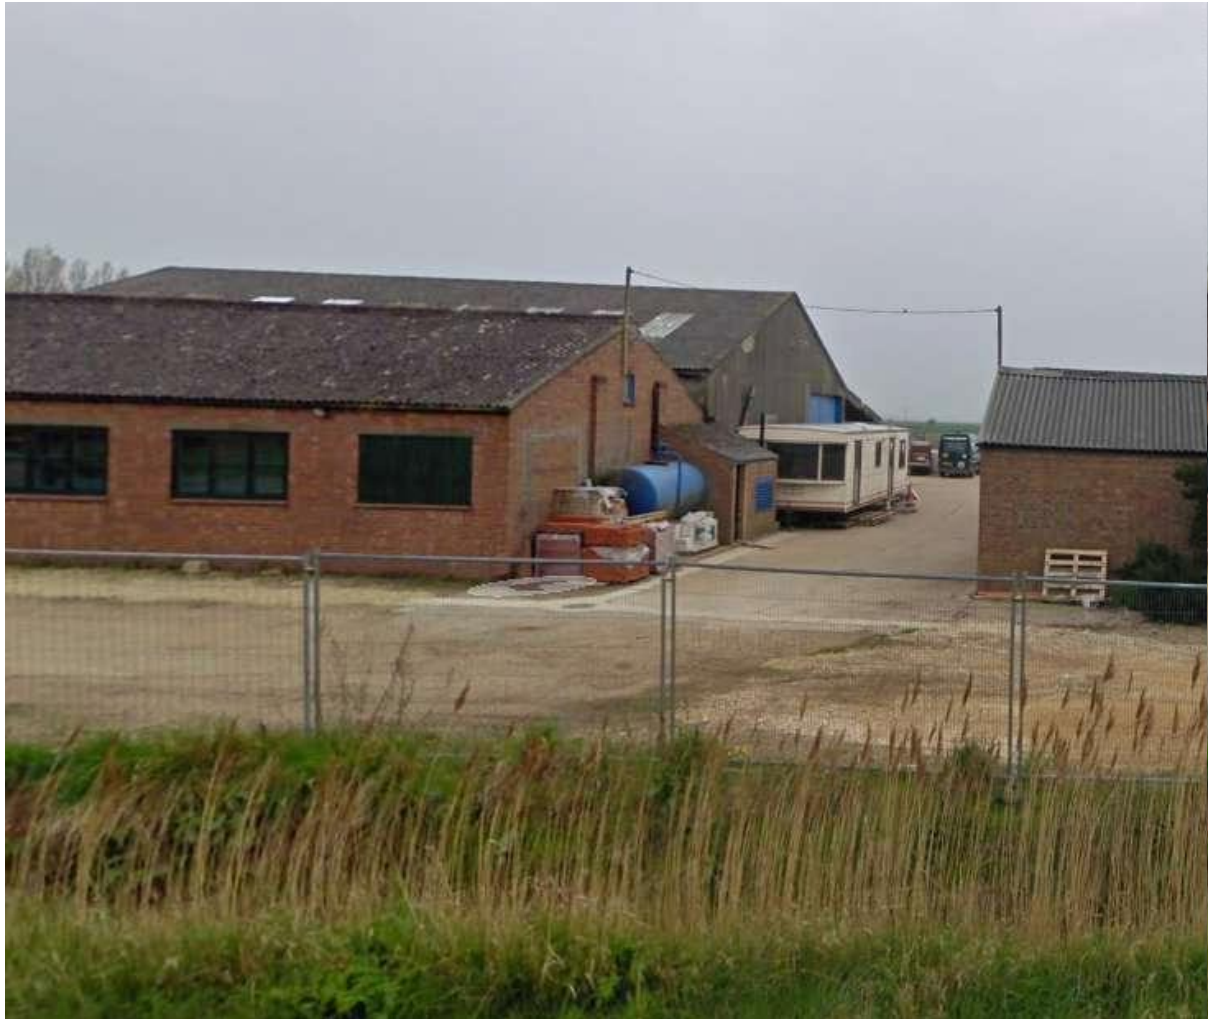
Figure 2 Google street level photograph of western side of building in 2009

I did look at the street level photos on Google and there was a tank on the western side of the main building, but as it appeared to be a water tank (UN identification of water tank/pipe is to colour it blue and liquid hydrocarbons are coloured black). Please see a Google street level photograph of the front of the site showing the tank and the so-called boiler house. I looked at the small building next to the tank but it was too small to house a boiler and the vertical pipe or strut was not high enough to act as an efficient flue. The photos of the site of the blue tank and the refrigeration unit are at the end of this report. Then the site visit found the refrigeration unit, but as it was not relevant, I did not record it. I looked into the buildings, but found boxes with electrical components and mounting boxes, but again nothing to note.

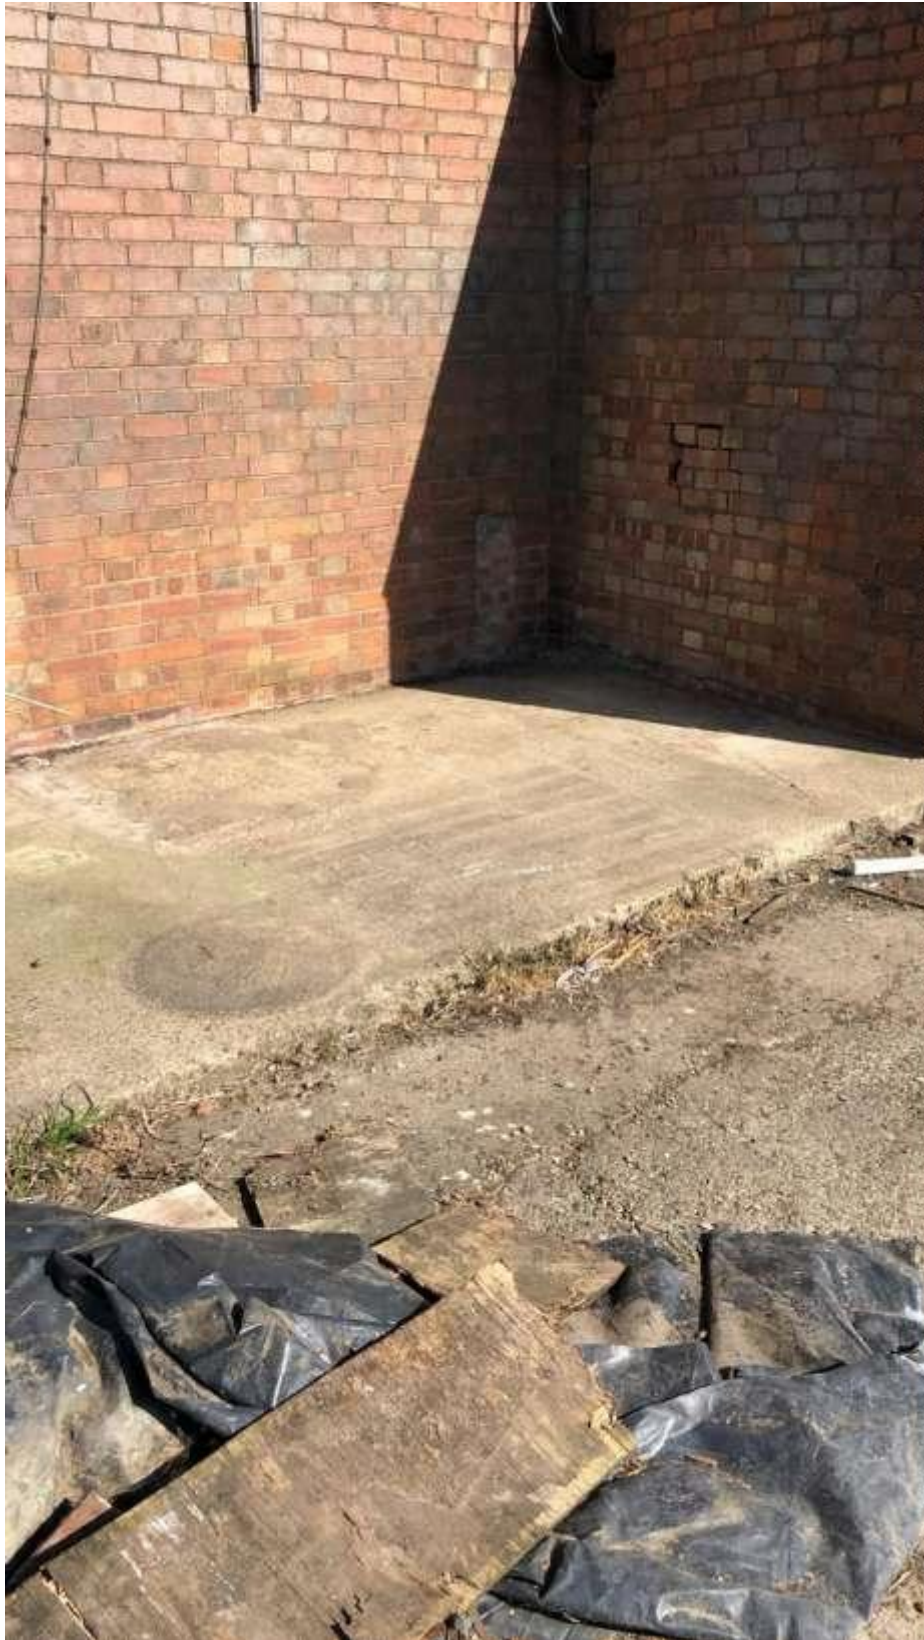
The blue tank is understood to be a water container from what we can ascertain.

Photo 11 Site of blue tank looking toward the small extension

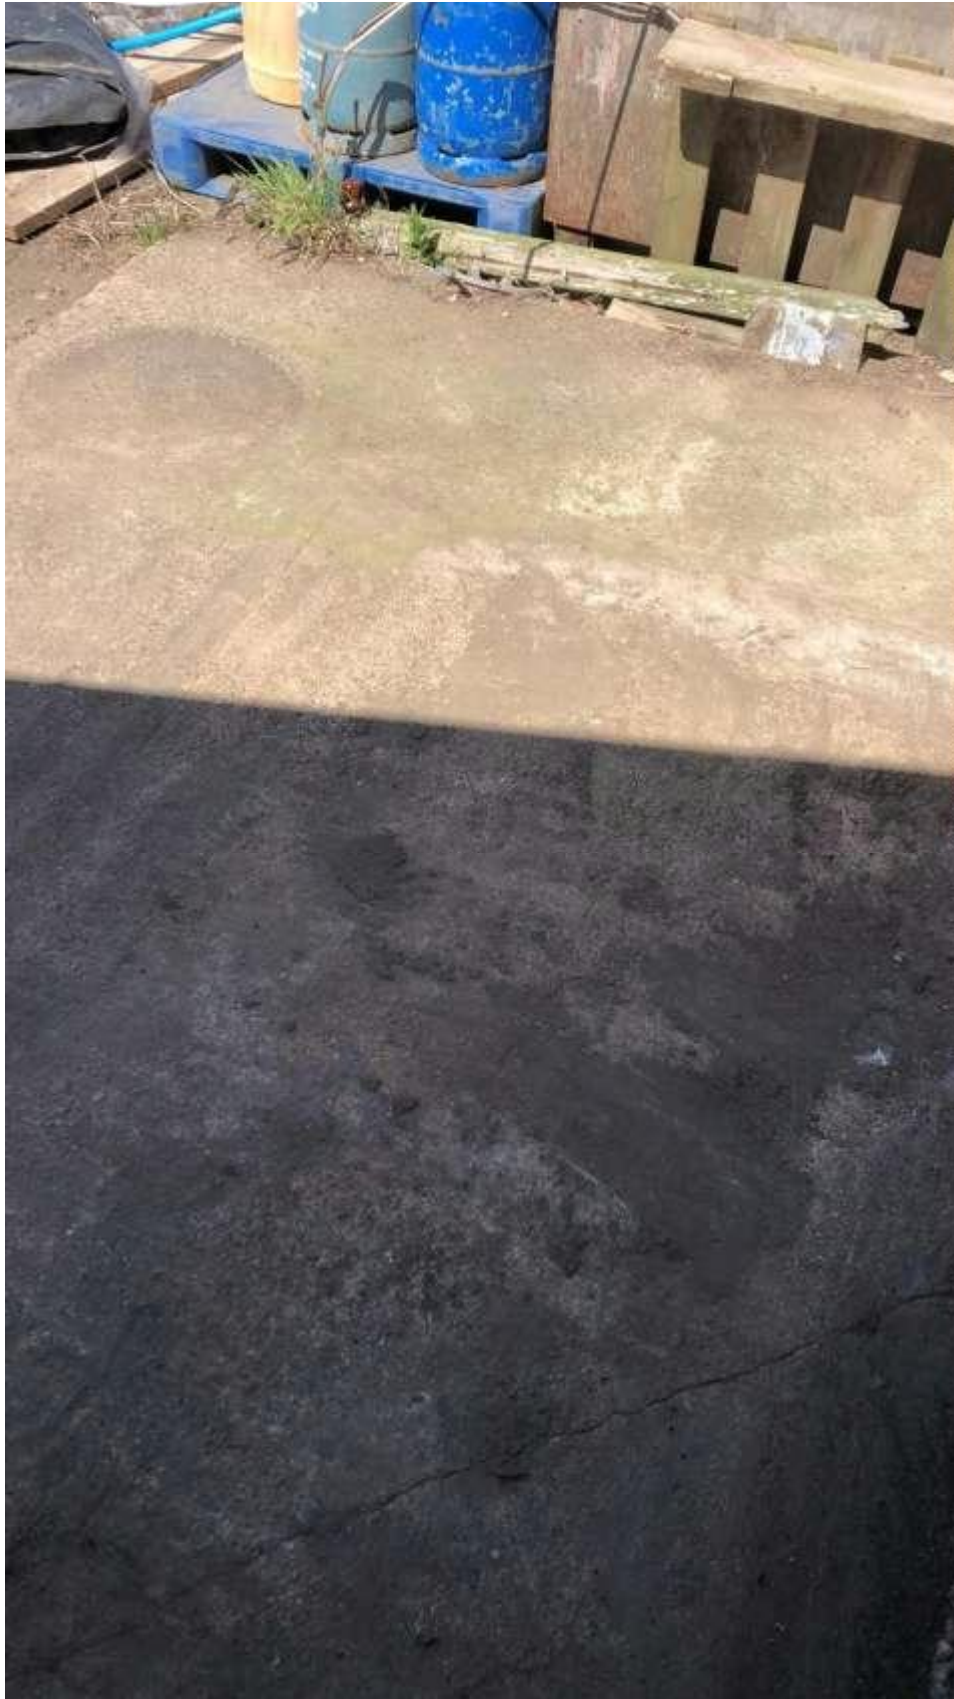
There are no visible signs of fuel of any sort. Please see attached photo.

Photo 12 Site of blue tank looking towards the front

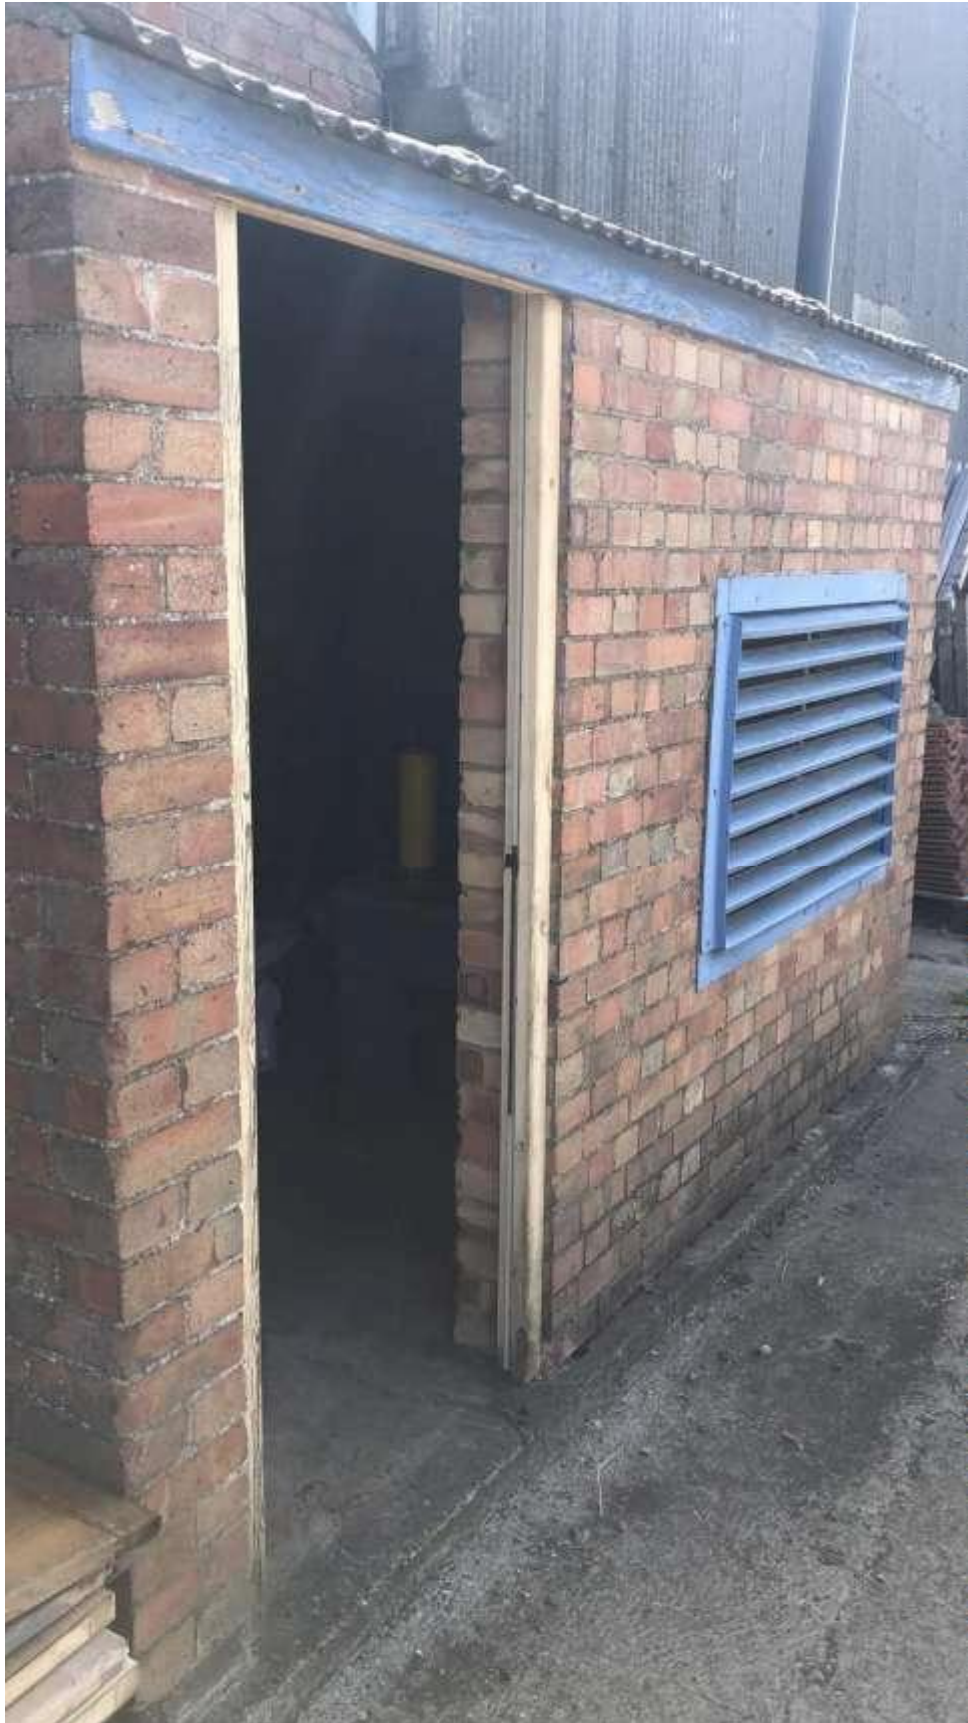
Photo 13 Small extension adjacent to water tank

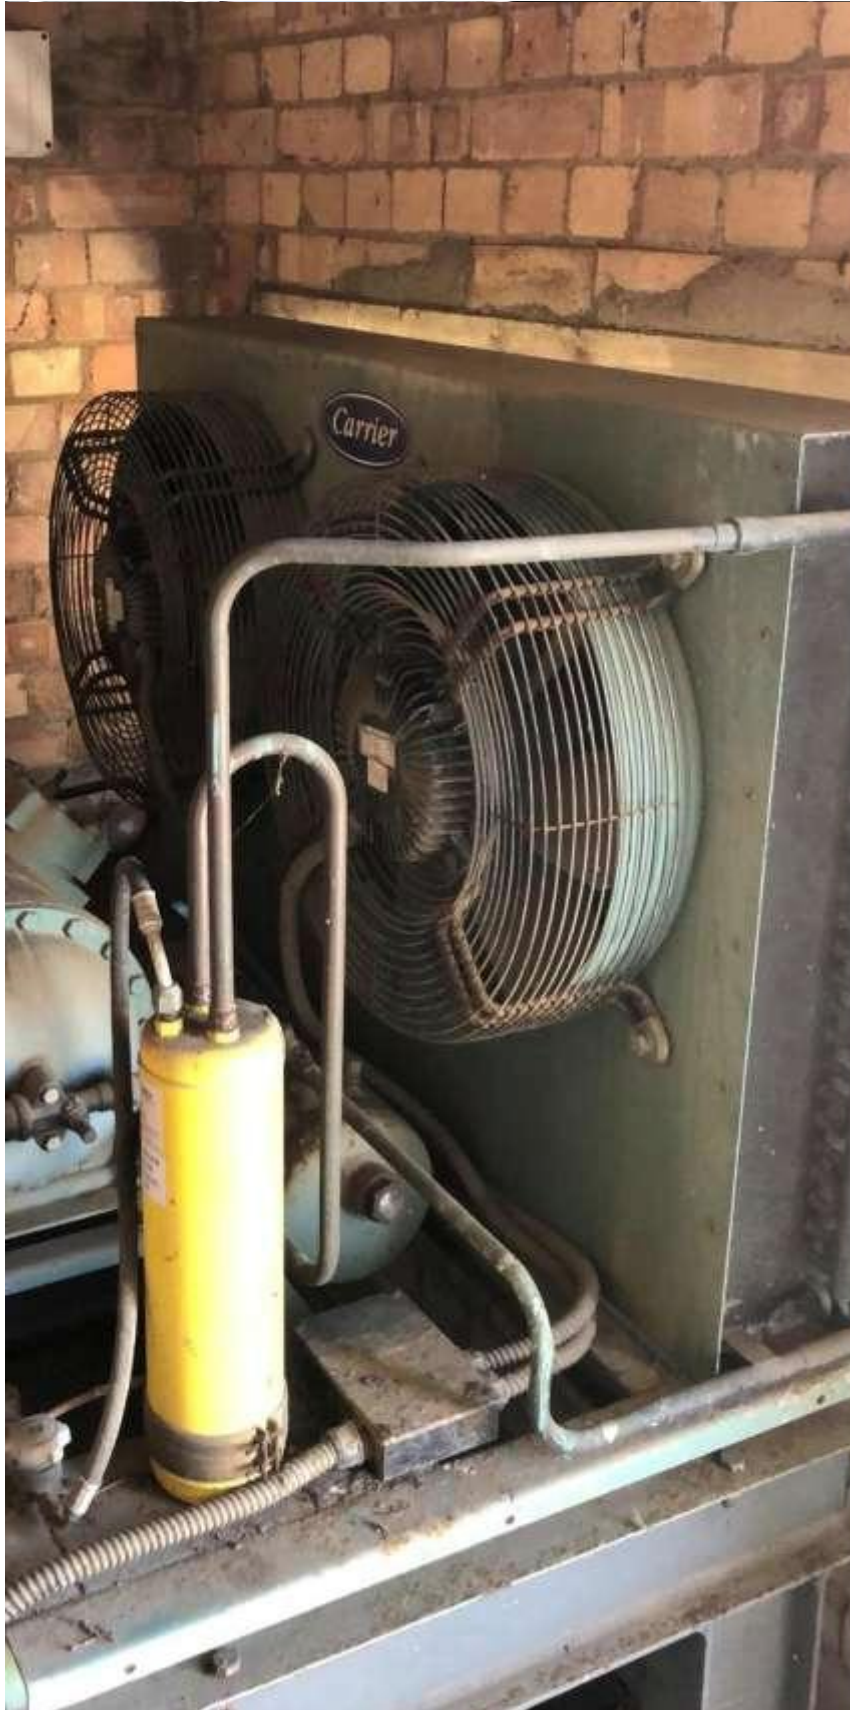
The unit referred to as a potential boiler house contains a refrigeration compressor as per the attached photo

Photo 14 Refrigeration unit in small extension
