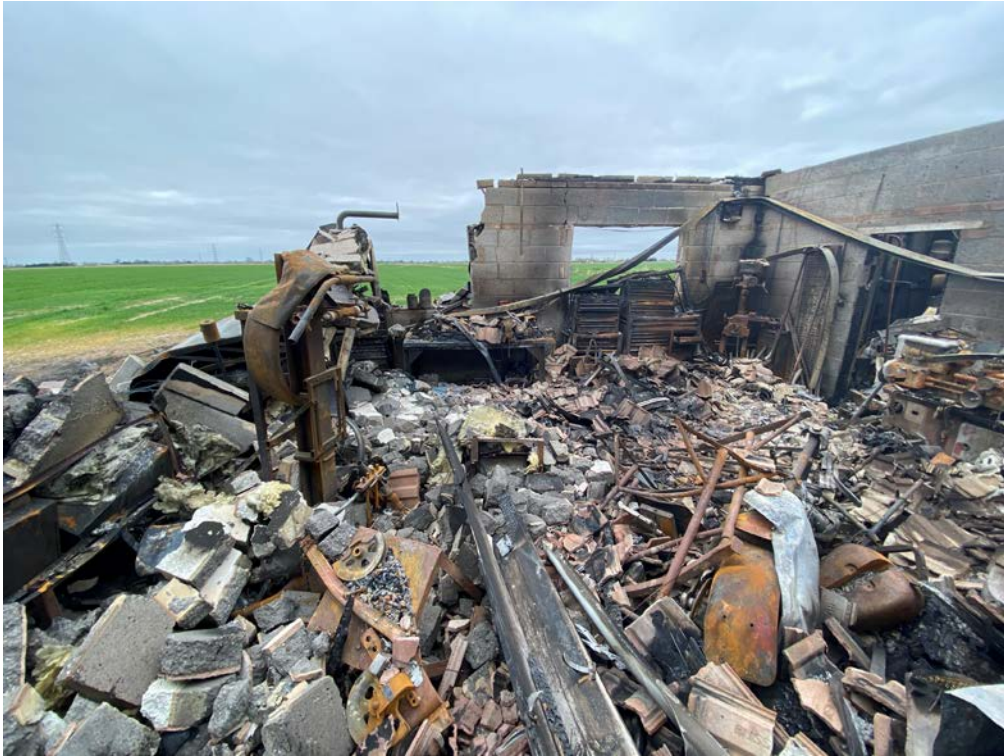
Photo 5 – Building F with failed left elevation, roof and covered in fire debris and contents.

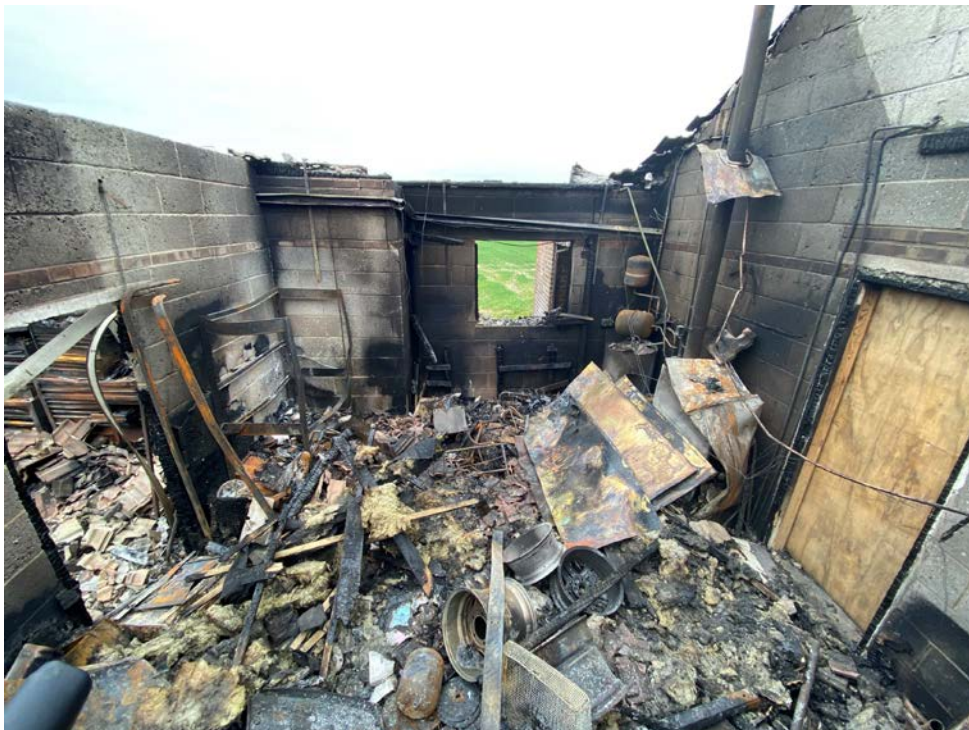
Photo 6 – Workshop 1 and partition (door to) kitchen.

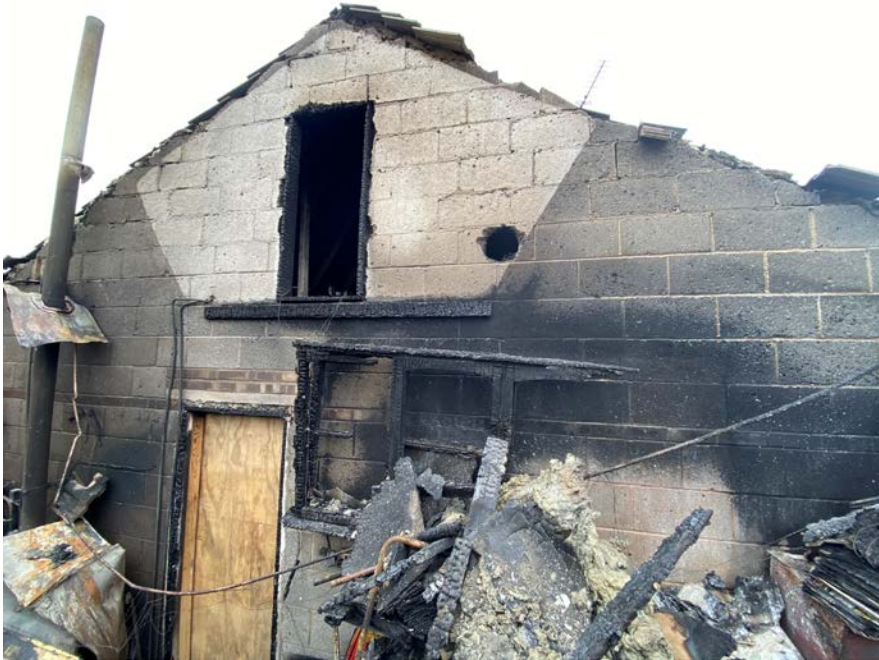
Photo 7- Workshop 1 and partition (door to) kitchen and access to loft void.

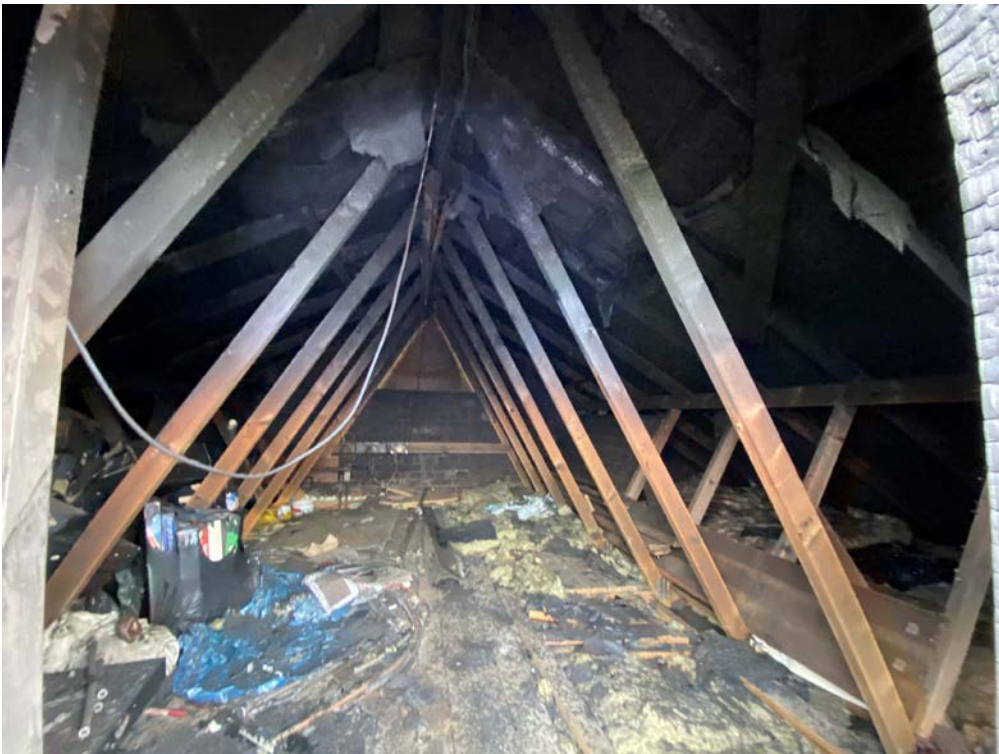
Photo 8 – Truss roof above kitchen extension appears to be in a reasonable condition but further inspection require upon removal of covering.

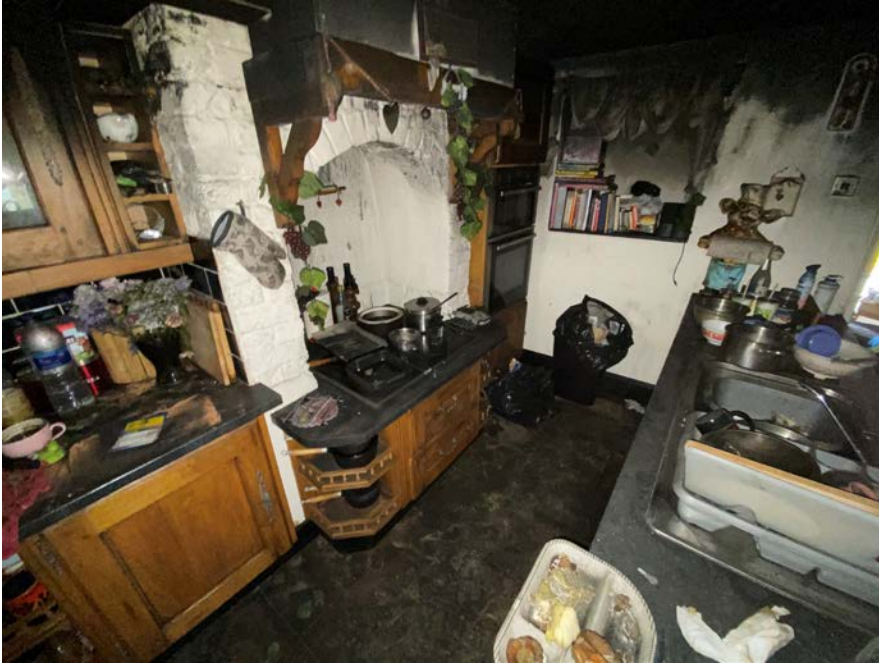
Photo 9 – Oak Kitchen within building A.

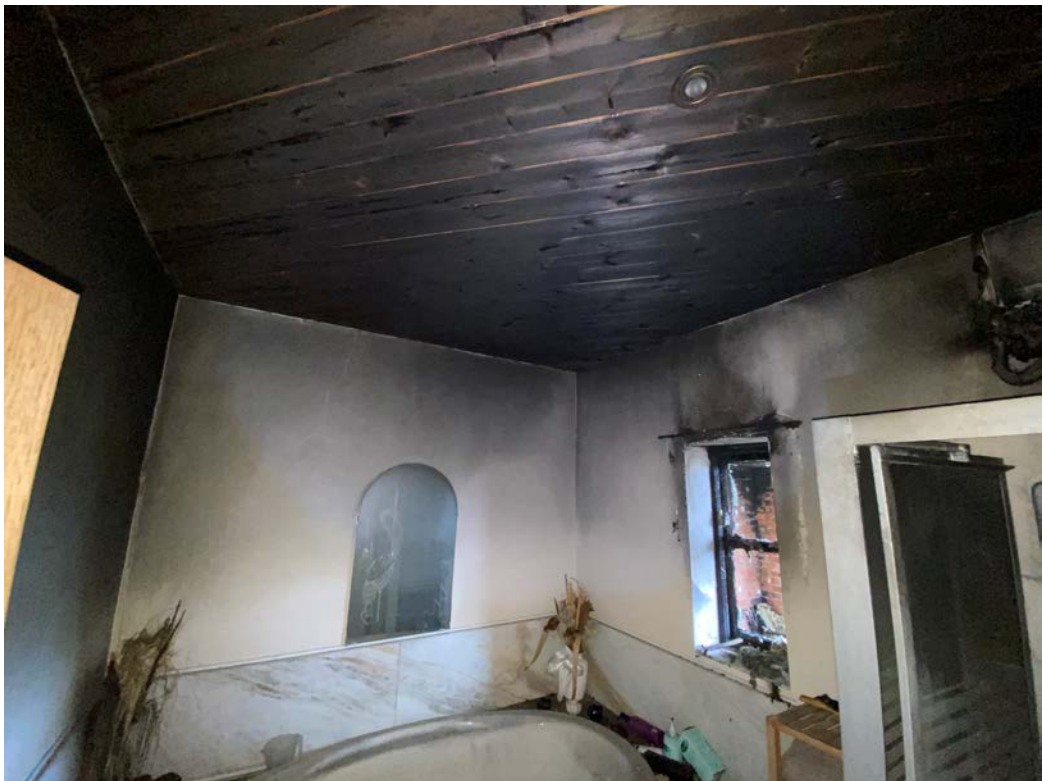
Photo 10 – Bathroom with marble splashback and very large bath.
