## **PHOTOGRAPHIC RECORD**

## **SINGLE STOREY BARN**

**BROADGATE BARN  
694 BROADGATE  
WESTON  
SPALDING  
LINCOLNSHIRE  
PE12 6JA**

**PLANNING APPLICATION ISSUE**

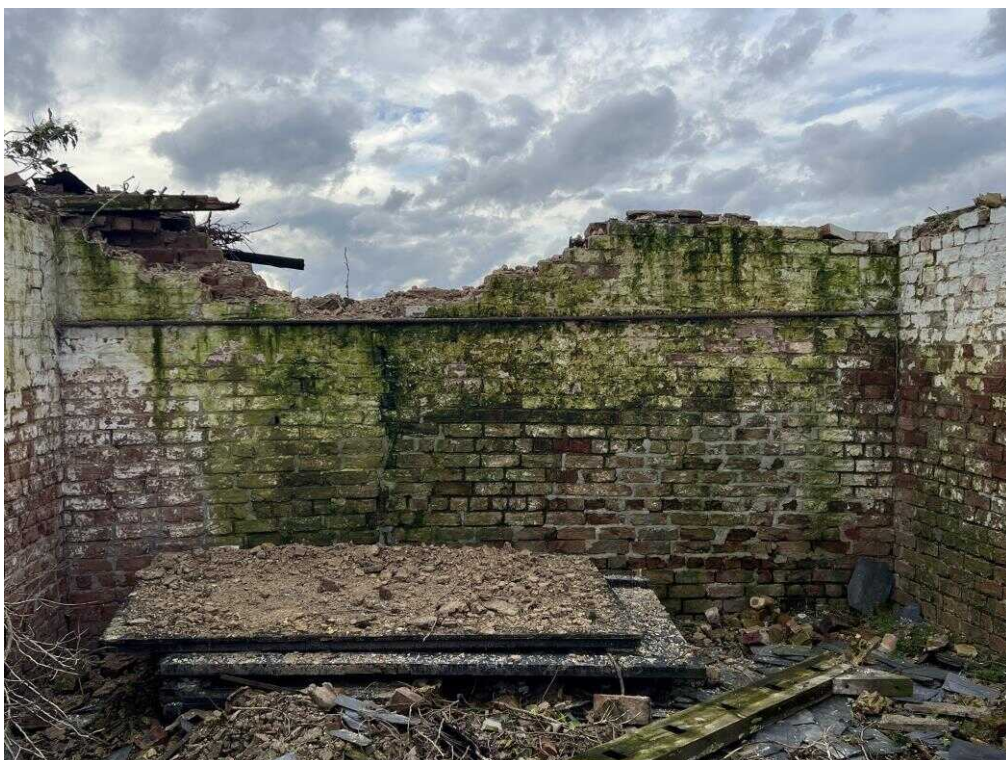
Fig. 19 – View within covered bay looking to west.

Note that the east side of the covered bay is open, with no wall. The roof has collapsed, and the debris has been removed.

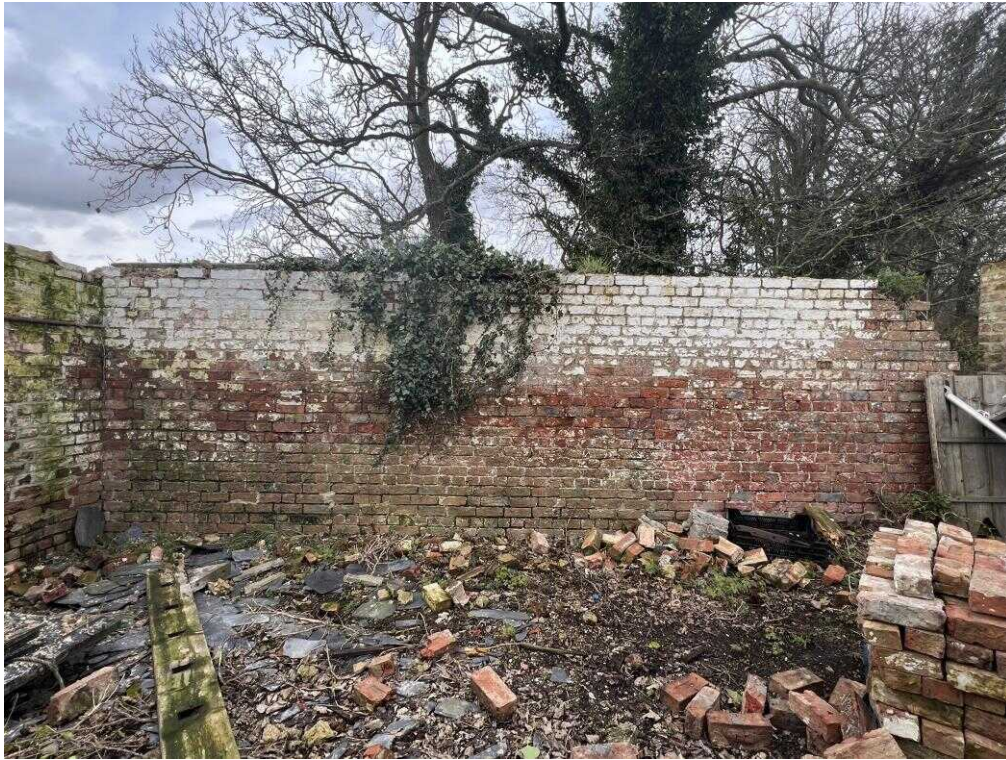
Fig. 20 – View within covered bay looking to north.

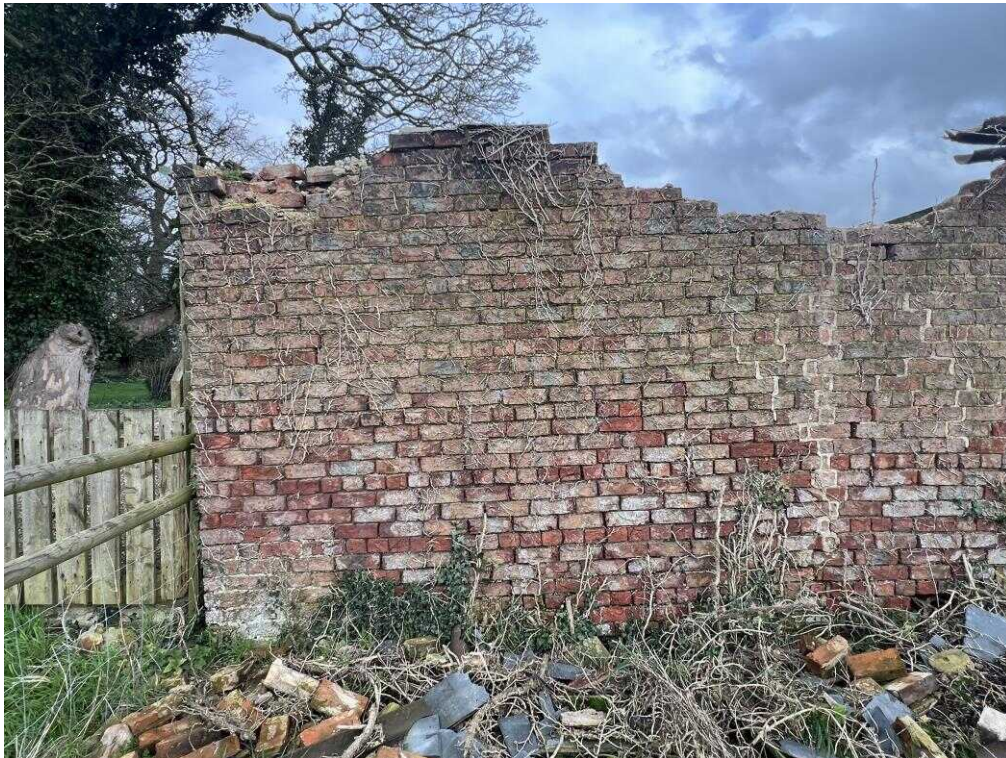
The extant barn is rectangular in plan form, now comprising only a single room and an adjacent open space with a roof over. Historic maps provide evidence that this was once part of a larger complex and there is evidence on site of further construction adjacent, though it is not known whether this is original. Site evidence suggests that the walls forming the covered area at the north end of the barn have moved historically because there is an area where the brickwork appears to have been altered to stitch the two walls back together. This crack is evident in photographs 19 and 21.

Fig. 21 – North section of west elevation with repaired crack in brickwork evident.

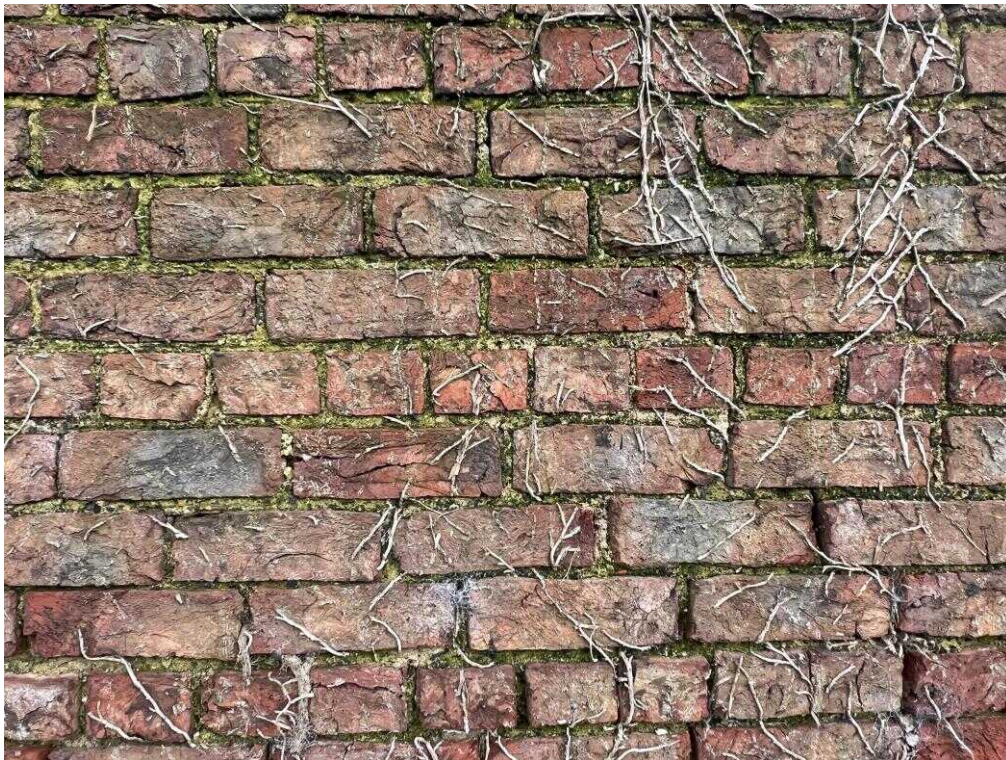
The main external structure is formed by a solid brick wall (3 skins thick), the thickness of the wall is generally circa 350mm. At present the walls extend from ground level to approximately 2500mm above, though this is a maximum figure, and numerous areas are lower than this. All substructure works is concealed and cannot therefore be determined. Bricks on site vary in size, but an average for what appear to be the original bricks is 220mm long x 105mm wide x 70mm deep (fig. 22, 23 & 24). The brick bond is English Garden Wall, with 1 header course, 3 stretcher courses and then a further headed, repeated (fig. 25). Ten courses in depth equates to 820mm. Mortar appears to be a traditional lime-mix, but erosion has meant that the original pointing profile cannot be determined.

Fig. 25 – Brick pattern (south area of west elevation).

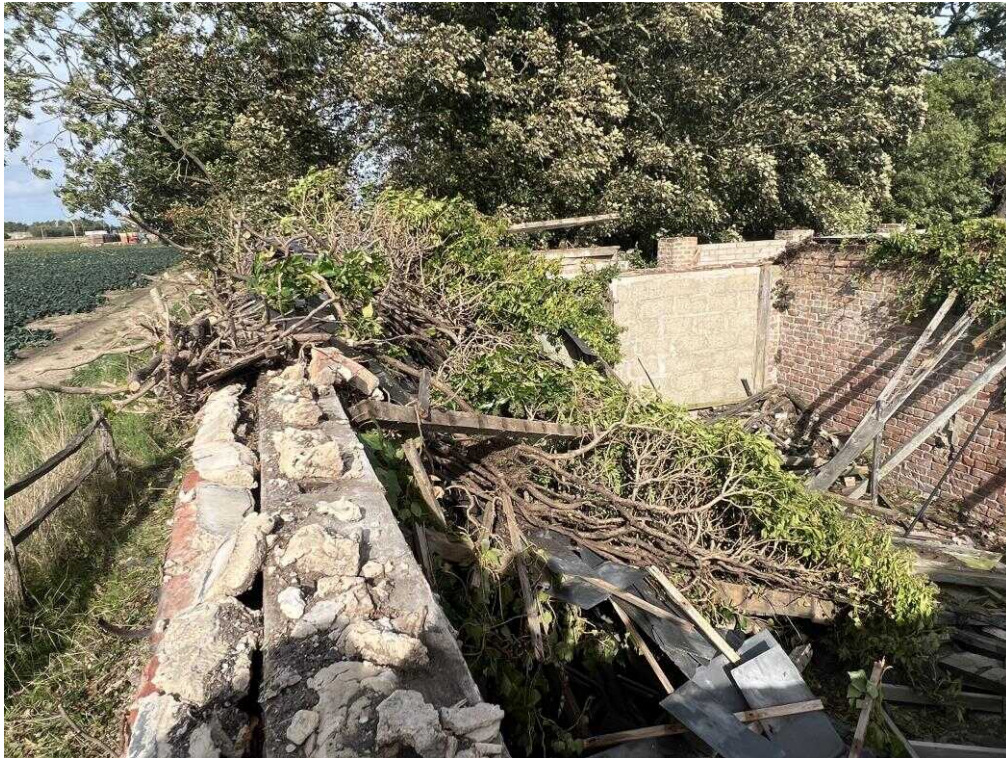
The wall is capped by a timber wall plate which is laid flat with its inner face flush to the inner face of the external wall. The plate measures nominally 200mm wide x 60mm deep.

Fig. 26 – Wall plate set on wall.

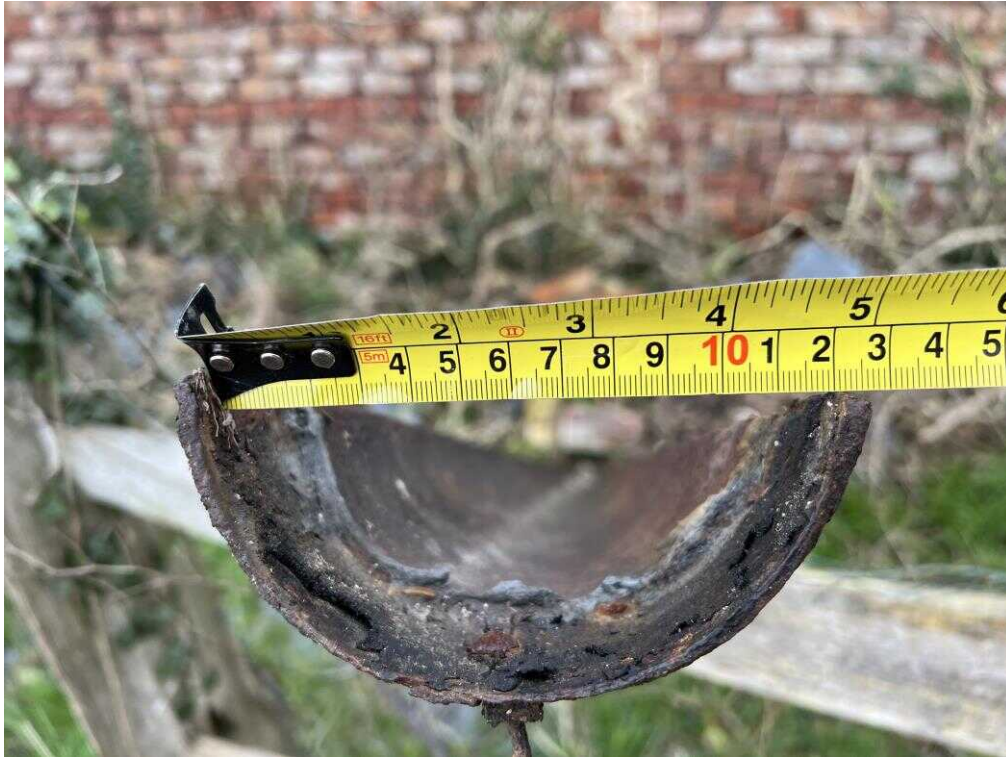
The rainwater goods comprise cast iron half-round gutters (fig. 27) supported on iron threaded bar rise and fall brackets. These are attached to the building at eaves level along the west and south elevations via spikes set into the brickwork bed joints (fig. 28). There are no external brackets to the other elevations. Bracket details are as follows (fig. 29):

Fig. 27 – Cast iron half-round gutter section detail (loose on floor)

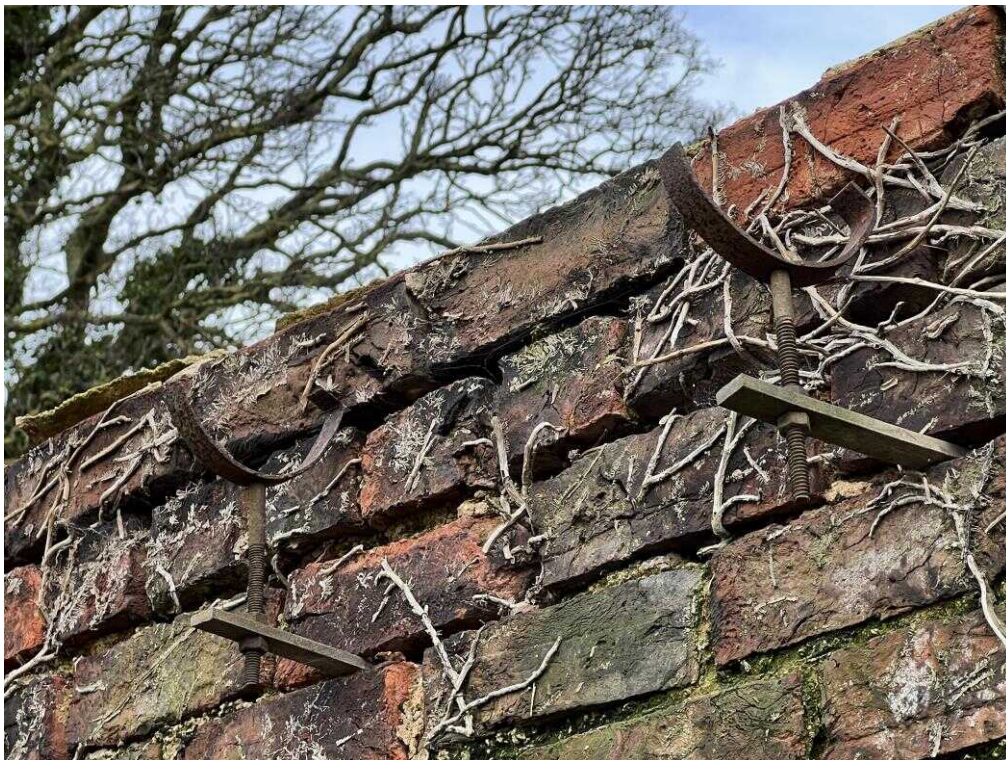
Fig. 28 – Gutter brackets evident on south end of west wall only.

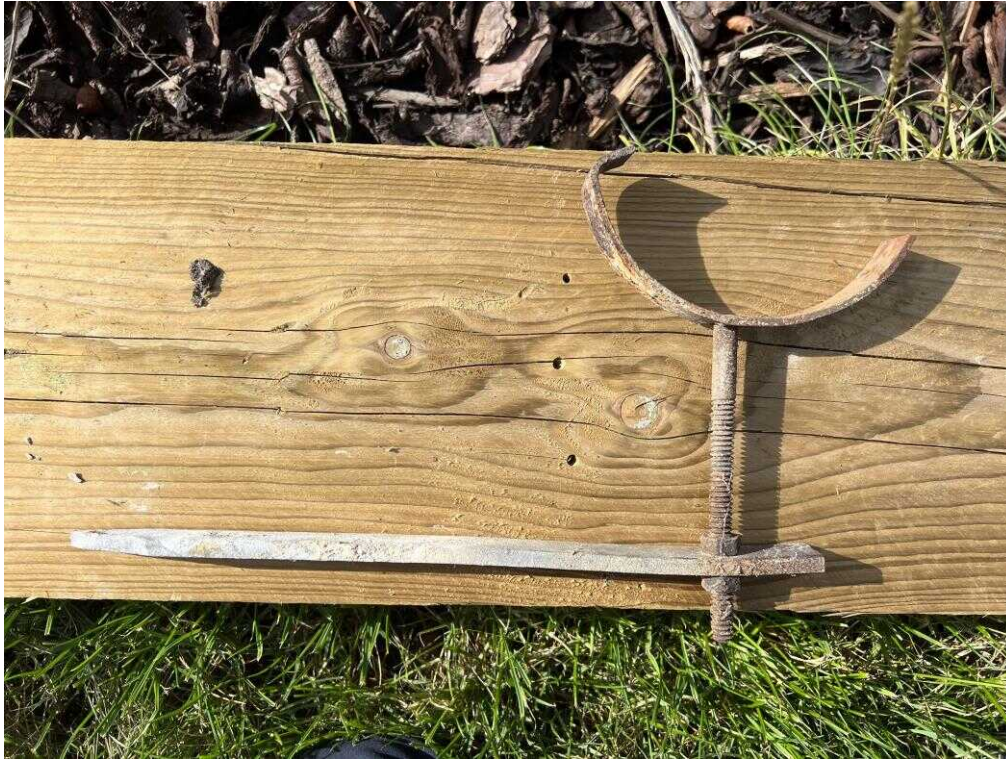
Nom. 310x22x5mm flat bar bracket with last 40mm cut to flat spike.  
10mm threaded bar, nominally 130mm long.  
20x2mm steel band fixed to top of threaded bar and in half-round shape to support gutter.

Fig. 29 – Gutter bracket detail (loose on floor)

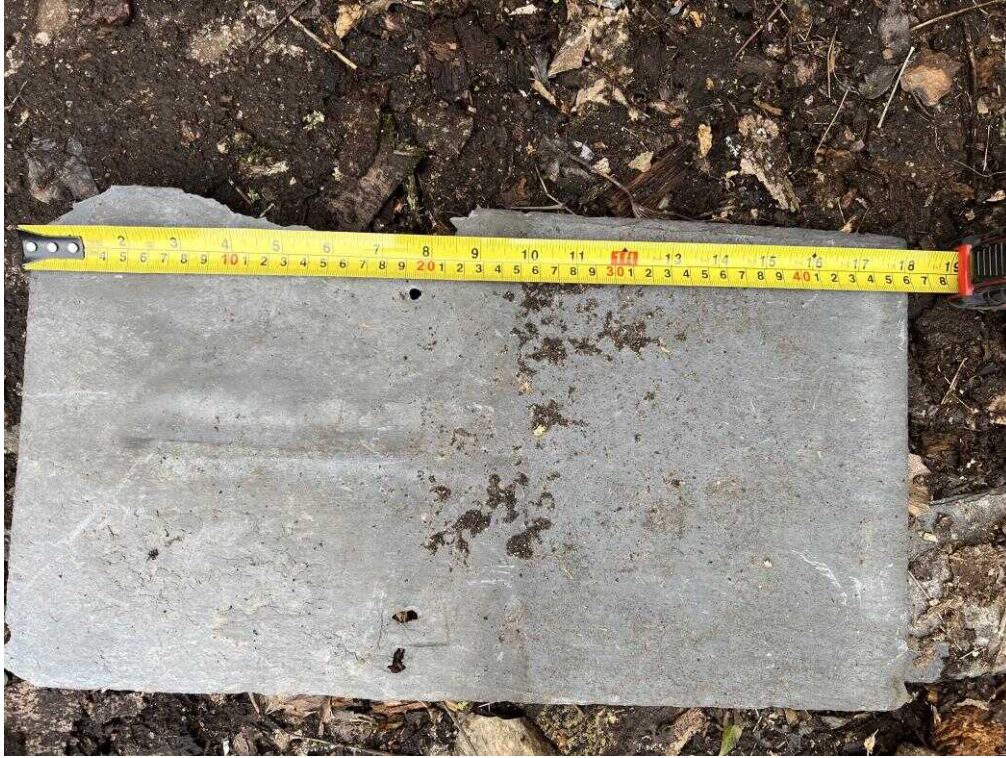
The roof of the building has collapsed but there are several slates still on site that were on the west slope prior to collapse. A sample slate was measured, and its dimensions were 460mm x 260mm x 6mm (figs. 30 & 31). Each slate featured 2 nail holes towards the centre of the slate. It is known that the slates to the east slope were removed historically, and a light-weight sheet covering was utilized for a many years.

Fig. 30 – Roof slate detail 460mm x 260mm x 6mm (loose on floor).

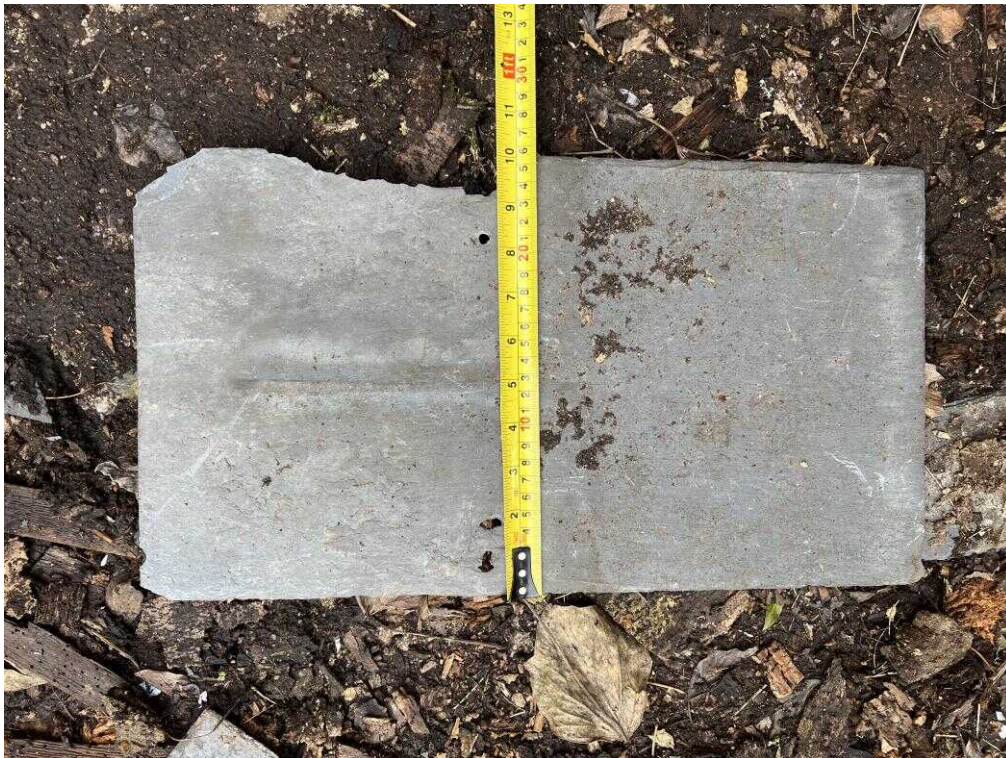
Fig. 31 – Roof slate detail 460mm x 260mm x 6mm (loose on floor).

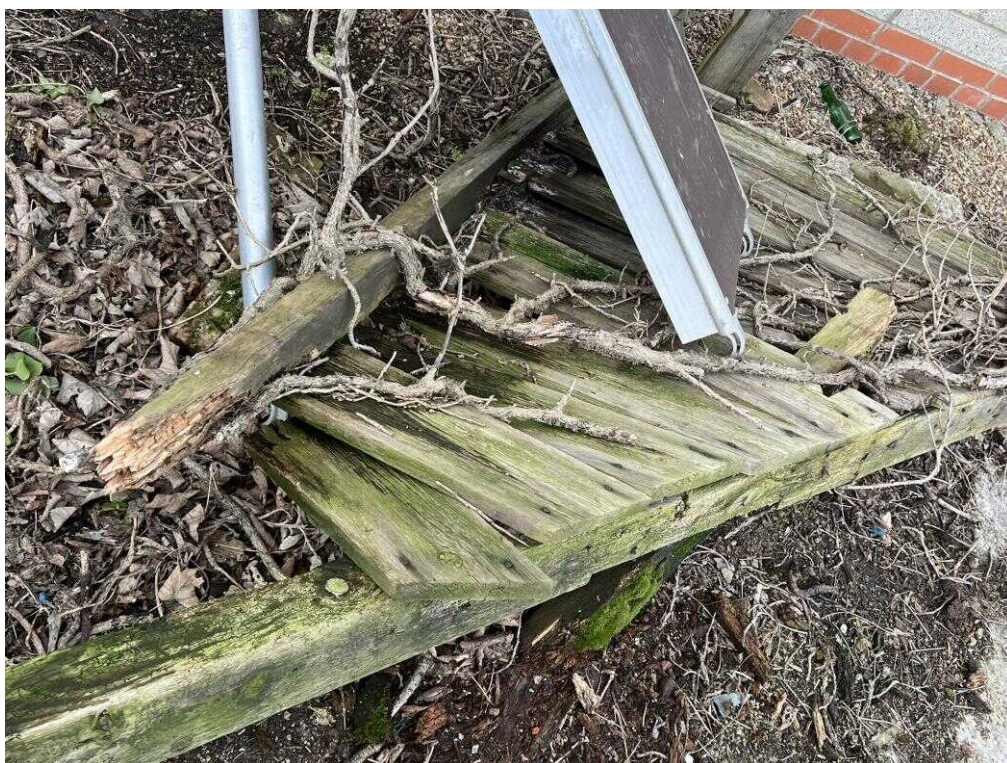
The east gable of the roofed-in area was historically infilled by timber weather-boarding fixed to the rafters. This gable has collapsed, as has the section of roof behind it. Part of the weather-boarding is however still on site (figs. 32 & 33).

Fig. 32 – Collapsed weather-boarding infill from east gable of roofed-in area.

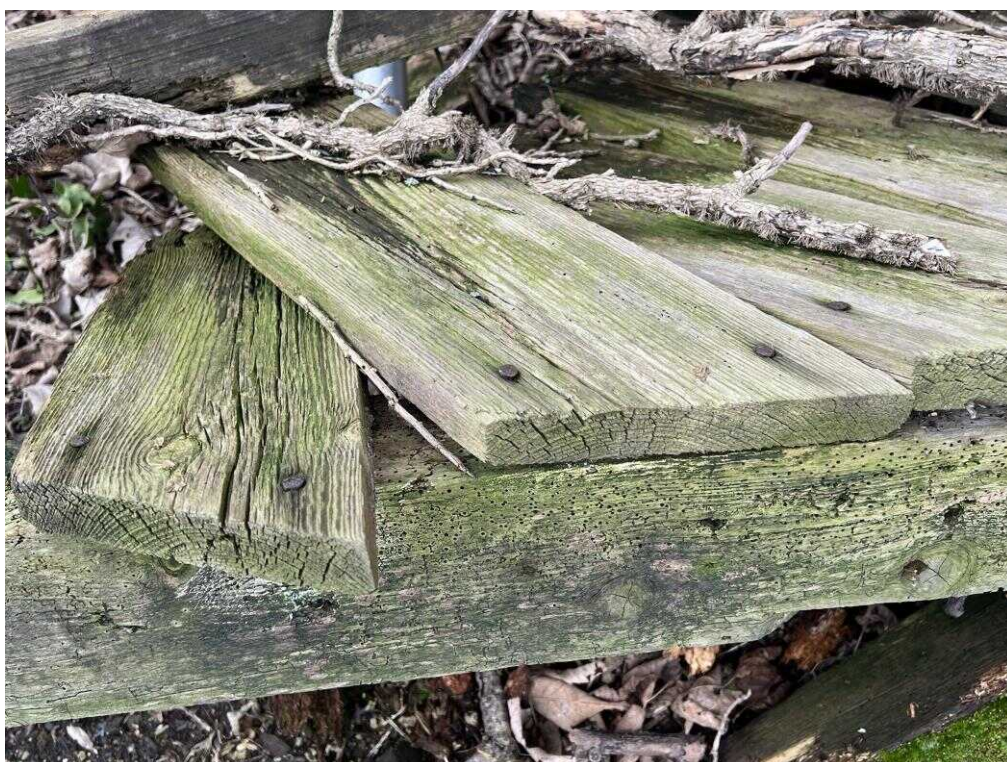
Fig. 33 – Detail of weather-boarding infill from east gable of roofed-in area.

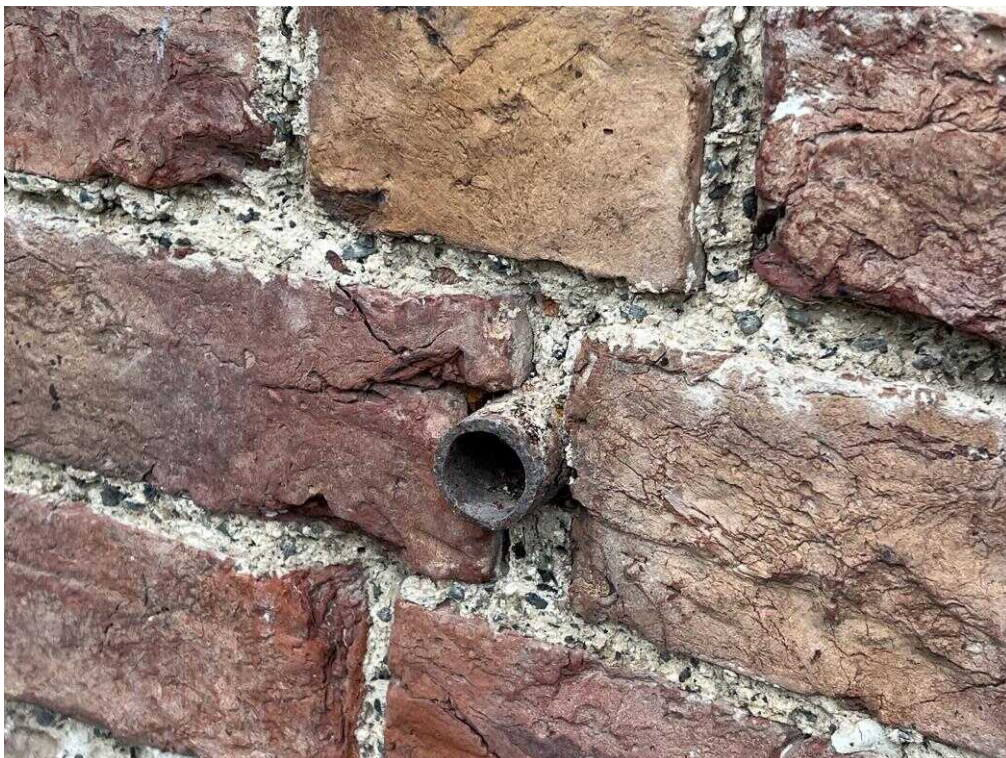
Fig. 42 – Redundant pipe through external wall.

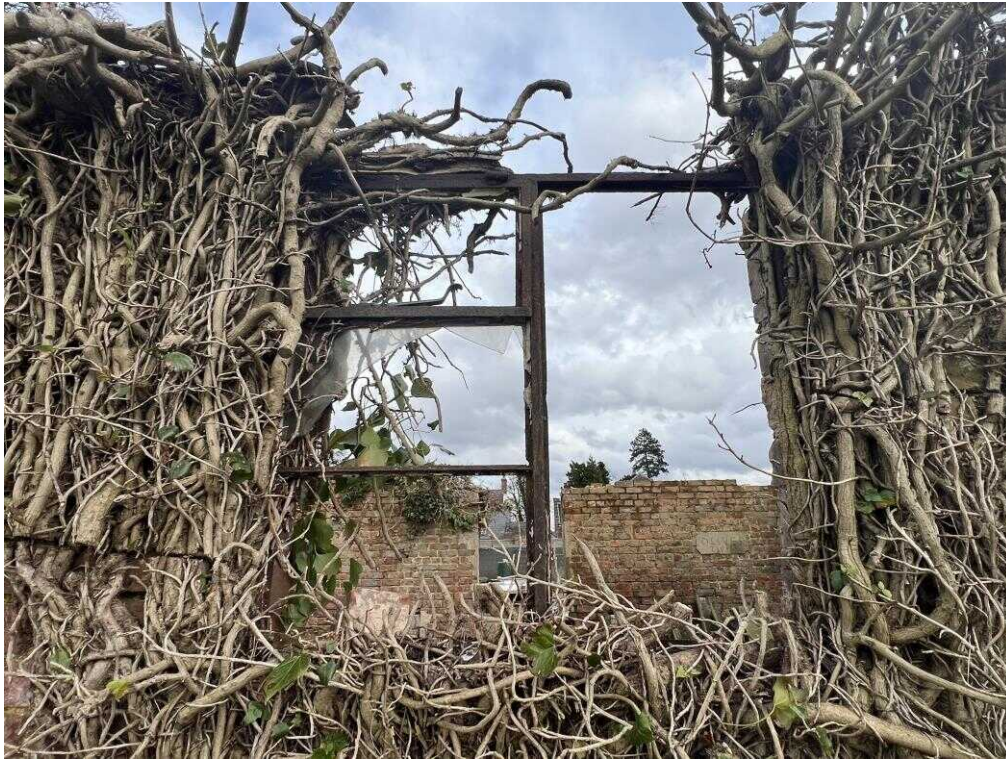
One window remains in-situ, though the casement is part-buried in undergrowth below the opening. It is a steel framed putty-glazed unit of the type produced by Crittall. It is therefore suspected that this dates from the interwar period or just after (fig.

Fig. 43– Steel framed window in west elevation.
