**Limited Environmental Desk Study of site adjacent  
to 87, Moulton Chapel Road, Moulton Chapel  
Spalding, Lincolnshire PE12 0XD**

**10<sup>th</sup> December 2023**

**REPORT NUMBER 23-12-01**

## **Limited Environmental Risk Assessment of Land adjacent to**

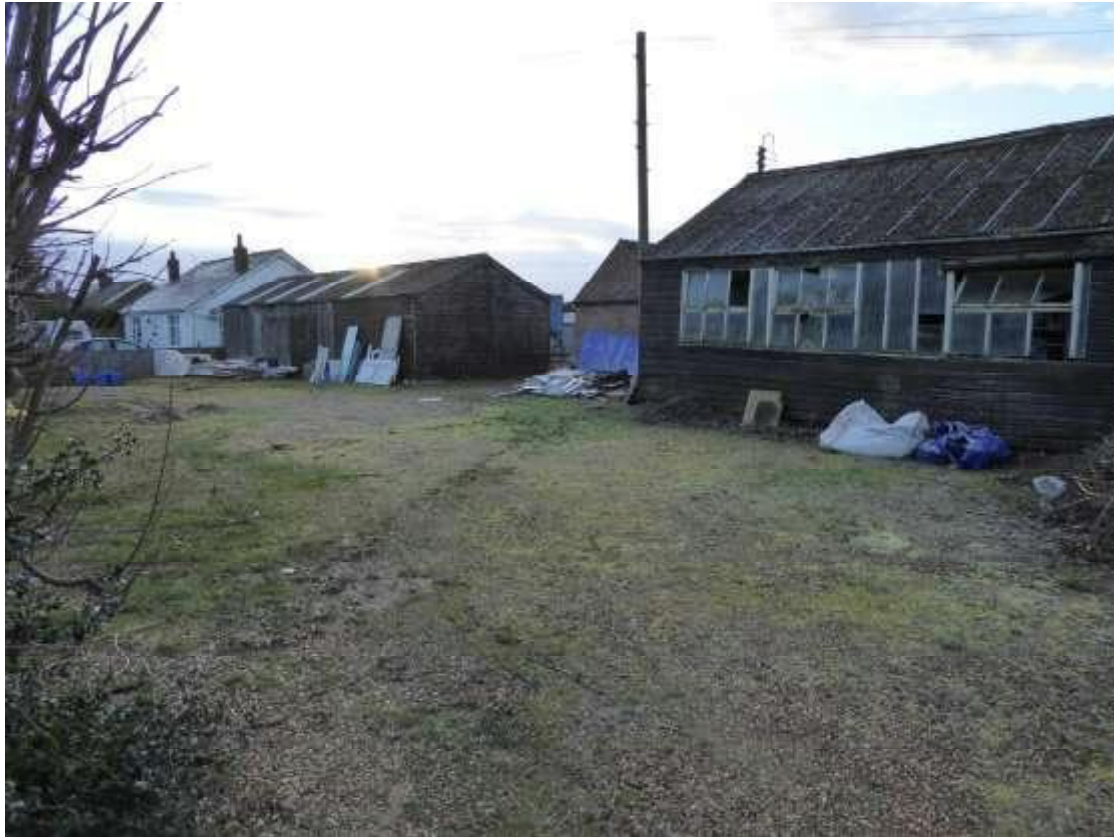
2.2 The March 2020 site visit also involved examining the new site for the presence of potential contamination (photo 1), but as none was found, it was included in the general observation about the lack of contaminating processes or potential contamination near to the site.

Photo 1 Photograph of site adjacent to March 2020 site visit

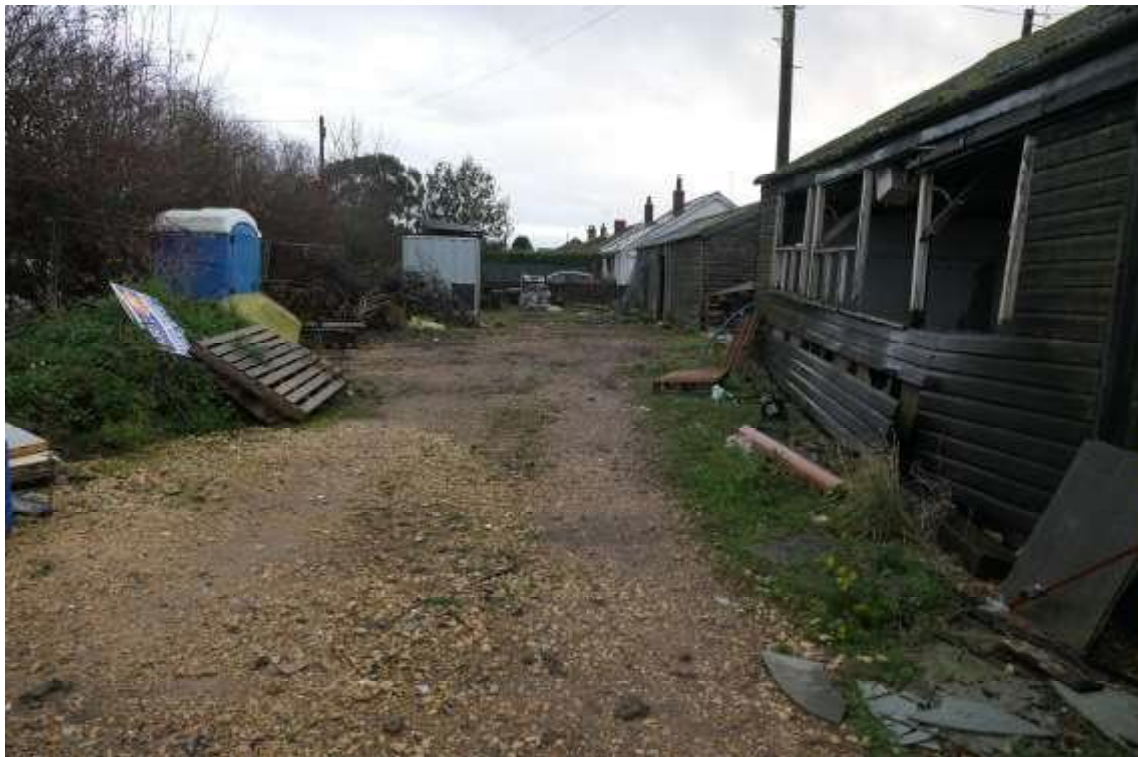
3.1 The site has changed very much since photo 1 with the shed to the front having all windows and door removed (photo 2). At no. 87, the sixth dwelling is nearly completed with four large houses and one bungalow either completed or nearing so. Some of the rubble from the demolition of the commercial buildings on the first site is being stored on the present site (photo 3 and 4), but that will be removed once the new development commences. An examination of the rubble did not find any evidence for contamination. The near buildings on

Photo 2 Sheds on site on 5<sup>th</sup> December 2023 with windows and doors removed

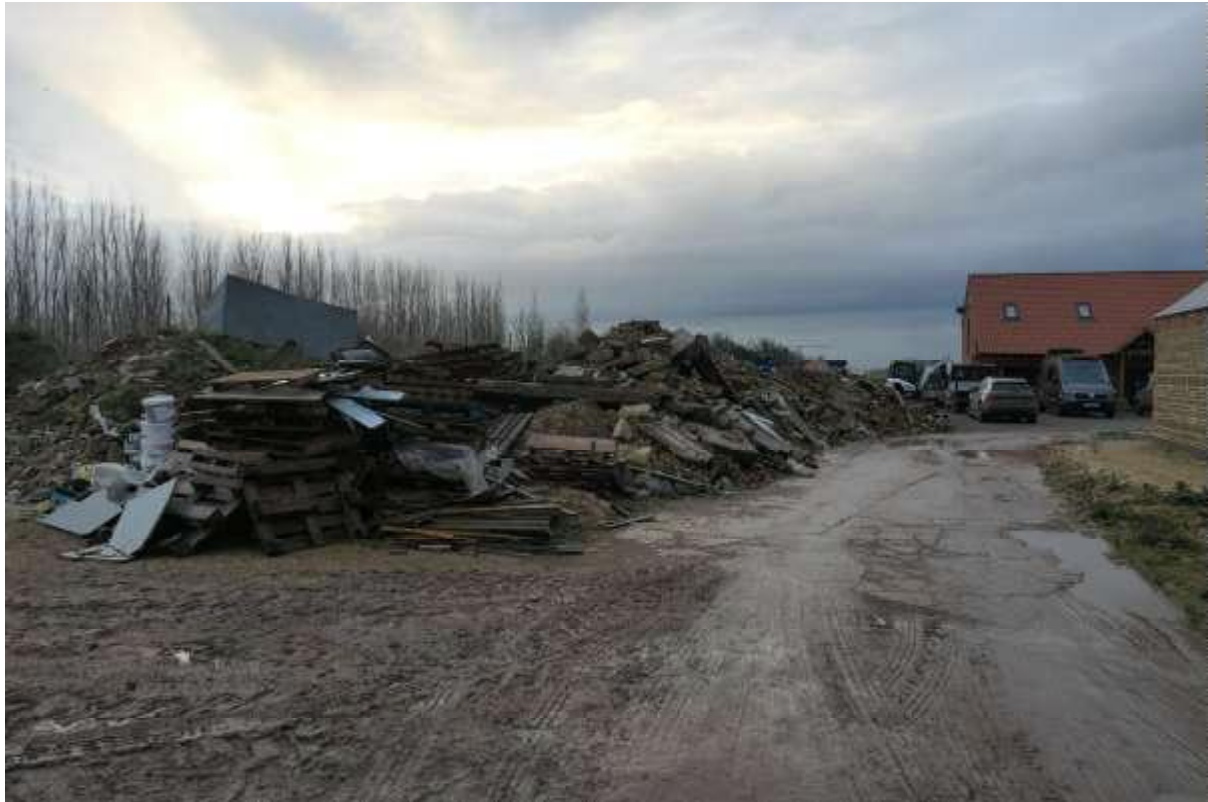
Photo 3 Rubble from 87 Moulton Chapel Road stored on the adjacent site

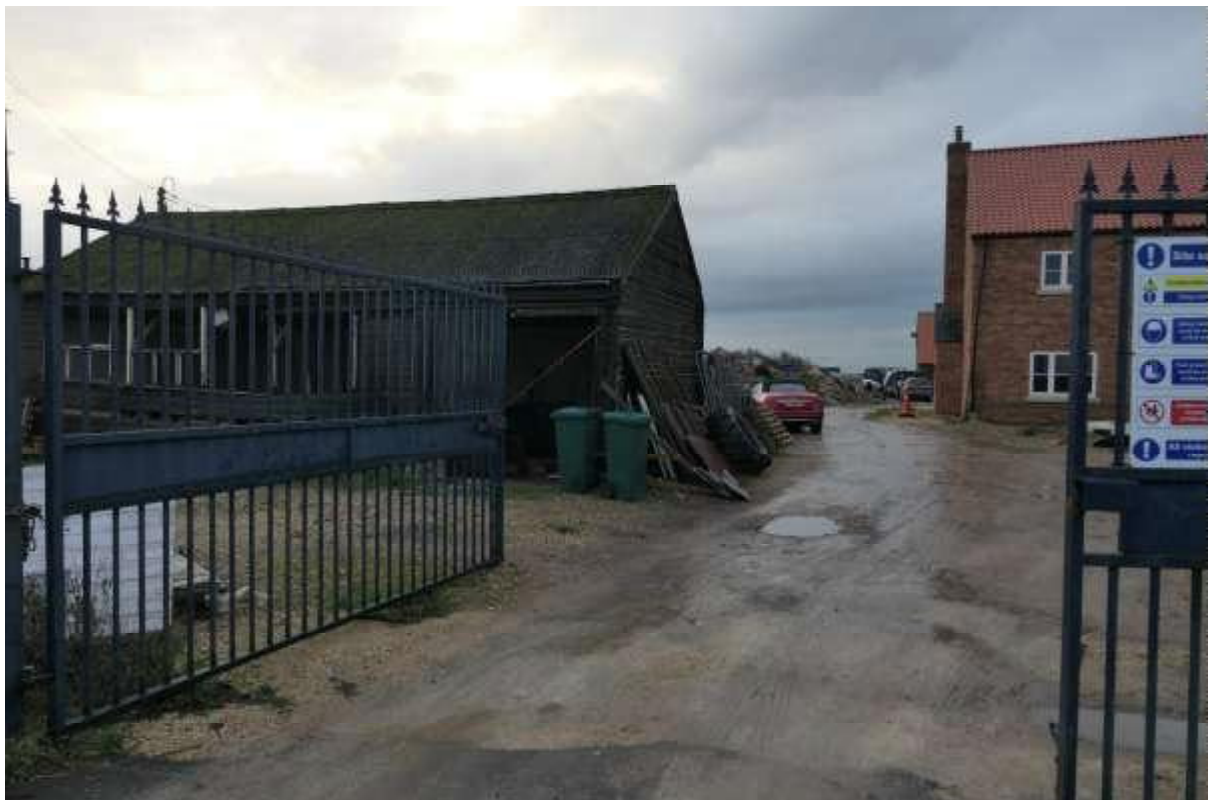
Photo 4 Shed to front of site, rubble to rear and last house in first development

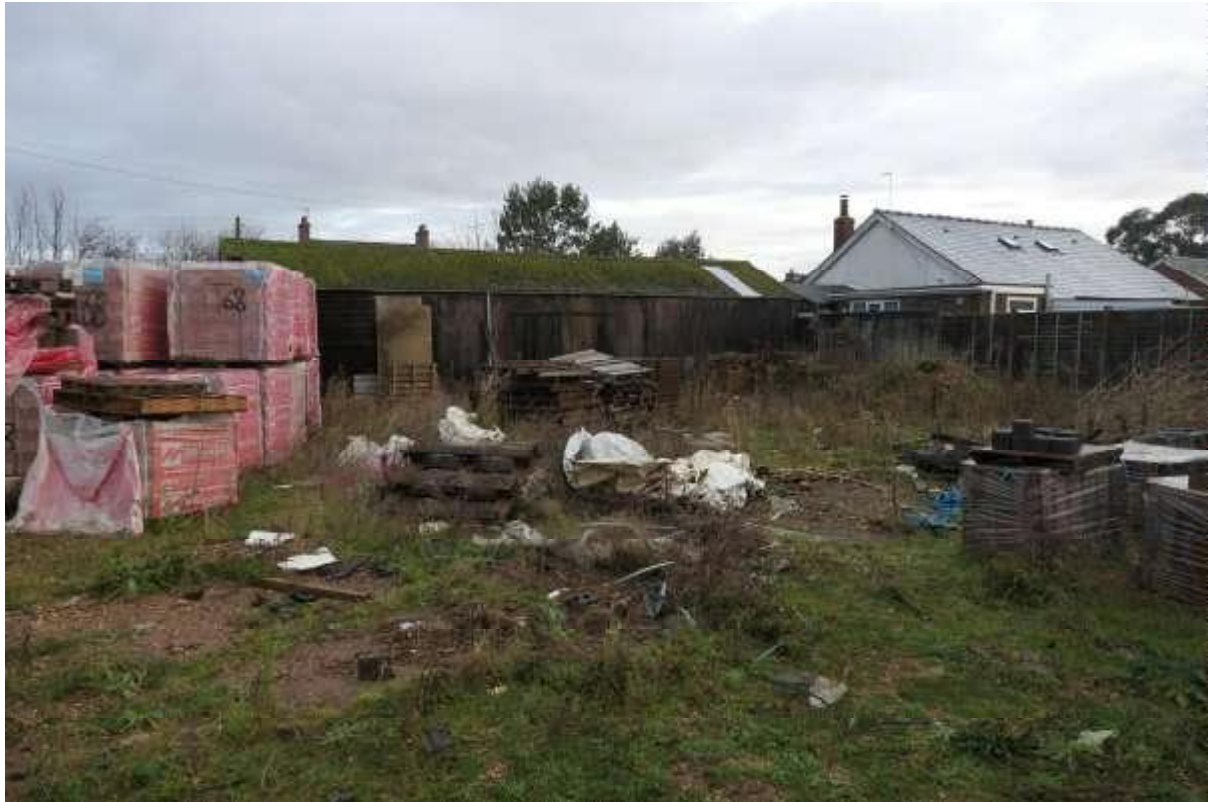
Photo 5 Building materials behind the sheds on the site

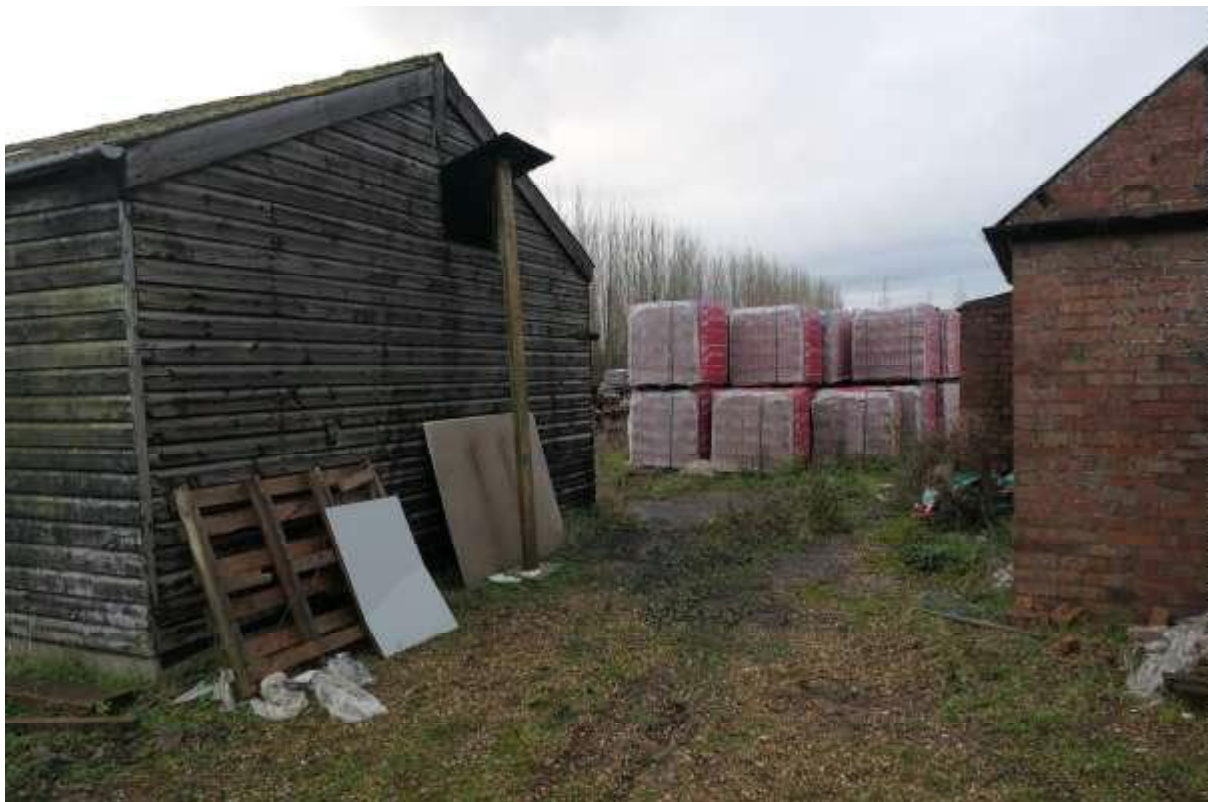
Photo 6 New bricks stored on site

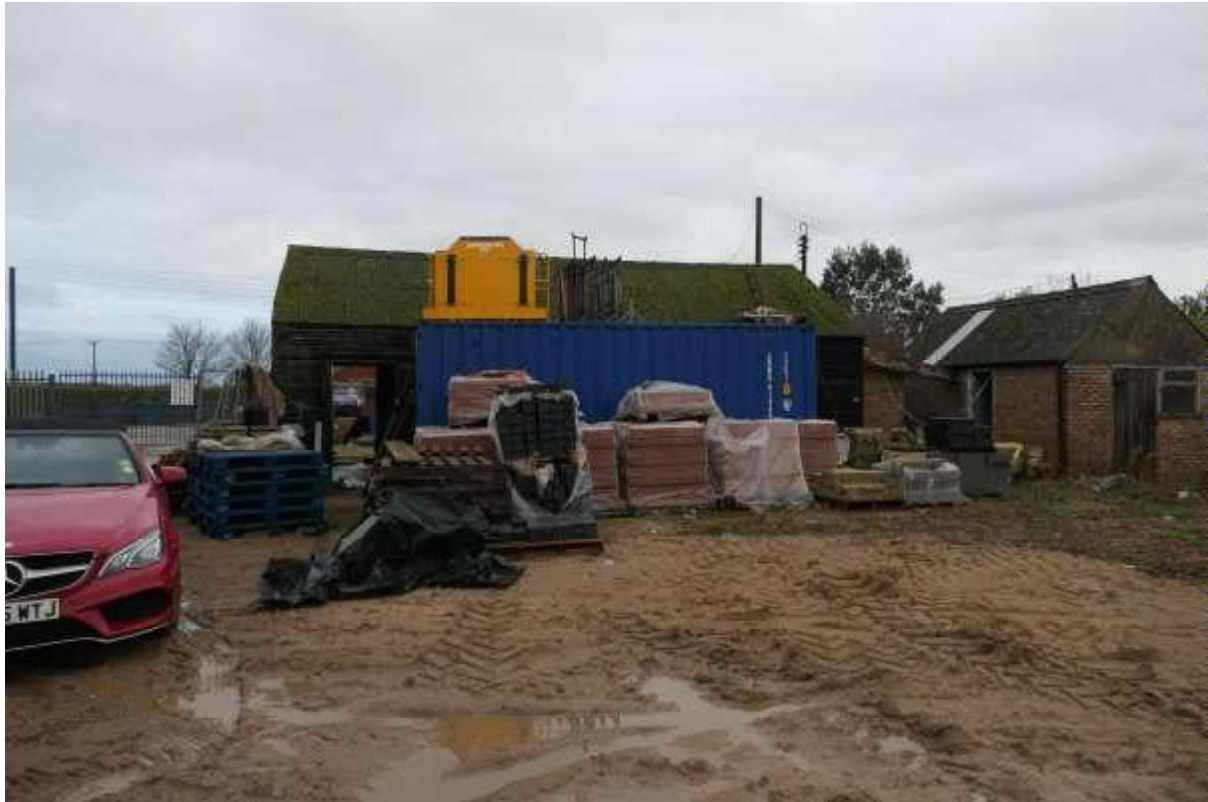
Photo 7 Roof tiles and pavers stored on site as well as secure steel shipping container

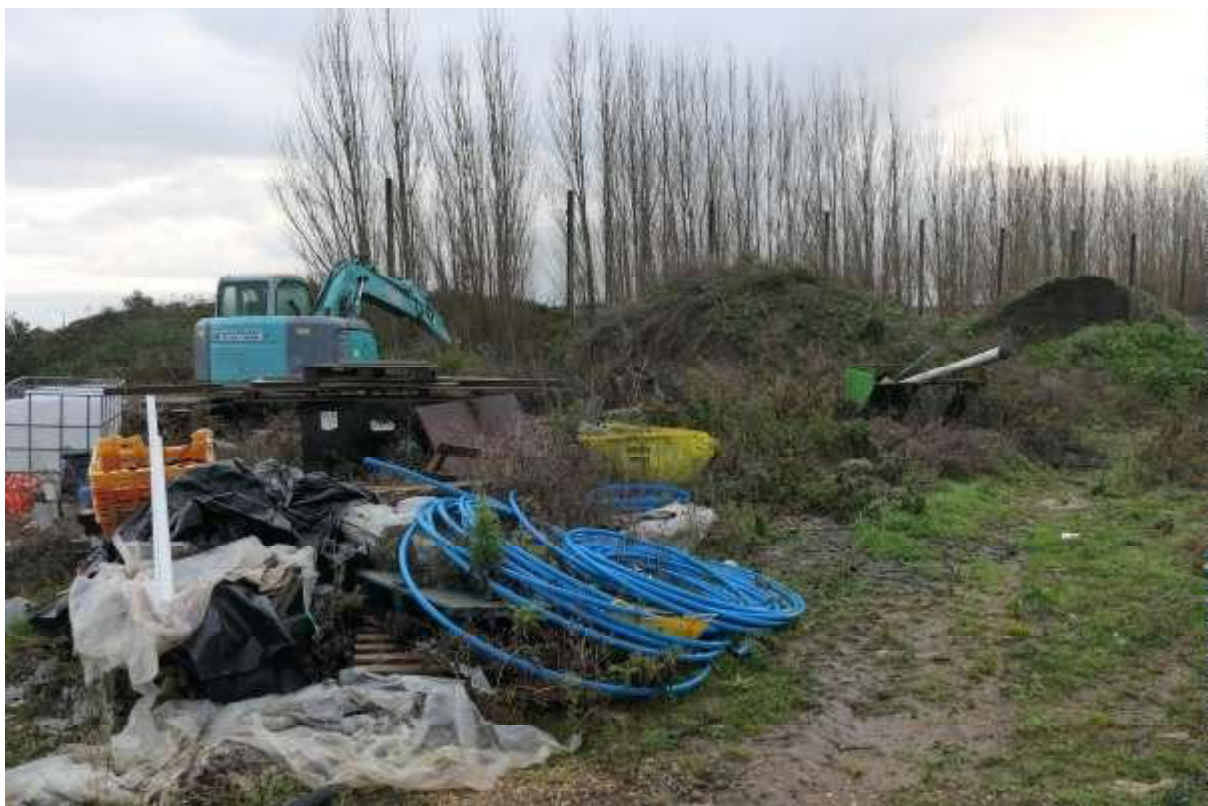
Photo 8 Small excavator, plastic water pipe and various containers

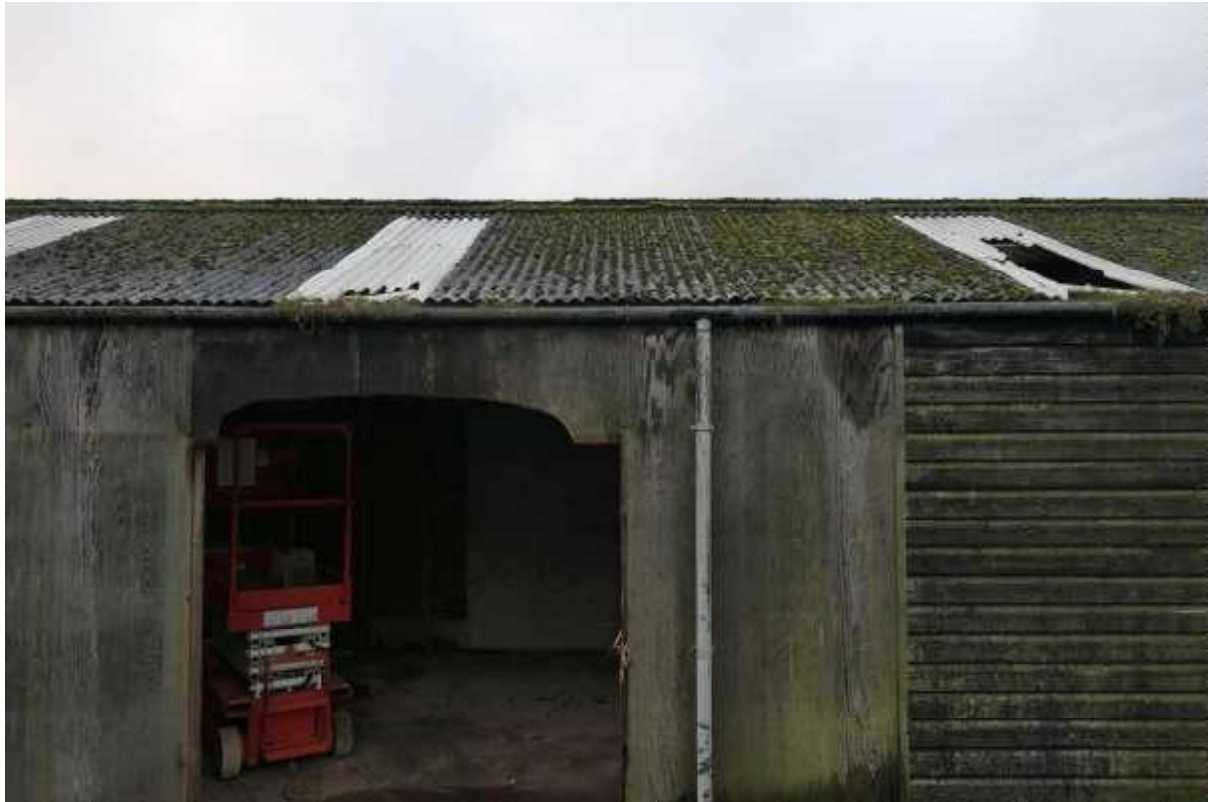
3.2 There were many building materials on the site as would be expected if space is available. They comprised pallets of building bricks (photos 5 & 6), pallets of tiles and block pavers (photo 7), and various small and large items, such as plastic water pipes and a small excavator. Various containers for waste metal and waste plastic were also around the rear of the site (photo 7). The wooden sheds were in very poor condition and needed supports to keep them from collapsing, whilst the roofing sheets on all of the sheds appear to be constructed from fibre reinforced cement (photo 8). These may contain asbestos fibres and should be tested and, if detected, they should be removed by a competent operator.

Photo 9 Roofing sheets that may contain asbestos fibres

4.3 The site is substantially free of potentially contaminated materials. The cement stabilised sheeting should be sampled and analysed for the presence of asbestos fibres. If asbestos fibres are identified, then the Health & Safety Executive should be notified and a specialist company employed to remove the sheeting. That company should also produce a method working statement for the Health & Safety Executive.

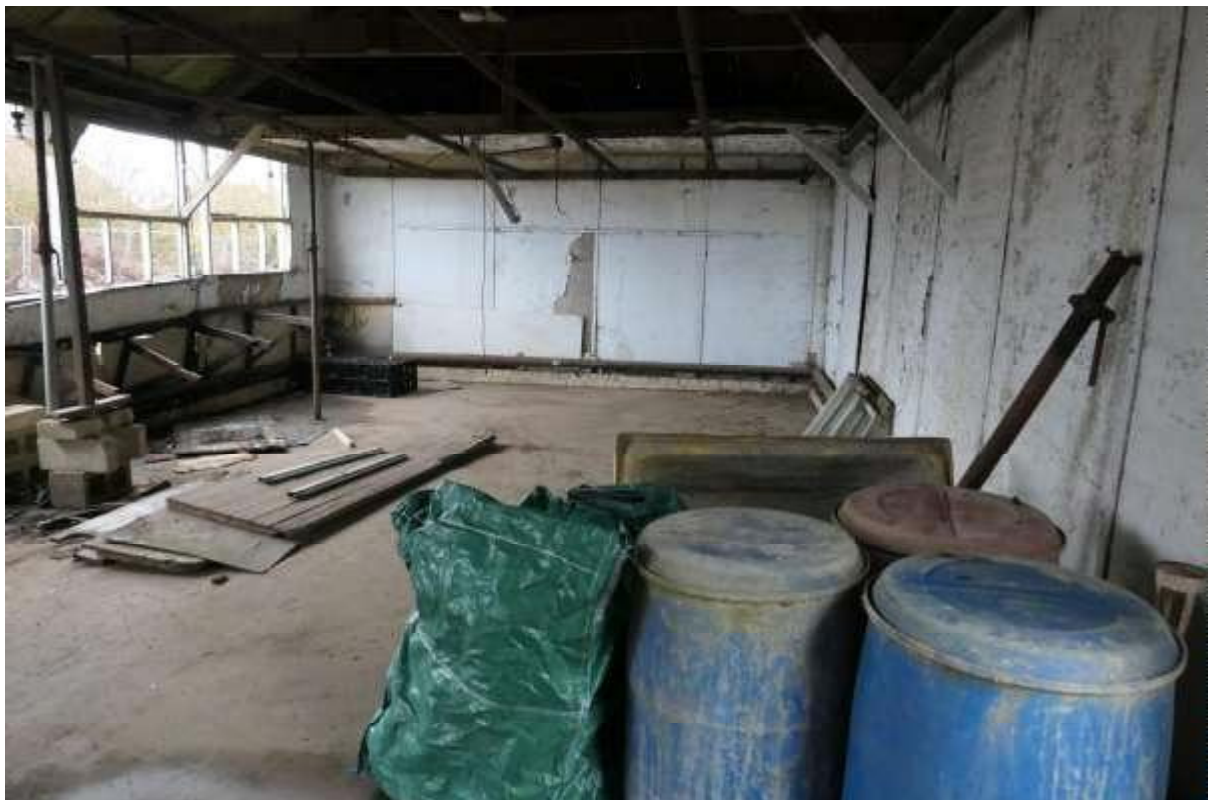
3.3 The inside areas of the sheds were examined and found to be clean with no oily stains on the floor (photos 9 and 10) or any evidence for herbicides or pesticides. The polytunnels shown on the Google aerial photo were reported as being damaged in the 2020 report and most of the frames have now been sold and transferred.

Photo 10 Inside shed near entrance on west of site

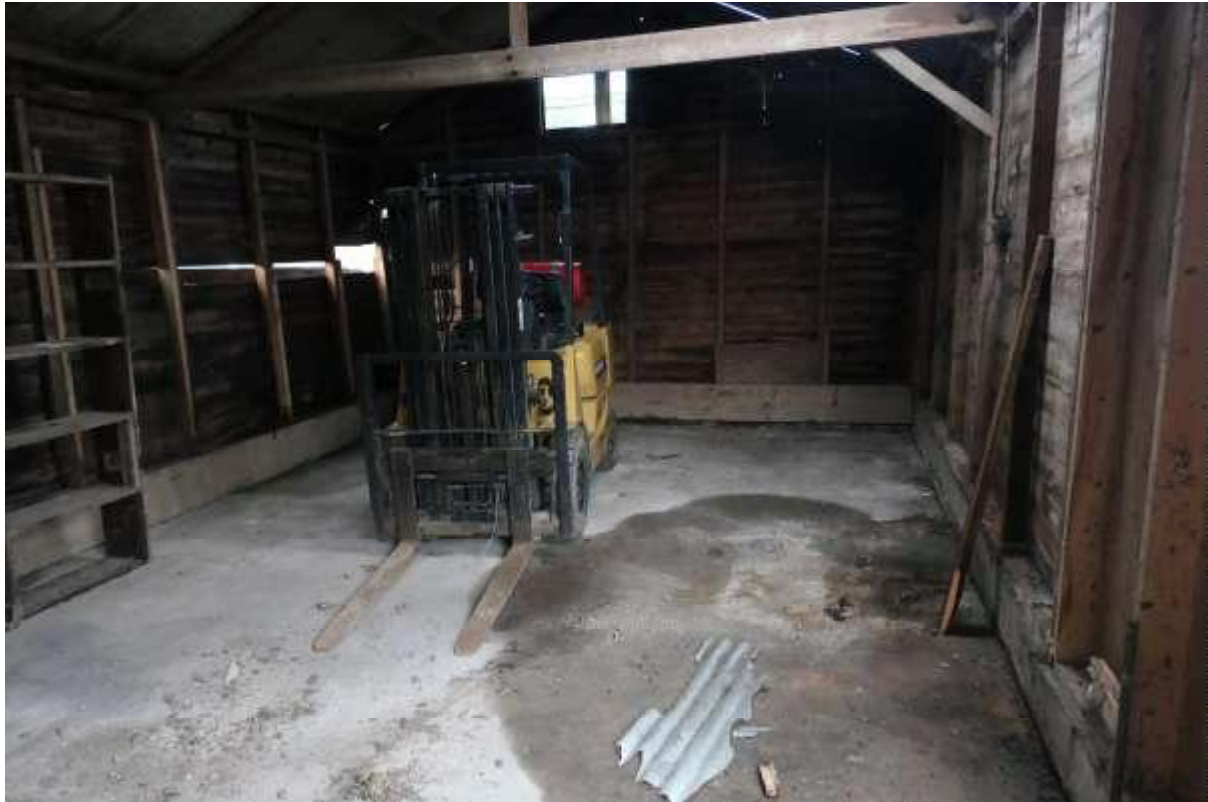
Photo 11 Inside shed to east of site
