## **HISTORIC BUILDING RECORDING POPLAR FARM WESTON HILLS LINCOLNSHIRE**

Prepared For  
Karen Milsom

By  
Neil Parker MA ACIfA

APS Report No: **54/22**

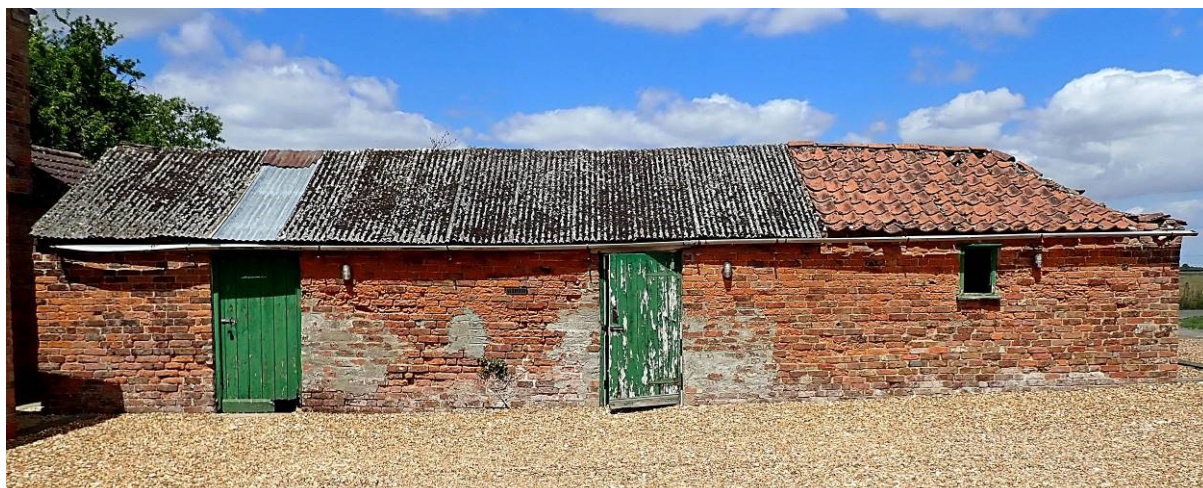
The south elevation of Building 1, the east – west aligned single storey building to the east of the farmhouse has a brick wall with no discernible bond pattern. The bricks are laid as stretchers with random headers inserted where it was expedient. The bricks are handmade and of a roughly standard size.

There are three apertures within this elevation. On the west side is a door to Room 1; centrally a further door to Room 2 and at the west end a small window which gives light to Room 3.

At the east end survives a hipped pantile roof over Room 3. The remainder of the roof is corrugated asbestos ending in a gable at the western end. The guttering around the eaves is modern.

**Plate 2** (Above). The south elevation of Building 1

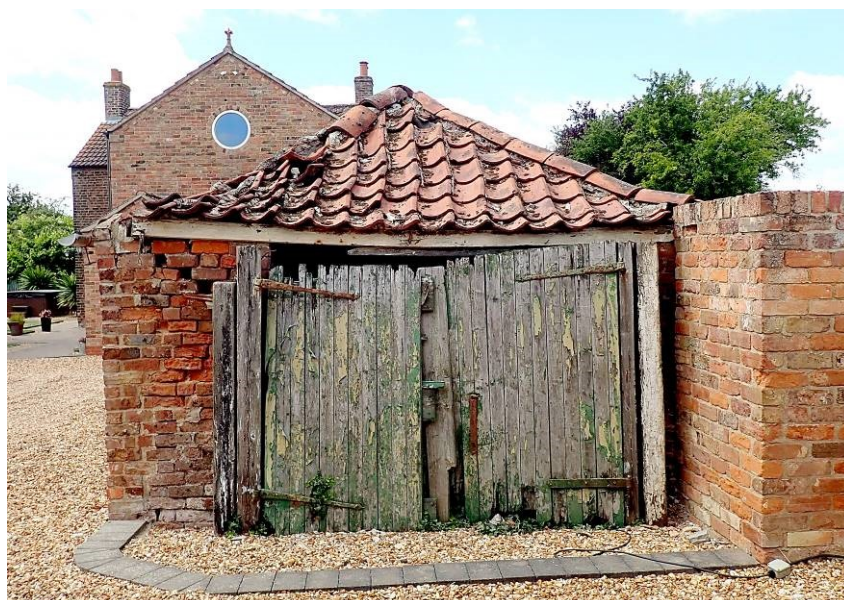
Below the hipped roof on the east elevation, the majority of the end wall serves as a wide, double doored entrance, offset to the north adjacent to a more recent garden wall.

**Plate 3** (left). The east elevation of Building 1

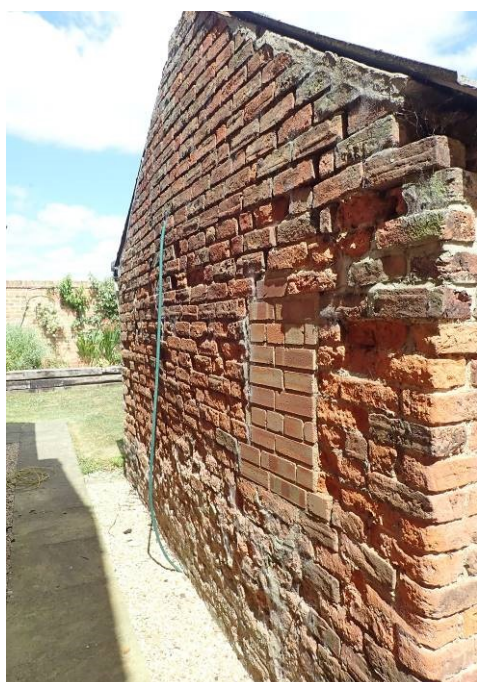
The west elevation is a plain gable end with an aperture blocked with modern brick.

**Plate 4.** The west elevation of building 1 with a blocked window aperture on its south end

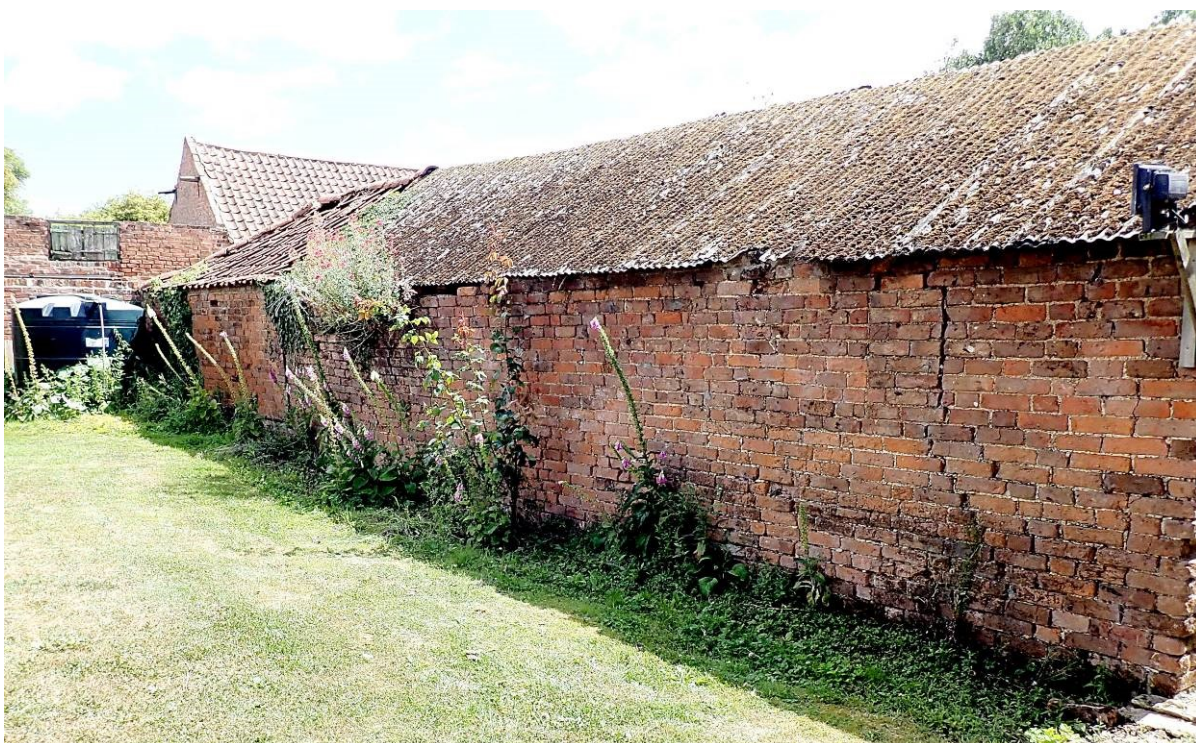
The remainder of the north elevation, as with the south and west elevations, has no discernible bond pattern to the brickwork.

**Plate 5.** The north elevation of Building 1

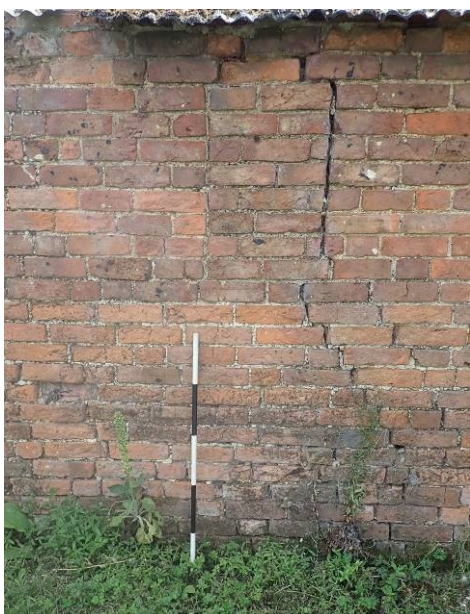
A further blocked aperture can be seen at the west end of the north elevation, this time blocked with contemporary brick.

**Plate 6.** Blocked aperture on the west end of the north elevation of Building 1

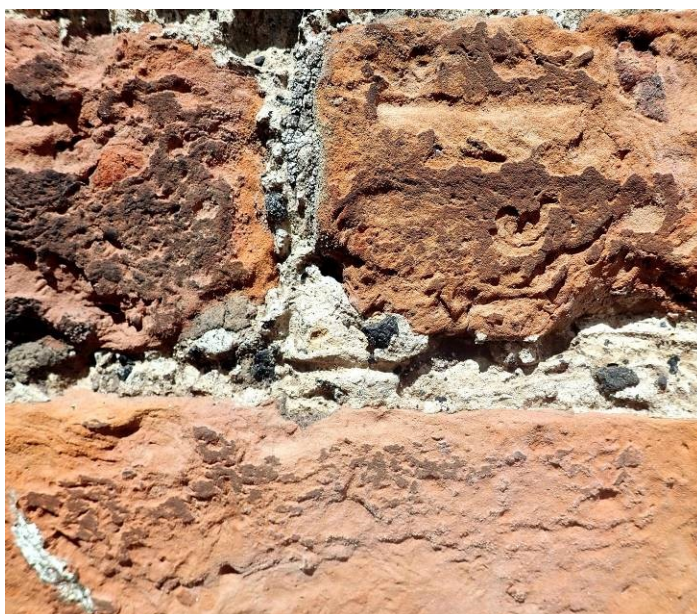
The lime mortar bonding the bricks in building 1 has been tempered with crushed fragments of overfired brick (see Plate 7)

**Plate 7.** Detail of the lime mortar on Building 1

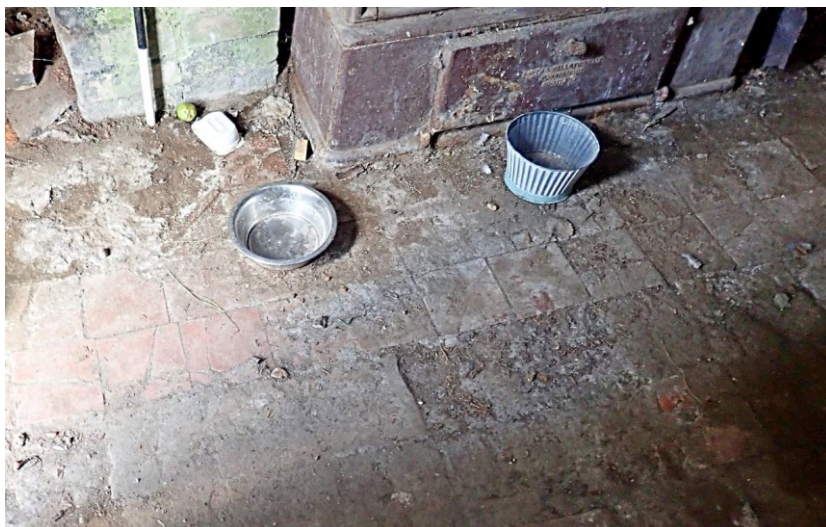
The floor has been laid with quarry tiles throughout the room. The western wall is dominated by a hearth and chimney. In the hearth space is a medium sized iron range oven and stove

The washing copper in the corner butts against the wall, hearth space and chimney while the hearth and chimney are integral to the construction of this end of building 1 suggesting the copper is a later addition.

**Plate 8.** The quarry tile floor in Room 1 of Building 1

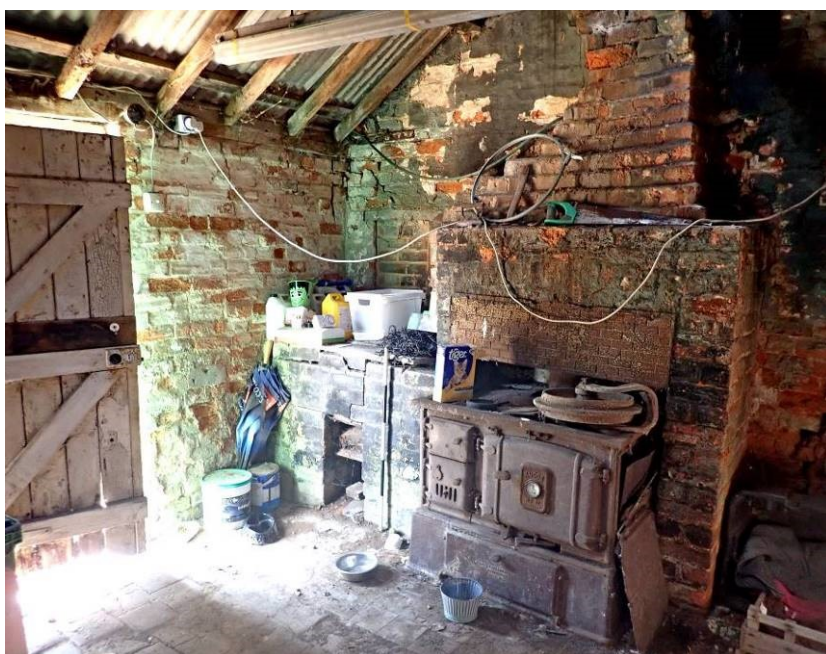
The aperture of the hearth/fireplace in which the range cooker sits was larger than the current space and has been partly infilled with later fire bricks above the stove. The hearth is not quite central to the end wall and the chimney is staggered so that it exits at the centre of the ridge. There are no external remains of the stack.

**Plate 9.** The hearth and copper in the west wall of Room 1 in Building 1

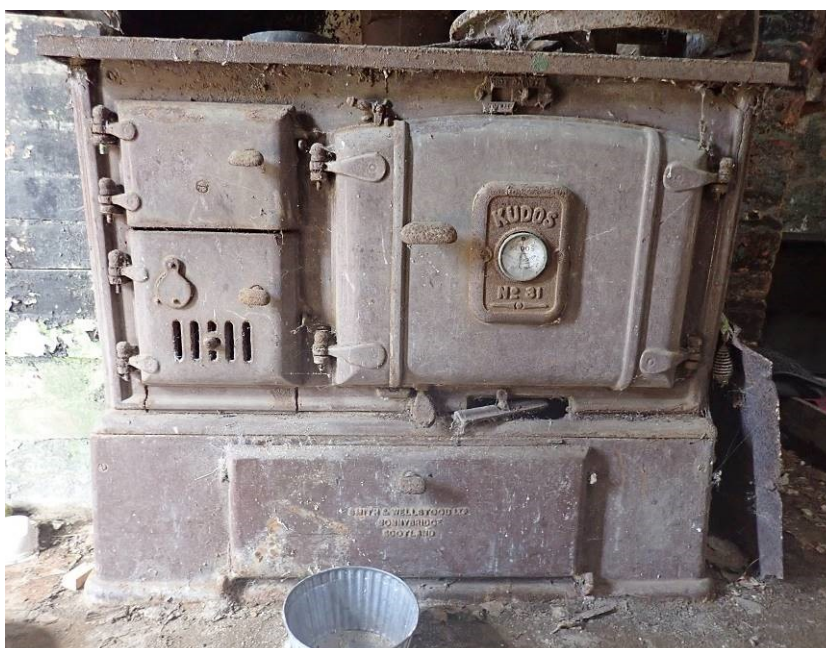
The range cooker, a Smith and Wellstood Kudos No.31 with outside thermostat fits tightly inside the hearth space which appears to have been widened on its southern side to accommodate it. The brickwork for the copper now forms the southern wall of the hearth.

**Plate 10.** The range cooker occupying the hearth space in Room 1 of Building 1

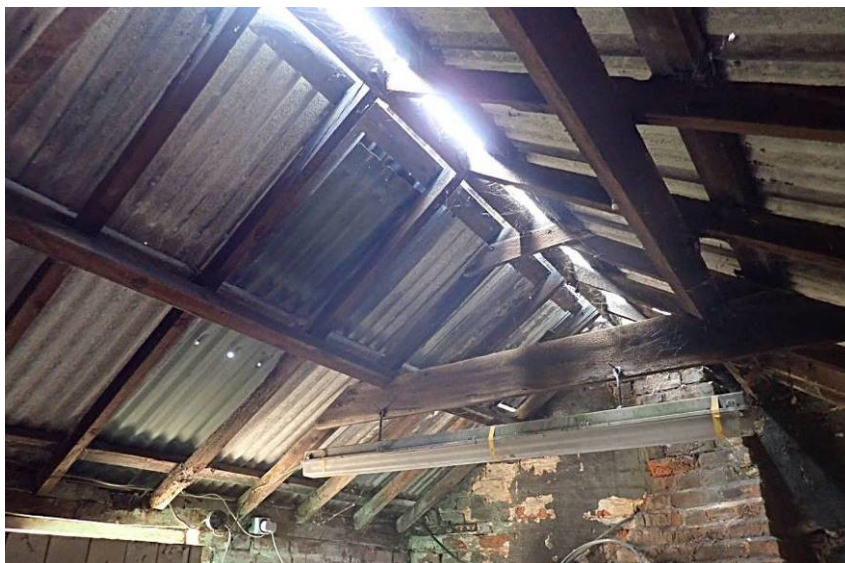
In Room 1 and further to the east where the roof is corrugated asbestos, the roof timbers are later replacements and appear to date entirely to the 20<sup>th</sup> century.

**Plate 11.** Replacement roof timbers in Building 1

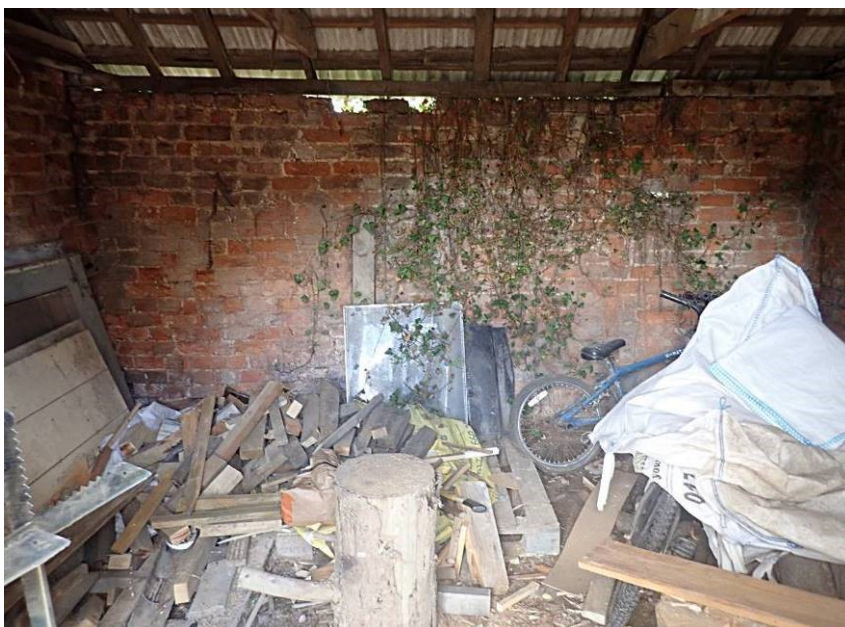
Room 2 in Building 1 has no internal features or apertures, either on the rear outside wall or in the two internal dividing wall. Accessed only from the southern entrance door the room may have served as a store.

**Plate 12.** Room 2 in Building 1, a possible store

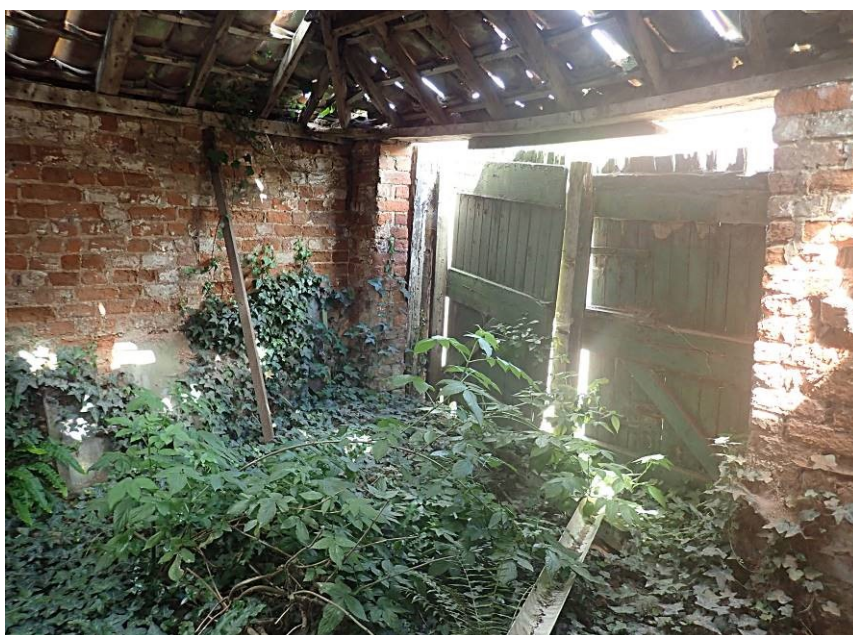
Internally, Room 3 at the east end of Building 1 is also now featureless. The single window on the south side is not repeated on the rear wall. The large aperture on the east end forming the double doorway appears to be original as there is no sign that the bricks have been cut. This may have served as a trap house (see discussion).

**Plate 13.** The eastern opening in Room 3 of Building 1

The roof, although pantile rather than corrugated asbestos, sits on replacement timbers of greater age than those to the west, but still replacements for the originals.

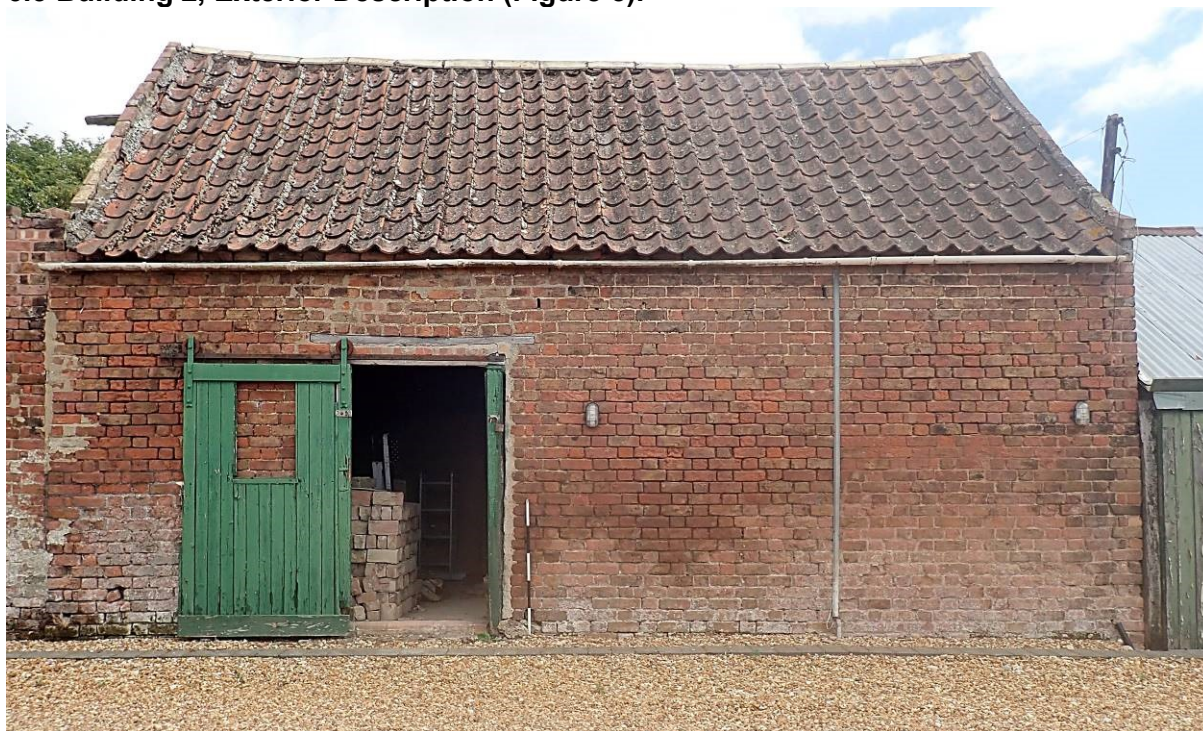
**Plate 14.** The west elevation of the southern part of Building 2

The west elevation of Building 2 is constructed of brick laid in Single Flemish Bond (see discussion), the external face having alternate stretchers (bricks laid lengthways) and headers (bricks laid end on). Half width headers known as queen closers are used for strength. A single door offset to the north of centre is the only aperture in this elevation. The roof is pantile.

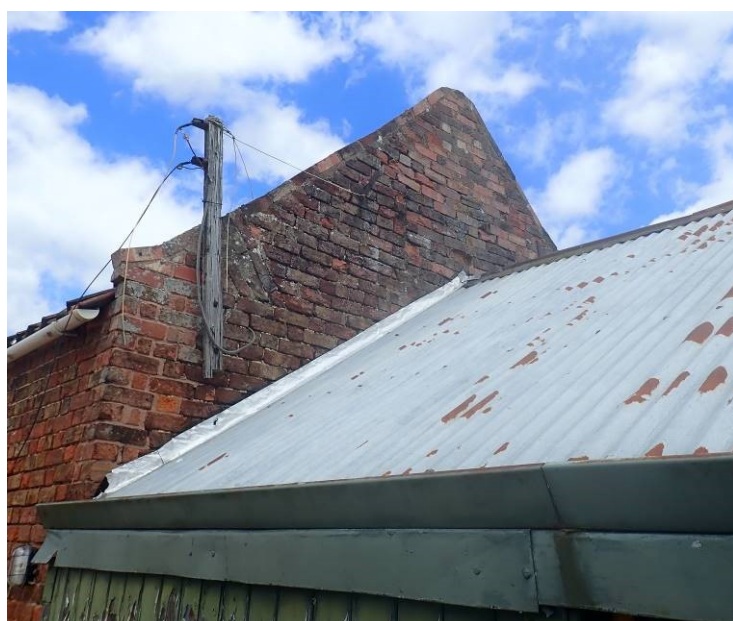
**Plate 15** (above). Detail of the tumbled brickwork on the south elevation of Building 2

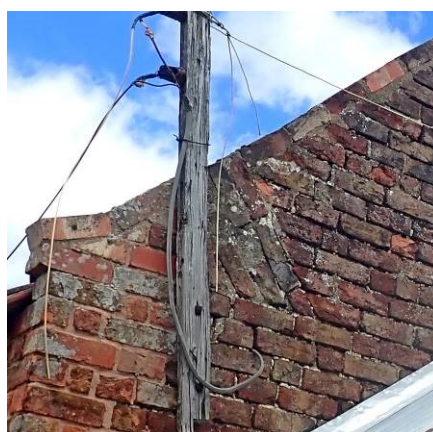
**Plate 16** (left). South Elevation, Building 2

The south elevation is mostly covered by a modern breeze, concrete and corrugated metal shed, although the tumbled brickwork on the gable end is still visible.

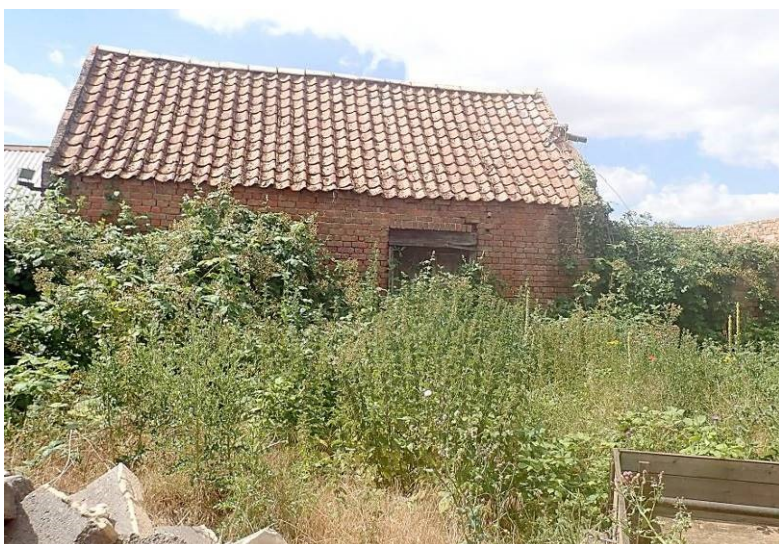
Due to the amount of vegetation, a detailed inspection of the east elevation of building 2 was not possible, however, the opposing door reflecting that in the west elevation was visible indicating the original purpose of the building as a threshing barn (see discussion).

**Plate 17.** The east elevation of the southern part of Building 2

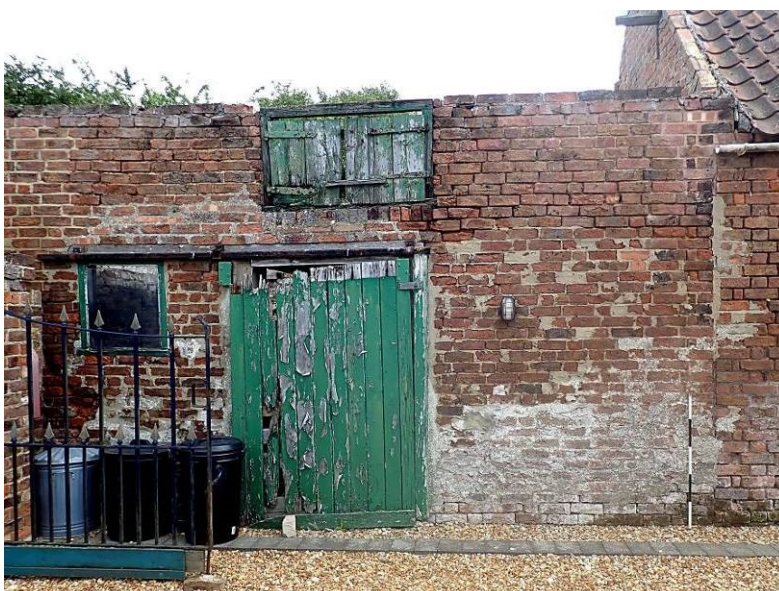
The northern part of Building 2 is a separate phase of construction. Butting against the southern part, the brickwork is similar to Building 1 in that it follows no distinctive bond pattern. At ground floor level is a single door aperture, covered by a sliding wooden door, with a modern window cut next to it.

**Plate 18.** The west elevation of the northern part of Building 1

The upper roof section of this elevation had collapsed prior to the survey, but an upper door to a granary floor still remains.

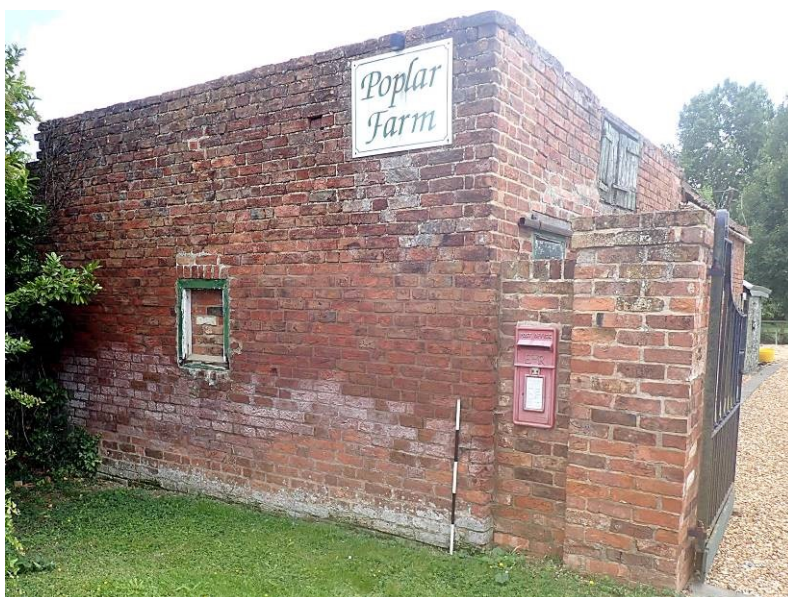
The north elevation of Building 2 has a recently blocked original window aperture. At the east end, the ragged brickwork indicates where the building continued but has, as seen in historic mapping, either collapsed or been demolished. A more recent wall and gate pillar butt against the east elevation.

**Plate 19.** The north elevation of Building 2

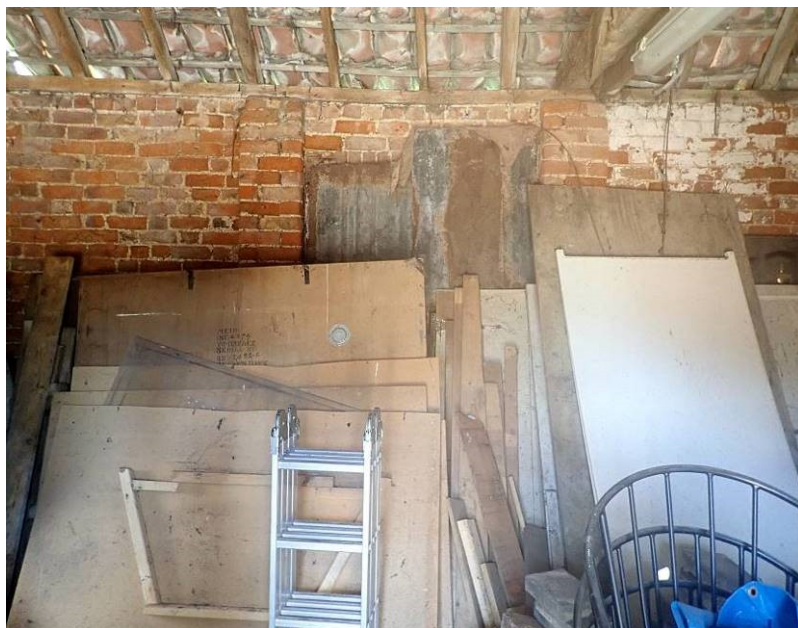
Currently used for storing wood and other materials, Room 1 in the southern section of the barn is an open space.

The floor is concrete and on the internal walls there are brick pillars for strength on either side of the opposing doors.

**Plate 20.** Brick pillars either side of the eastern door in Room 1 of Building 2

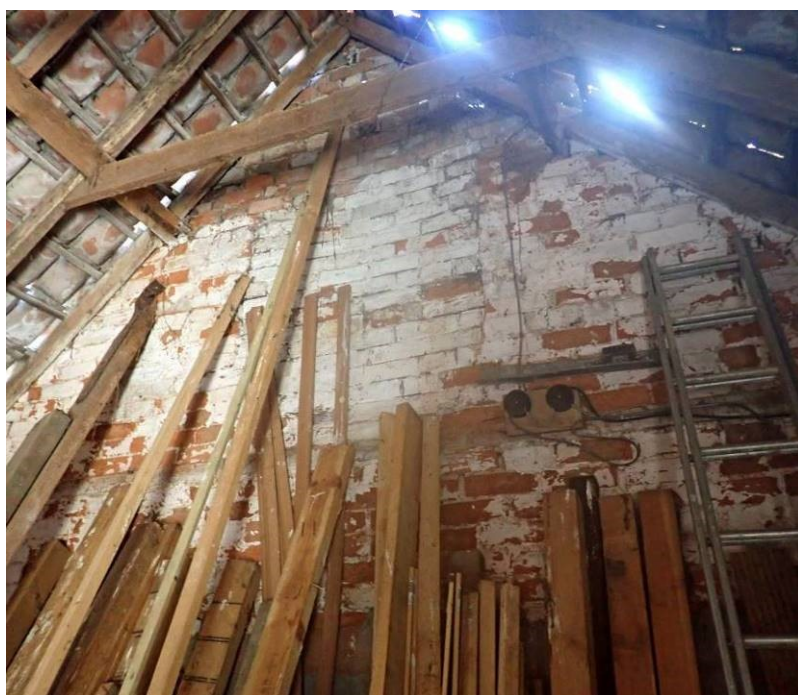
On the southern internal wall, a blocked door can be seen that would have given access to an upper storage area, for bags of grain produced in the barn below.

The roof timbers are, as with Building 1, replacements and appear to be of a similar age to those in the pantiled section of that building.

**Plate 21.** Blocked door to the upper storage area at the south end of Room 1

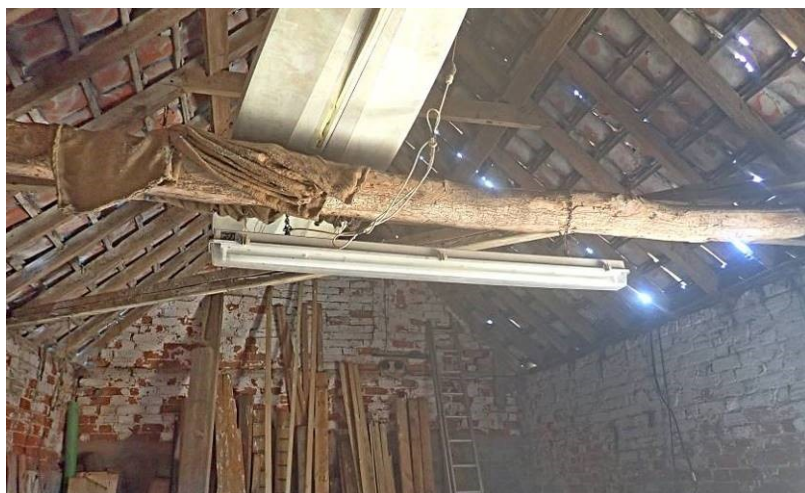
A single rough timber spans the space between the opposing doors in Room 1. It no longer serves any load carrying capacity but may be a remnant timber original to this barn or a building that pre-dated it.

**Plate 22.** A rough timber spanning the space between the opposing doors in Room 1

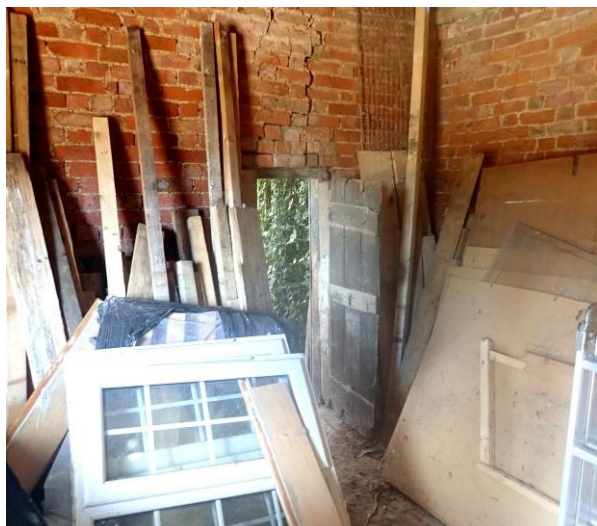
**Plate 23** (above). The door from Room 1 in Building 2 to Room 2 with cracking above

On the north wall of Room 1, on the east side is a doorway to Room 2. This is not an original aperture and has been cut into the brickwork. It is notable that the gable end walls are not as thick as the east and west walls and are laid in Flemish Bond rather than Single Flemish Bond. Cracking has been caused due to the insertion of the door.

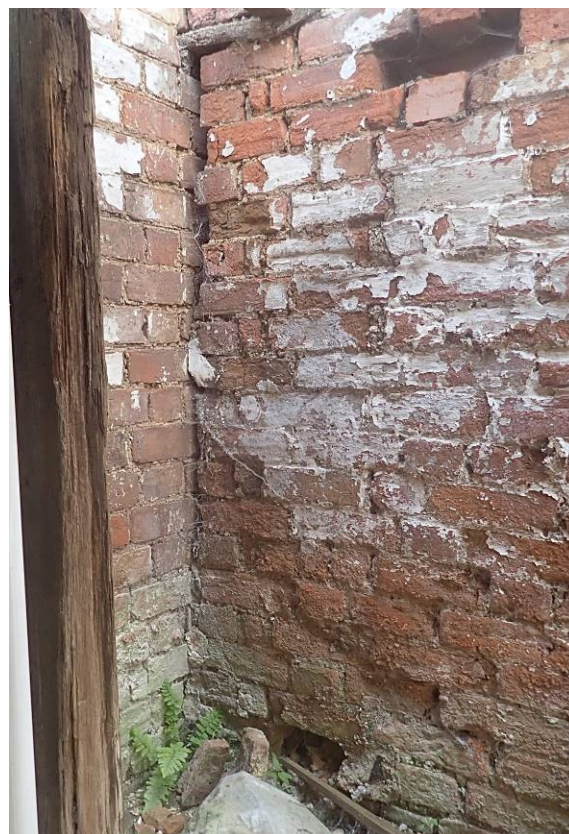
**Plate 24** (right). The western wall of Room 2 butting against the northern wall of Room 1, a previously external wall

In Room 2 it can be clearly seen that the west wall of this room butts against the wall of the southern section rather than keying into it (Plate 24).

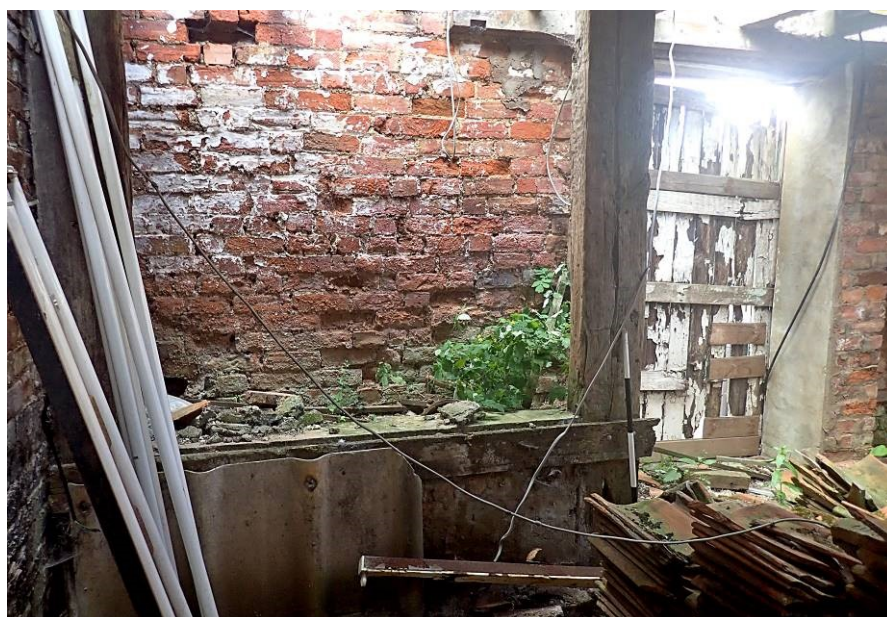
On the west wall of Room 2 is the door aperture, reinforced internally with brick pillars on either side indicating an original feature.

To the south of this is a feed trough, which appears to be a later insertion.

**Plate 25.** The feed trough and door on the west side of Room 2 in Building 2

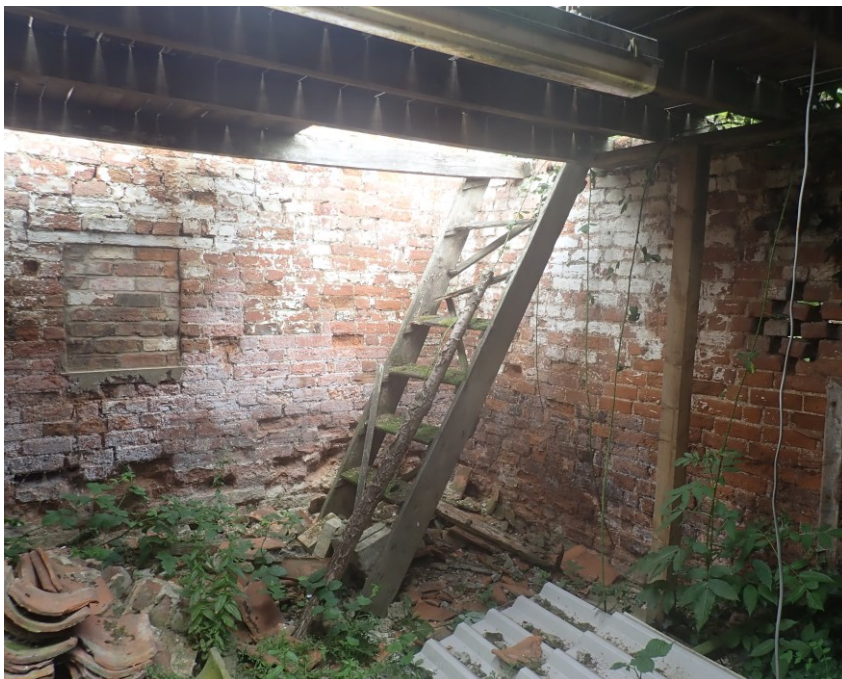
On the north side of Room 2, near to the recently blocked window is the wooden steps leading to the upper floor. Comprising sturdy beams and a closely boarded surface, this would have served as a grain store.

**Plate 26.** Wooden Steps in Room 2 of Building 2 to the upper floor; a grain store

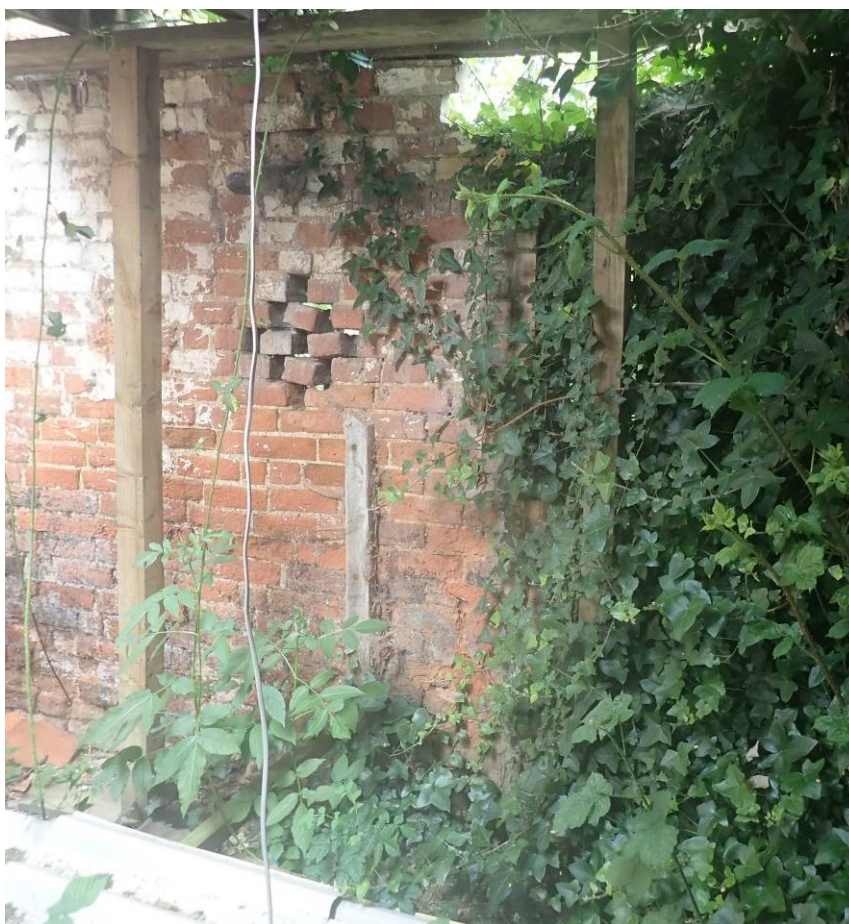
On the west wall is a partially collapsed diamond shaped "breather" slit to allow airflow into Room 2.

To the south of this, mostly hidden by ivy is a blocked doorway that would have lead into the historic east west range of the u-shaped complex.

**Plate 27.** The breather slit and position of a blocked doorway in Room 2 of Building 2
