# **STUART GUY CONSULTING**

**Report number 15-08-03/2**

## **Environmental Risk Assessment of site off Kirkgate**

### **Whaplode, Spalding, Lincolnshire, PE12 6TF**

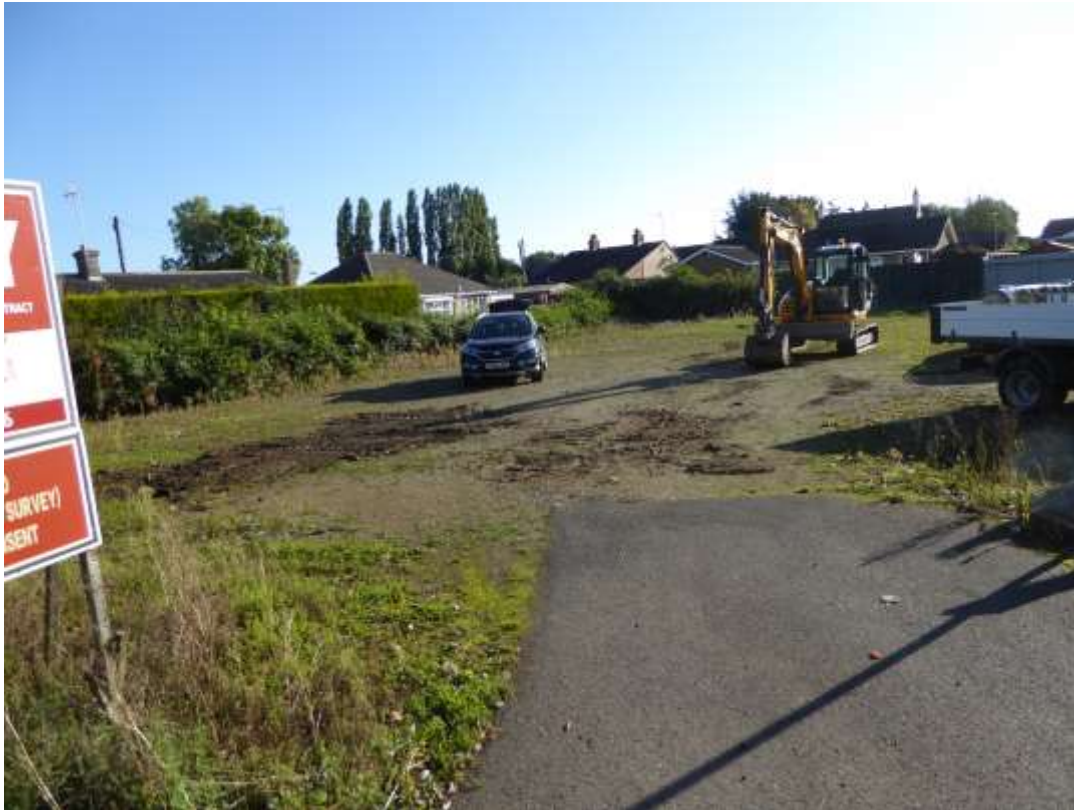
3.1 The site was visited when the weather was dry and bright, The site is surrounded on three sides by houses (photos 1 & 2). The Google map with ground level photographs shows the site to be owned at some stage by Green Structural (the name of the factory on the western side of the road opposite the site) and used as a car park.

Photo 1 View of site from Kirkgate with houses to north and east

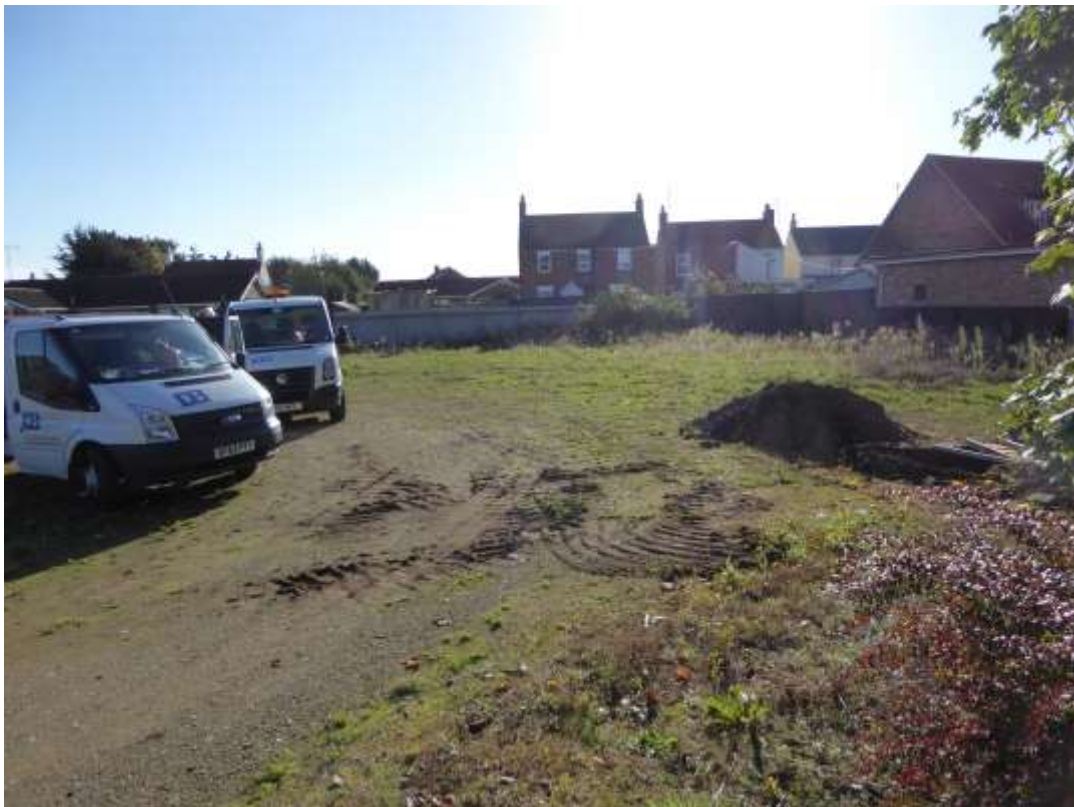
Photo 2 View of site from Kirkgate with houses to east and south

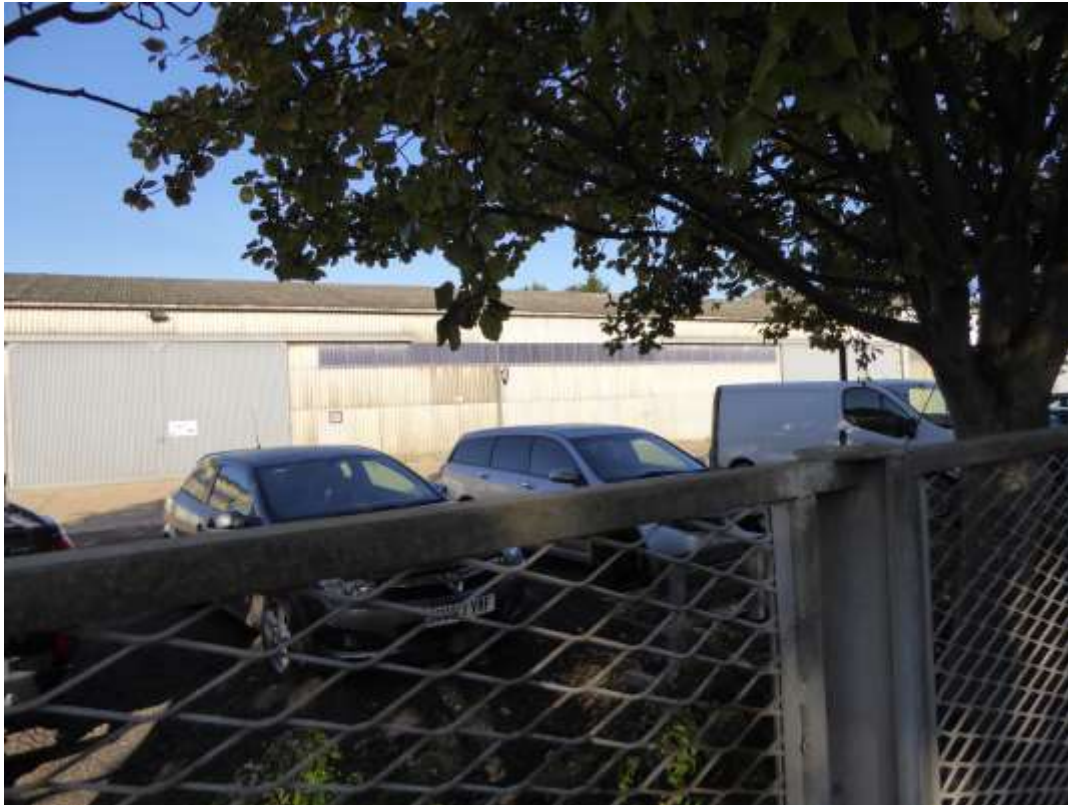
3.2 The large industrial site on the western side of the road is the only significant source of potential contamination near to the site (photos 3 & 4). The area is very flat and the fuel filling station locations are too far away to impact on this site. Myles Johnson worked at Green Structural and he explained that they produced structural fittings for a wide variety of industries. Many of them were subject to heat treatment and it is highly likely that the car park was originally used to dispose of the quench water. This would contain small fragments of metal oxides from the steel alloys that were used and may contribute to contamination of the site. Latterly, the site was used as a car park and engine oil and sooty deposits from exhaust systems could be sources of potential contamination.

Photo 3 Very small part of buildings on large industrial site (trees block view)

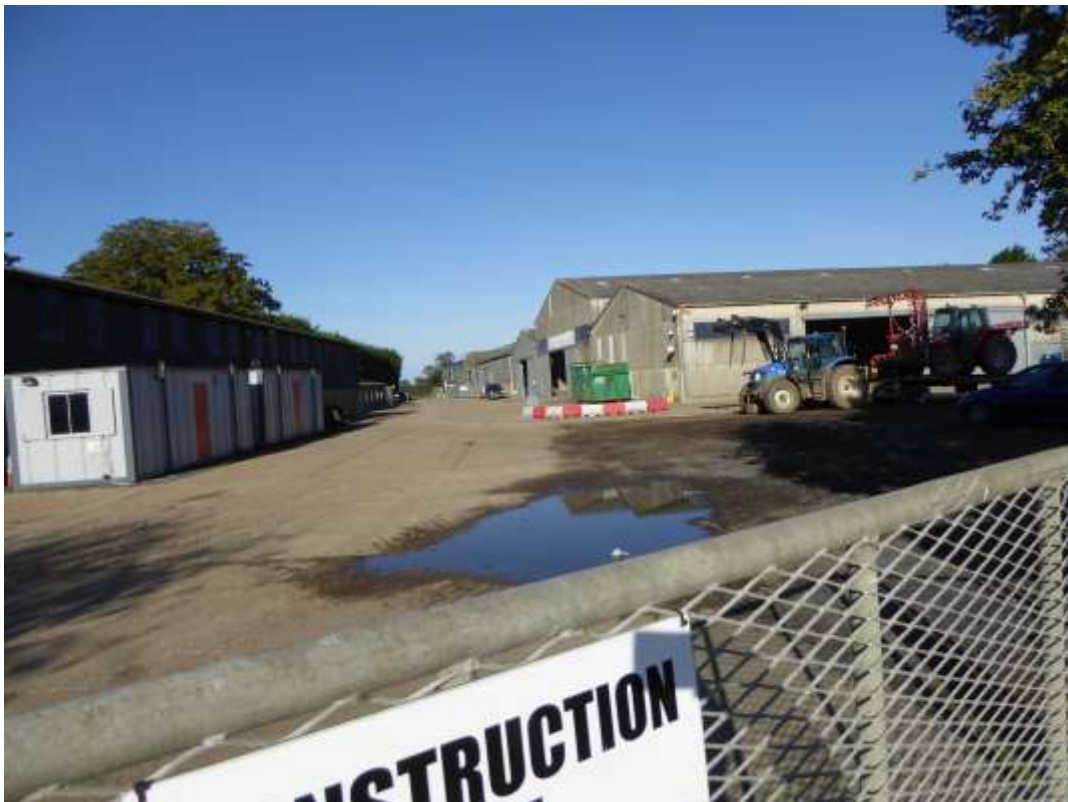
Photo 4 Large industrial site from near southern end

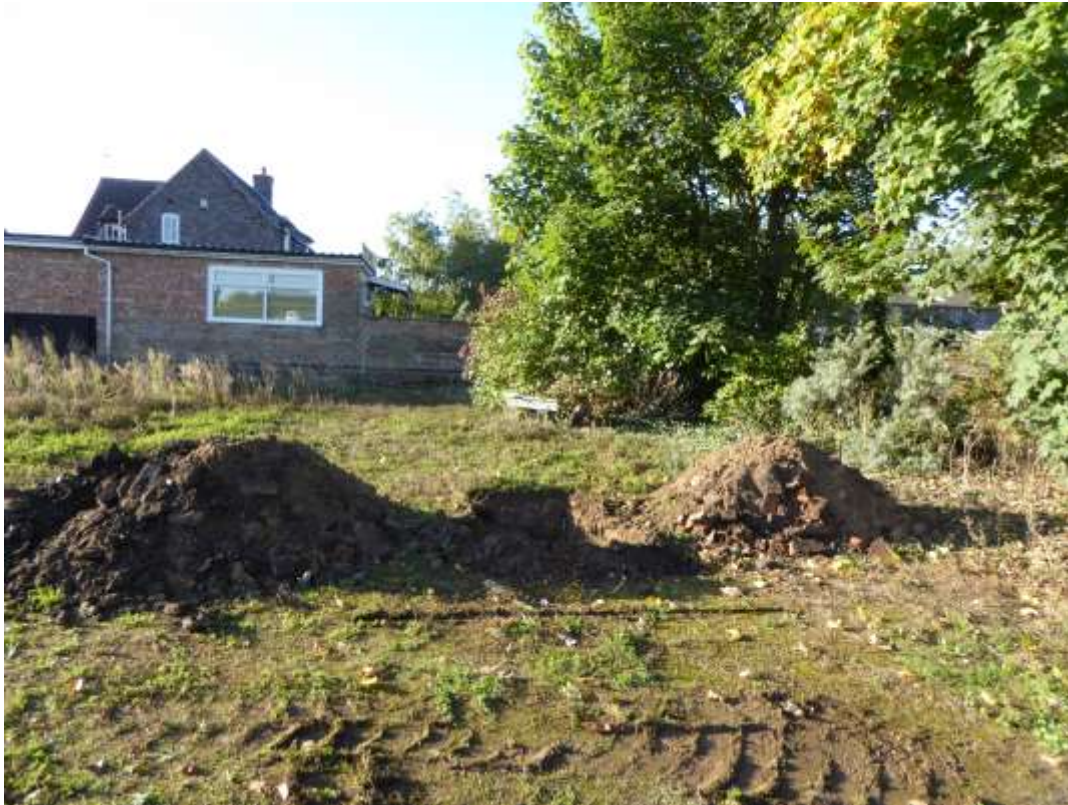
Photo 5 TP1 in southwest corner of site (Kirkgate side)

TP1 in southwest corner of site (Kirkgate side) (photo 5)

| Depth | Description of ground |
|---|---|
| 0 – 0.4 m | Soil, bricks (whole and fragments), stones and thin layer of gravel on top |
| 0.4 – 0.95 m | Light brown silty sand with sandstone lumps |
| 0.95 – 1.4 m | Dark brown silty clayey sand |

6.4 A very crude soakaway test was performed whilst the soil samples were being collected, in that water from three barrels holding, each holding approximately 200 litres, was tipped into TP1 and left to see how fast it would soak into the ground. After 30 minutes there was still a substantial depth of water in TP1, showing that infiltration rates into the silty clayey sand were very low.

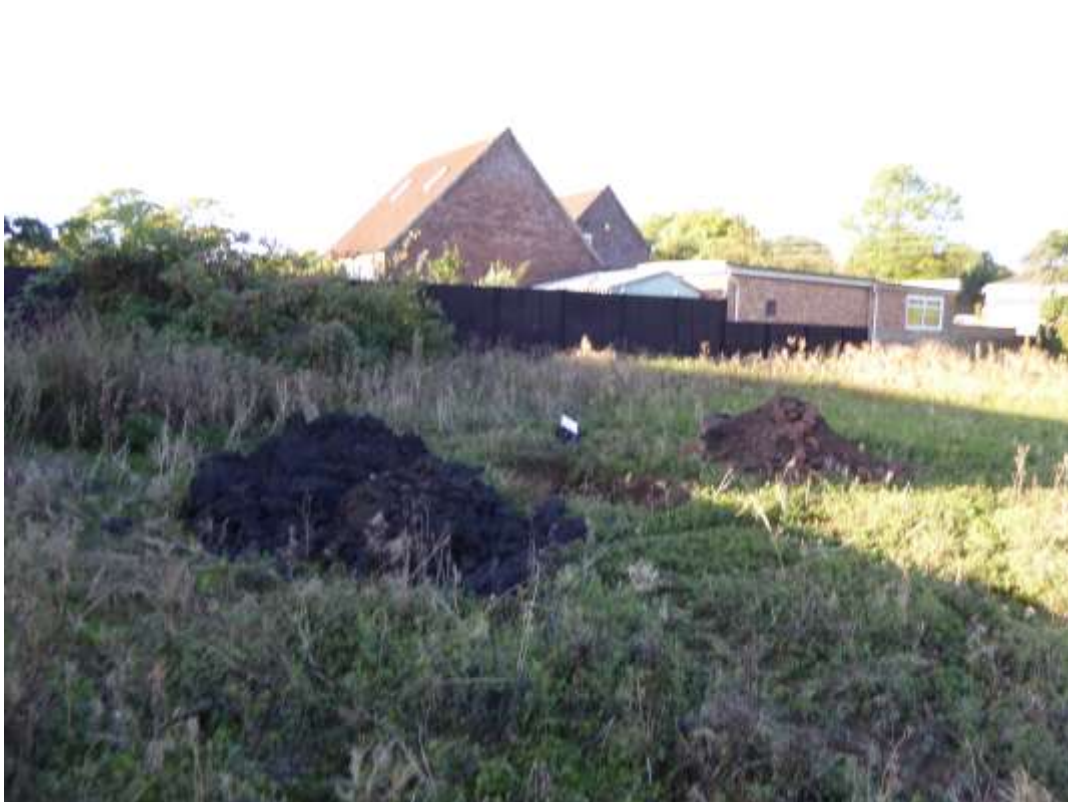
Photo 6 TP2 in southeast corner of site

TP2 in southeast corner of site (photo 6)

| Depth | Description of ground |
|---|---|
| 0 – 0.3 m | Soil, bricks (whole and fragments), stones and thin layer of gravel on top |
| 0.3 – 1.2 m | Dark brown silty clayey sand |

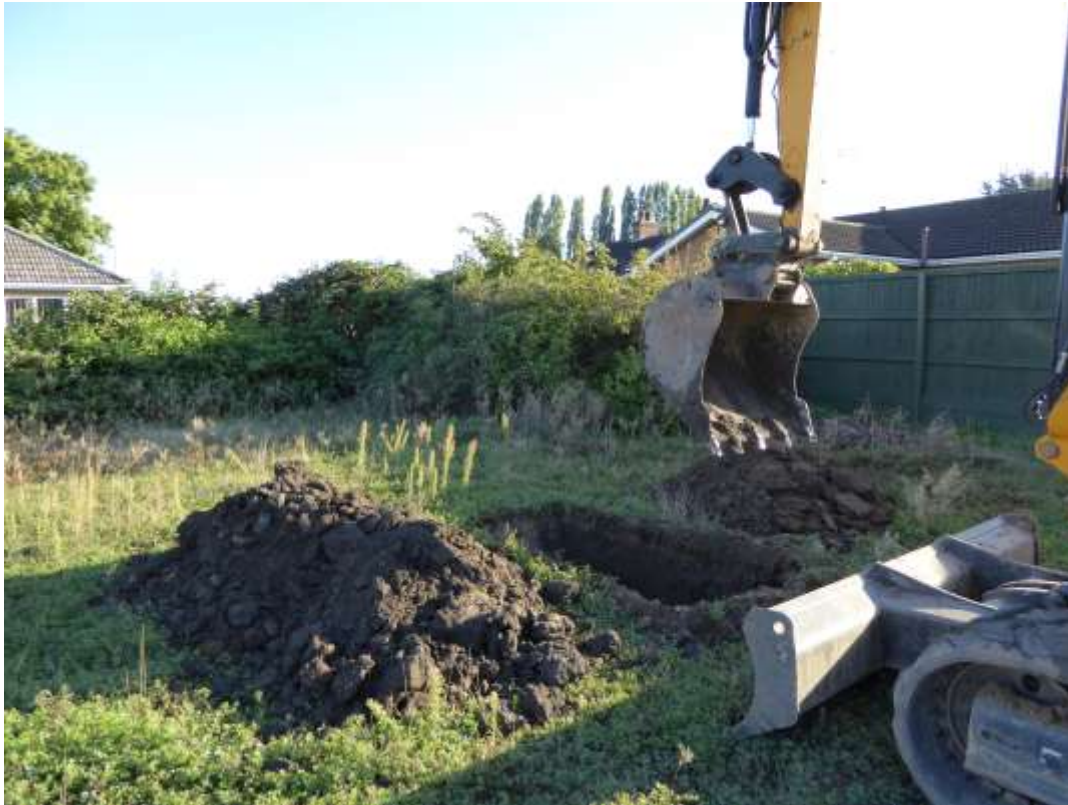
Photo 7 TP3 in northeast corner of site

TP3 in northeast corner of site (photo 7)

| Depth | Description of ground |
|---|---|
| 0 – 0.2 m | Thin layer of gravel, then light brown silty sand under |
| 0.2 – 1.0 m | Dark brown silty clayey sand |

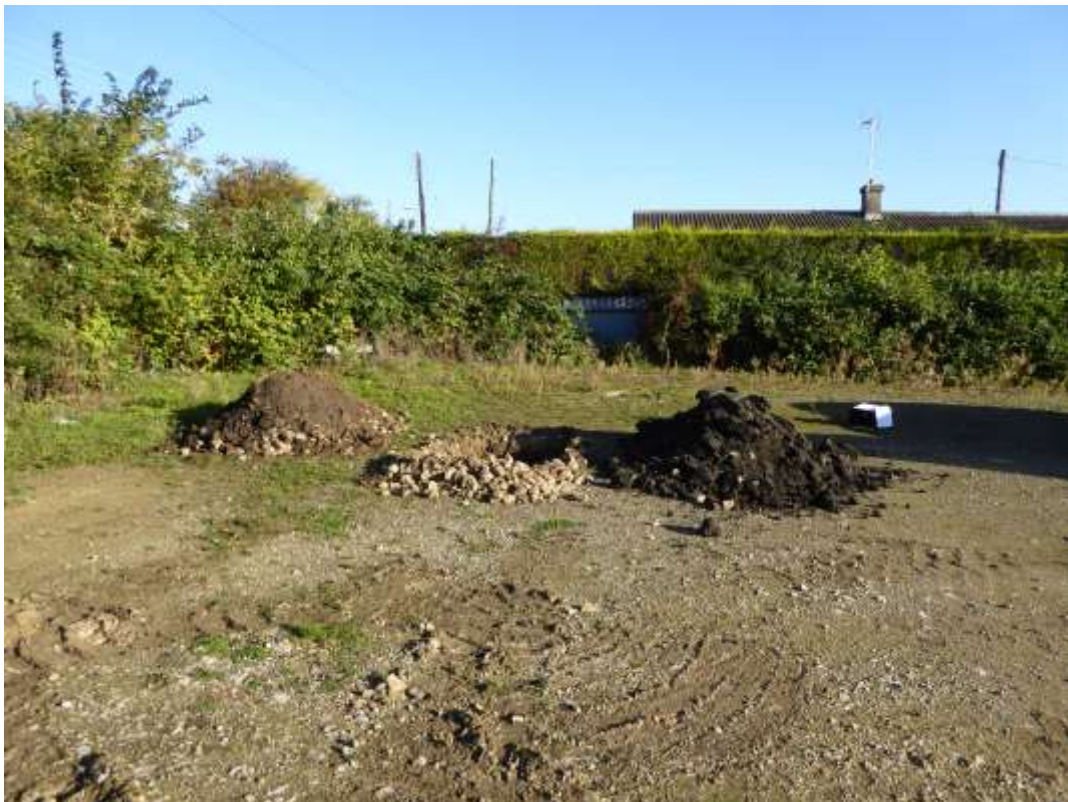
Photo 8 TP4 in northwest corner of site (Kirkgate side)

TP4 in northwest corner of site (photo 8)

| Depth | Description of ground |
|---|---|
| 0 – 0.2 m | Thin limestone hardcore top with light brown silty sand under |
| 0.2 – 1.2 m | Dark brown silty clayey sand |

7.3 The concentrations of petroleum hydrocarbon fractions were very low in sample from TP1, 2 and 3, but slightly elevated in TP4 (the two largest molecular mass fractions account for 208 mg/kg out of the total of 211 mg/kg).
