# **STUART GUY CONSULTING**

**Report number 17-09-01**

## **Environmental Risk Assessment of Cedarwood**

### **14 Churchgate, Whaplode, Spalding, PE12 6TA**

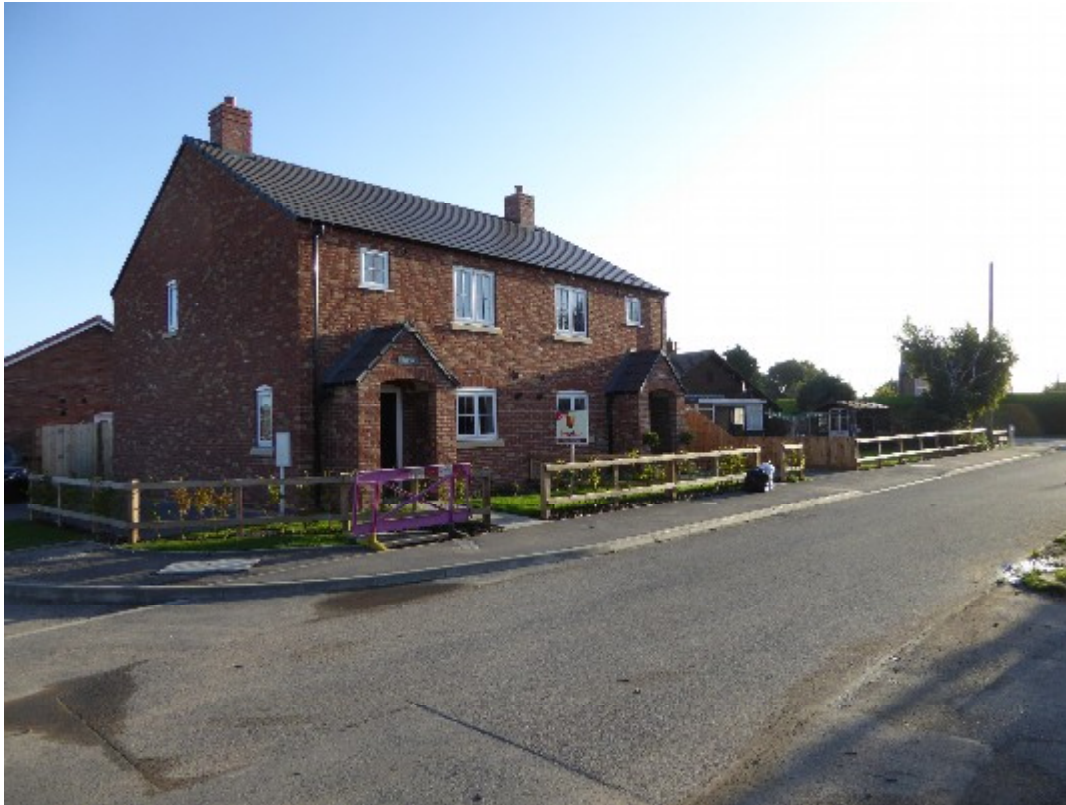
3.1 The site was visited when the weather dry and sunny. It is situated on the corner of Churchgate and Cross Street immediately adjacent to a site that is being developed on the Cross Street (photo 1). The site comprises a wooden clad building (photo 2) with a drive to the front and side and rear gardens (photo 3). The gardens were very tidy and all trees and plants were growing very strongly. The garage to the northern end appears to have cement stabilised sheeting (photo 4) that should be tested for the presence of asbestos fibre prior to their removal.

Photo 1 New semis next to Cedarwood to the right

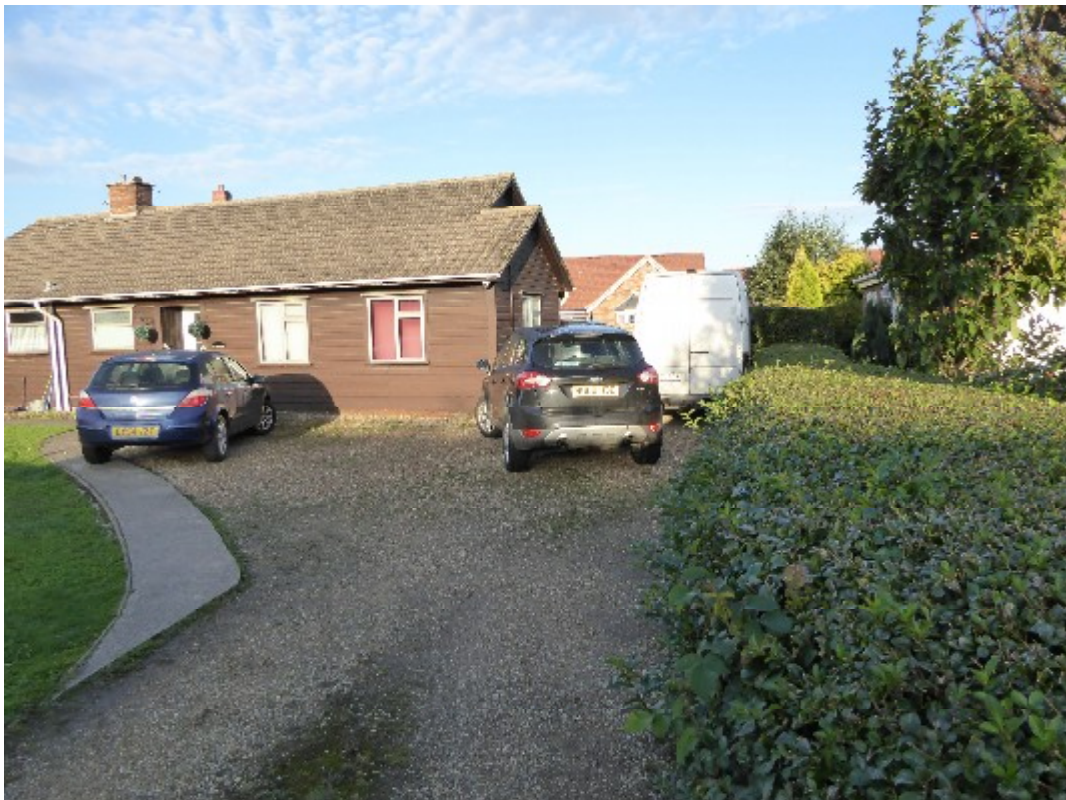
Photo 2 Cedarwood with drive on Churchgate

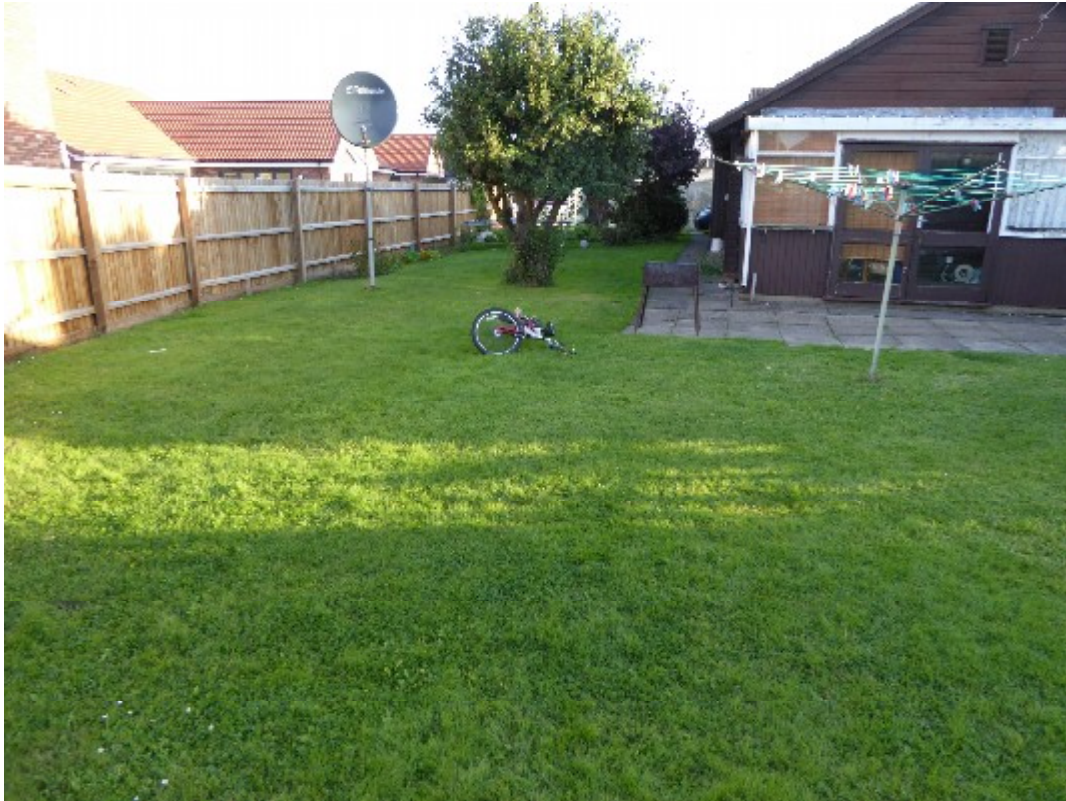
Photo 3 Side and rear gardens with new development on left

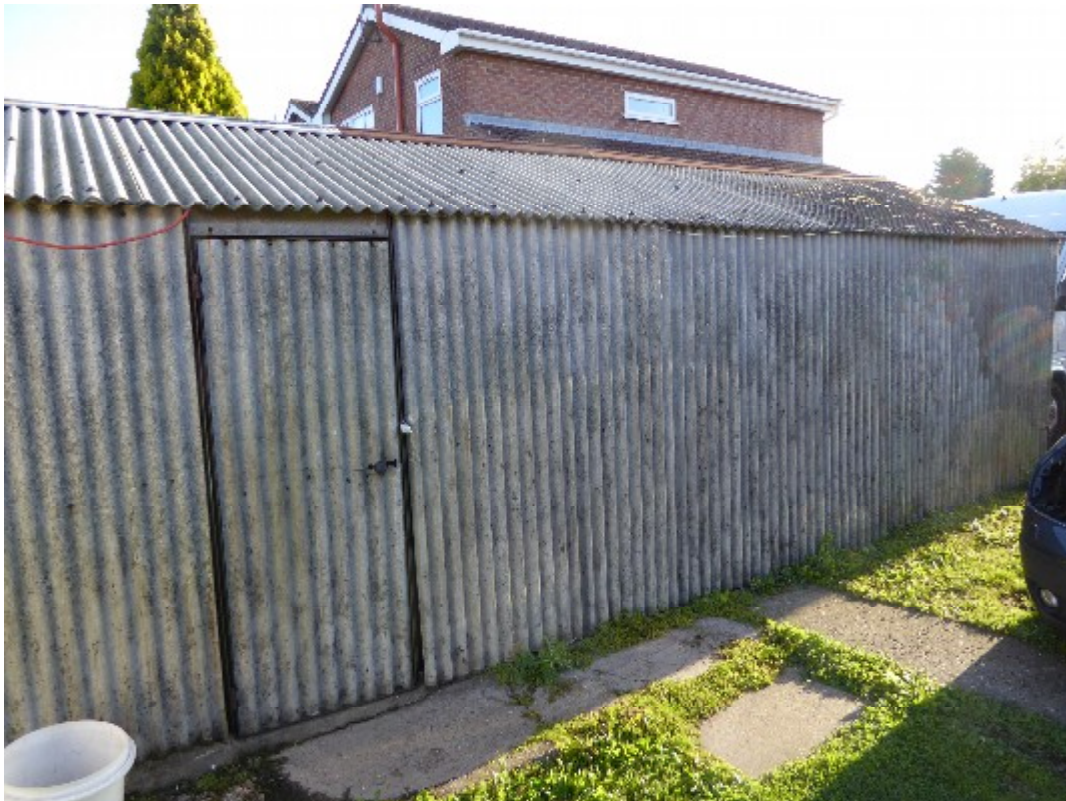
5.2 The potential cement stabilized asbestos fibres in the sheeting on the garage present a significant risk of harm to the occupiers of the developed site and analysis of samples of the sheeting should be undertaken prior to demolishing the garage. The soil in the garden may be suitable for use in the new buildings, but agreement to use that soil should be discussed with the land contamination officer.

Photo 4 Cement stabilized fibre panels on garage at Cedarwood

6.2 Cement stabilized fibrous sheeting was identified on the garage in this development. Prior to removing this type of sheeting samples should be taken and analysed for the presence of asbestos fibres and if found the sheeting should be removed by a competent operator.

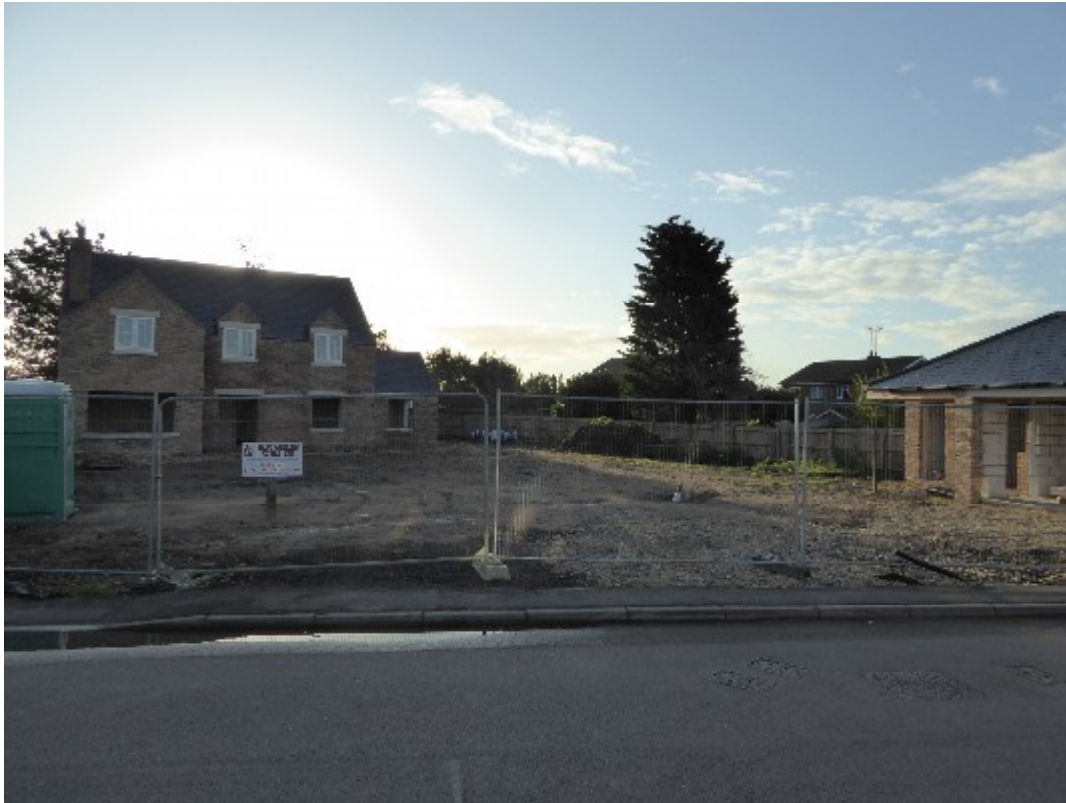
3.2 A walk along Churchgate to the north found well-established houses with healthy looking trees and plants in all the gardens and one new construction that was directly onto the so-designated landfill site known as the 'Piggery' (photos 5 & 6). The map of 1888 on pages 28 and 29 of the Goldfinch desk study shows the middle of the site was called The Broads and appeared to be a body of water. There is no trace of this water on the new build site or on Middle Road on the southern perimeter of Piggery landfill. Off Middle Road were a couple of quite old buildings (photo 7) which corresponded to those on the 1888 map.

Photo 5 New construction just behind J R Cycles on High Road

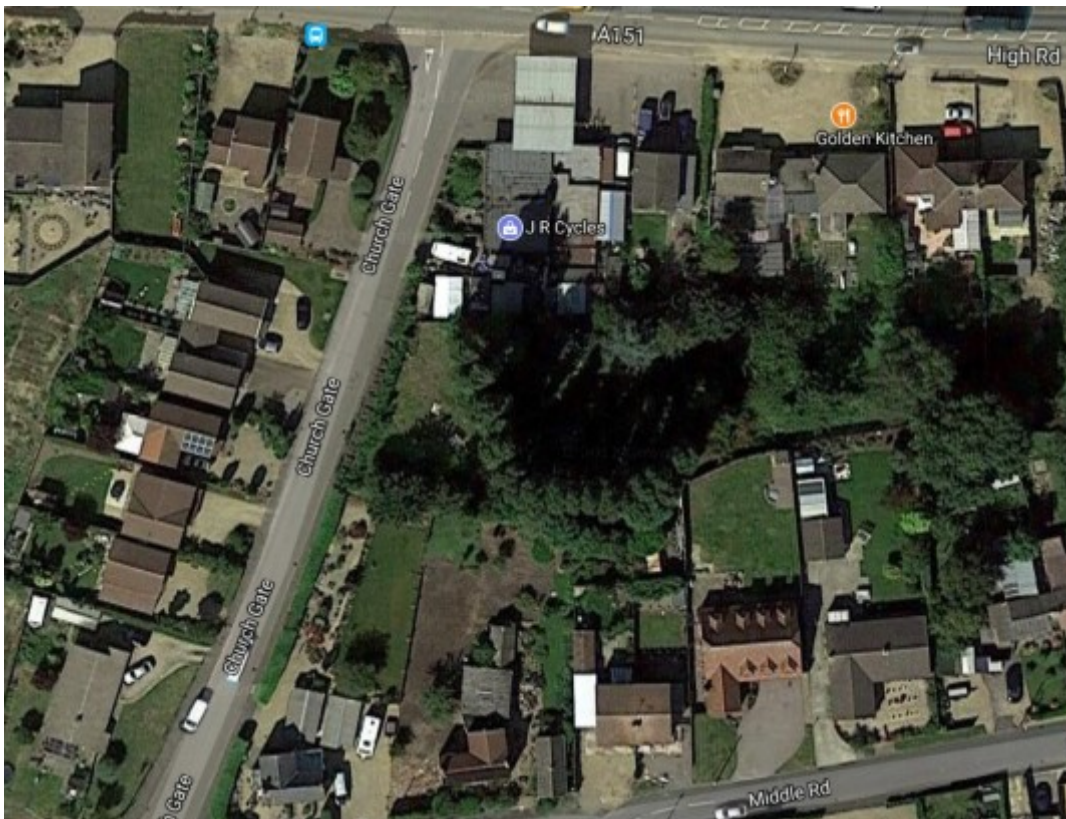
Photo 6 Google satellite image showing site of new build south of J R Cycles

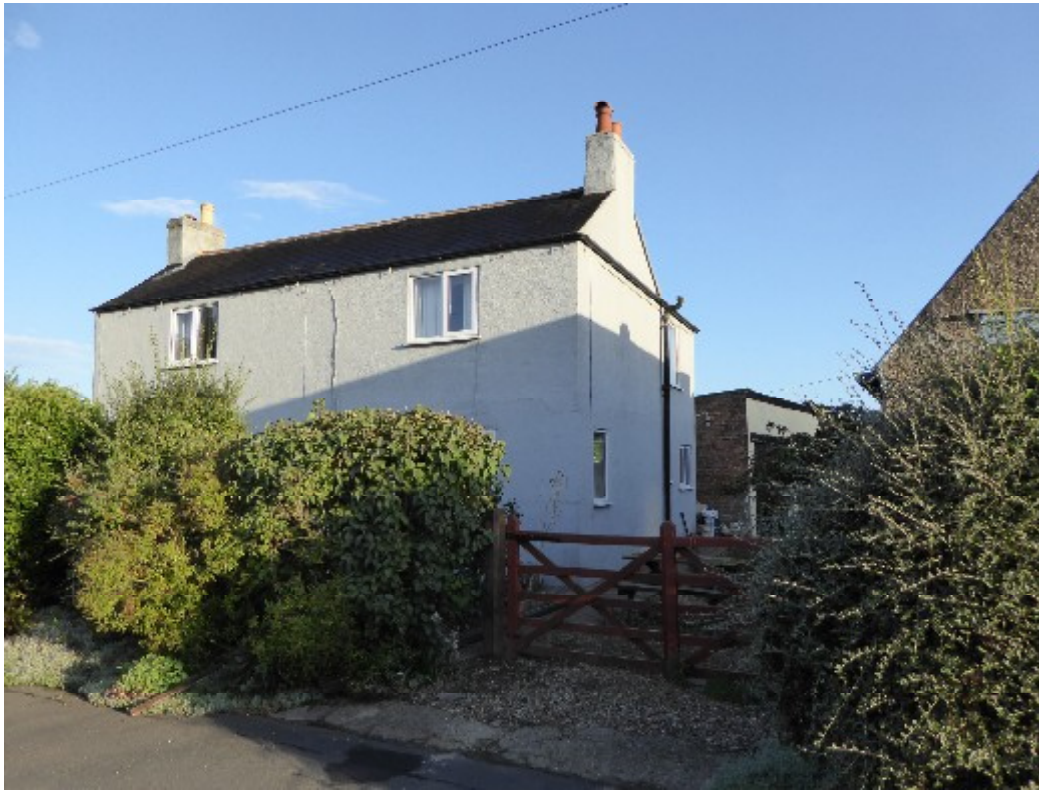
Photo 7 Old building on Middle Road corresponding to one on 1888 map

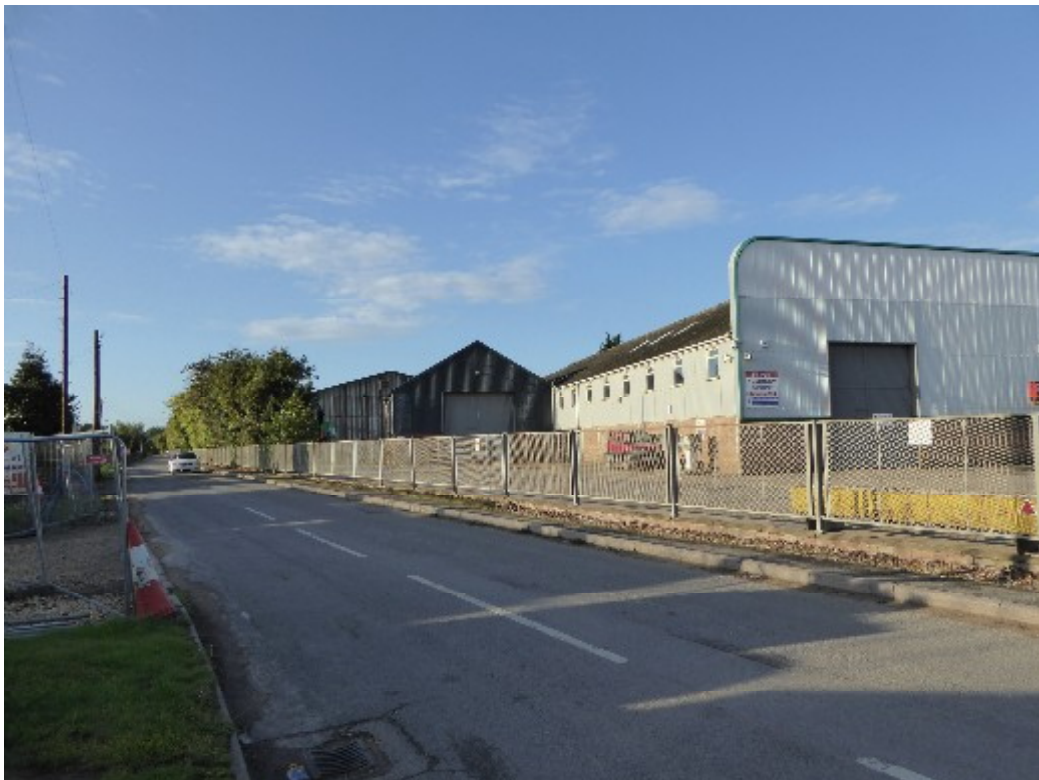
3.3 A walk along High Road from Malten Lane to Kirkgate passed by the former small fuel filling facility that is still in operation as a cycle shop. There was no sign of the fuel tank and the site appeared to be very clean and tidy. The former factory in Kirkgate (photo 8) appears to be multi use with various businesses using the site. The factory is very clean and does not appear to have any significantly contaminating uses.

Photo 8 Factory in Kirkgate with apparently multiple business users
