STRUCTURAL APPRAISAL REPORT

Existing Telephone Exchange Building;-

Common Road,
Whaplode Drove,
Spalding,
Lincolnshire.
PE12 0UF

Our Ref;- JC/25/12/8380

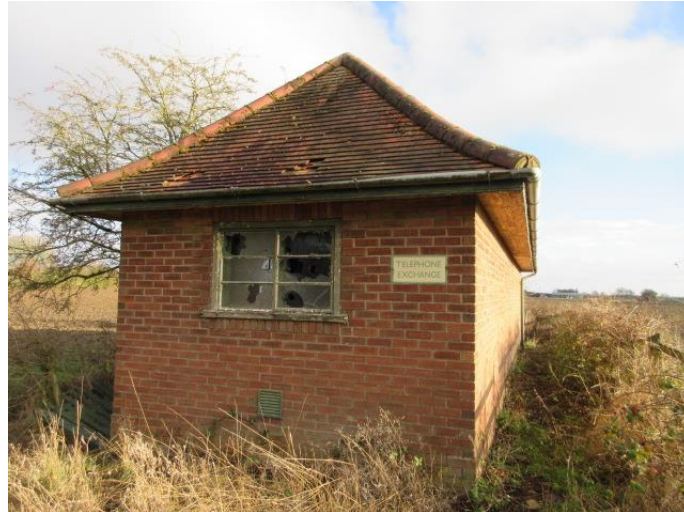
Photograph # 1 (Front – West facing elevation)

This elevation contained a centrally located window opening. The wall panel was free from any major defects. No significant cracking noted externally or when viewed internally. No evidence of any bulging masonry or lateral movement to the panel noted.

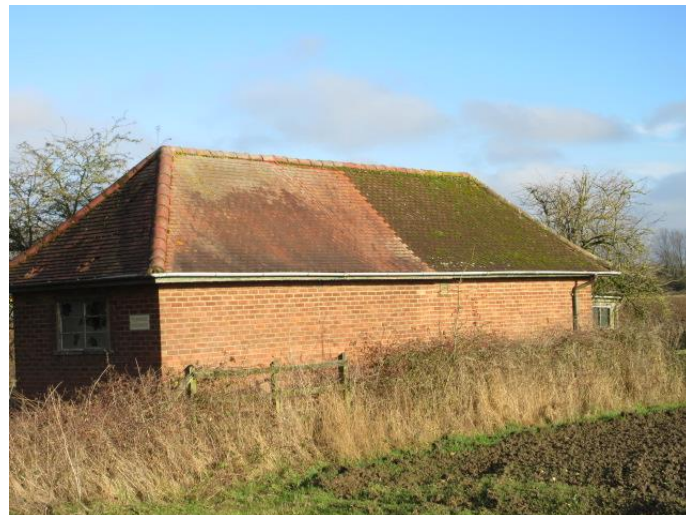
Photograph # 2 (Side – South facing elevation)

This elevation is a continuous full-length panel of approximate 12m length, with no openings present. No evidence of any bulging masonry or lateral movement to the panel noted.

When viewed along the bed joints of this elevation there was a slight downward slope towards the East facing end of the building. Estimates suggest that the East end of the building may have settled in the order of 20-30mm.

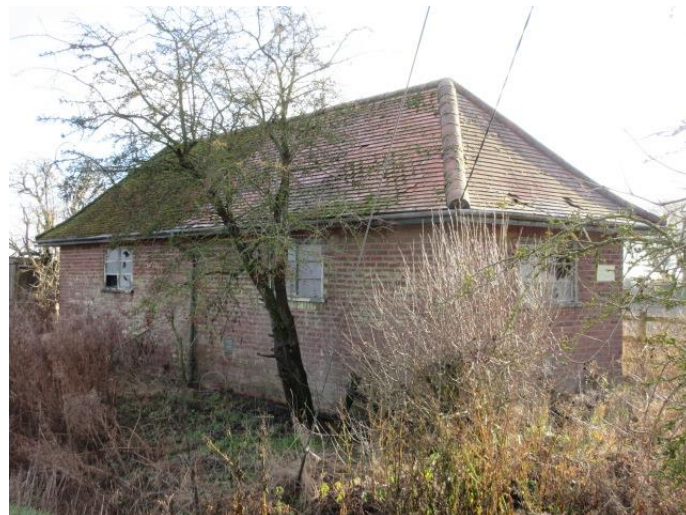
Photograph # 3 (Side – North facing elevation)
(

This elevation is a continuous full-length panel of approximate 12m length, with two window openings present. No evidence of any bulging masonry or lateral movement to the panel noted. Similar to the South facing elevation, there was a slight downward slope towards the East facing end of the building. No significant cracking was noted at the mid point of this elevation, however cracks were noted below and above the two window openings. Externally the cracks travelled vertically from dpc level to sill level, and above the window at lintel bearing location. The width of the cracks was estimated at 3 - 4mm. Internally the cracking was reflective within the inner leaf blocks, albeit the crack was located adjacent to the window reveal. Internally the widths of the cracks were estimated at 8 – 9mm worse case, with others being in the order of hairline to 3 – 4mm in width.

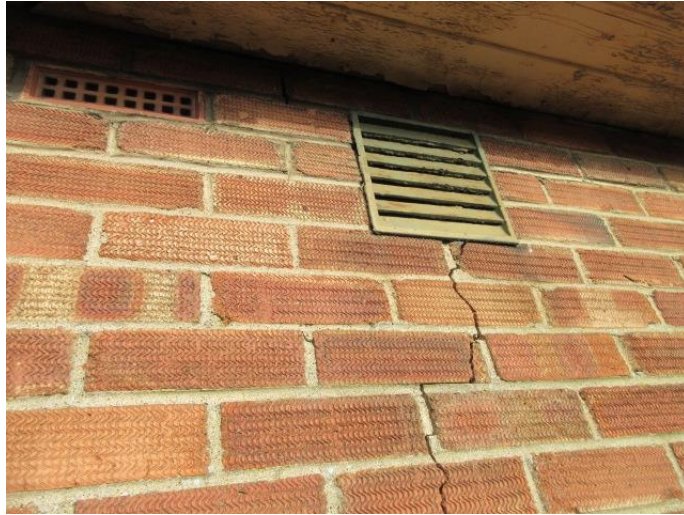
This movement is reflected at the 'hinge' point, whereby some localised vertical cracks in both the outer leaf and inner leaf were noted at approximately midpoint of the long elevation panel. Externally the crack travelled vertically from dpc level to eaves level, slightly tapering at its upper levels. The current width of the crack was estimated at a maximum of 3 - 4mm, although there was evidence of previous repointing to the fracture. Internally the cracking was reflective within the inner leaf blocks, with similar crack widths apparent. Further comparable cracks was present elsewhere within the inner leaf to this panel.

Photograph # 7 (Side – South facing elevation – Crack - high level)

- 5.6 Following the removal of the tree and replacement of the drainage systems, the performance of all walls can be improved by low key crack stitching using the 'Helifix' masonry repair system, which involves installing remedial 'Heli-bar' rods into the bed joint of the masonry at regular vertical centres over any open cracks. This can be conducted both externally and internally.

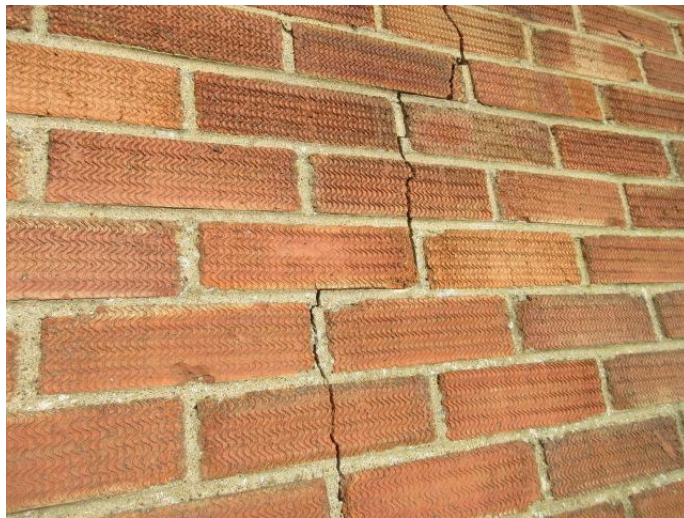
Photograph # 8 (Side – South facing elevation – Crack – mid height level)

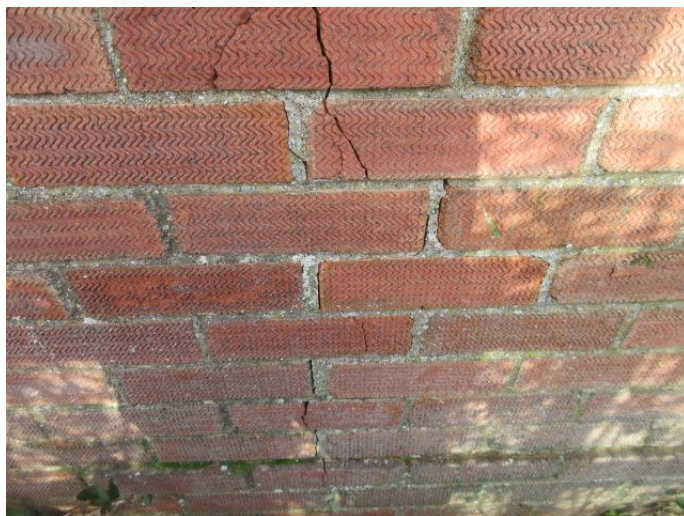
Photograph # 9 (Side – South facing elevation – Crack - low level)

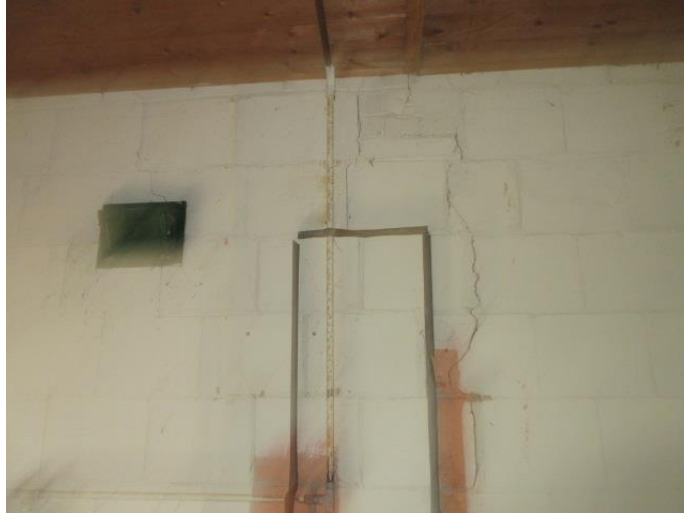
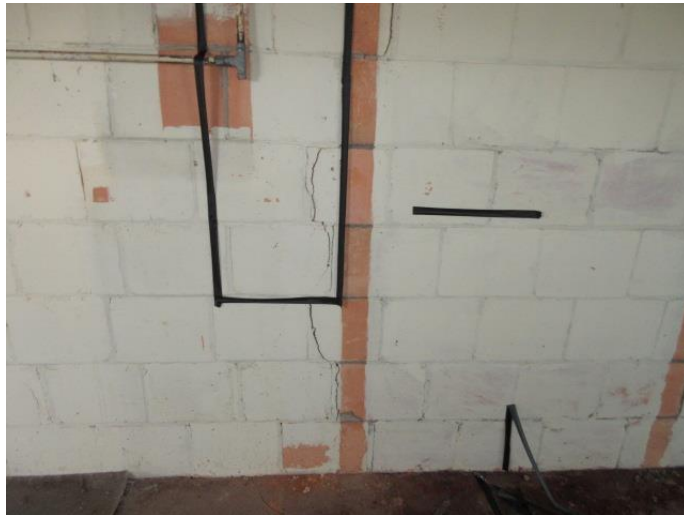
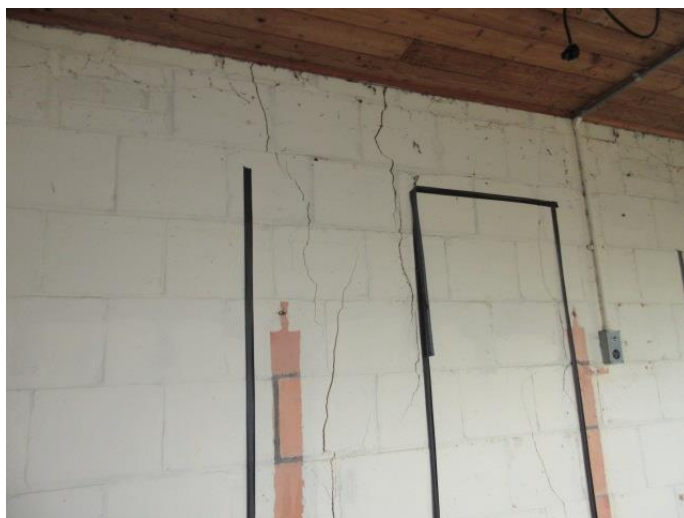
Photograph # 10 (Typical Internal – Side – South facing elevation)

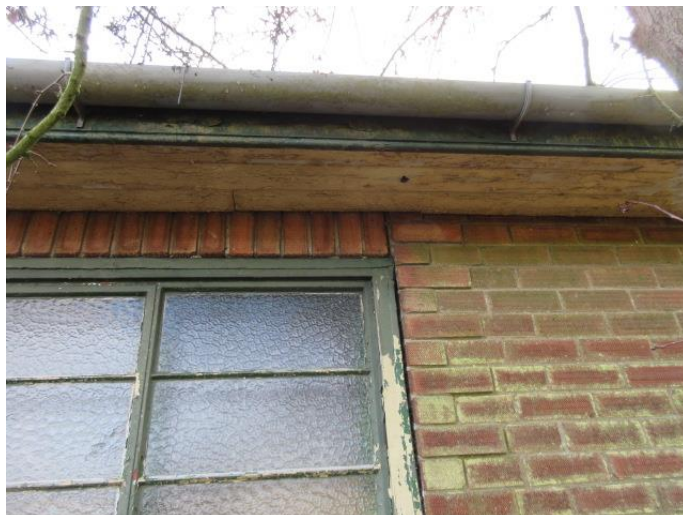
- 4.2 A tree, species unknown, with an estimated height of 5 – 6 metres is growing immediately adjacent to the North facing side elevation. The location of the tree coincides with the area of cracking that is deemed most severe within the masonry panel, which is located adjacent to the right-hand side window opening.

The close proximity of the tree noted will undoubtedly contributed to the movement observed in this panel and its removal should be undertaken as soon as possible.

Photograph # 13 (Side – North facing elevation – Adjacent Tree – Crack - high level - above window)

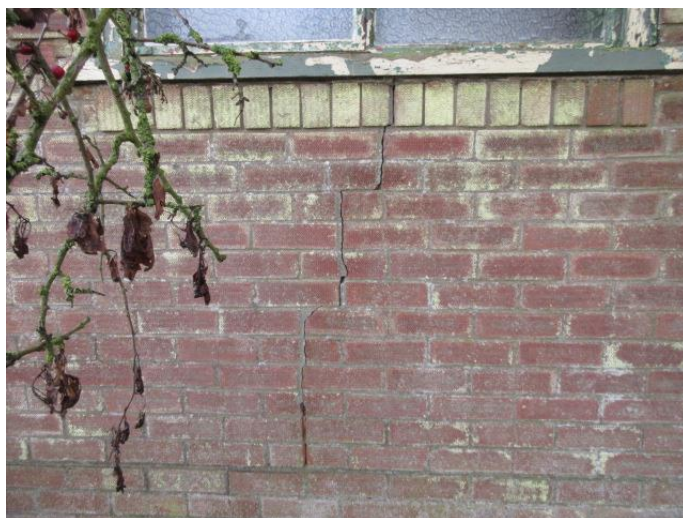
Photograph # 14 (Side – North facing elevation – Adjacent Tree – Crack - mid level - below window)

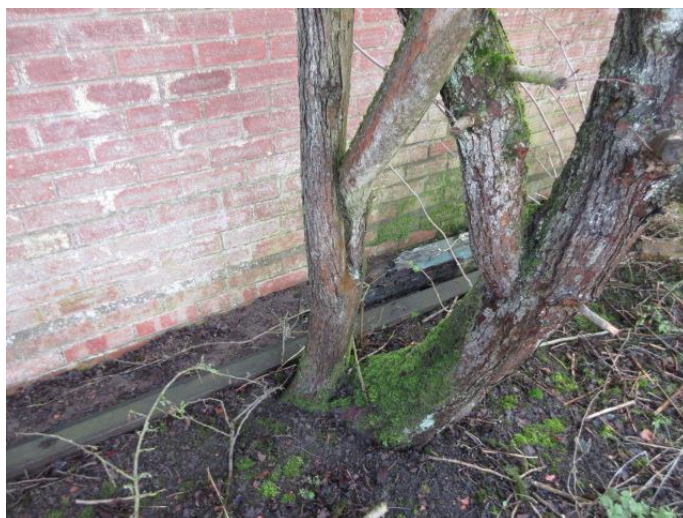
Photograph # 15 (Side – North facing elevation – Adjacent Tree – low level)

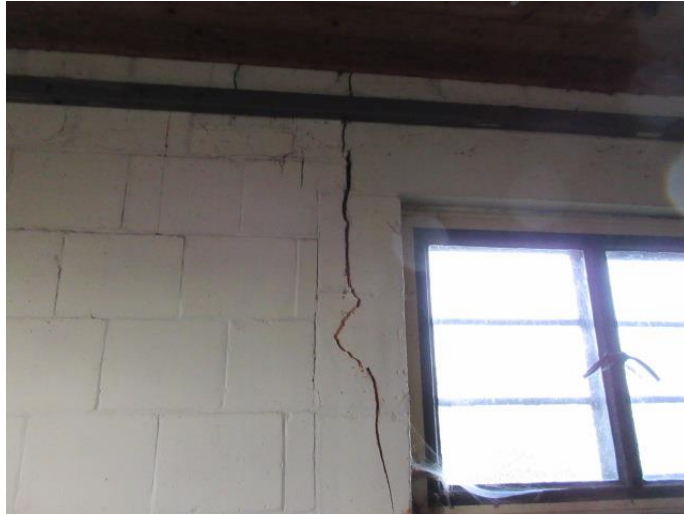
Photograph # 16 (Typical Internal – Side – North facing elevation – Adjacent Tree – Crack - high level - adj window)

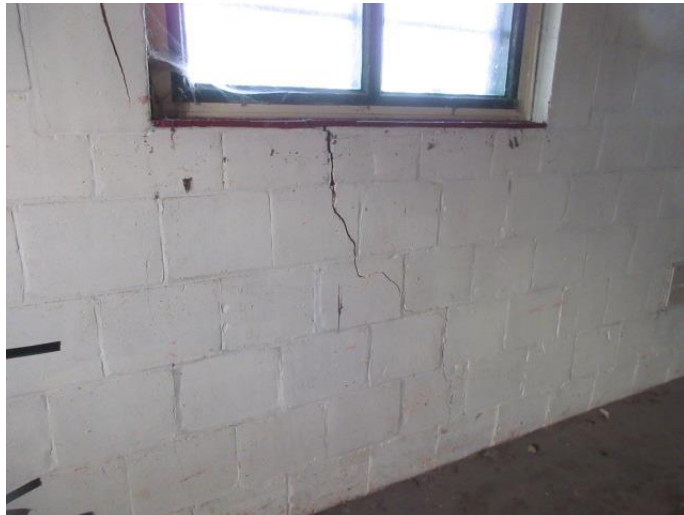
Photograph # 17 (Typical Internal – Side – North facing elevation – Adjacent Tree – Crack - mid level - below window)

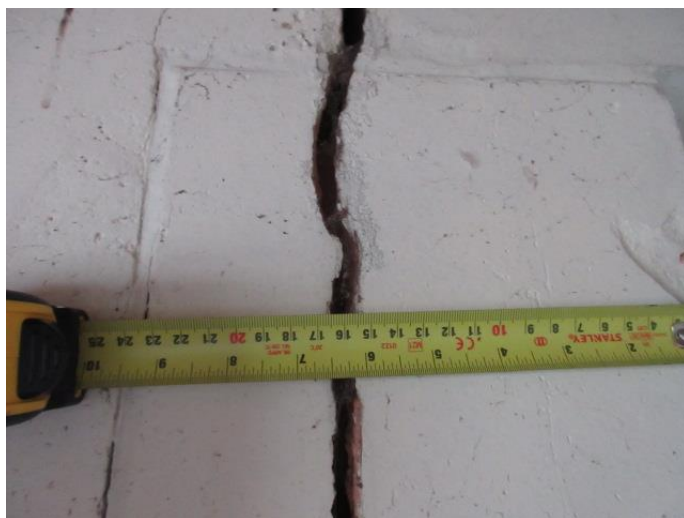
Photograph # 18 (Typical Internal – Side – North facing elevation – Adjacent Tree – Crack - high level - adjacent window)

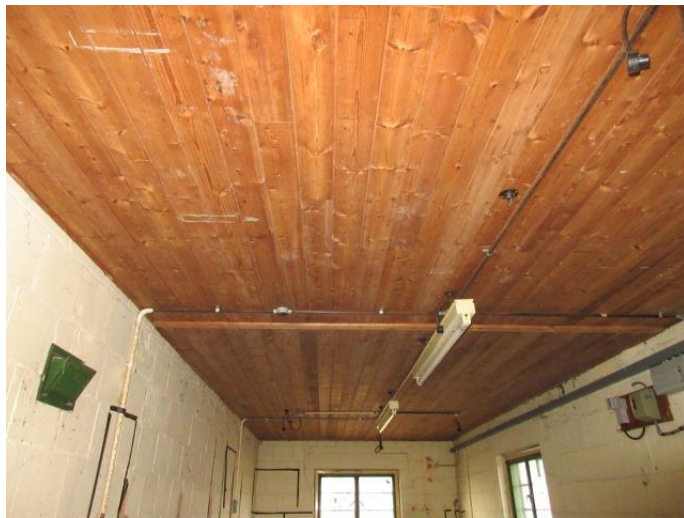
- 4.3 Internally, the existing duo pitched, hip ended roof structure could not be inspected as close boarding ceiling finishes are present with no access hatch available. Based on observations made externally, the roof appears to be structurally stable but may need localised attention / repair during any conversion process. There was some dishing to the roof slope noted within the rosemary tile roof finish, and some minor ridge sag along its length suggesting that some timbers may need replacing or strengthening and allowance should be made for this.

Photograph # 20 (Typical Internal - Underside of Ceiling)

- 5.7 Based on observations made externally, the roof appears to be structurally stable but may need localised attention / repair during any conversion process. Following opening up works some timbers may need replacing or strengthening and allowance during any conversion should be made for this. Whilst reference to damp is outside the scope of this report it is possible that the roof structure has suffered from a degree of water penetration over the years. As such it is essential that advice and any required treatment from specialists in the field of damp and decay should be carried out in conjunction with the conversion, in order to ensure that damp and timber decay are not trapped within the fabric post completion.

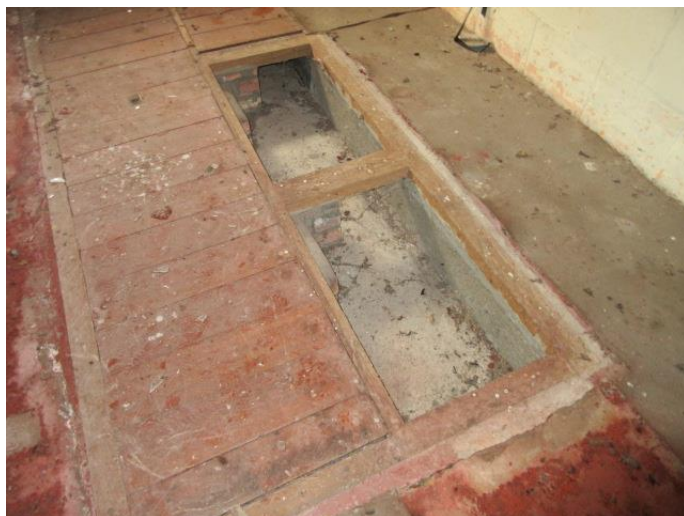
- 4.4 The floor slab appeared reasonably level, and had little evidence of major fractures to those areas that were not covered by finishes. The former recessed pits, presumably originally housing equipment and ducting remained present.

Photograph # 21 (Typical Internal – slab with former recess / pits still present)
