Hither Hold Farm, Further Old Gate  
Screening Assessment Photographs  
31.05.2022

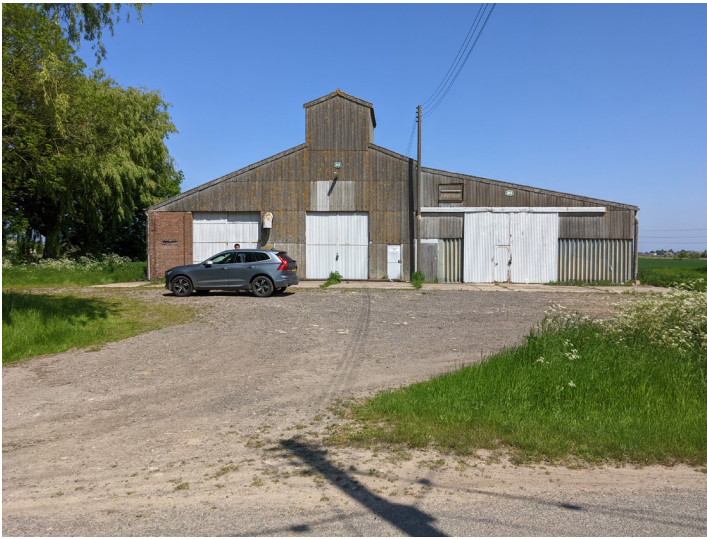
1.  
View of front of grain store as seen from Further Old Gate, showing hardcore access track and vegetation along the road either side.

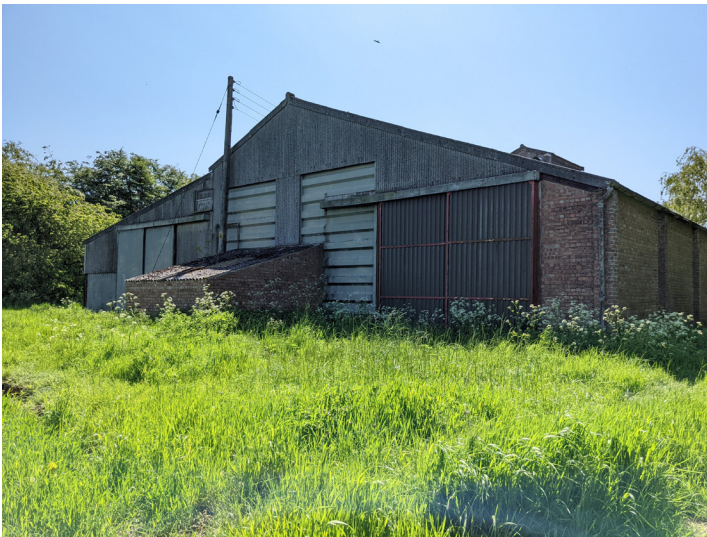
2.  
View of rear of grain store facing the fields to the north, showing self seeded grass meadow vegetation. Tree cluster visible on the left is on adjacent land. Brick wall forming the west wall of the grain store visible on the right hand side, with brick pier structure on the outside suggesting that any earlier structures faced 'inwards' and were therefore contained within the footprint of the grain store. No other footings, slabs or rubble are present elsewhere on the site.

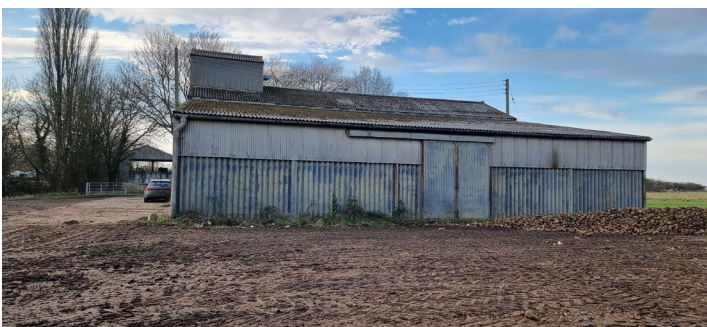
3.  
View of grain store from the west showing the ground in agricultural use after the winter season.

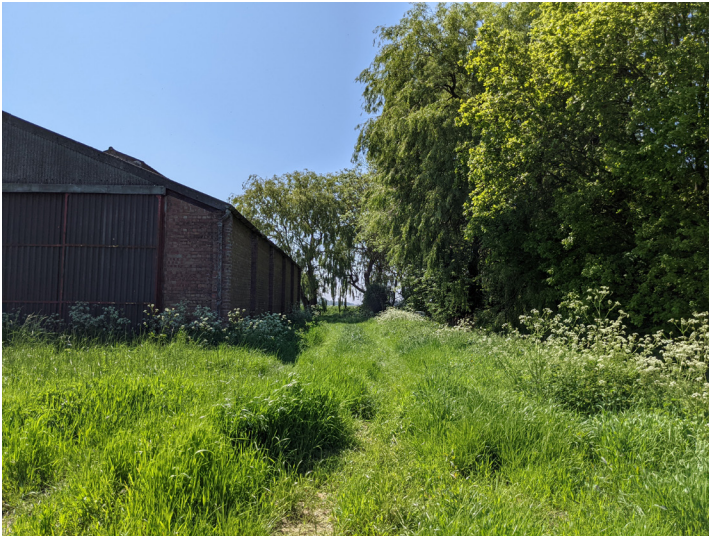
4.  
View to the side of the grain store looking south. Private drain runs along the right hand side, with tree clump on adjacent land to the other side of the drain formed of willow, oak and ash trees. Grassland meadow vegetation typical to the Lincolnshire agricultural lowlands seen in the foreground. Vegetation is consistent throughout the site and surrounding land, and is in good condition with no signs of distress or dieback.

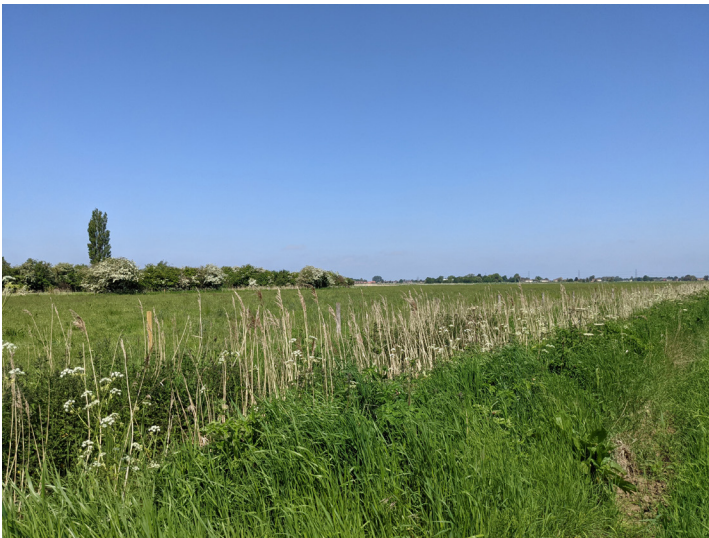
5.  
View of drain running to the west of the site, with meadow grassland verges typical of the area.

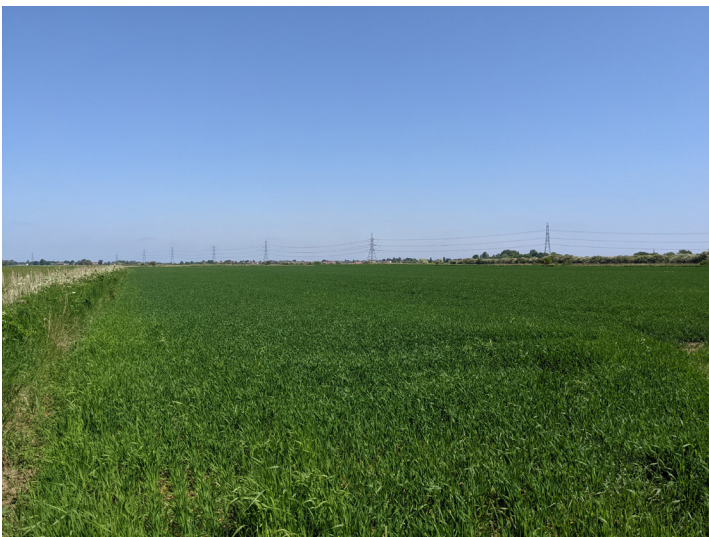
6.  
View of fields to the north of the grain store.

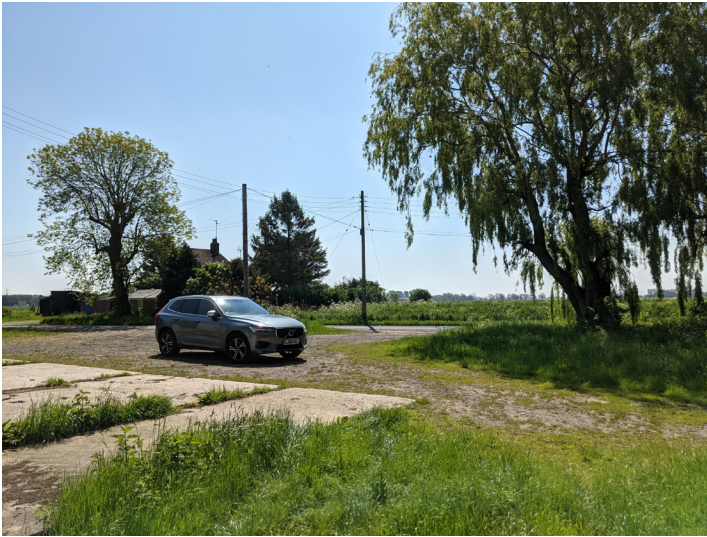
7.  
View of hardstanding to the front of the grain store, showing concrete formed of 4 slabs in good condition and clear of staining or cracks. Adjacent residential property visible beyond.

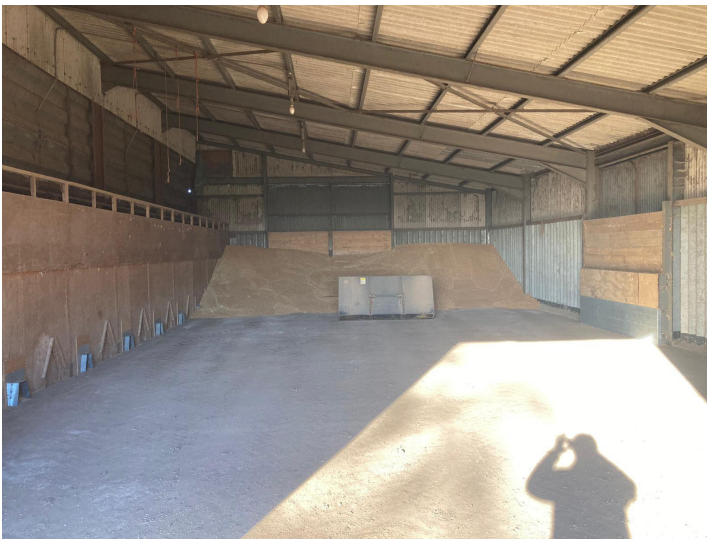
8.  
Interior of grain store showing structure in good condition, clean and clear of any signs of contamination, spillages or chemical attack.
