# ANTHONY-JOHNSON

Carter's Farm,  
Oxcroft Bank,  
Shepeau Stow,  
Spalding, Lincs.  
PE12 0TY

The visual survey of four existing structures, previously employed as Barn structures on a farm. The purpose of this survey is to consider three of the structures with a view to conversion to residential use and review the retention and use of existing structural elements.

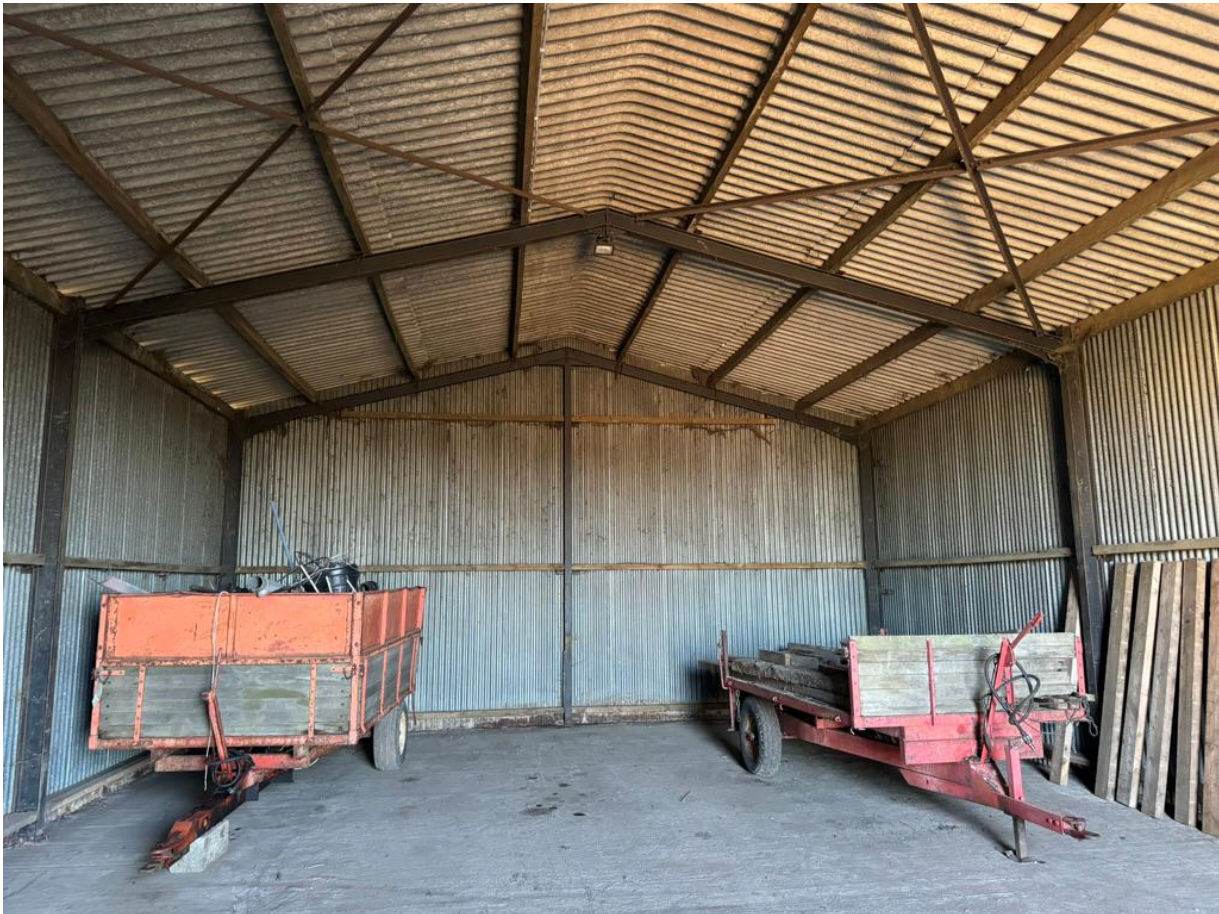
Image 1.0: Internal view of Barn

Portal frames provide support to timber purlins, which span between adjacent steel frames, in turn proffering support to the external steel corrugated cladding.

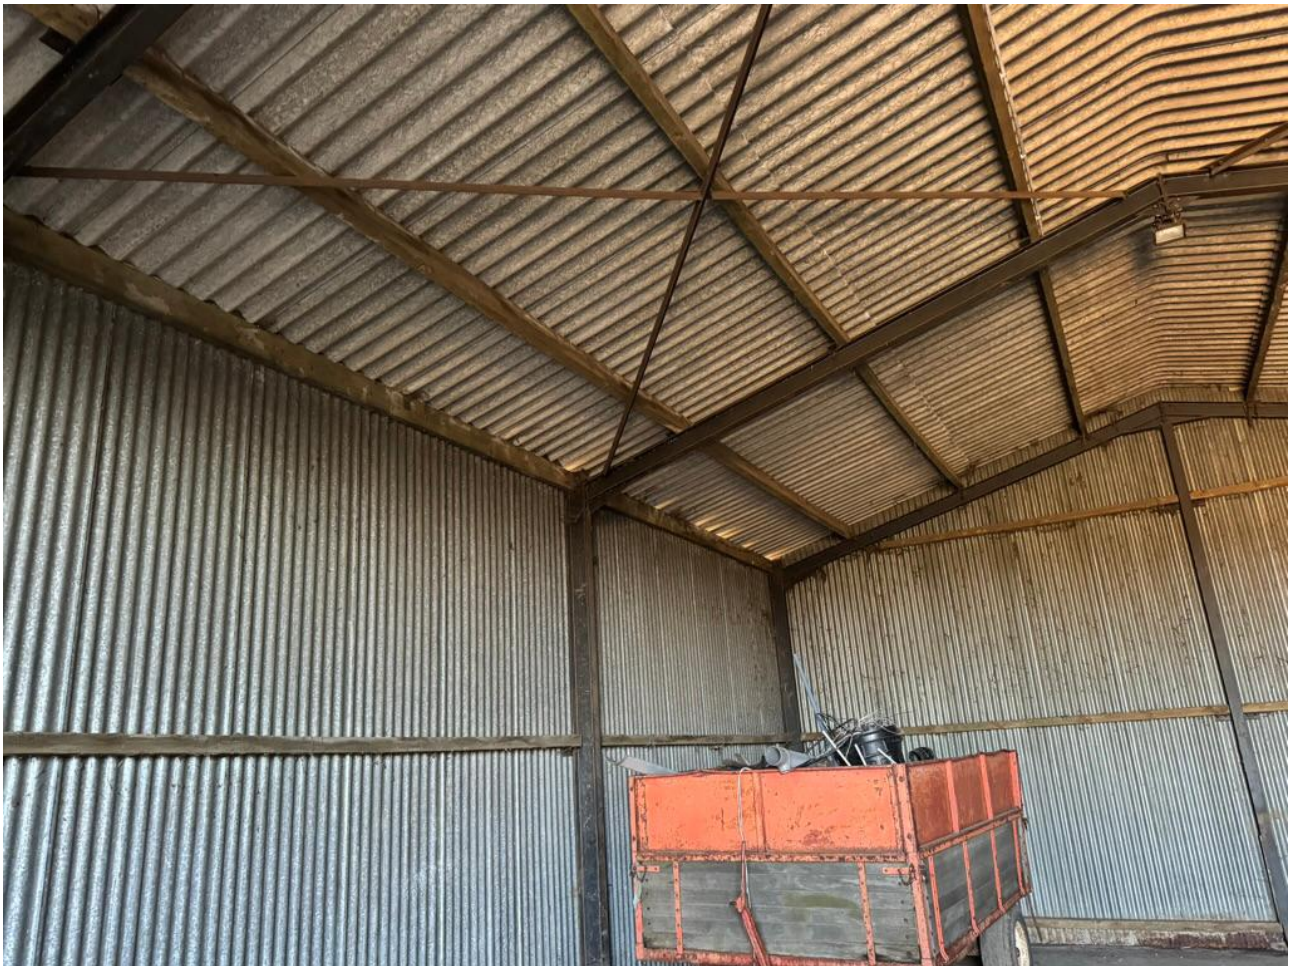
Sway perpendicular to the portal frames is resisted by circular hollow sections, forming crossed tubular bracing, set in the depth of the Portal frame rafters. The bracing transfers loads in tension into the eaves of the building, at the confluence of rafters and columns. Loads are then carried in shear in the external cladding of the building. Conversely, the portal frames carry sway due to wind loading in moment resisting connections, formed at eaves and apex.

Image 2.0: View of cross bracing, removing longitudinal sway due to wind loading

The superstructure appears to be visually intact. Cladding does not exhibit defects and sections are not missing. Cladding was noted as having been finished with a zinc coating,

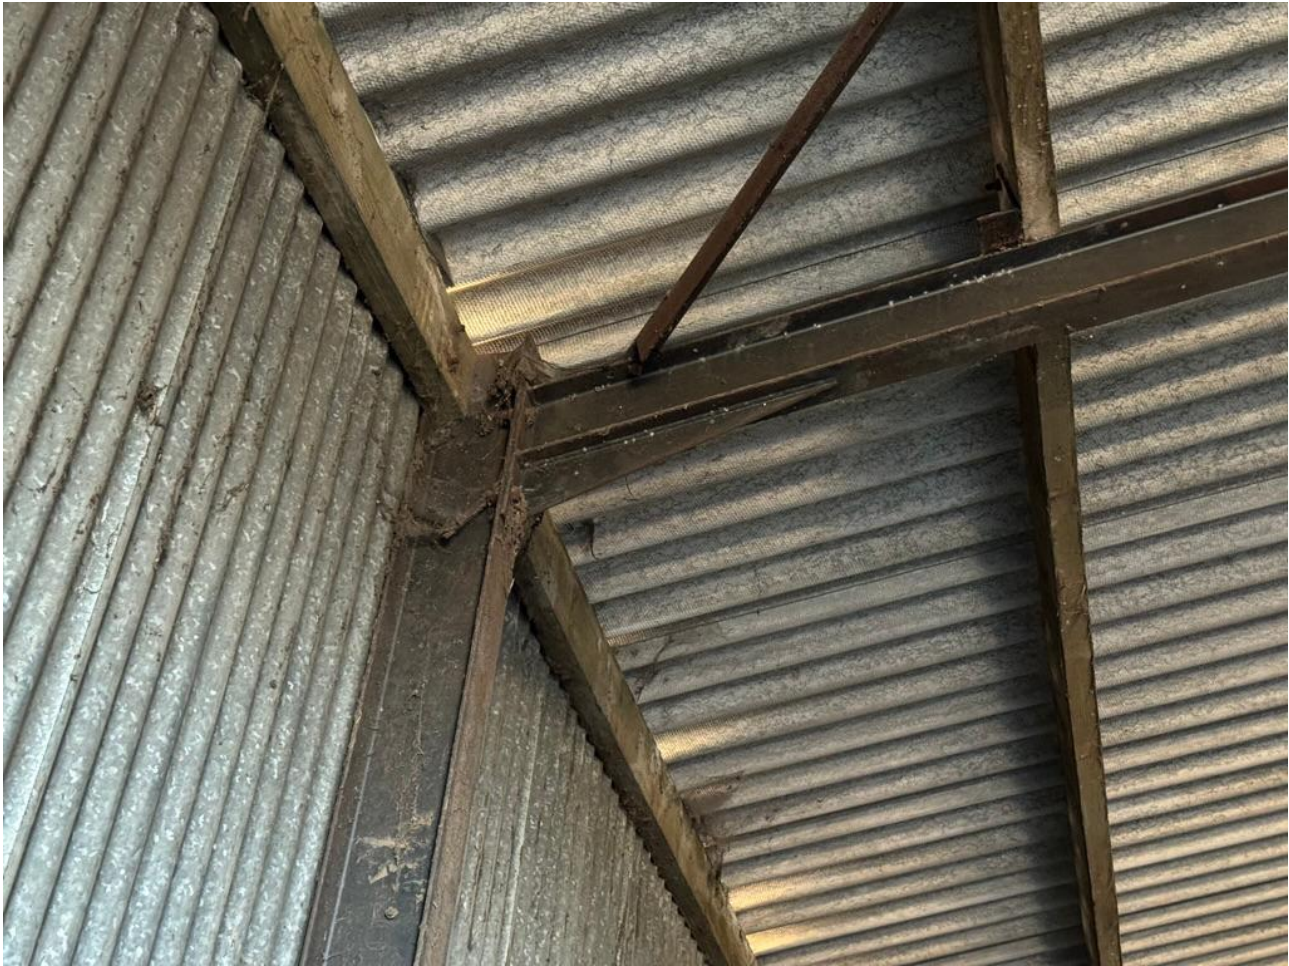
Purlins were found to run with no significant deviation within their span, reflecting elements that have been suitably spaced and are not overloaded. Purlins have been affixed to the head of steel portal frame beams, providing restraint to the compression flanges of the beams, preventing the development of lateral torsional buckling.

Image 3.0: Hunch connection between column and beam, fixing between CHS brace and beam and cleated purlin running to head of rafter.

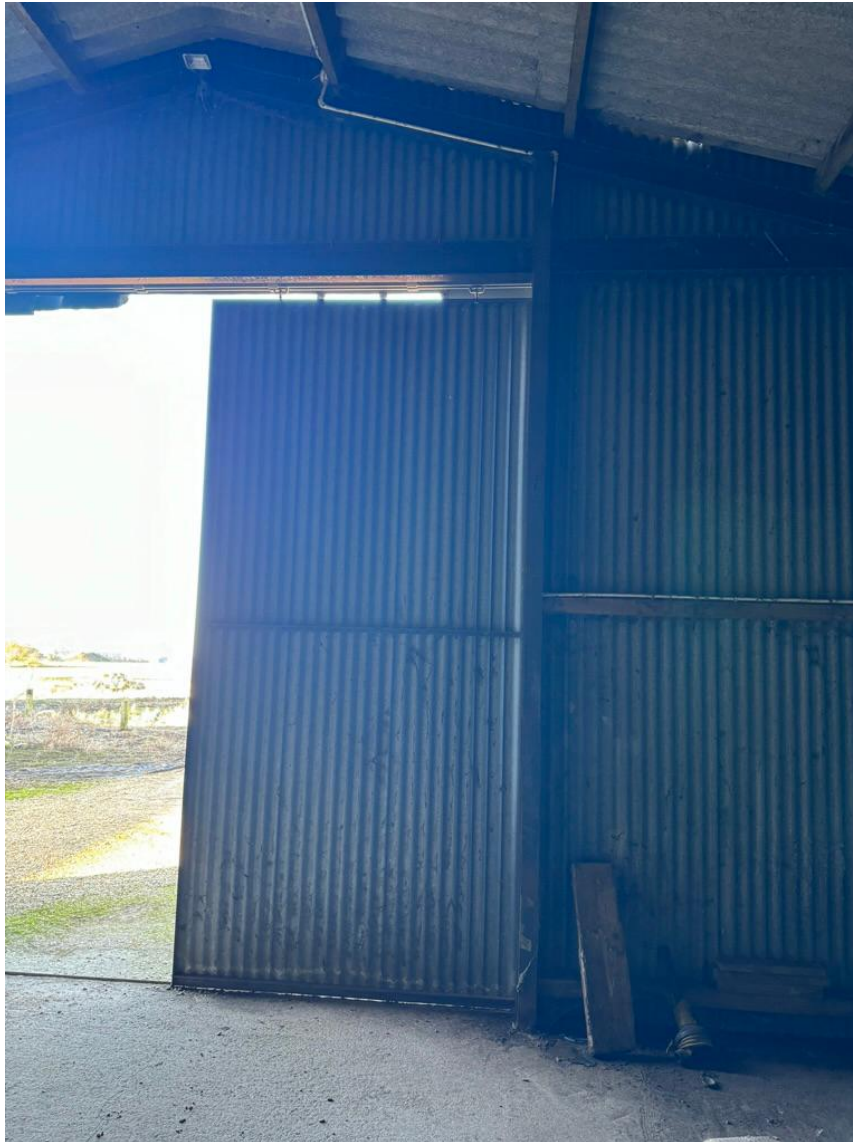
To the front gable elevation of the structure, a pair of sliding doors run from ground to eaves level. Supported off rails at the head of the door, they were found to remain intact

and functioning as originally intended. Columns run from ground to roof either side of the doors and support a header beam, set to the head of the doors.

Image 4.0: Sliding doors to the front of the Barn

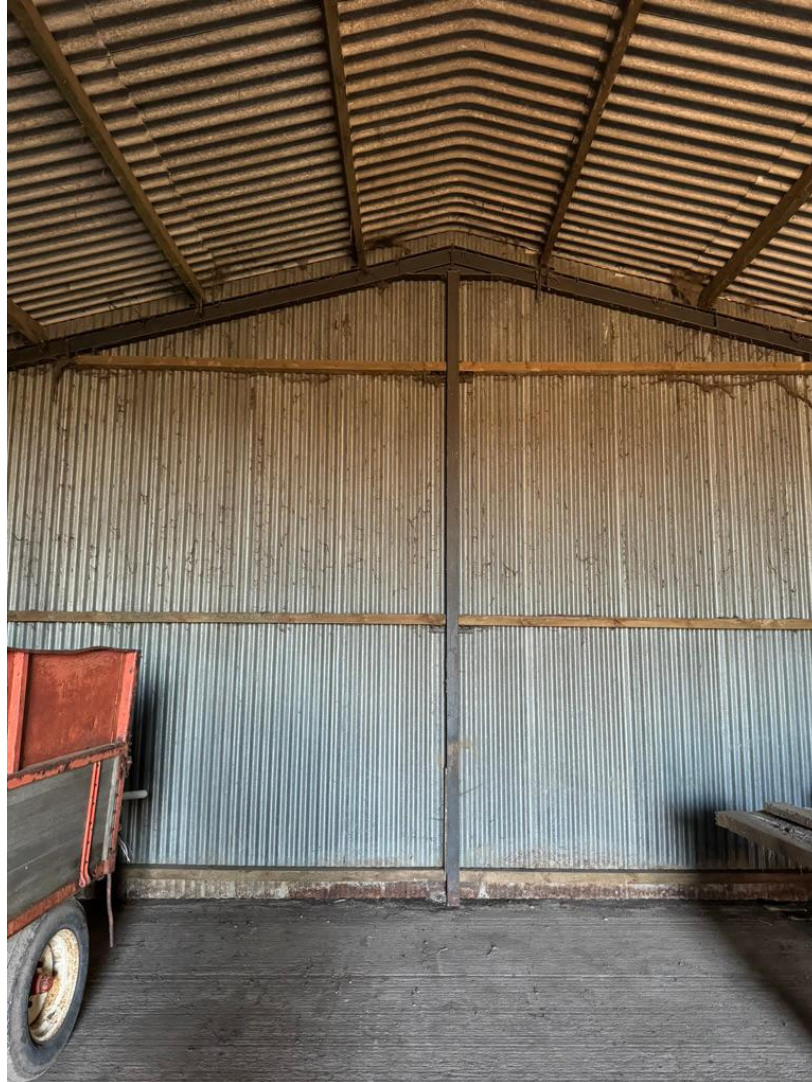
To the rear elevation, the structure comprises a final portal frame with steel rising from finished floor level to underside of Haunch at ridge. The purpose of the vertical steel element is to form a horizontal restraint to the horizontal purlins and supported cladding, preventing flexure under wind load. The column is not intended to provide support to the portal frame at ridge line.

Image 5.0: Prop running floor to ridge, providing horizontal restraint to horizontal purlins against wind suction/ pressure

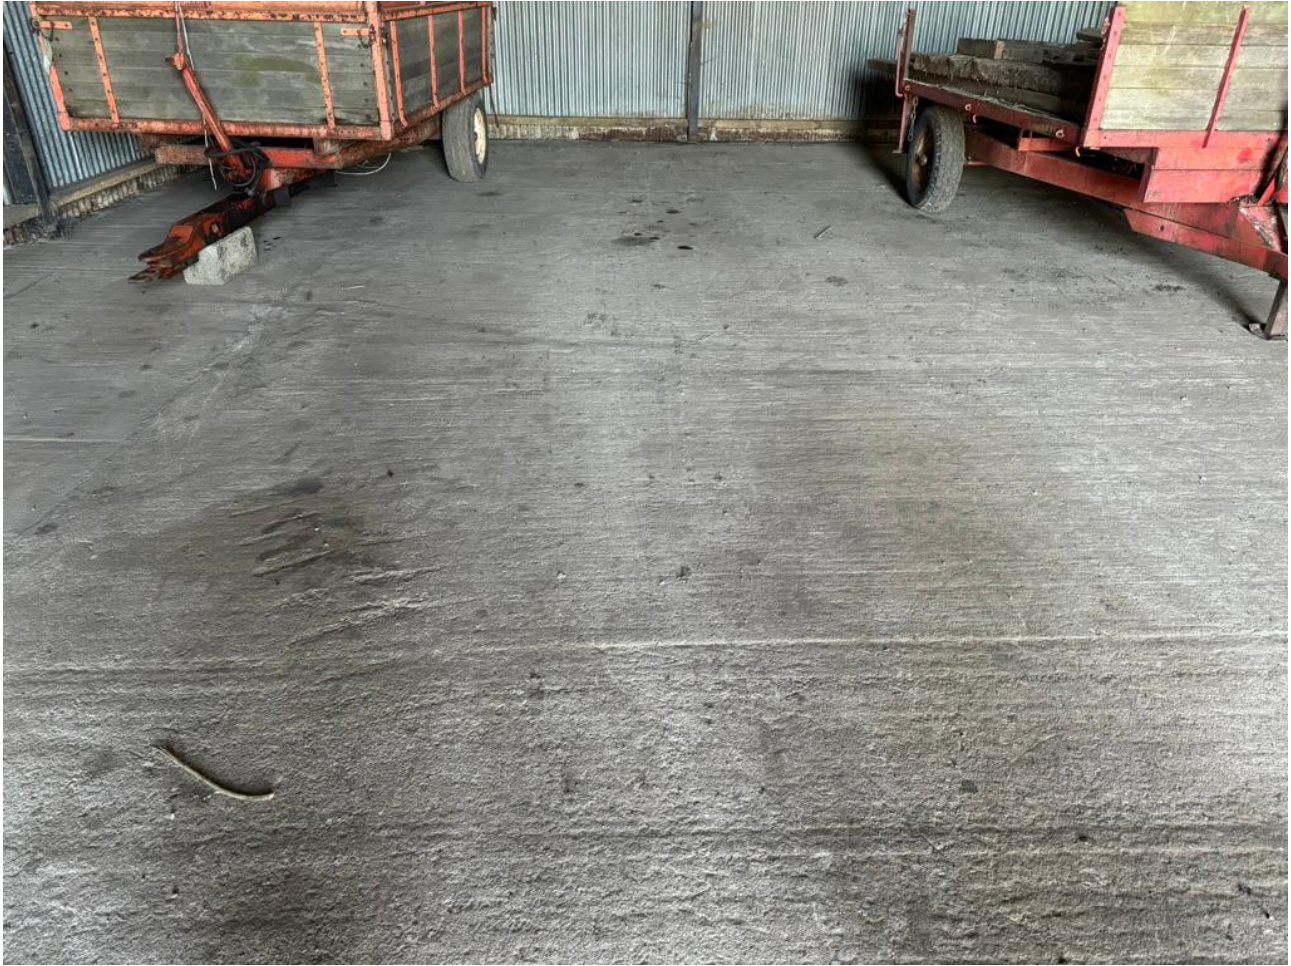
The floor to the footprint of the barn is formed from concrete, cast in situ and tamped/ levelled by hand. The concrete appears intact with no visible movement. However, cracking within the concrete was observed and may be ascribed to the lack of expansion joints, resulting in non-structural shrinkage cracking. This coupled with a lack of vertical movement infers that the finished floor suitably distributes applied loads to a suitable sub-base.

Image 6.0: Existing concrete floor, noted as being intact and functioning as originally intended

The conversion of the structure to single storey residential use may be carried out with the retention of the existing steel portal frames and associated purlins. Timber stud, set suitably in-board of the steel framing and purlins will allow for the formation of an insulated shell, internal to and separate from the external superstructure. Sway due to wind loading, for which the portal frame structure is designed, will consequently not be transferred to the internal timber stud walls. Given the limited mass of the timber stud walls, they may be sited to the head of the existing concrete floor. Line loads imparted by the timber studwork will be less than unit loading applied to the concrete floor by farm vehicles, plant and other machinery.

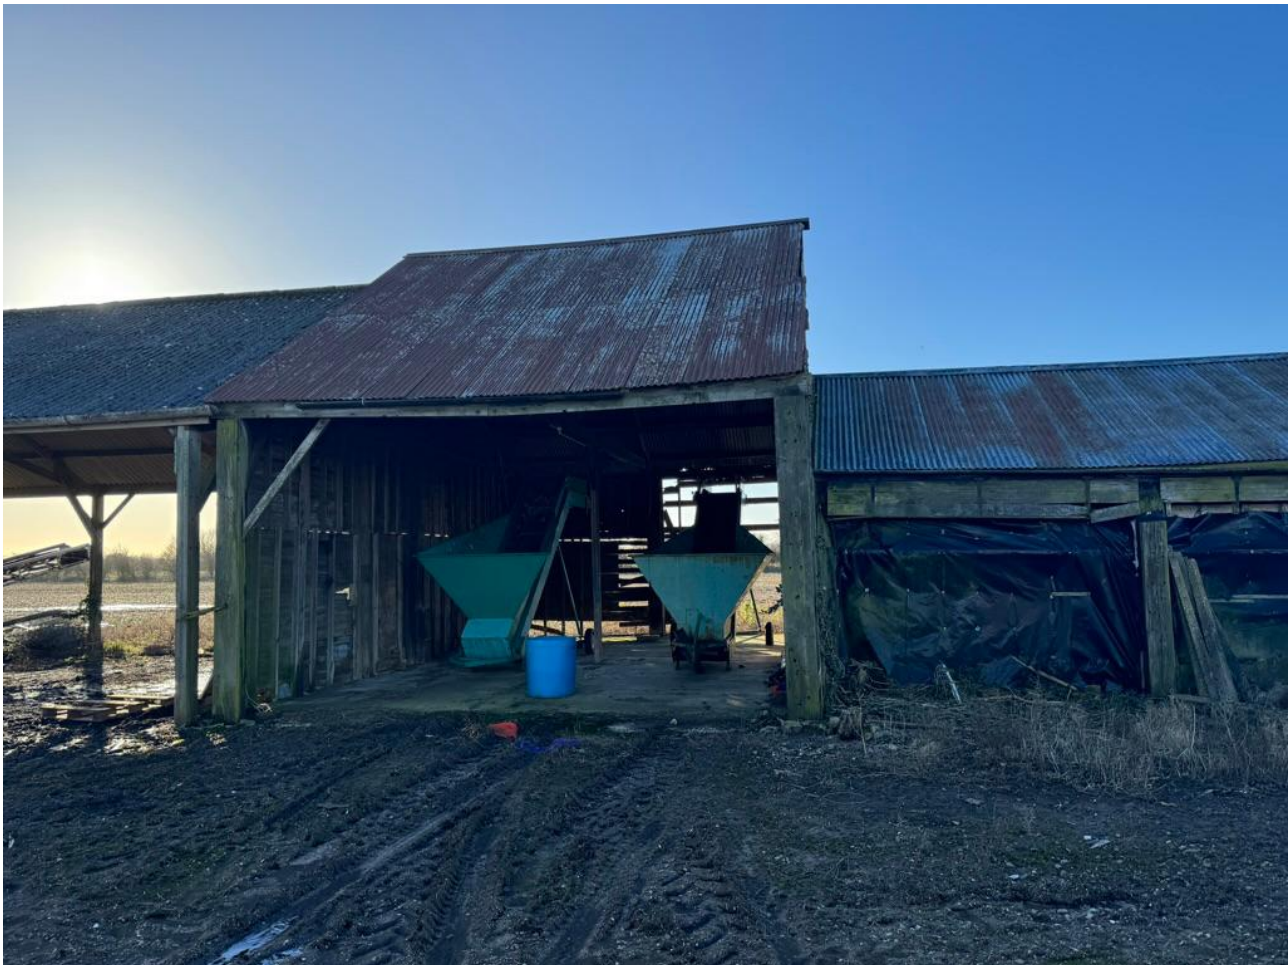
Image 12.0: External view to front of Barn 2

The structure is open at the front with a timber header beam spanning side to side between supporting timber columns. A single knee brace runs from a column up at 70° to meet the underside of the eaves beam forming a brace to prevent sway due to wind.

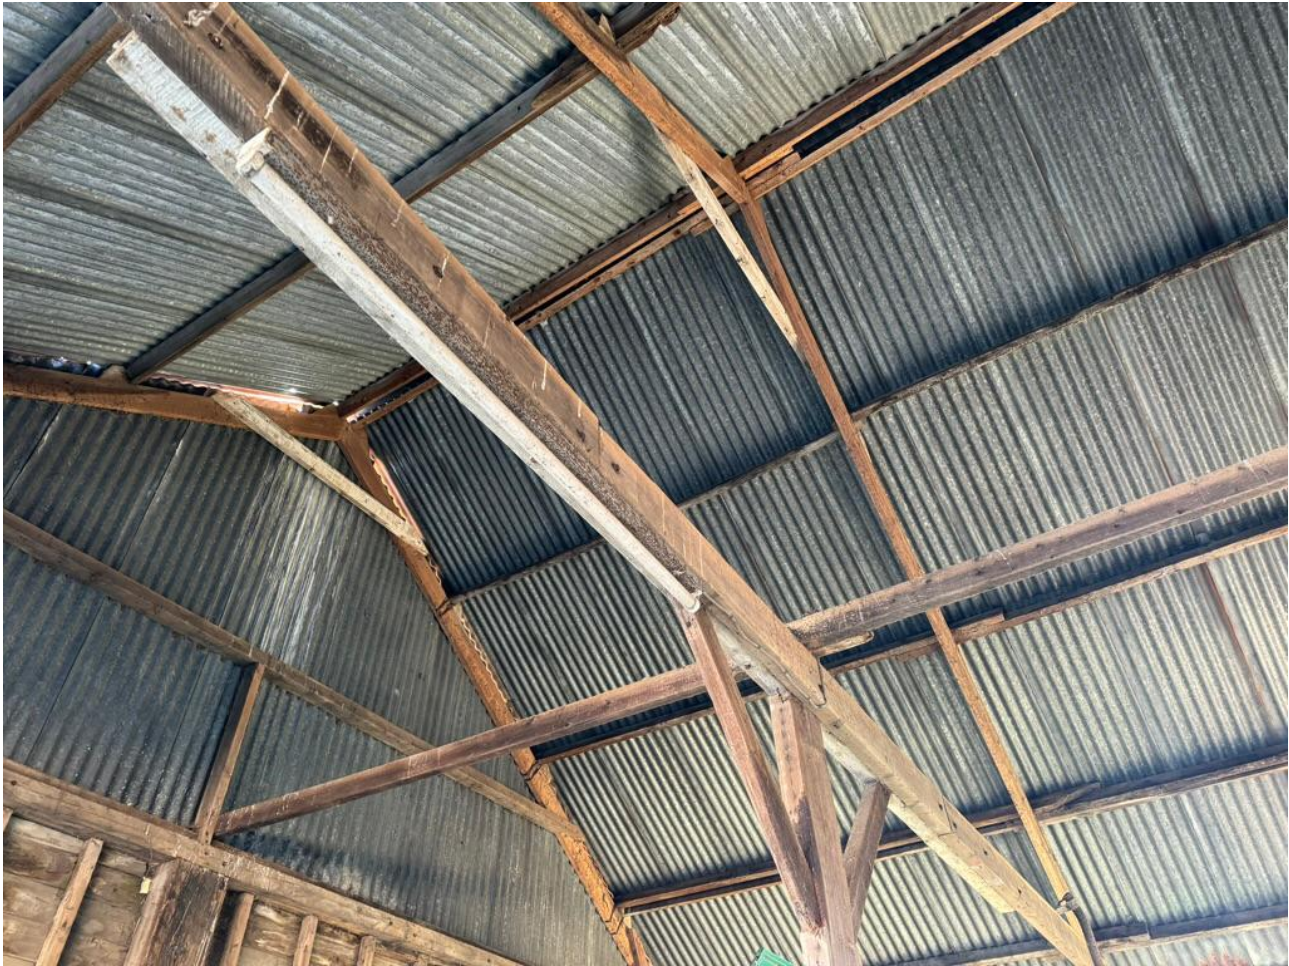
Internally, the roof structure is formed of timber purlins and ridge boards, spanning side to side between supporting side elevations. Purlins and ridge are supported midspan by a hand cut timber truss, formed of rafters and ceiling binder. A timber post is set central to the underside of the ceiling binder, providing a support to the long span timber member.

Image 13.0: Internal view of existing roof structure

The roof structure is suitable for use with the replacement of the existing corrugated metal sheeting on a Like for like basis, with a suitable composite insulated corrugated sheeting.

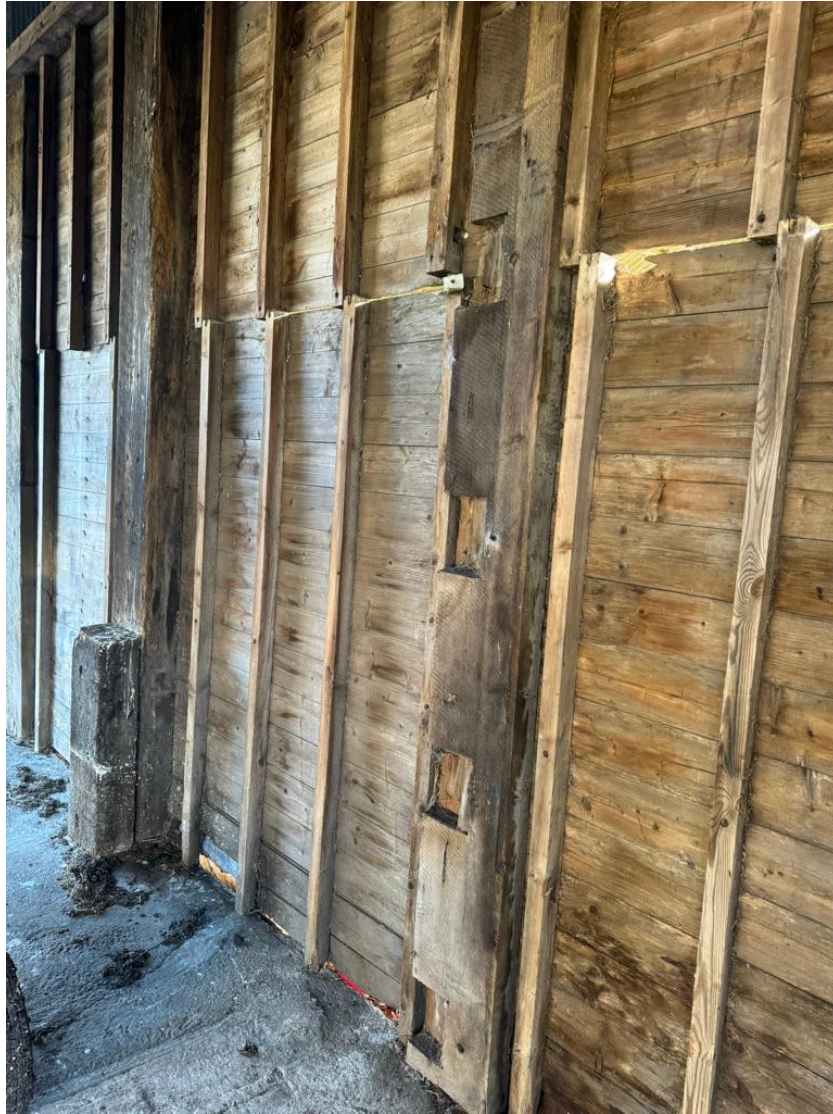
Side elevations of the structure are clad in timber between floor level and eaves. Corrugated metal sheeting runs vertically from eaves level terminating at roof level. Structural support to the side elevations is provided by railway sleepers set vertically at suitable centres and running from finished floor to a Tie Beam set in the depth of the wall running horizontally front to back.

Image 14.0: Timber columns, formed of railway sleepers set to side elevations.

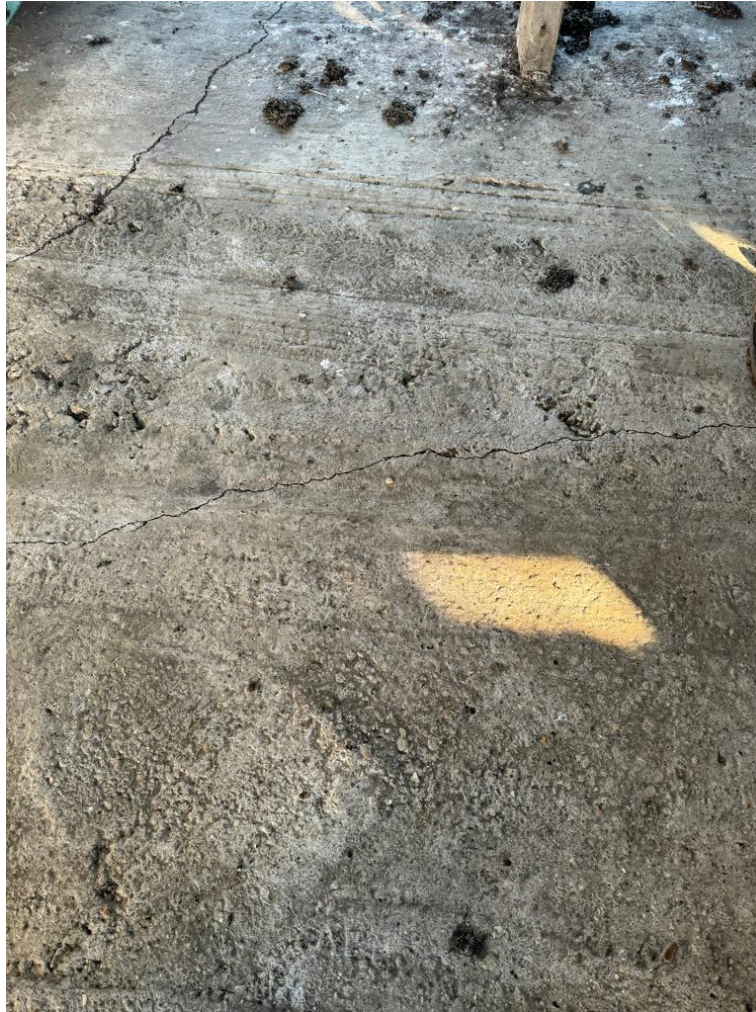
The rear of the structure incorporates timber cladding, supported by a framing system formed of timber with a central timber post formed from a railway sleeper. The finished floor is formed of concrete that has been cast in situ and Tamped firm by hand. The slab appears intact with limited movement, likely arising as a result of a lack of expansion joints. Vertical deviation in the slab was not observed.

Image 15.0: View of floor slab.

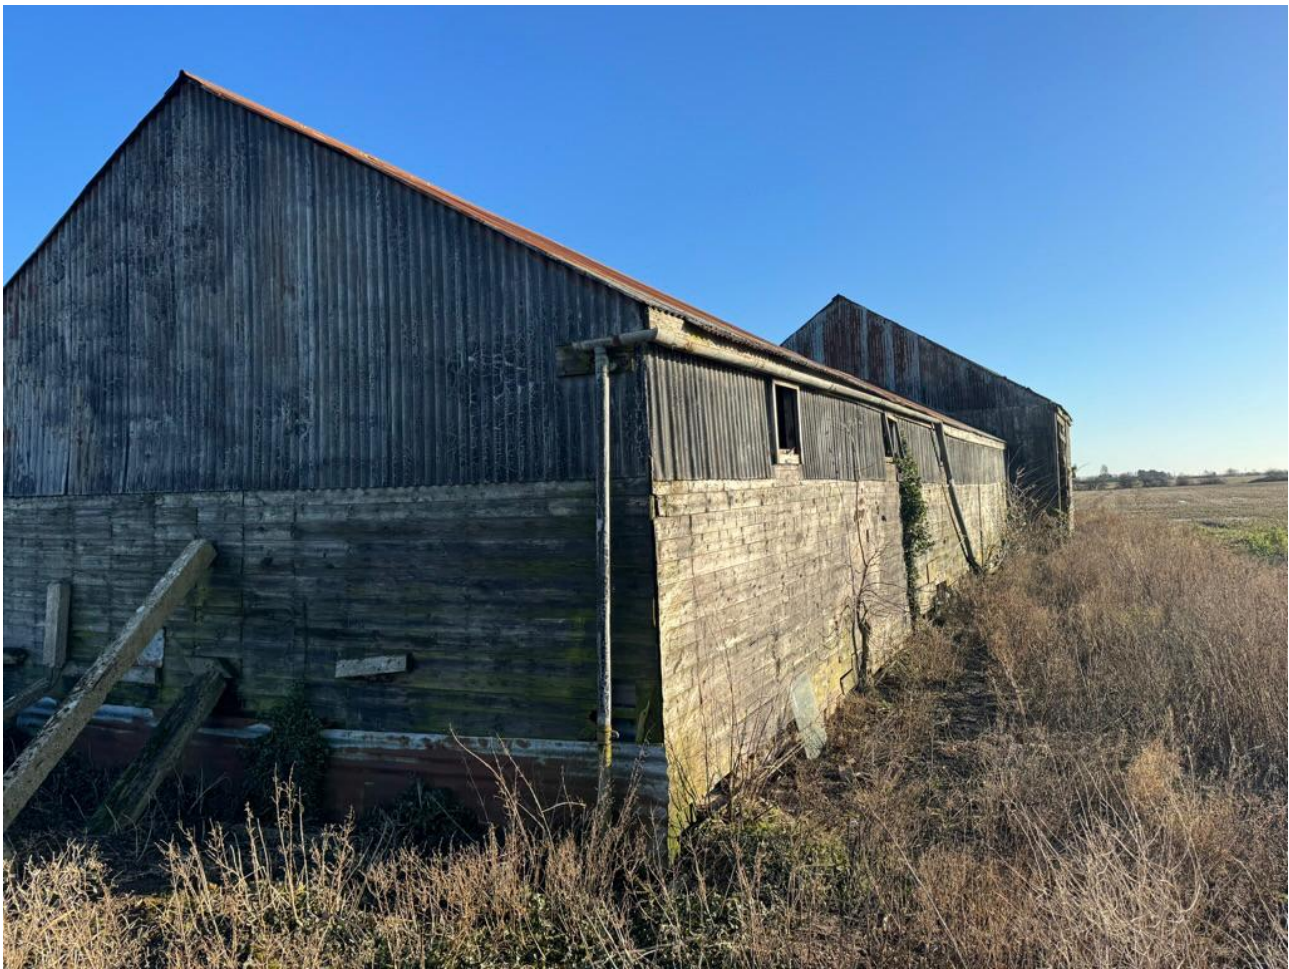
Barn Four comprises a long, single storey structure clad to the rear and end gable elevation in timber, rising to the underside of a series of small window openings, set just below eaves level. Corrugated steel sheeting run vertically between eaves and the head of the timber. To the gable end, the corrugated sheet runs from roof line down to meet the head of the timber.

Image 16.0: Gable and rear elevation of Barn 4

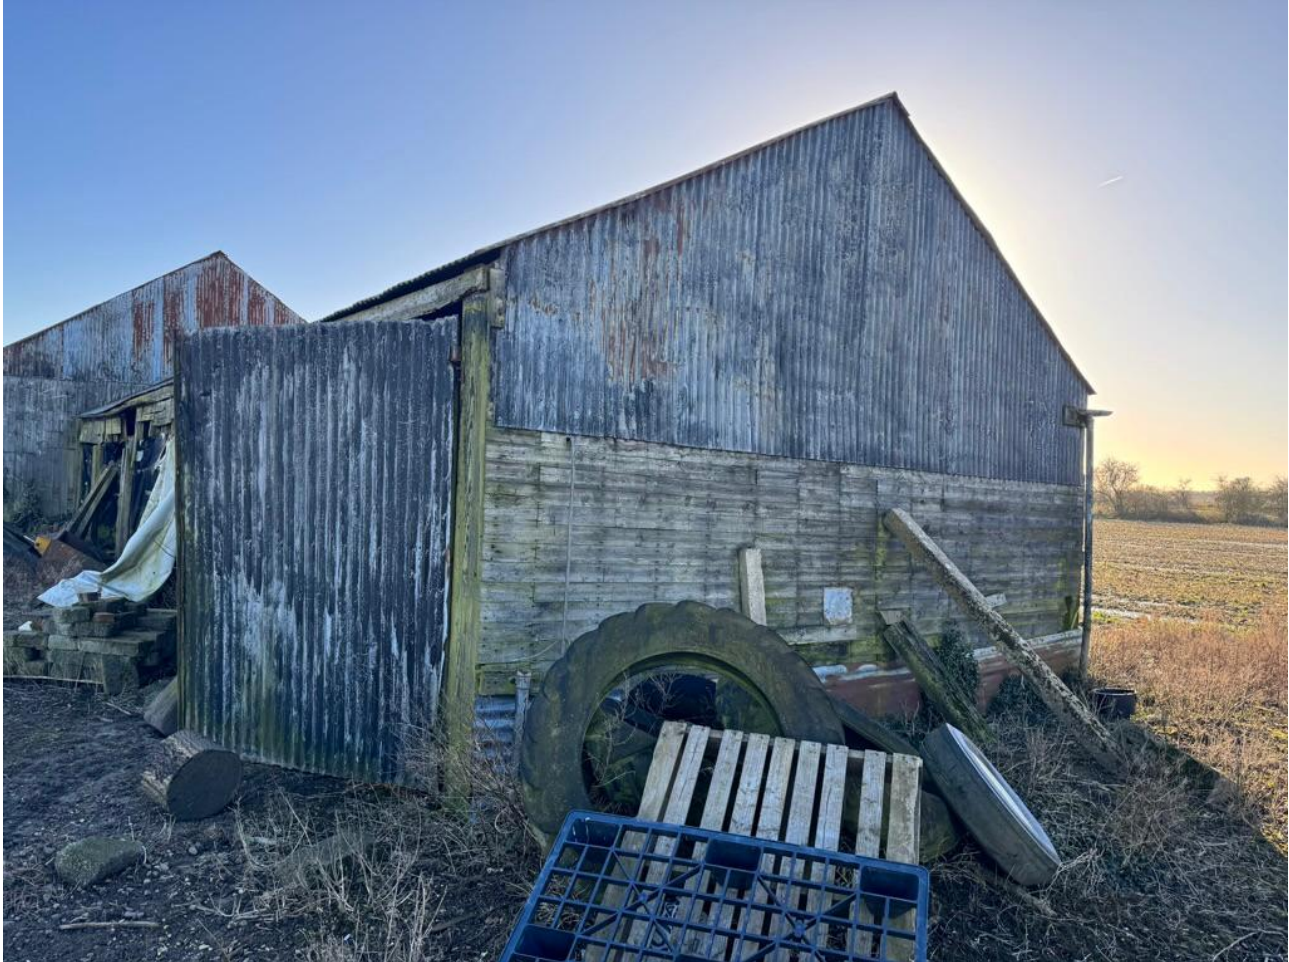
On the front elevation, a corrugated steel door provide access to the barn and the remainder of the front elevation is partially clad in a plastic sheet with timber cladding to the head of this, set to timber studs which clearly form the infill structure to this elevation.

Image 17.0: View of front entrance into Barn 4

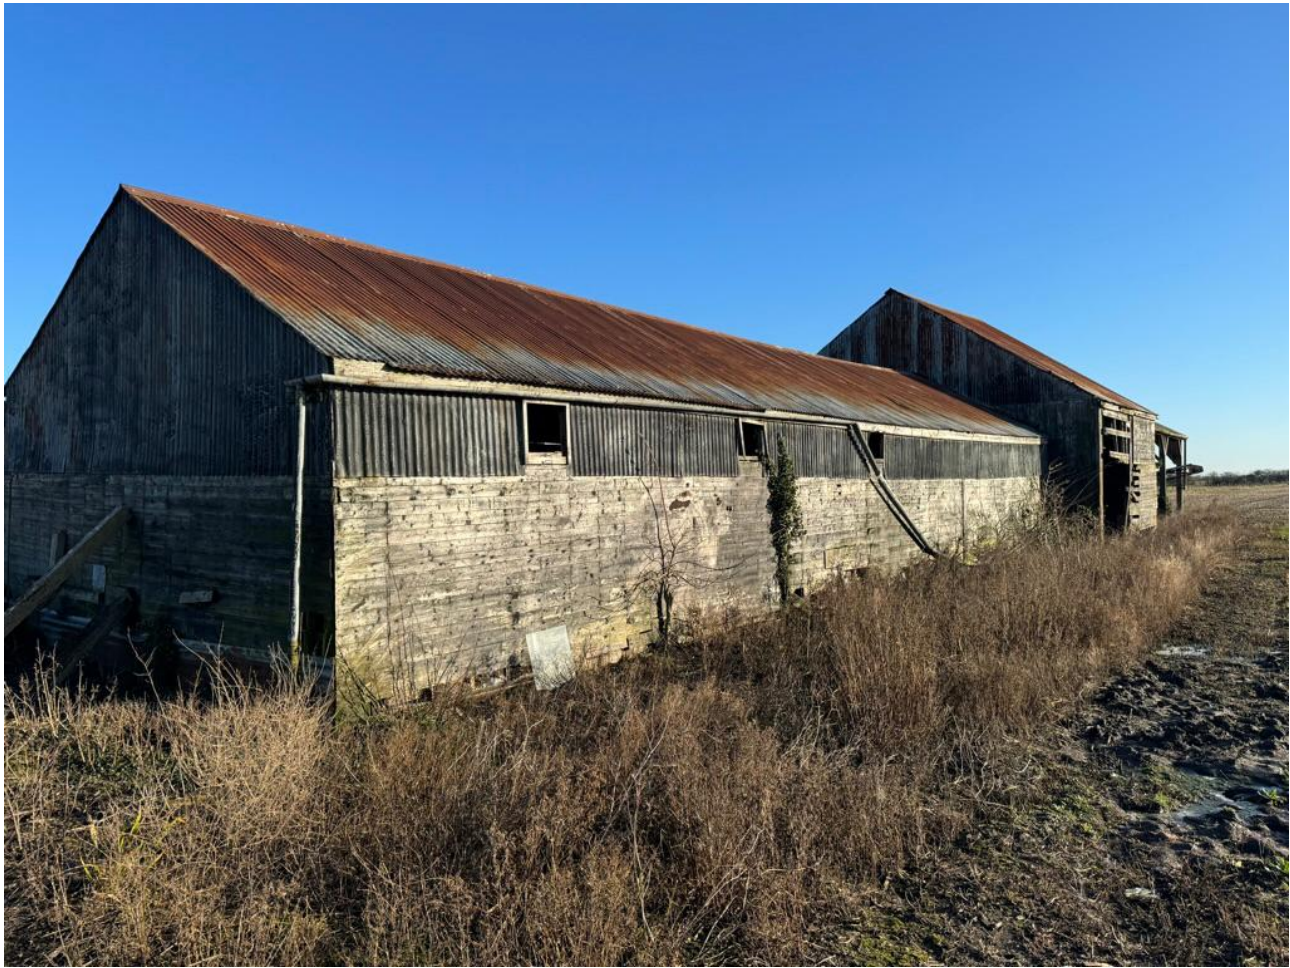
The roof structure is clad in corrugated steel sheeting, again laid to falls and the roof line is noted as being straight and with no deviation evident.

Image 18.0: View along roof and rear of Barn 4, with roof remaining intact

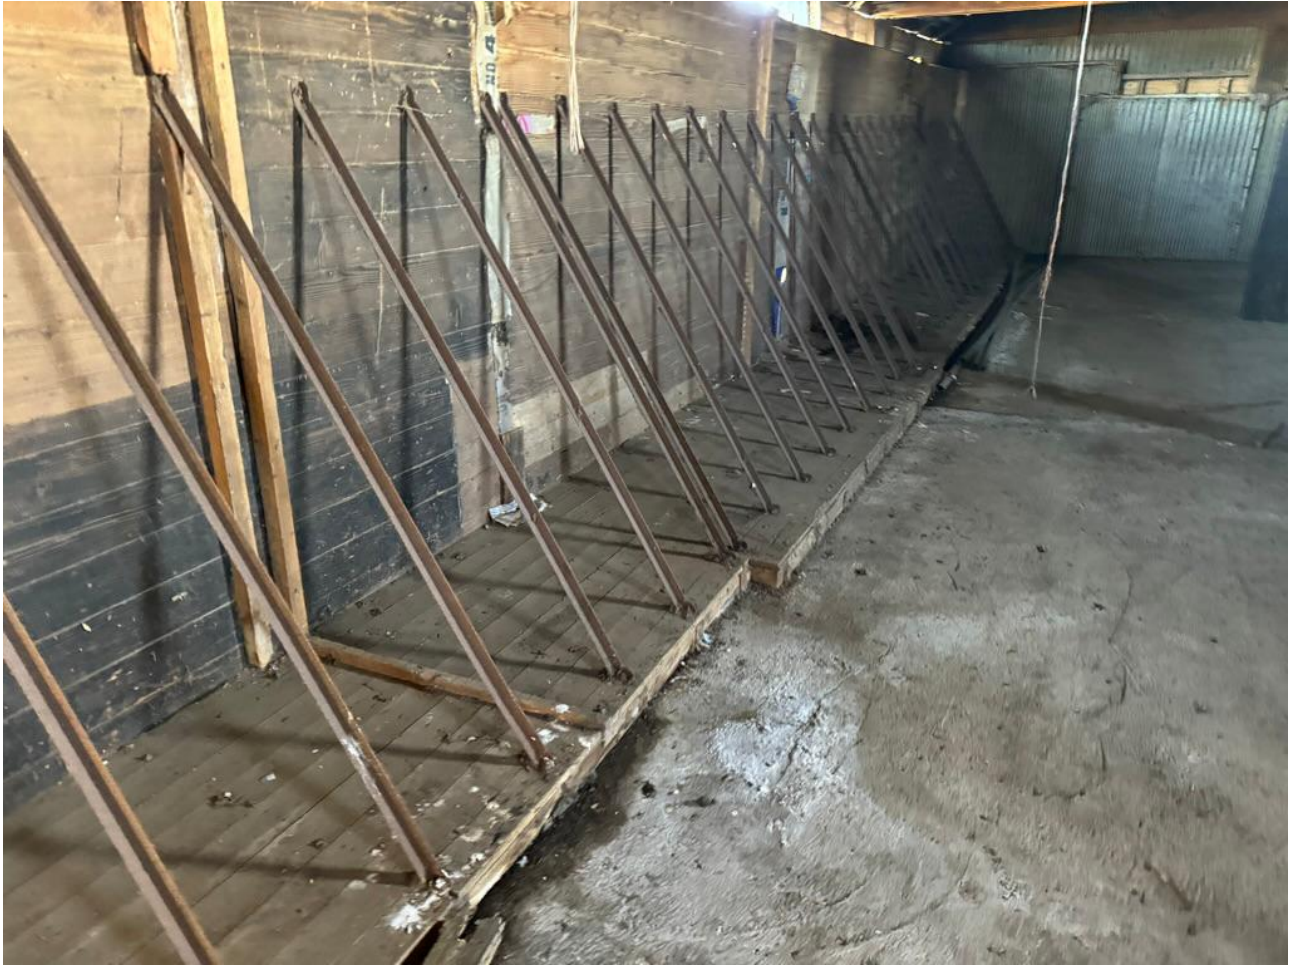
Internal to the barn, the structure is clad on the side elevations with timber. On the rear elevation, steel props run from ground level up to the timber cladding, inferring a robust structure used for storage of grain.

Image 19.0: Props between rear elevation of floor of barn 4

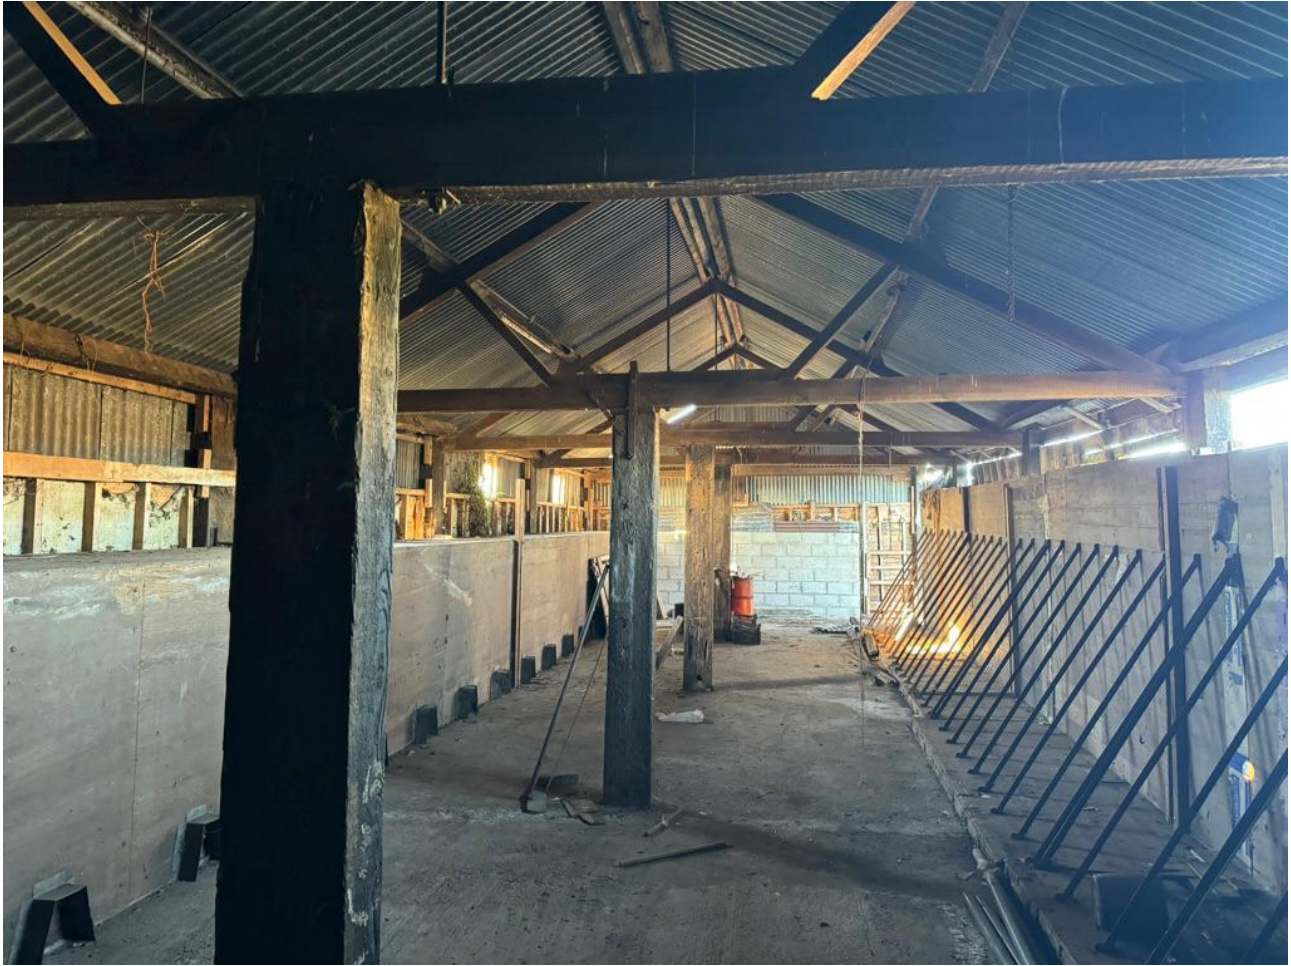
The roof structure comprises a series of timber hand cut trusses, set at centres to match supporting timber columns formed from railway sleepers. To the head of the roof are set a series of timber purlins, running between trusses. The trusses have been propped at their centres with additional railway sleepers, running from finish floor to underside of ceiling binders.

Image 20.0: Hand cut timber roof with timber supports formed from railway sleepers

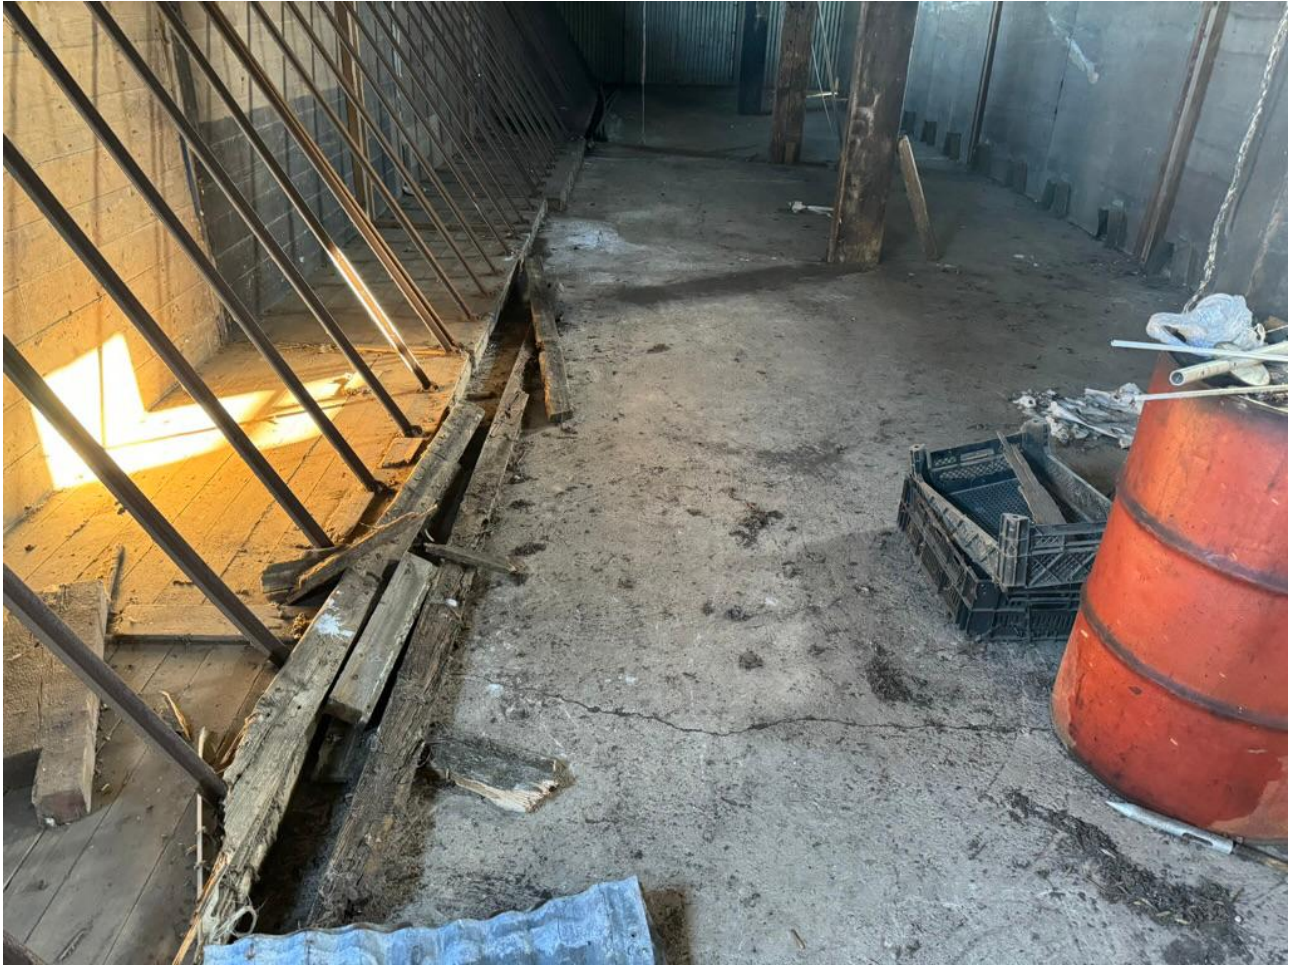
The finished floor has been cast in situ, formed of hand tamped concrete, set without suitable expansion joints. As a result, cracking has occurred. However, the slab remains suitably intact with no significant vertical deviation, indicating that it is set to a good hard-core base.

Image 21.0: View of finished concrete floor

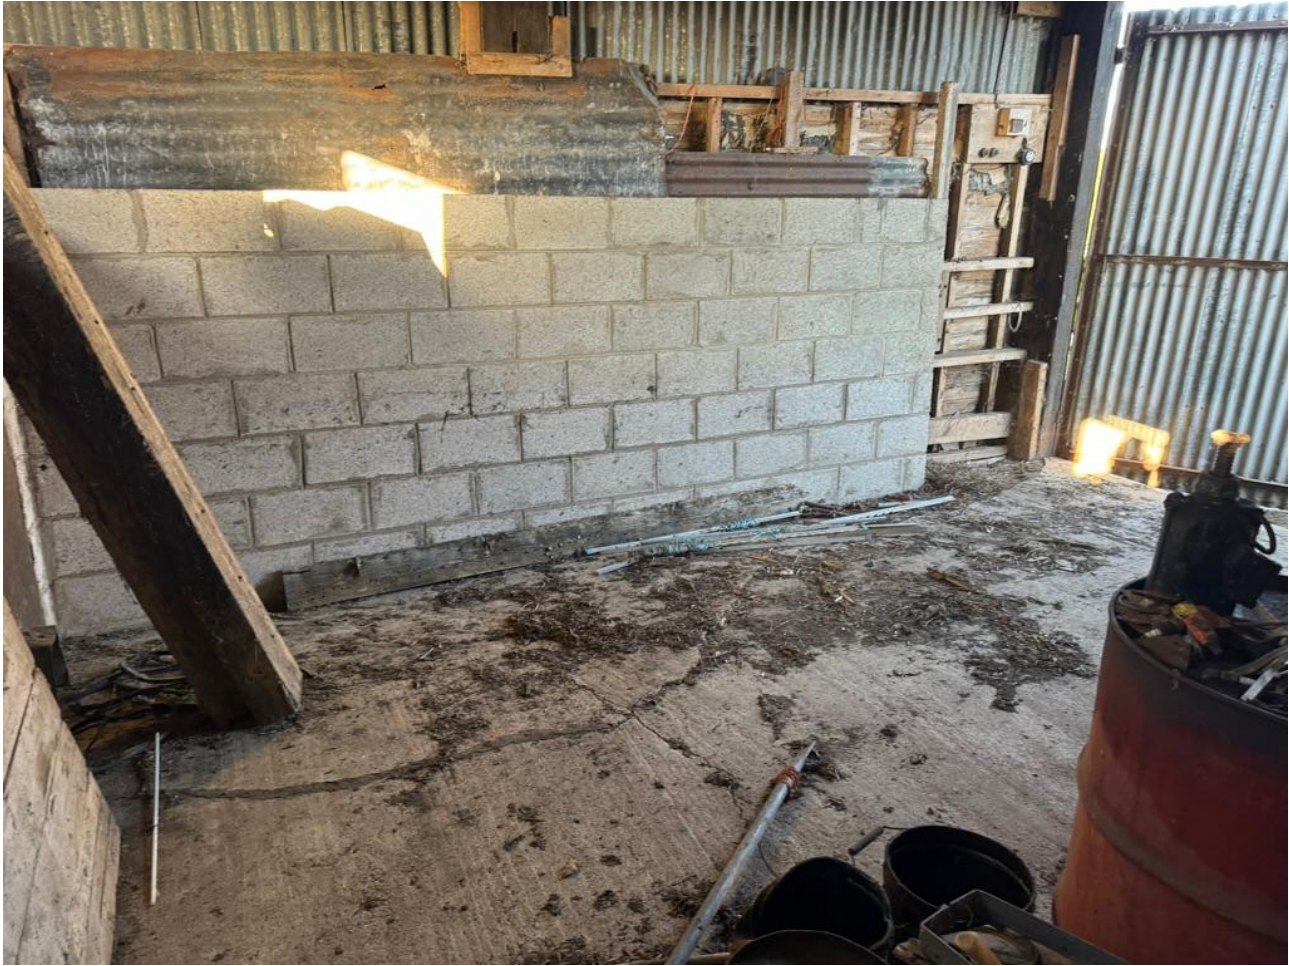
A block Work wall has been formed to the rear gable end, concealing a timber stud frame with corrugated steel sheeting running vertically to the head of this.

Image 22.0: Gable end of structure

Rainwater goods have clearly failed to the perimeter of the structure, and some discolouration to the rear and gable elevation is indicative of a high moisture content as a result of rainwater, shedding onto the relevant elevations.
