**Report number 15-08-03**

## **Environmental Risk Assessment of site off Kirkgate**

### **Whaplode, Spalding, Lincolnshire, PE12 6TF**

**Planning Application No. H23-0273-15**

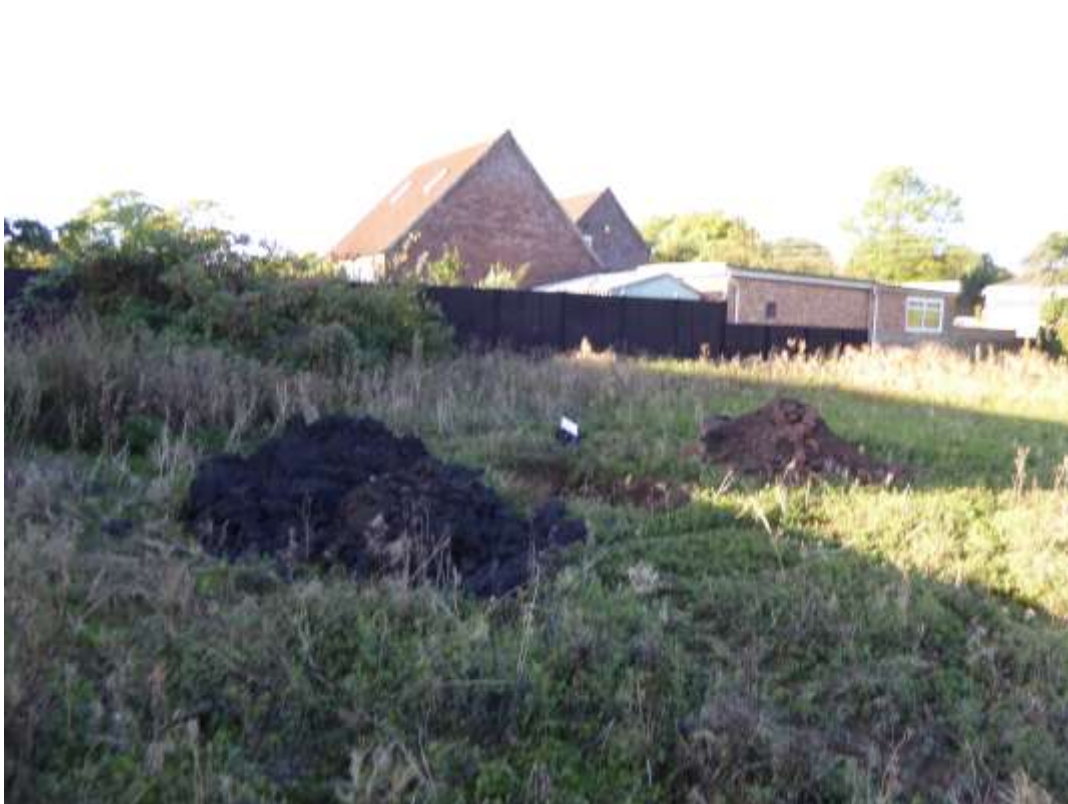
Photo 6 TP2 in southeast corner of site

TP2 in southeast corner of site (photo 6)

| Depth | Description of ground |
|---|---|
| 0 – 0.3 m | Soil, bricks (whole and fragments), stones and thin layer of gravel on top |
| 0.3 – 1.2 m | Dark brown silty clayey sand |
