## STRUCTURAL APPRAISAL REPORT

**Existing Farm Buildings at;-  
Crown Farm,  
4 Stockwell Gate West,  
Whaplode,  
Lincolnshire**

| <b>Reference:-</b> | JC/17/11/4158 | <b>Issued:-</b> Jan 2018<br><b>Updated;-</b> Oct 2021 |

# STRUCTURAL APPRAISAL REPORT,

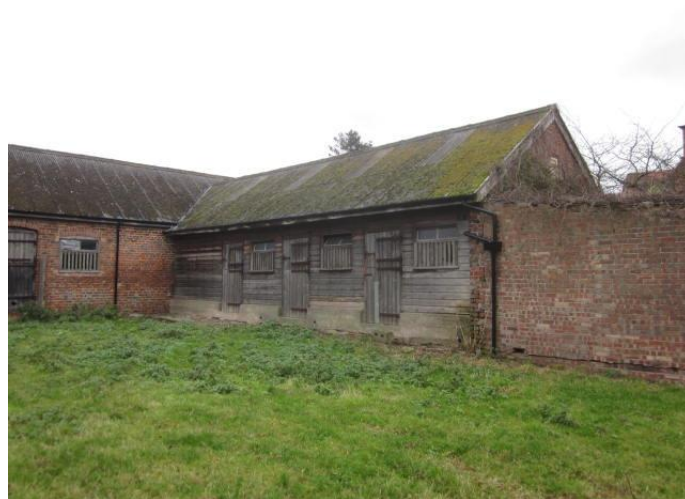
A West facing elevation is formed using a timber infill panel structure with timber weatherboarding over. The timber panels are constructed off a roughcast concrete plinth at low level. If a timber panel arrangement is to be incorporated into any proposed scheme, allowance should be made for the removal of the existing concrete plinth and construction of a suitable plinth at low level, together with substructure walling off a suitable cast foundation.

**Photograph # 5**  
*West Facing Elevation (timber Infill Wall Panels)*

As discussed previously, one of the West facing elevations is formed using timber infill panels. Depending on the proposed scheme, allowance should be made for the introduction of a new concrete strip foundation at this location, in order to provide support for remedial substructure and plinth masonry.

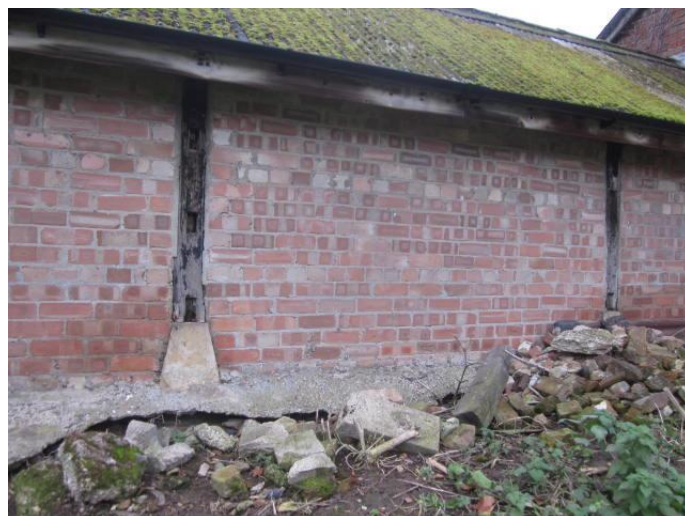
- The single storey Garage and low level pen type structures that have been added / adjusted to the South facing elevation, using 'Common' type masonry units, have been constructed in a crude manner off unsuitable rough cast foundations. As such movement of these additions have occurred, and it is assumed within our commentary that these additions will be demolished as part of any proposed scheme.

**Photograph # 6**  
*Low Level Pens – Adjusted Masonry – Later ‘Common’ Units*

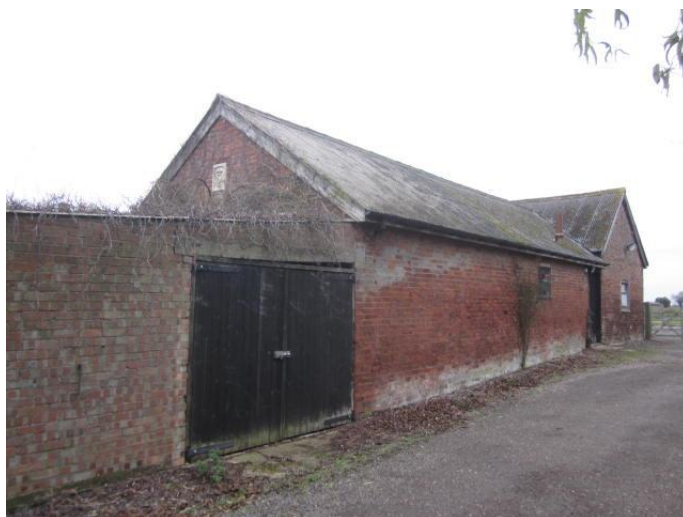
**Photograph # 8**  
*East Facing Elevation – Later Garage constructed using 'Common' units*

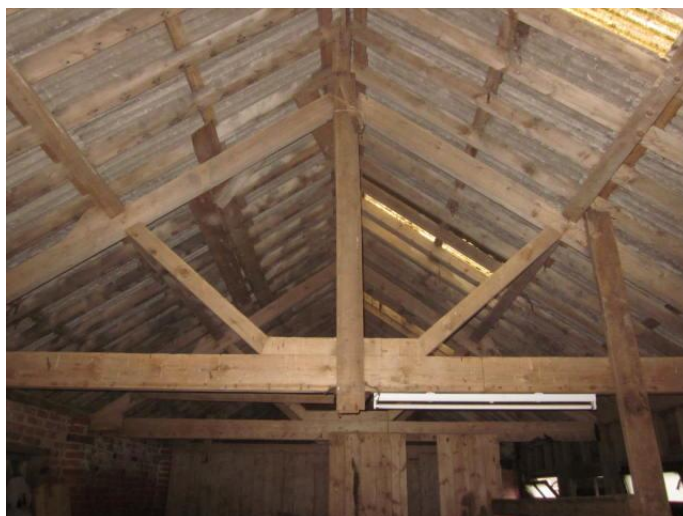
The roof structure appears generally sound and in a reasonable condition. The roof appears well tied with a combination of king post trusses and collar ties present.

**Photograph # 9**  
*Typical Roof*

The current roof covering is extremely lightweight, and we do anticipate that some strengthening works will be required in order to accommodate a heavier tile / slate finish. However, loss of original timbers is likely to be low and additional rafter / purlin timbers can be introduced to enhance the overall performance of the roof structure. New felt and insulations will need to be installed in accordance with the architect's requirements and roof specifications.

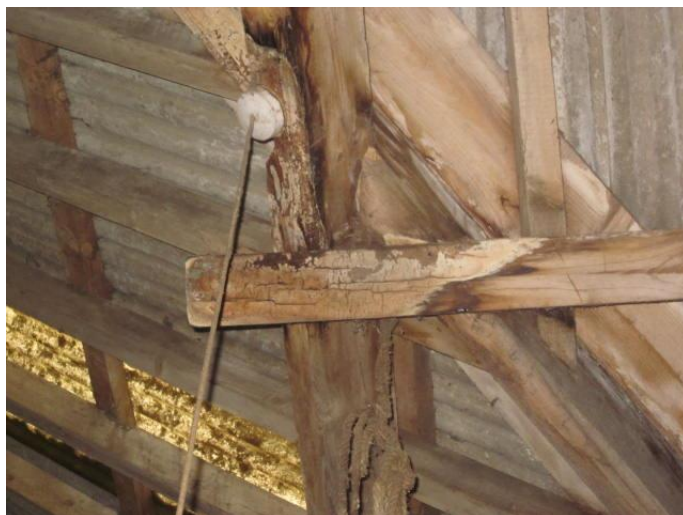
As per usual in a conversion of this nature, allowance should be made for the repair of any decayed timbers, many of which may be hidden until works commence. Most fatigued timbers will occur where they have been exposed to continued wetting or are in contact with masonry elements. We observed a small amount of localised decay to timbers around roof valley intersections which is a typical defect on buildings of this nature.

**Photograph # 10**  
*Typical Roof – Decay at Valley Intersection.*

Allowance should be made for localised repair of decayed valley timbers, together with more general inspection and repair of any decayed rafter feet, purlin and beam ends and wall-plates.

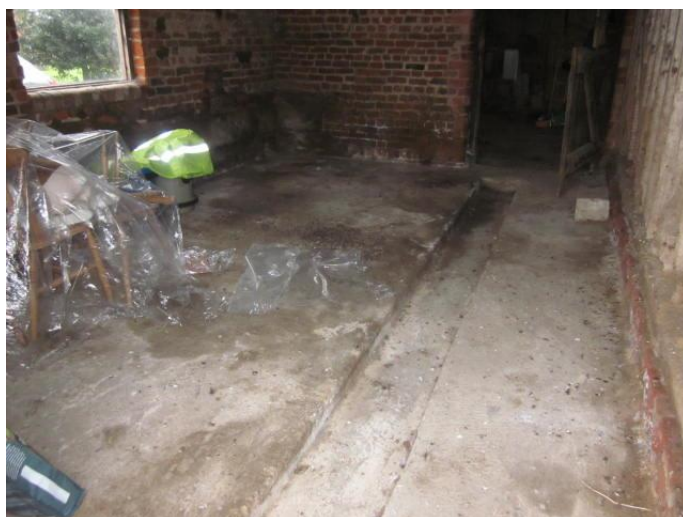
- The floors have been used for the storage of goods, livestock and general agriculture use. As such the condition of the floors reflects this.
- The concrete floor slab had channels cast within and was of unknown construction, however there was no evidence of undue settlement.

**Photograph # 11**  
*Typical Ground Floor*

We recommend that allowance is made to replace all ground floors with a ground bearing, concrete ground floor slab that is suitable to accommodate loadings from the proposed use, including partitions. Slabs should be installed at levels to suit architects' requirements, and should incorporate suitable DPC, insulations and screeds to the architects' specification.

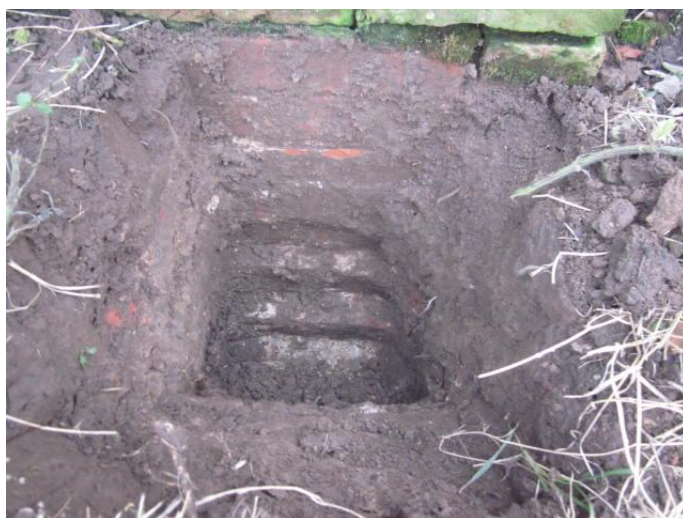
- The existing foundation was inspected via a single trial hole. Foundations consist of a corbelled masonry foundation bearing at a reasonable depth onto a weak mix concrete spreader (specification unknown) cast onto the ground strata below. The foundation detail provides a distribution of foundation loads over a width in excess of 600mm.

- The ground strata at foundation level appeared of reasonable bearing capacity.
- The superstructure is not displaying any signs that would suggest the foundation system is under excessive stress. The foundations appear to be performing satisfactorily.

**Photograph # 12**  
*Typical Foundation*

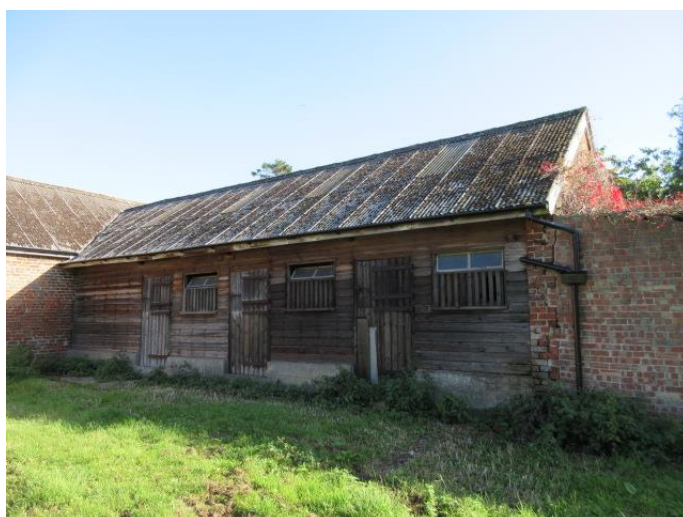
**Photograph # 5** *(Taken Oct 2021)*  
West Facing Elevation (timber Infill Wall Panels)

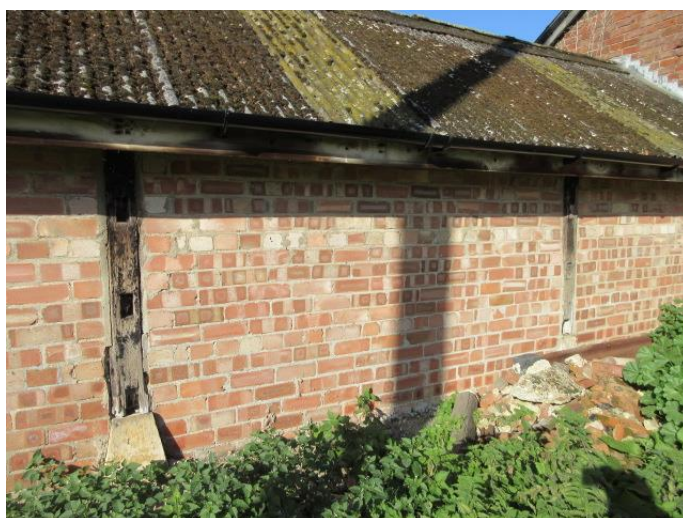
**Photograph # 6** *(Taken Oct 2021)*  
Low Level Pens – Adjusted Masonry – Later ‘Common’ Units

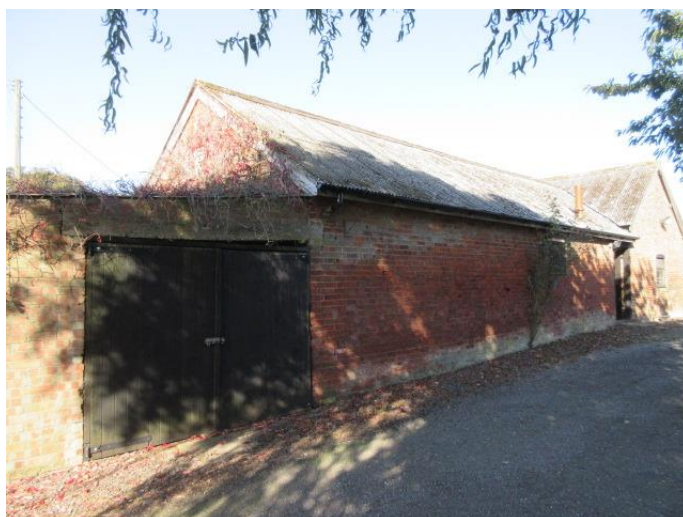
**Photograph # 8** *(Taken Oct 2021)*  
East Facing Elevation – Later Garage constructed using 'Common' units

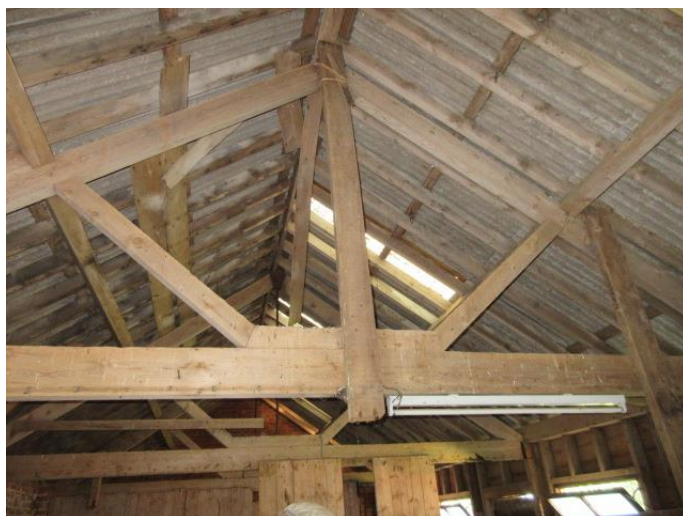
**Photograph # 9** *(Taken Oct 2021)*  
Typical Roof

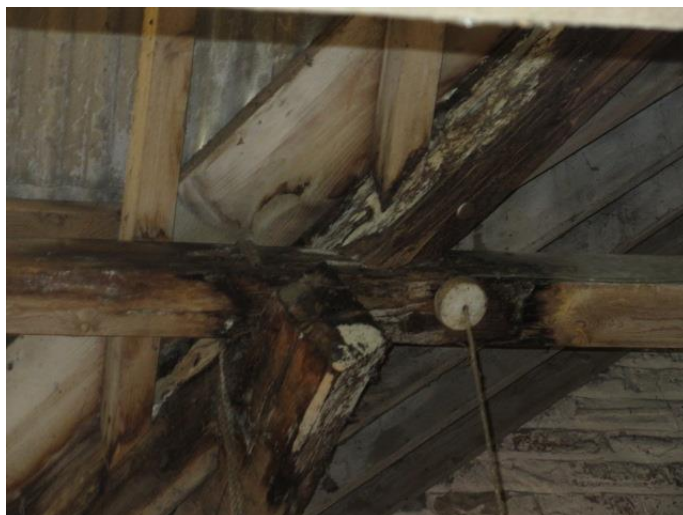
There did appear to have been some further acceleration in decay of roof timbers since our last visit. This is to be fully expected, and again, as per November 2017 the concentrated area of high decay appears to be localised around roof valley intersections.

**Photograph # 10** *(Taken Oct 2021)*  
*Typical Roof – Decay at Valley Intersection.*

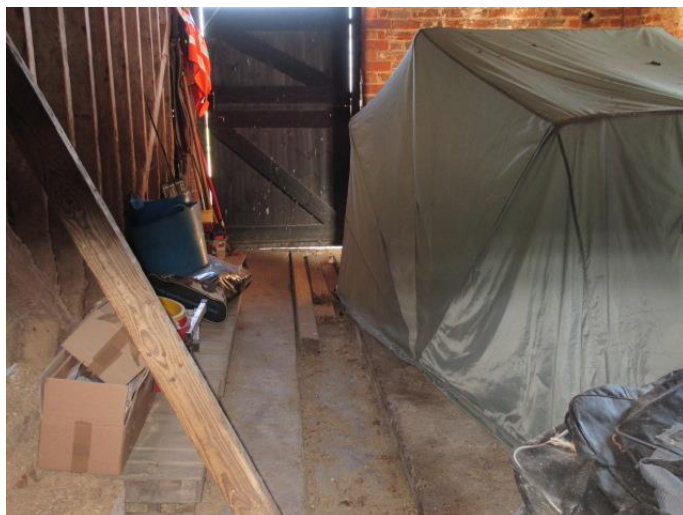
**Photograph # 11** *(Taken Oct 2021)*  
*Typical Ground Floor*
