**From:** Gedney, David  
**Sent:** 16 January 2024 14:26  
**To:** \_planningadvice  
**Subject:** FW: SE-2039 - H23-1132-23 - Conversion of three agricultural barns into four residential dwellings involving the demolition of a fourth barn  
**Attachments:** carter's farm, rev 01.pdf

# ANTHONY-JOHNSON

Carter's Farm,  
Oxcroft Bank,  
Shepeau Stow,  
Spalding, Lincs.  
PE12 0TY

The visual survey of four existing structures, previously employed as Barn structures on a farm. The purpose of this survey is to consider the structures with a view to conversion to residential use and review the retention and use of existing structural elements.

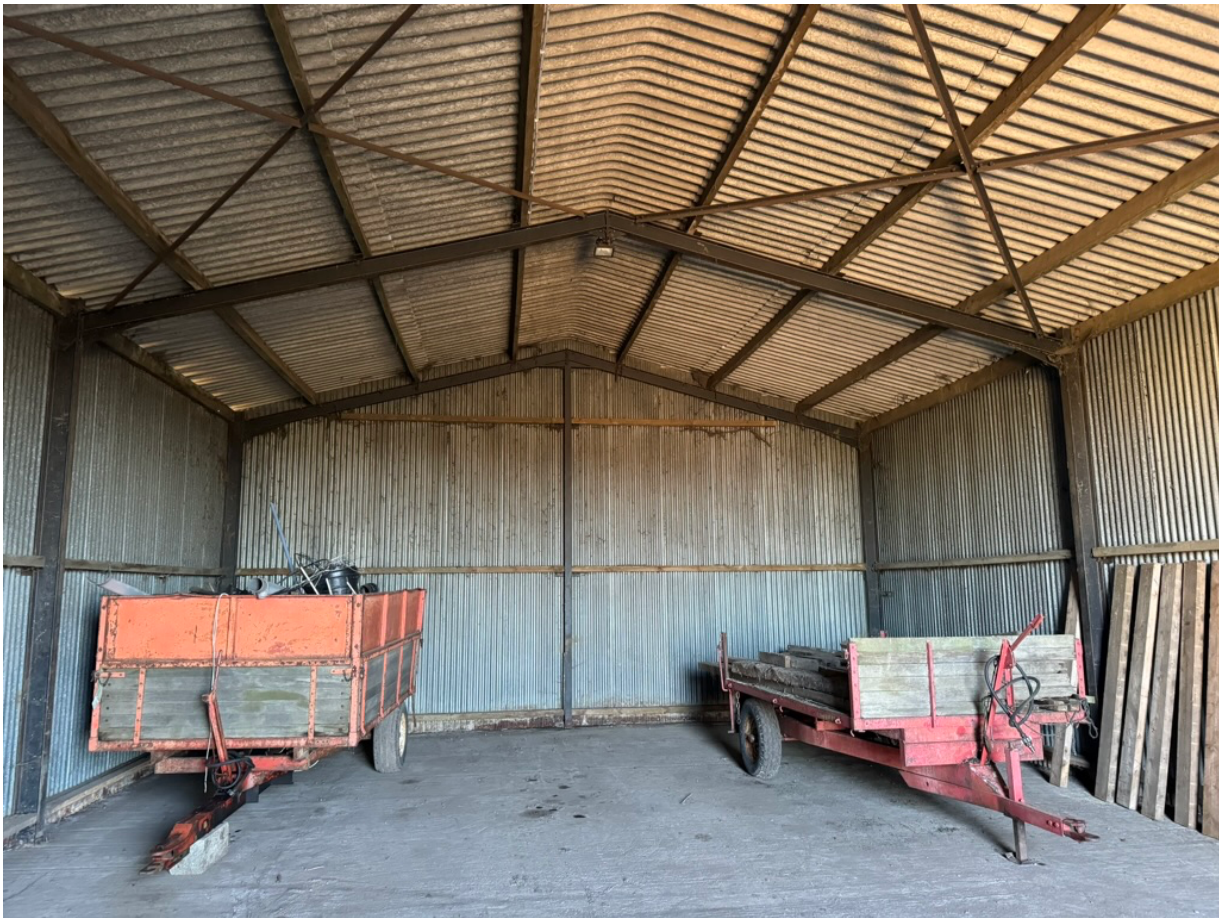
Barn 1 comprises a steel portal framed structure, employing 152x89UB16 sections, set at suitable centres, forming frames that resist vertical and horizontal loading imparted by the mass of the structure, wind and snow loading on the external cladding.

Image 1.0: Internal view of Barn

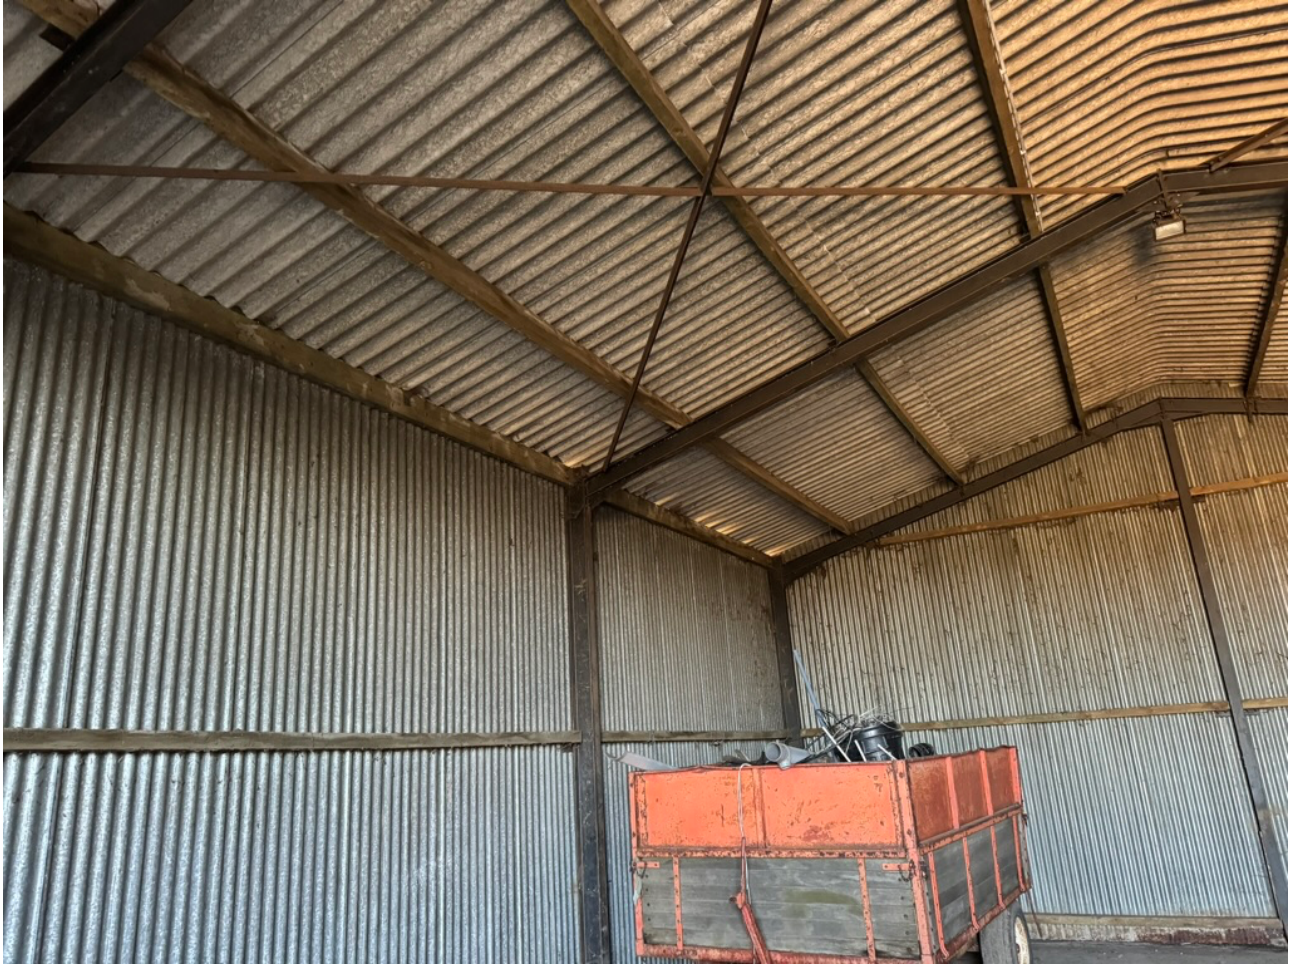
Image 2.0: View of cross bracing, removing longitudinal sway due to wind loading

The superstructure appears to be visually intact. Cladding does not exhibit defects and sections are not missing. Cladding was noted as having been finished with a zinc coating, providing a long term sacrificial coating that corrodes in preference to the underlying steel.

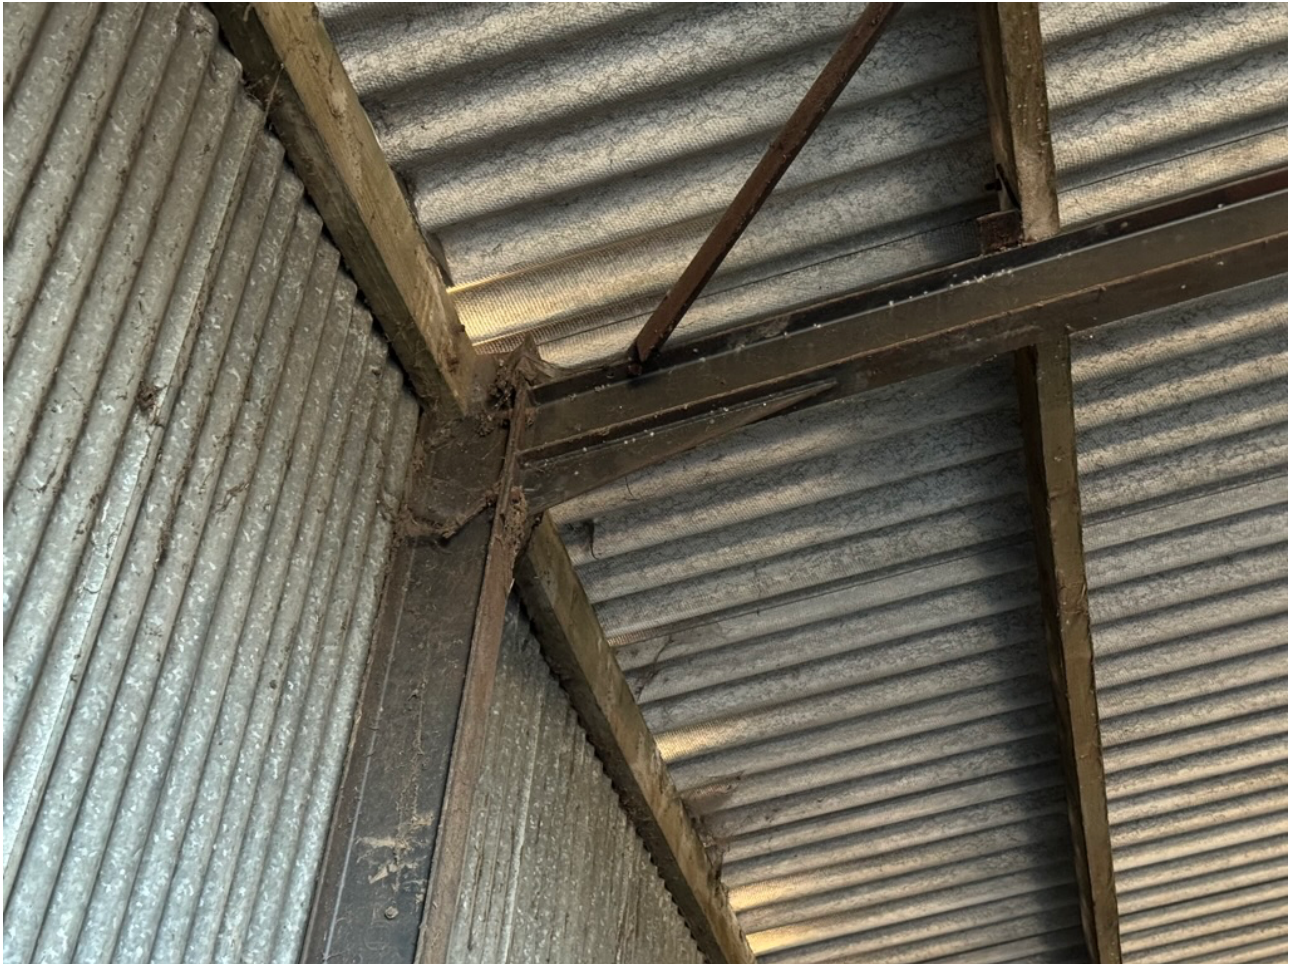
Purlins were found to run with no significant deviation within their span, reflecting elements that have been suitably spaced and are not overloaded. Purlins have been affixed to the head of steel portal frame beams, providing restraint to the compression flanges of the beams, preventing the development of lateral torsional buckling.

Image 3.0: Hunch connection between column and beam, fixing between CHS brace and beam and cleated purlin running to head of rafter.

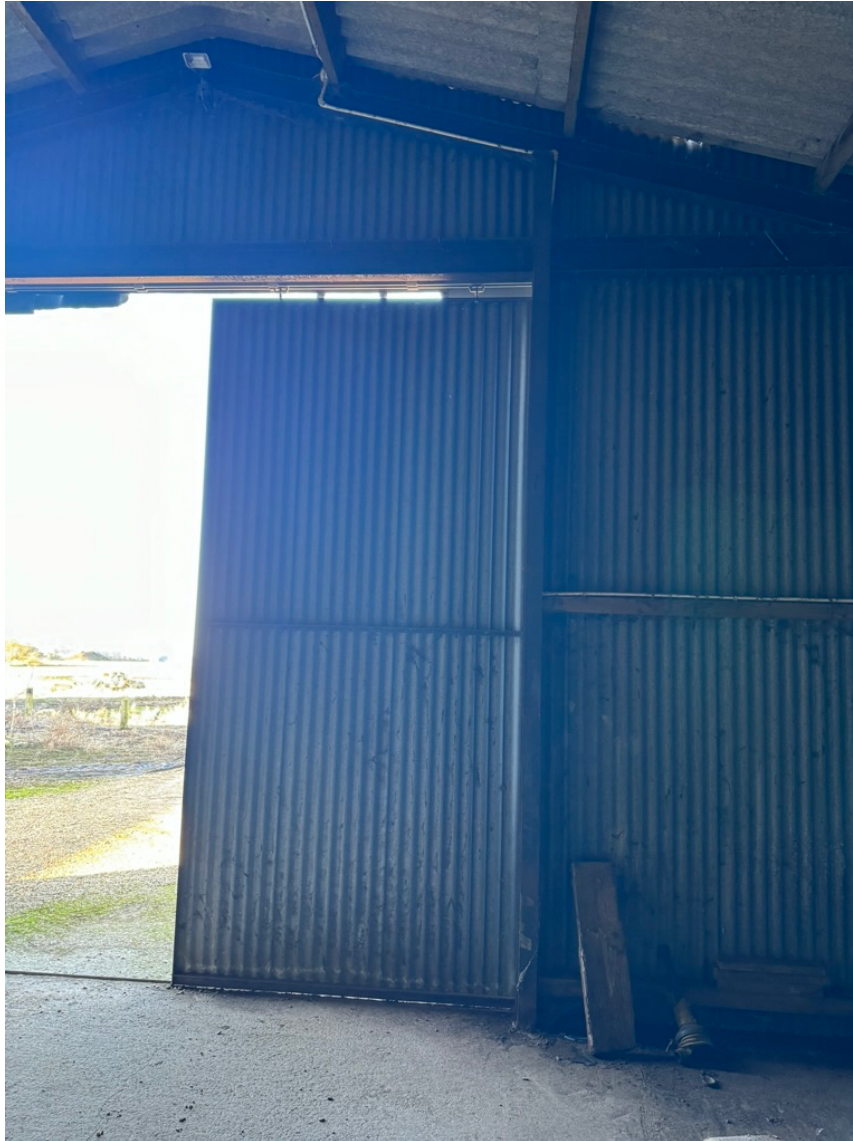
To the front gable elevation of the structure, a pair of sliding doors run from ground to eaves level. Supported off rails at the head of the door, they were found to remain intact and functioning as originally intended. Columns run from ground to roof either side of the doors and support a header beam, set to the head of the doors.

Image 4.0: Sliding doors to the front of the Barn

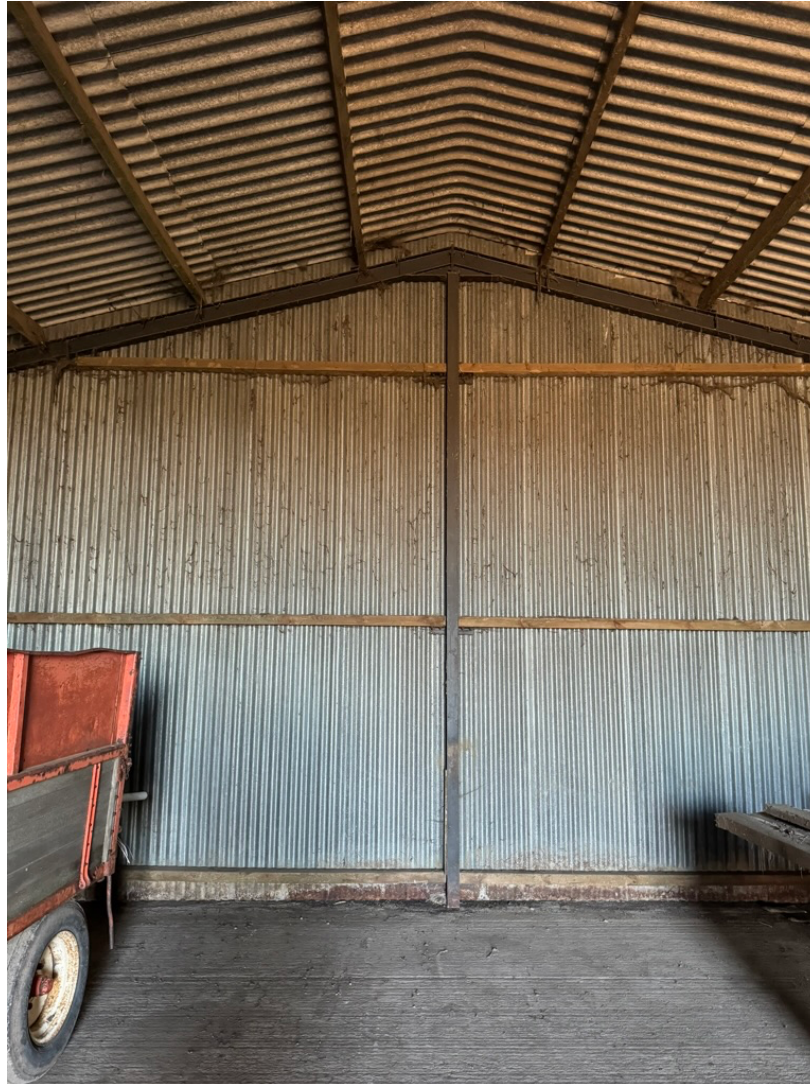
To the rear elevation, the structure comprises a final portal frame with steel rising from finished floor level to underside of Haunch at ridge. The purpose of the vertical steel element is to form a horizontal restraint to the horizontal purlins and supported cladding, preventing flexure under wind load. The column is not intended to provide support to the portal frame at ridge line.

Image 5.0: Prop running floor to ridge, providing horizontal restraint to horizontal purlins against wind suction/ pressure

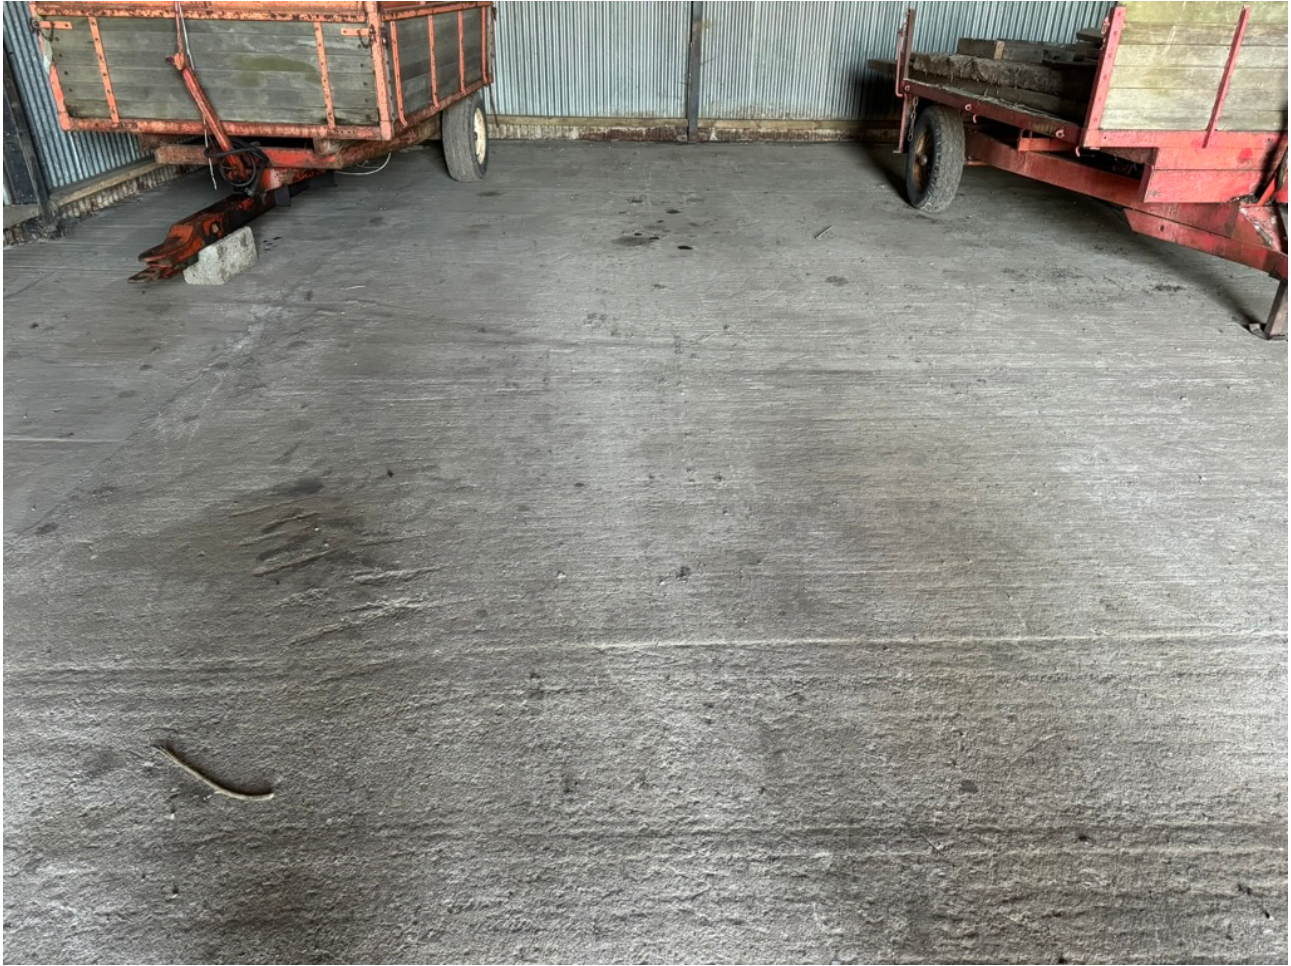
The floor to the footprint of the barn is formed from concrete, cast in situ and tamped/ levelled by hand. The concrete appears intact with no visible movement. However, cracking within the concrete was observed and may be ascribed to the lack of expansion joints, resulting in non-structural shrinkage cracking. This coupled with a lack of vertical movement infers that the finished floor suitably distributes applied loads to a suitable sub-base.

Image 6.0: Existing concrete floor, noted as being intact and functioning as originally intended

The conversion of the structure to single storey residential use may be carried out with the retention of the existing steel portal frames and associated purlins. Timber stud, set suitably in-board of the steel framing and purlins will allow for the formation of an insulated shell, internal to and separate from the external superstructure. Sway due to wind loading, for which the portal frame structure is designed, will consequently not be transferred to the internal timber stud walls. Given the limited mass of the timber stud walls, they may be sited to the head of the existing concrete floor. Line loads imparted by the timber studwork will be less than unit loading applied to the concrete floor by farm vehicles, plant and other machinery.

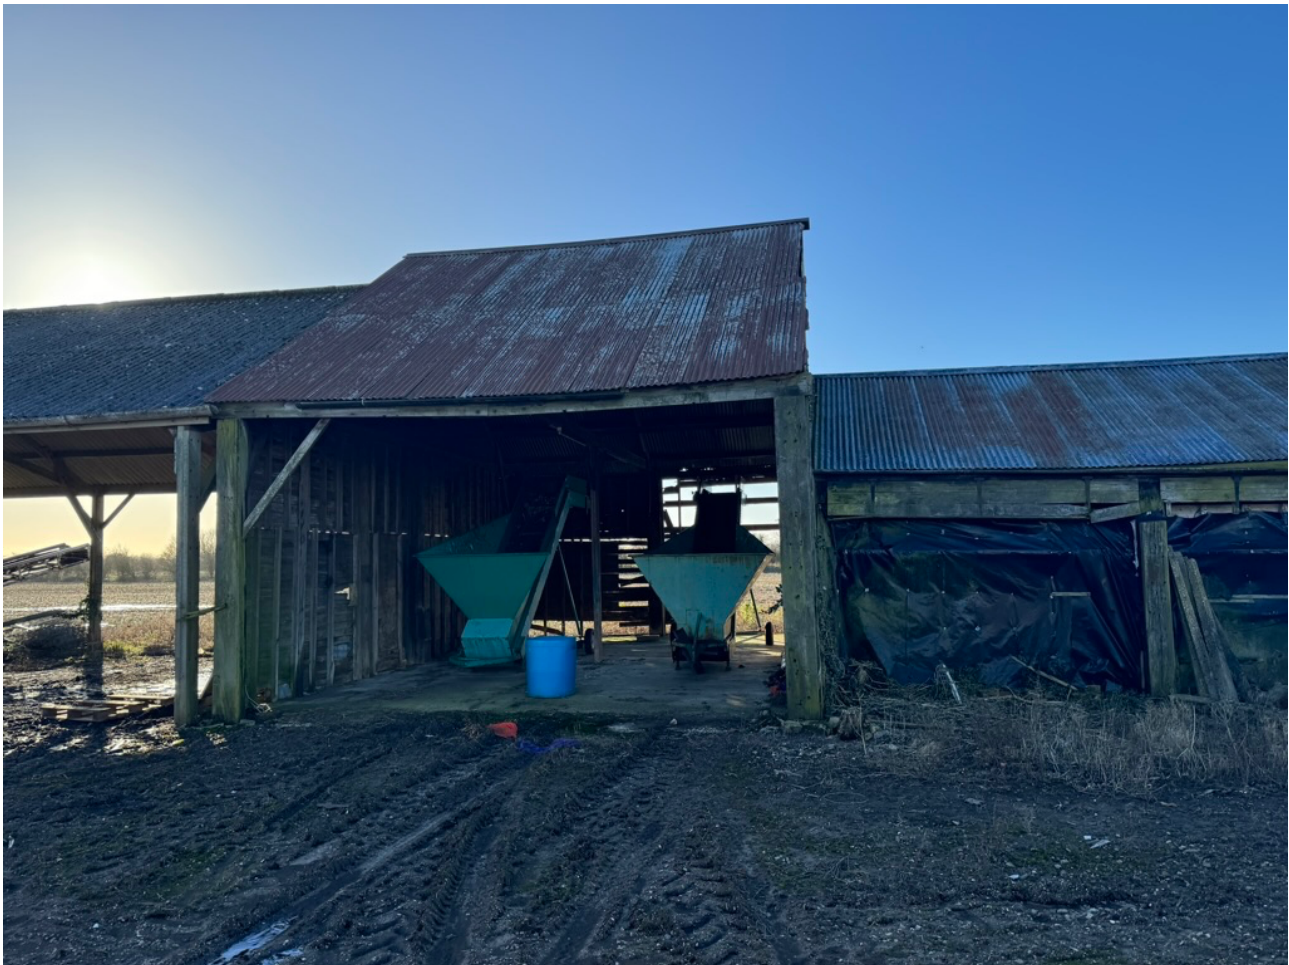
Image 12.0: External view to front of Barn 2

The structure is open at the front with a timber header beam spanning side to side between supporting timber columns. A single knee brace runs from a column up at 70° to meet the underside of the eaves beam forming a brace to prevent sway due to wind.

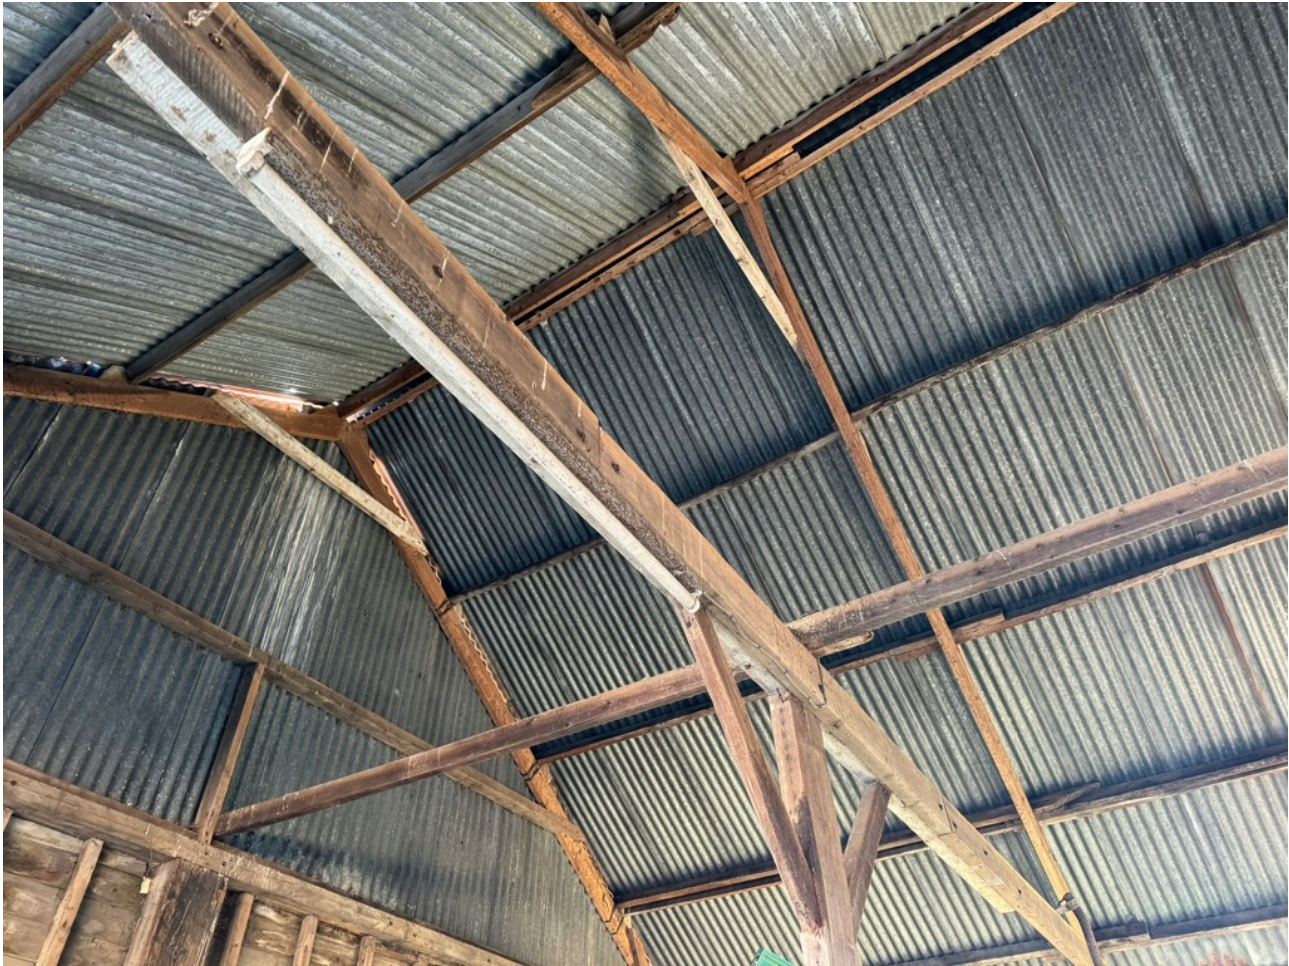
Internally, the roof structure is formed of timber purlins and ridge boards, spanning side to side between supporting side elevations. Purlins and ridge are supported midspan by a hand cut timber truss, formed of rafters and ceiling binder. A timber post is set central to the underside of the ceiling binder, providing a support to the long span timber member.

Image 13.0: Internal view of existing roof structure

Structural elements within the roof appear intact and functioning as originally intended. The roof panels and ridge line have not visibly deviated or deflected. No excessive flexure was observed and neither rafters, nor purlins were found to deviate significantly along their run. Deflection was noted in the front eaves beam to main opening, indicating that the timber spans too far. Some decay was observed in two purlins. Cladding to the side elevations appears to remain intact and functioning as originally intended. To the rear, part of the cladding appears to have been damaged. However, the superstructure and framing remains suitably intact. Timber posts formed from railway sleepers, coupled with the eaves level tie beams form a suitable frame which remains intact with no significant

The roof structure is suitable for use with the replacement of the existing corrugated metal sheeting on a Like for like basis, with a suitable composite insulated corrugated sheeting.

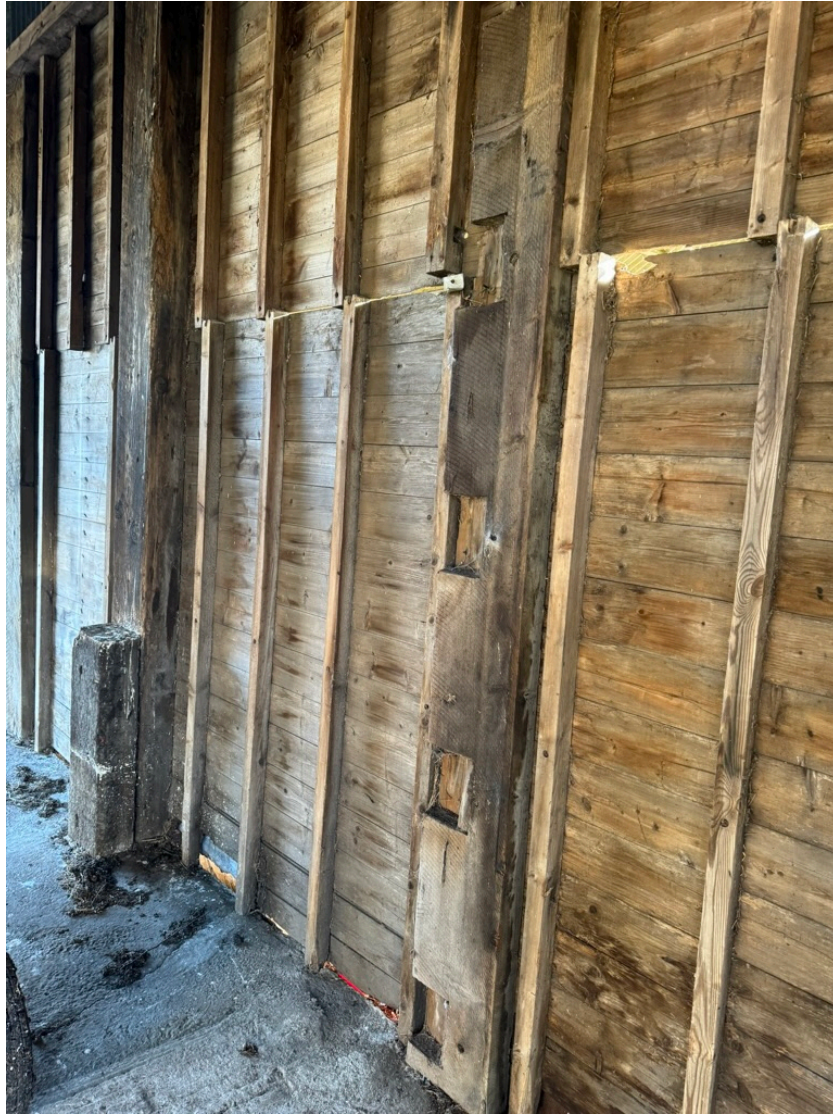
Side elevations of the structure are clad in timber between floor level and eaves. Corrugated metal sheeting runs vertically from eaves level terminating at roof level. Structural support to the side elevations is provided by railway sleepers set vertically at suitable centres and running from finished floor to a Tie Beam set in the depth of the wall running horizontally front to back.

Image 14.0: Timber columns, formed of railway sleepers set to side elevations.

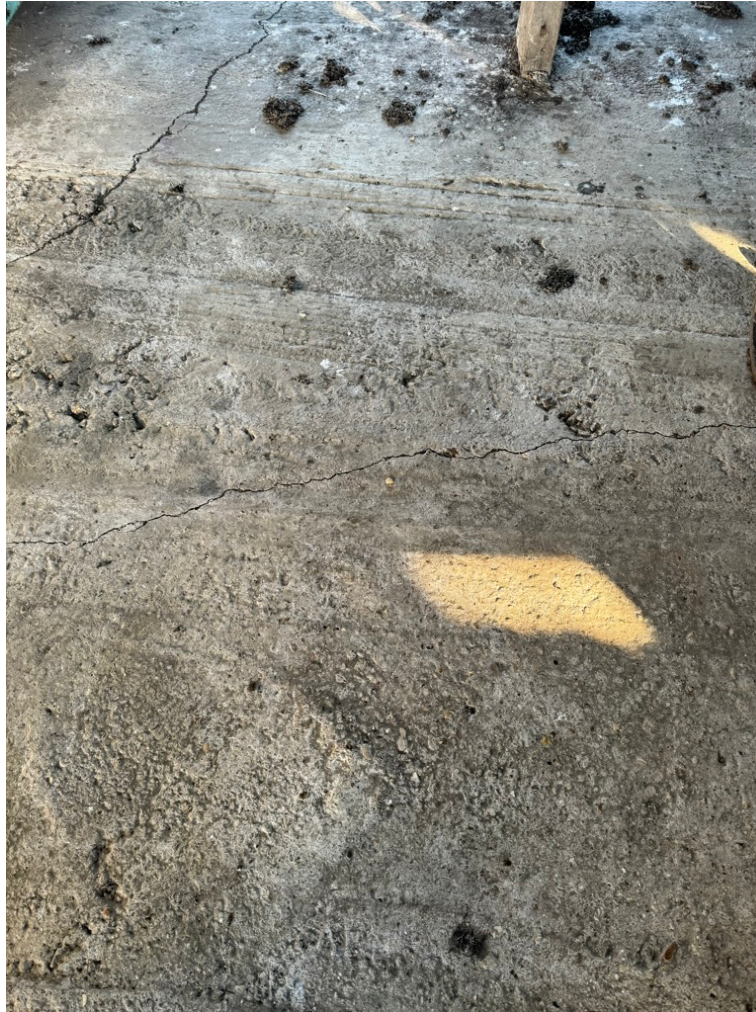
The rear of the structure incorporates timber cladding, supported by a framing system formed of timber with a central timber post formed from a railway sleeper. The finished floor is formed of concrete that has been cast in situ and Tamped firm by hand. The slab appears intact with limited movement, likely arising as a result of a lack of expansion joints. Vertical deviation in the slab was not observed.

Image 15.0: View of floor slab.

The structure is considered suitable for conversion to residential use, with retention of the majority of timber elements to the existing superstructure. These may be subsumed into the converted structure with suitable modifications to cladding so as to meet relevant regulations. an internal show performed, employing timber stud, framing, so as to allow for the fixing of finishes whilst at the same time providing sufficient depth to allow for the inclusion of sufficient insulation. The existing floor may be retained allowing for the formation of a suitable finished floor, incorporating insulation to modern standards.

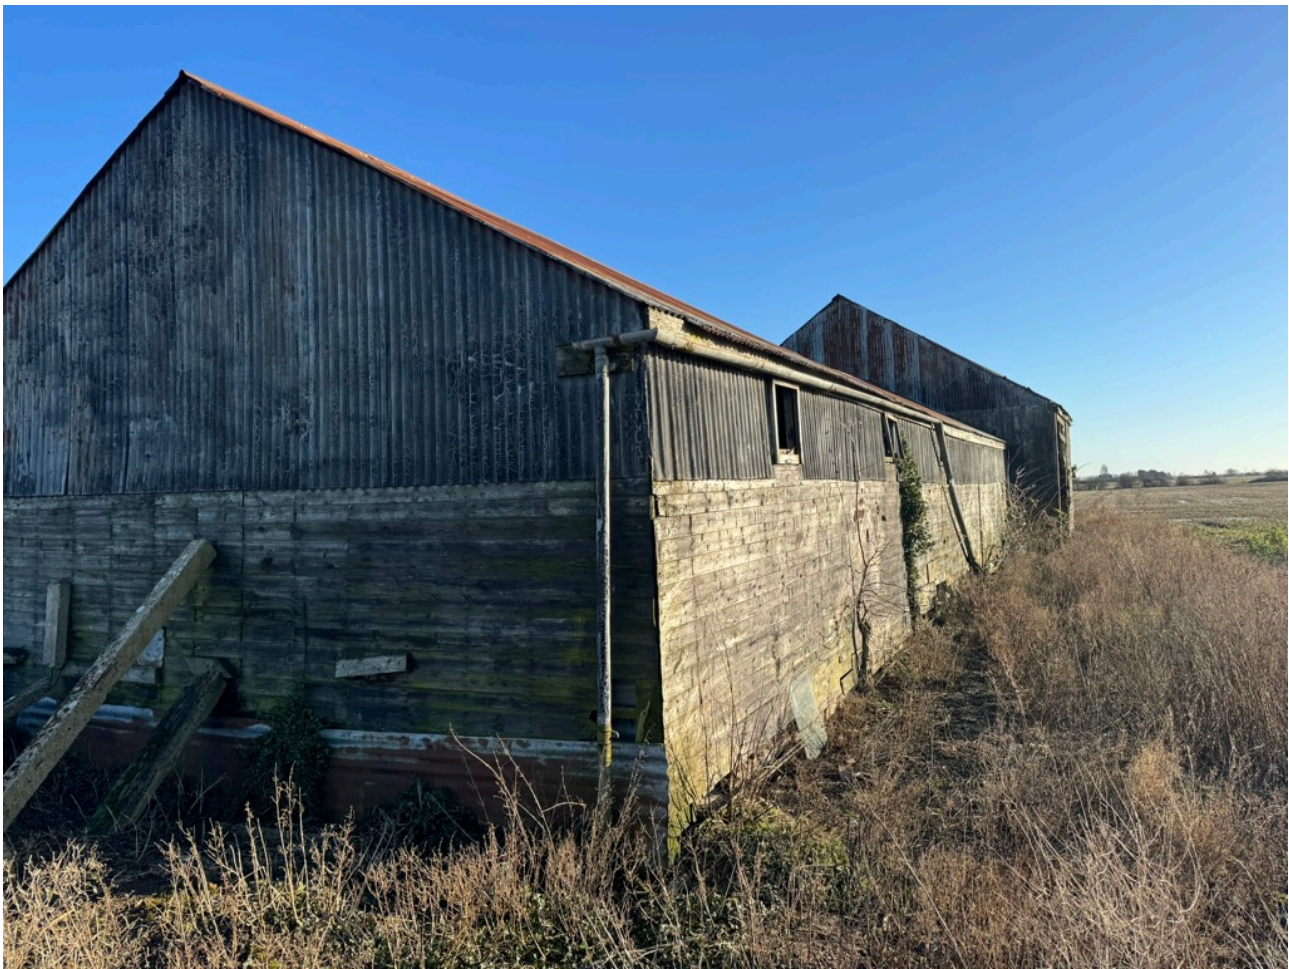
Barn Four comprises a long, single storey structure clad to the rear and end gable elevation in timber, rising to the underside of a series of small window openings, set just below eaves level. Corrugated steel sheeting run vertically between eaves and the head of the timber. To the gable end, the corrugated sheet runs from roof line down to meet the head of the timber.

Image 16.0: Gable and rear elevation of Barn 4

Rainwater goods are clearly failed to the perimeter of the structure, and some discolouration to the rear and gable elevation is indicative of a high moisture content as a result of rainwater, shedding onto the relevant elevations.

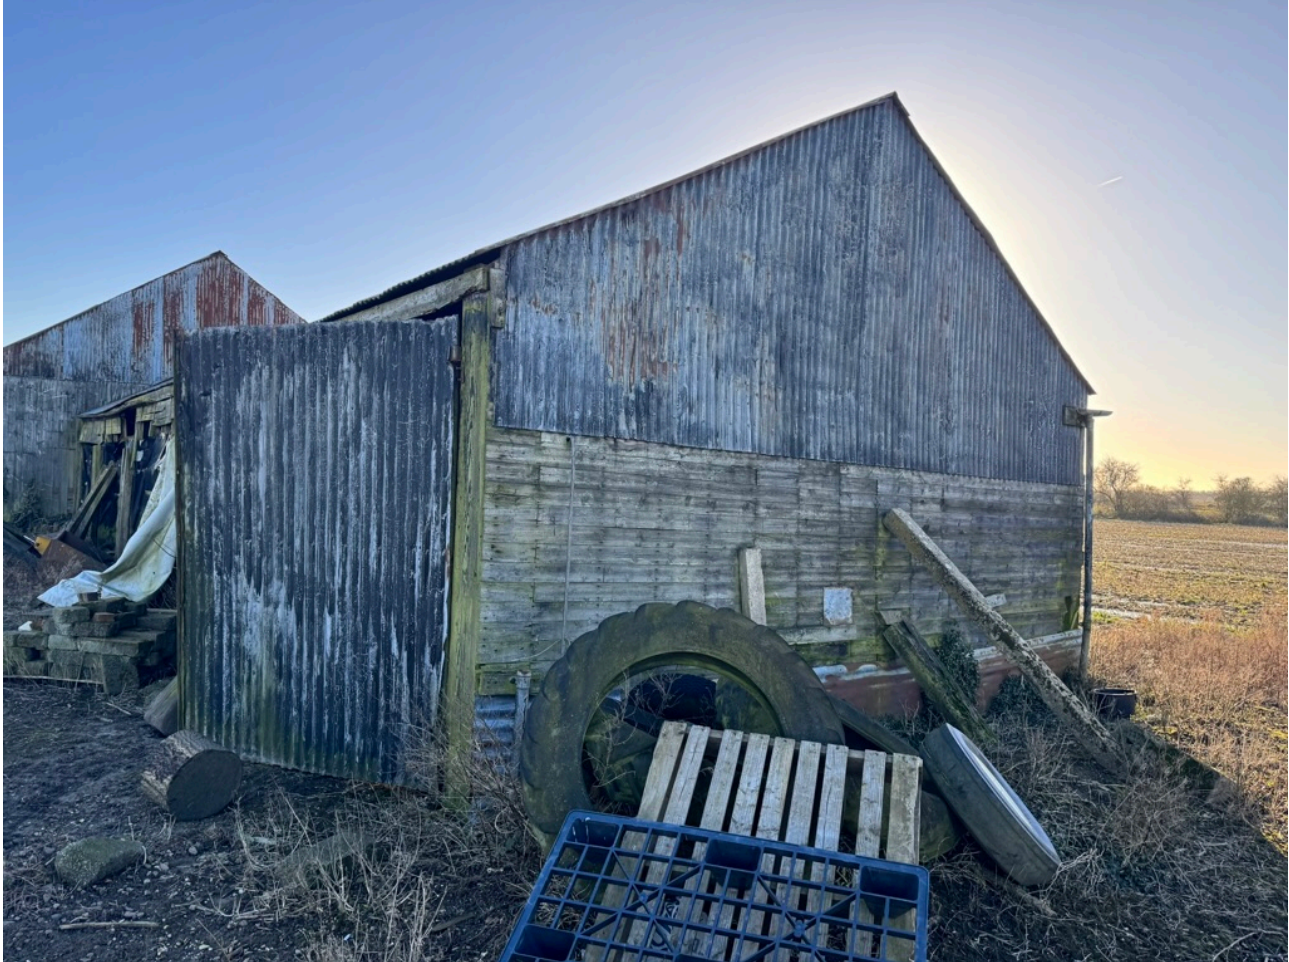
On the front elevation, a corrugated steel door provide access to the barn and the remainder of the front elevation is partially clad in a plastic sheet with timber cladding to the head of this, set to timber studs which clearly form the infill structure to this elevation.

Image 17.0: View of front entrance into Barn 4

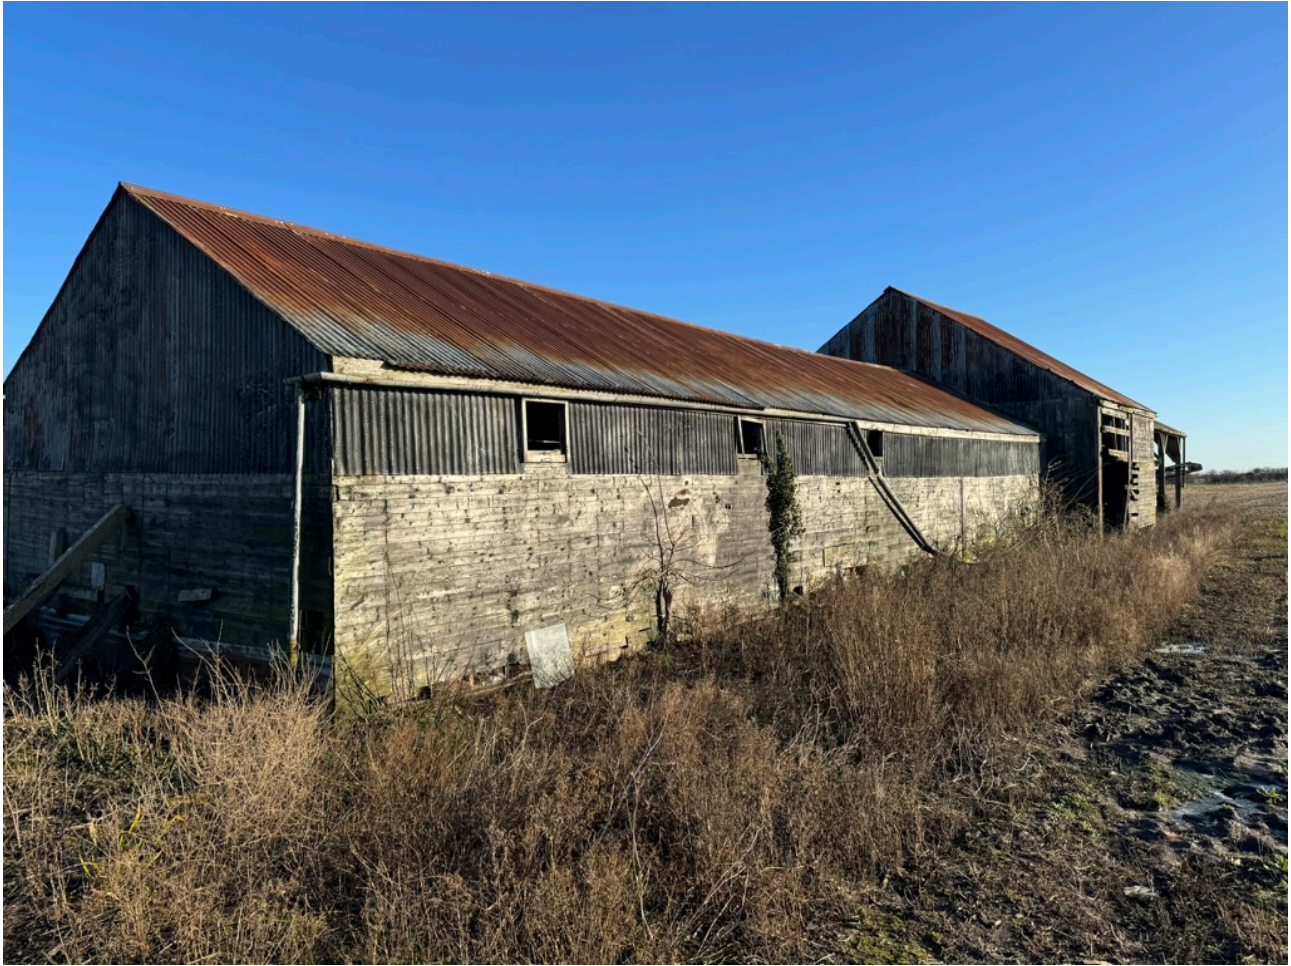
The roof structure is clad in corrugated steel sheeting, again laid to falls and the roof line is noted as being straight and with no deviation evident.

Image 18.0: View along roof and rear of Barn 4, with roof remaining intact

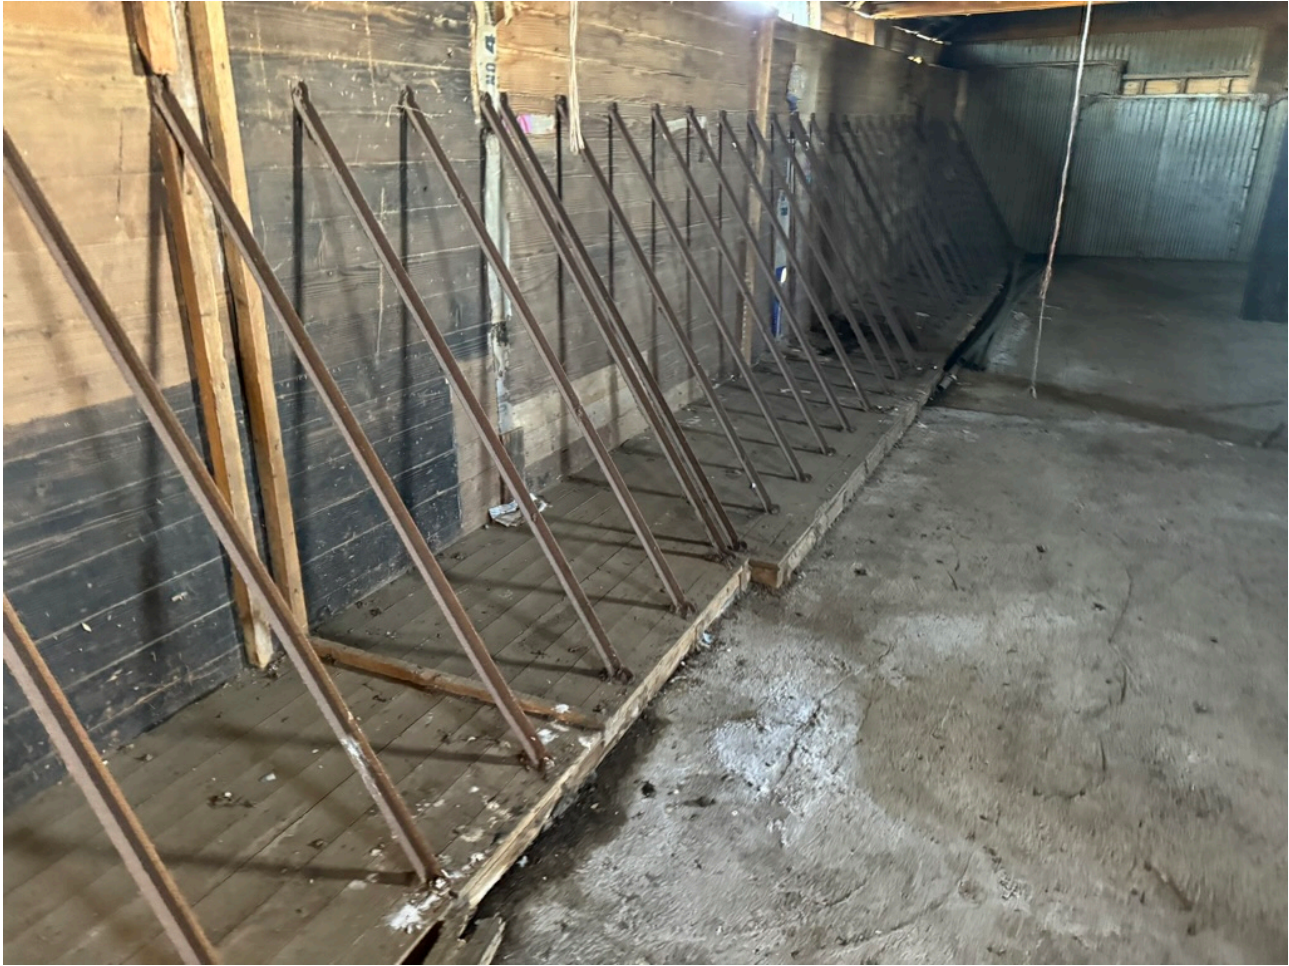
Internal to the barn, the structure is clad on the side elevations with timber. On the rear elevation, steel props run from ground level up to the timber cladding, inferring that side walls have been subjected to significant pressures, likely as a result of the barn being used as a grain store.

Image 19.0: Props between rear elevation of floor of barn 4

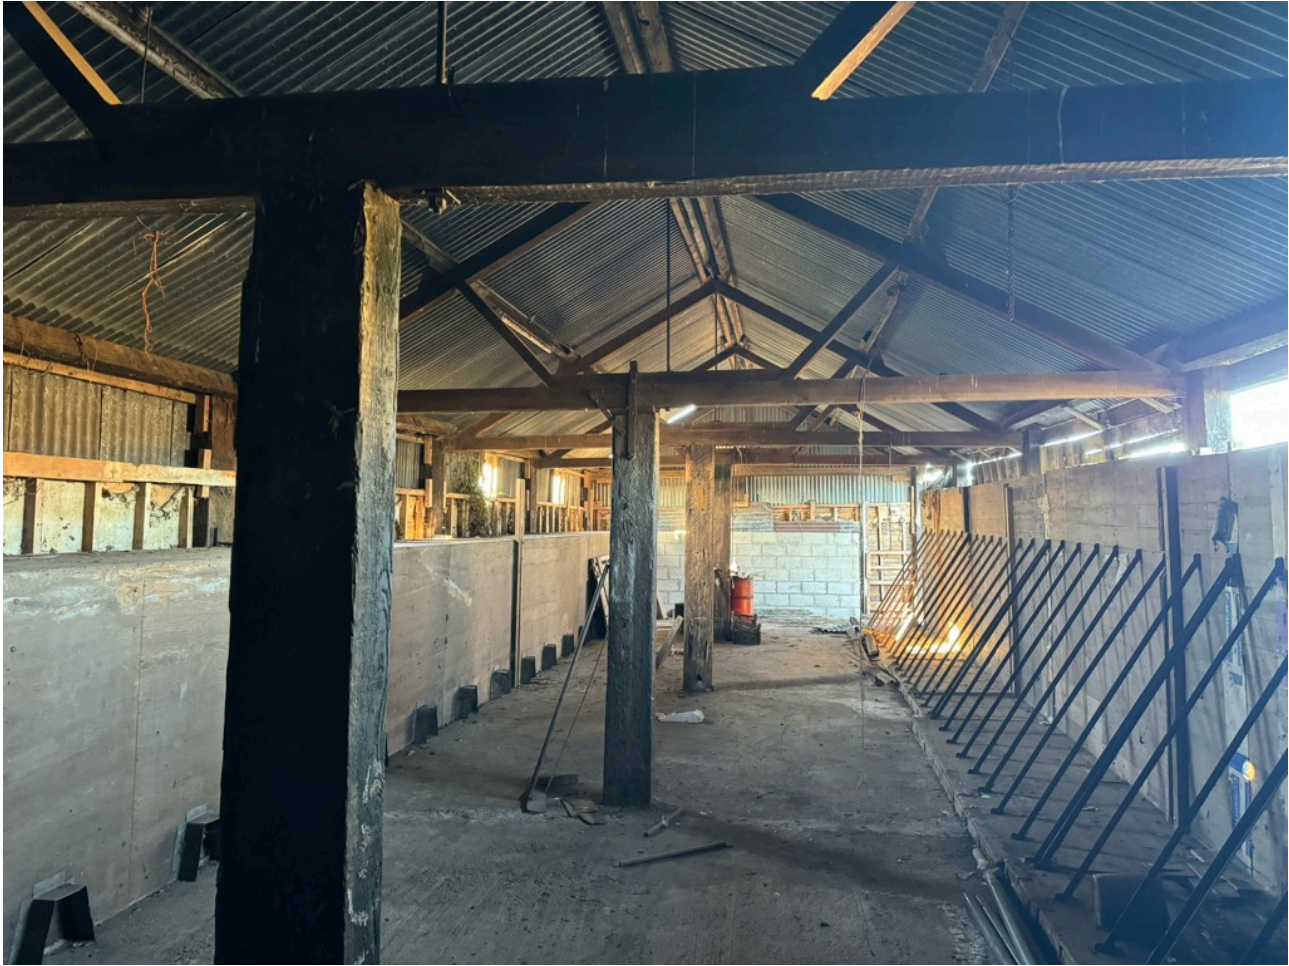
The roof structure comprises a series of timber hand cut trusses, set at centres to match supporting timber columns formed from railway sleepers. To the head of the roof is set a series of timber purlins, running between trusses. The trusses have been propped at their centres with additional railway sleepers, running from finish floor to underside of ceiling binders.

Image 20.0: Hand cut timber roof with timber supports formed from railway sleepers

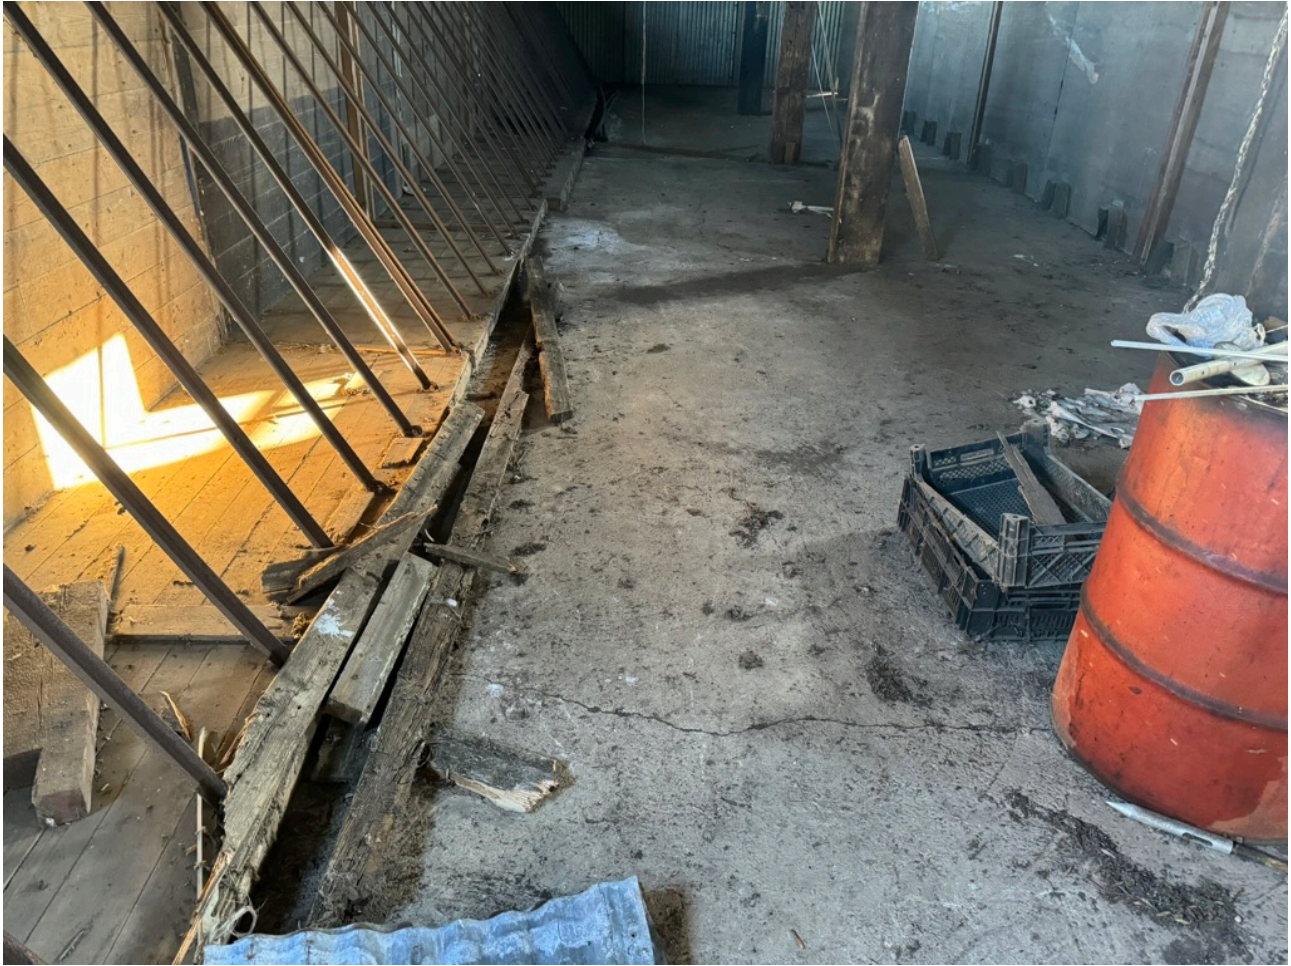
The finished floor has been cast in situ, formed of hand tamped concrete, set without suitable expansion joints. As a result, cracking has occurred. However, the slab remains suitably intact with no significant vertical deviation, indicating that it is set to a good hard-core base.

Image 21.0: View of finished concrete floor

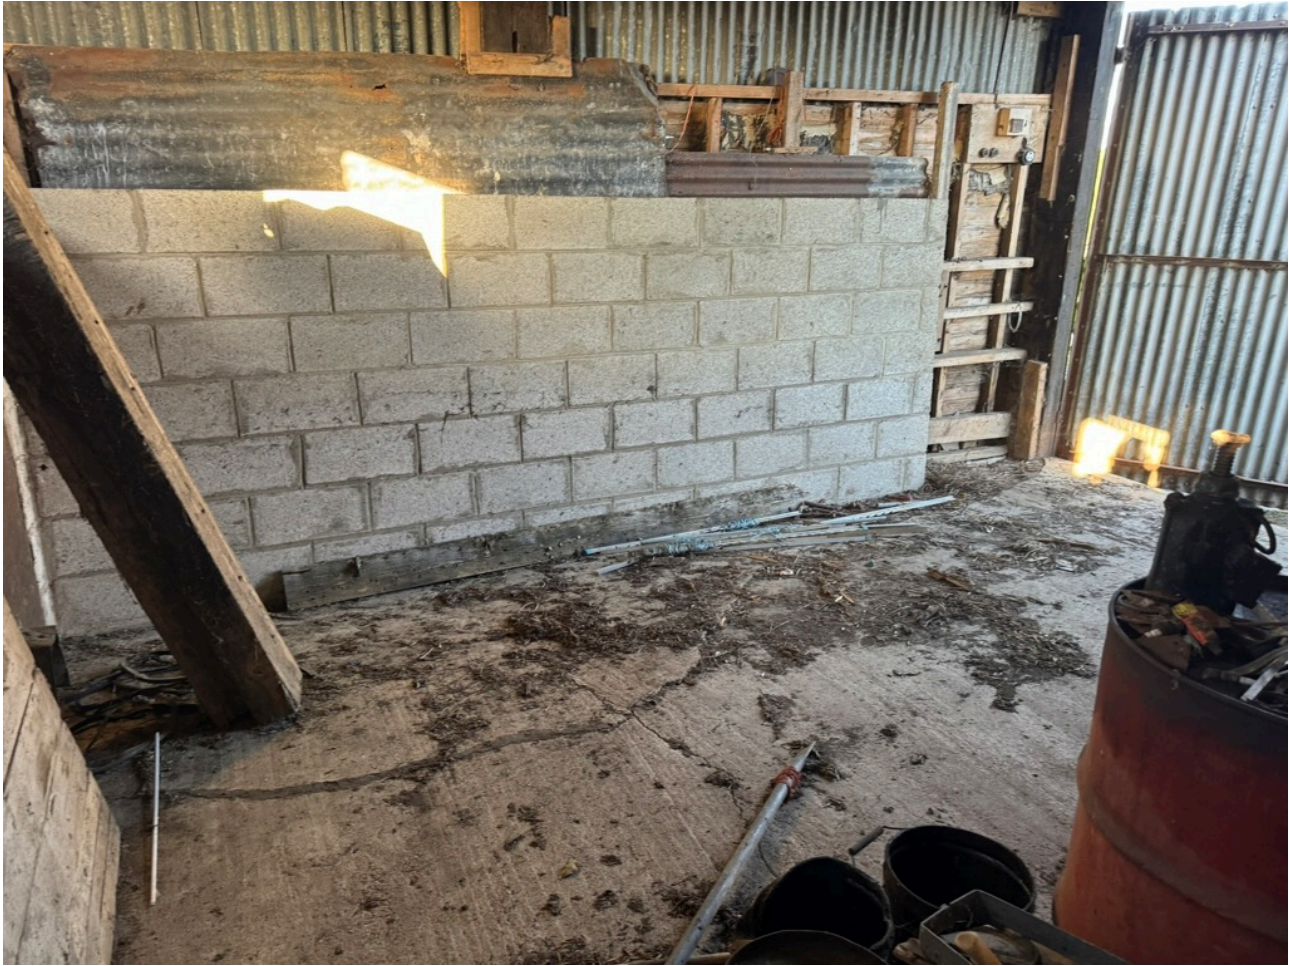
A block Work wall has been formed to the rear gable end, concealing a timber stud frame with corrugated steel sheeting running vertically to the head of this.

Image 22.0: Gable end of structure
