**REPORT:** REMEDIAL METHOD STATEMENT FOR SITE  
OFF BARRIER BANK, COWBIT, SPALDING

**CLIENT:** EAST ANGLIAN CIVILS LTD

Project No: E22131  
Ref No: E22131/3/0

Date: Sep. 2024  
Rev: -

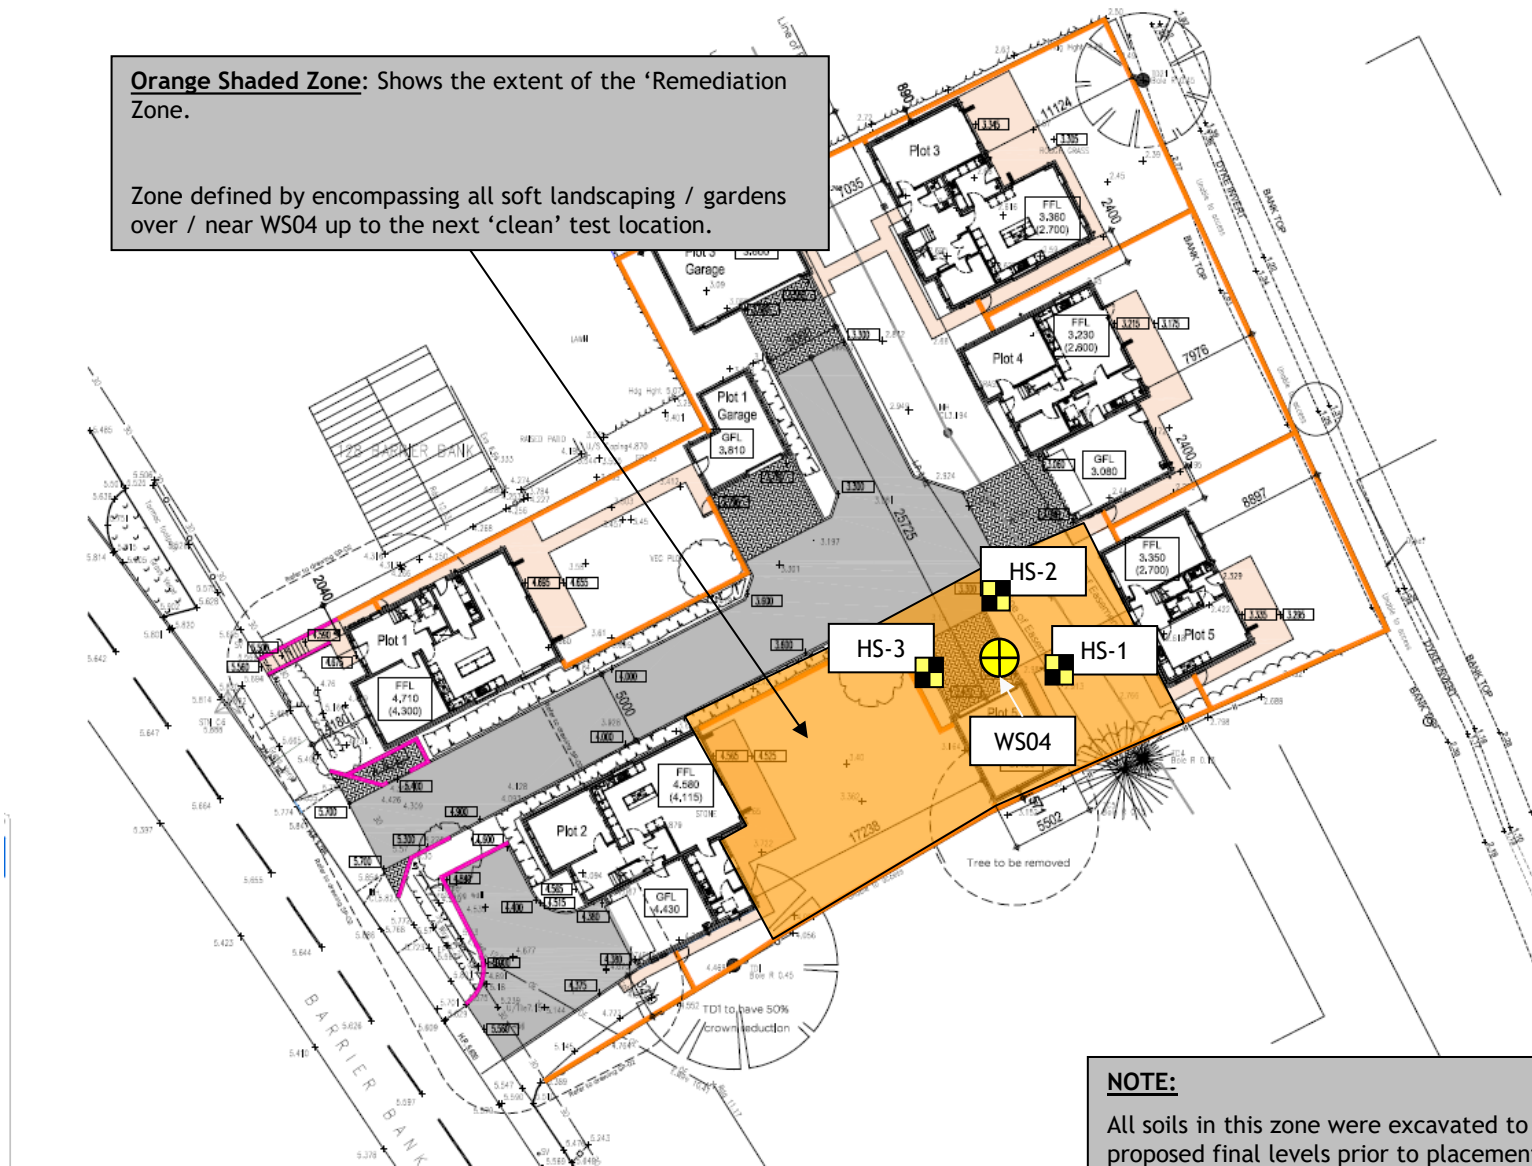
**Orange Shaded Zone:** Shows the extent of the 'Remediation Zone'.

Zone defined by encompassing all soft landscaping / gardens over / near WS04 up to the next 'clean' test location.

All soils in this zone were excavated to >1000mm below the proposed final levels prior to placement of granular 'hard dig' layer, membrane and at least 1000mm of 'clean' capping soils.

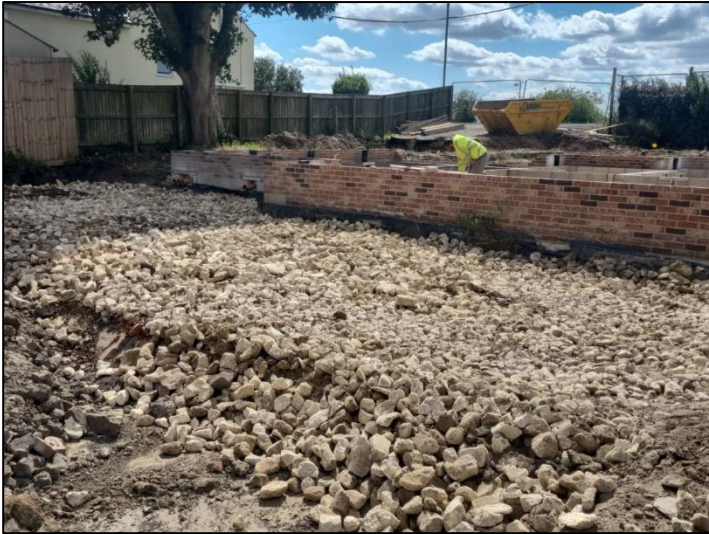
Photo 1 - Placement of 'Stone Layer' Following Excavation.

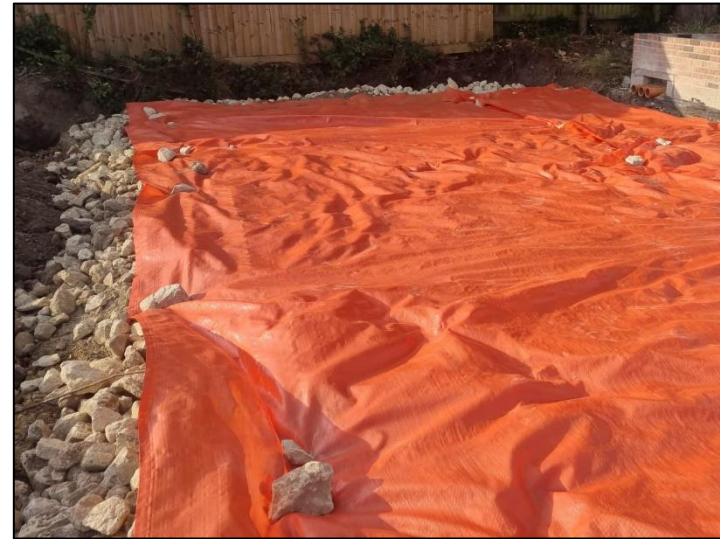
Photo 2 - Placement of 'Membrane Layer'

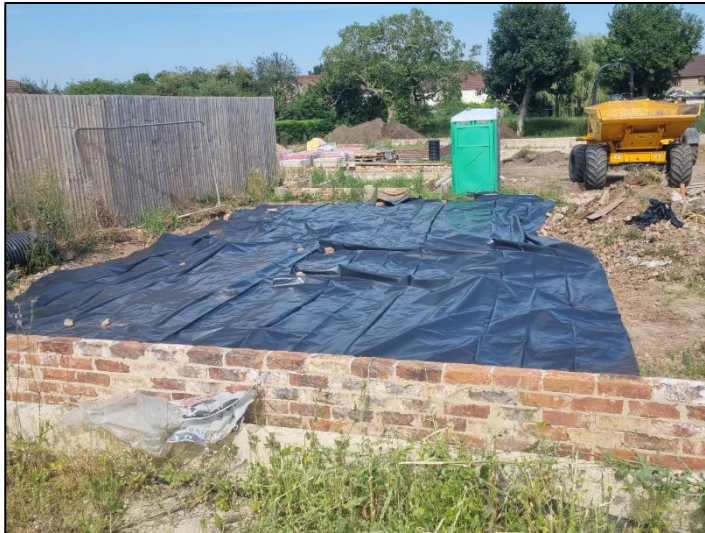
Photo 3 - Placement of Barrier Membrane for Storage.

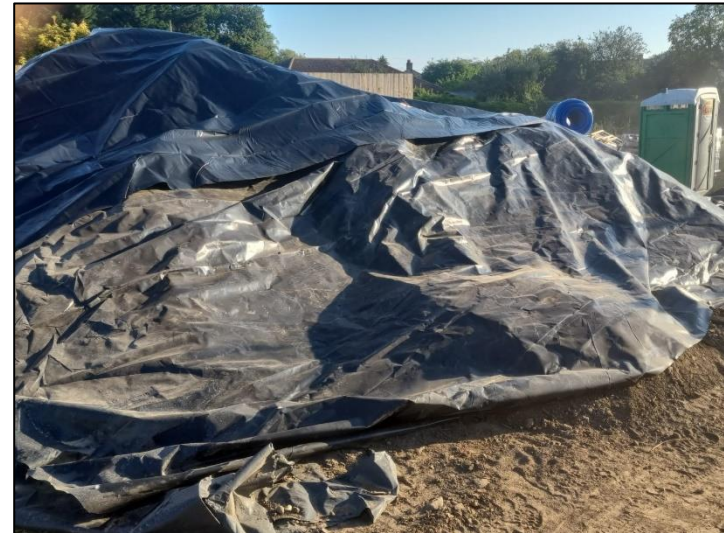
Photo 4 - Storage of Excavated Soils (Pre-Disposal).
