BS5837:2012 Tree Survey  
Land off Malting Lane  
Donington  
Lincolnshire  
NGR TF20379 35180

| | Report ref:<br>P2008 / 0220 / 01 | C B E Consulting<br>Highbank, 5 Grantham Road, Navenby<br>Lincoln. LN5 0JJ.<br>Telephone (01522) 810086.<br><a href="http://www.cbeconsulting.co.uk">www.cbeconsulting.co.uk</a> |

# **BS5837 Tree Survey, Land at Malting Lane, Donington**

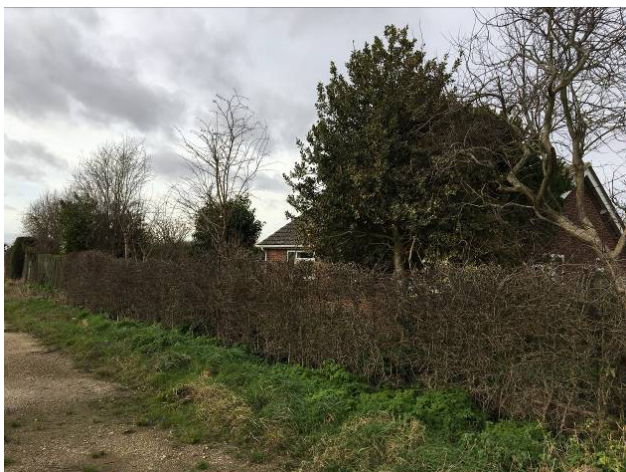
**Trees T1 -T3** are situated in a garden along the north eastern boundary of the site area. These are trees of small stature lying close to the existing site access road which comprises a concrete pad. Cherry T1 and Holly T2 are placed within Category C due to size and both are trees of reasonable quality providing screening to the garden. Oak T3 is a little larger and of sufficient size to be placed within Category B as it is in good condition and has sufficient space to continue to mature in this location.

Cherry T1 (foreground) and Holly T2

| Tree No | Species | Ht (m) | Stem Diam mm@ 1.5m | Canopy Spread (m) | Height of Crown Clearance | Age Class | Est yrs | Overall Condition | Structural condition | Recommendations | BS 5837 Category | RPA Radius (m) |
|---|---|---|---|---|---|---|---|---|---|---|---|---|
| T1 | Cherry<br><i>Prunus avium</i> | 5 | 165 | N-2<br>S-2<br>E-2<br>W-2 | 2 | SM | 10 | F | Single trunk. Irregular canopy extending east. Negligible roost potential. No structural faults visible from ground level | None | C2 | 1.9 |
| T2 | Variegated Holly<br><i>Ilex aquifolium variegatum</i> | 5 | 155 | N-2<br>S-2<br>E-2<br>W-2 | 1 | Y | 10 | F | Single trunk. Round crown. Lifted on south over hedge. Negligible roost potential. No structural faults visible from ground level | None | C2 | 1.9 |

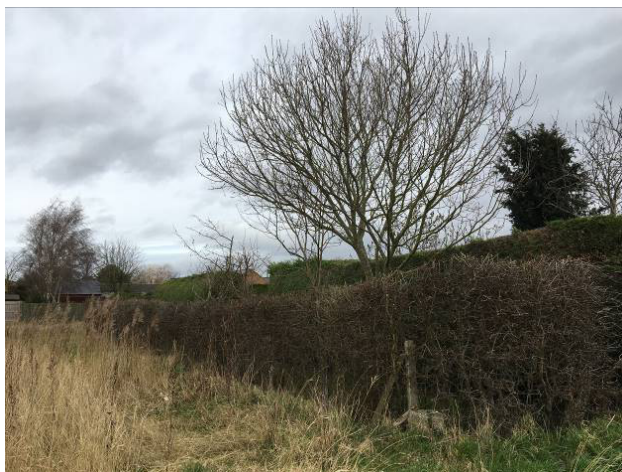
Oak T3

| Tree No | Species | Ht (m) | Stem Diam mm@ 1.5m | Canopy Spread (m) | Height of Crown Clearance | Age Class | Est yrs | Overall Condition | Structural condition | Recommendations | BS 5837 Category | RPA Radius (m) |
|---|---|---|---|---|---|---|---|---|---|---|---|---|
| T3 | Oak<br><i>Quercus petraea</i> | 6 | 180 | N-2<br>S-3<br>E-3<br>W-3 | 2 | Y | 20+ | G | Single trunk. Broadly ascending balanced crown. Negligible roost potential. No structural faults visible from ground level | RPA will extend across the boundary 0.5m but there is an existing concrete pad in this location. | B2 | 2.1 |

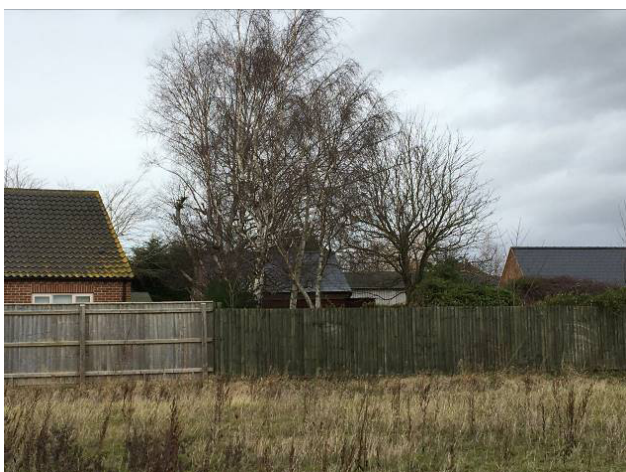
Group G4 comprises a line of semi-mature Birch trees situated in a garden adjacent to the northern boundary. The crown of the tree at the south end does extend past the site boundary and this group is placed within Category B,

Birch Group G4

| Tree No | Species | Ht (m) | Stem Diam mm@ 1.5m | Canopy Spread (m) | Height of Crown Clearance | Age Class | Est yrs | Overall Condition | Structural condition | Recommendations | BS 5837 Category | RPA Radius (m) |
|---|---|---|---|---|---|---|---|---|---|---|---|---|
| G4 | Birch<br><i>Betula pendula</i> | 6-9 | <200 | N-<br>S-3<br>E-<br>W- | 3 | Y-SM | 20 | F | Line of merging Birch in garden. Nearest 1m back from site boundary. Negligible roost potential. No structural faults visible from ground level | None | B2 | 2.4 |

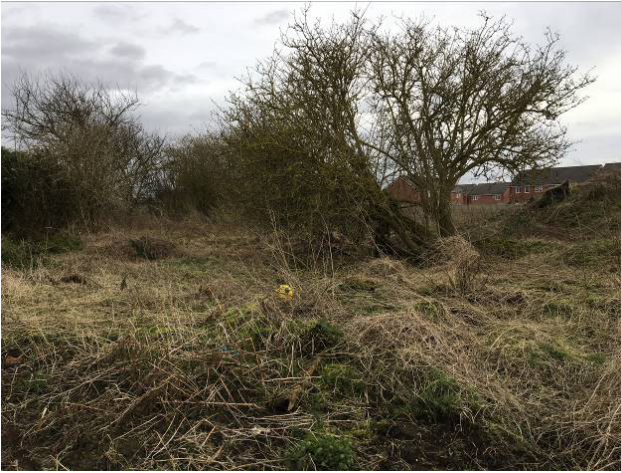
**Trees T5 – G7** are positioned close to the northern boundary but within the site area. These are small trees with limited space for development, crowded between a Leylandii hedgerow within the garden boundary to the north and a soil bund with scrub Hawthorn and Elder to the south. These are not trees of high quality of significant landscape value and they have been placed within Category C.

T5, Group 6 and T7

The removal of trees T5, G6 and T7 within the buffer zone adjacent to the northern boundary of the site will have negligible impact on visual amenity and canopy cover within this area as these are trees of small stature in a position where they are not highly visible.

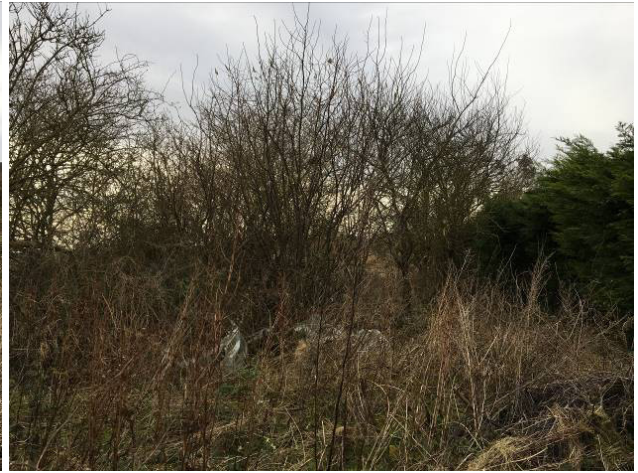
Group G6

| Tree No | Species | Ht (m) | Stem Diam mm@ 1.5m | Canopy Spread (m) | Height of Crown Clearance | Age Class | Est yrs | Overall Condition | Structural condition | Recommendations | BS 5837 Category | RPA Radius (m) |
|---|---|---|---|---|---|---|---|---|---|---|---|---|
| G6 | 3 x Cherry<br><i>Prunus avium</i> | 5 | <150 | N-2<br>S-2<br>E-2<br>W-2 | 1 | Y | 10 | F | Group of three broadly ascending cherry with merging canopies. Negligible roost potential. No structural faults visible from ground level | Likely to be removed to create the access buffer zone along the northern boundary. | C2 | 1.8 |

| Tree | Category | Impact of development |
|---|---|---|
| G6 3 x Cherry | C2 | It is likely this tree will be removed to provide the open buffer zone for access along the northern boundary. |

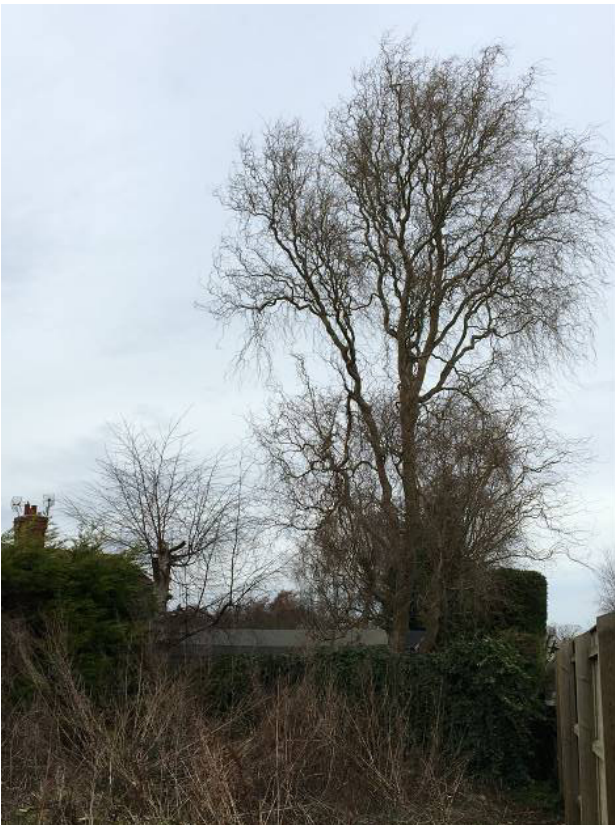
Birch T8 and Willow T9 are situated in a garden adjacent to the north boundary. The position of these trees is quite hidden but these do provide screening to the garden and the Willow in particular is a tree of reasonable quality. Birch T8 has been severely pollarded and is placed within Category C and Willow T9 is placed within Category B.

Birch T8 (left) Willow T9 (right)

| Tree No | Species | Ht (m) | Stem Diam mm@ 1.5m | Canopy Spread (m) | Height of Crown Clearance | Age Class | Est yrs | Overall Condition | Structural condition | Recommendations | BS 5837 Category | RPA Radius (m) |
|---|---|---|---|---|---|---|---|---|---|---|---|---|
| T8 | Birch<br><i>Betula pendula</i> | 4 | 200 | N-2<br>S-2<br>E-2<br>W-2 | 1 | SM | 10 | P | Single trunk pollarded with a very limited regenerative canopy. Negligible roost potential. No structural faults visible from ground level | None | C2 | 2.4 |
| T9 | Contorted Willow<br><i>Salix contorta</i> | 8 | 245 | N-3<br>S-2<br>E-2<br>W-3 | 2 | SM | 20 | F | Single trunk. Upright irregular canopy. Negligible roost potential. No structural faults visible from ground level | None | B2 | 2.9 |
