**Brindle
& Green**

Arboricultural Impact Assessment

Thomas Cowley High School, Donington

Report Reference: BG24.506

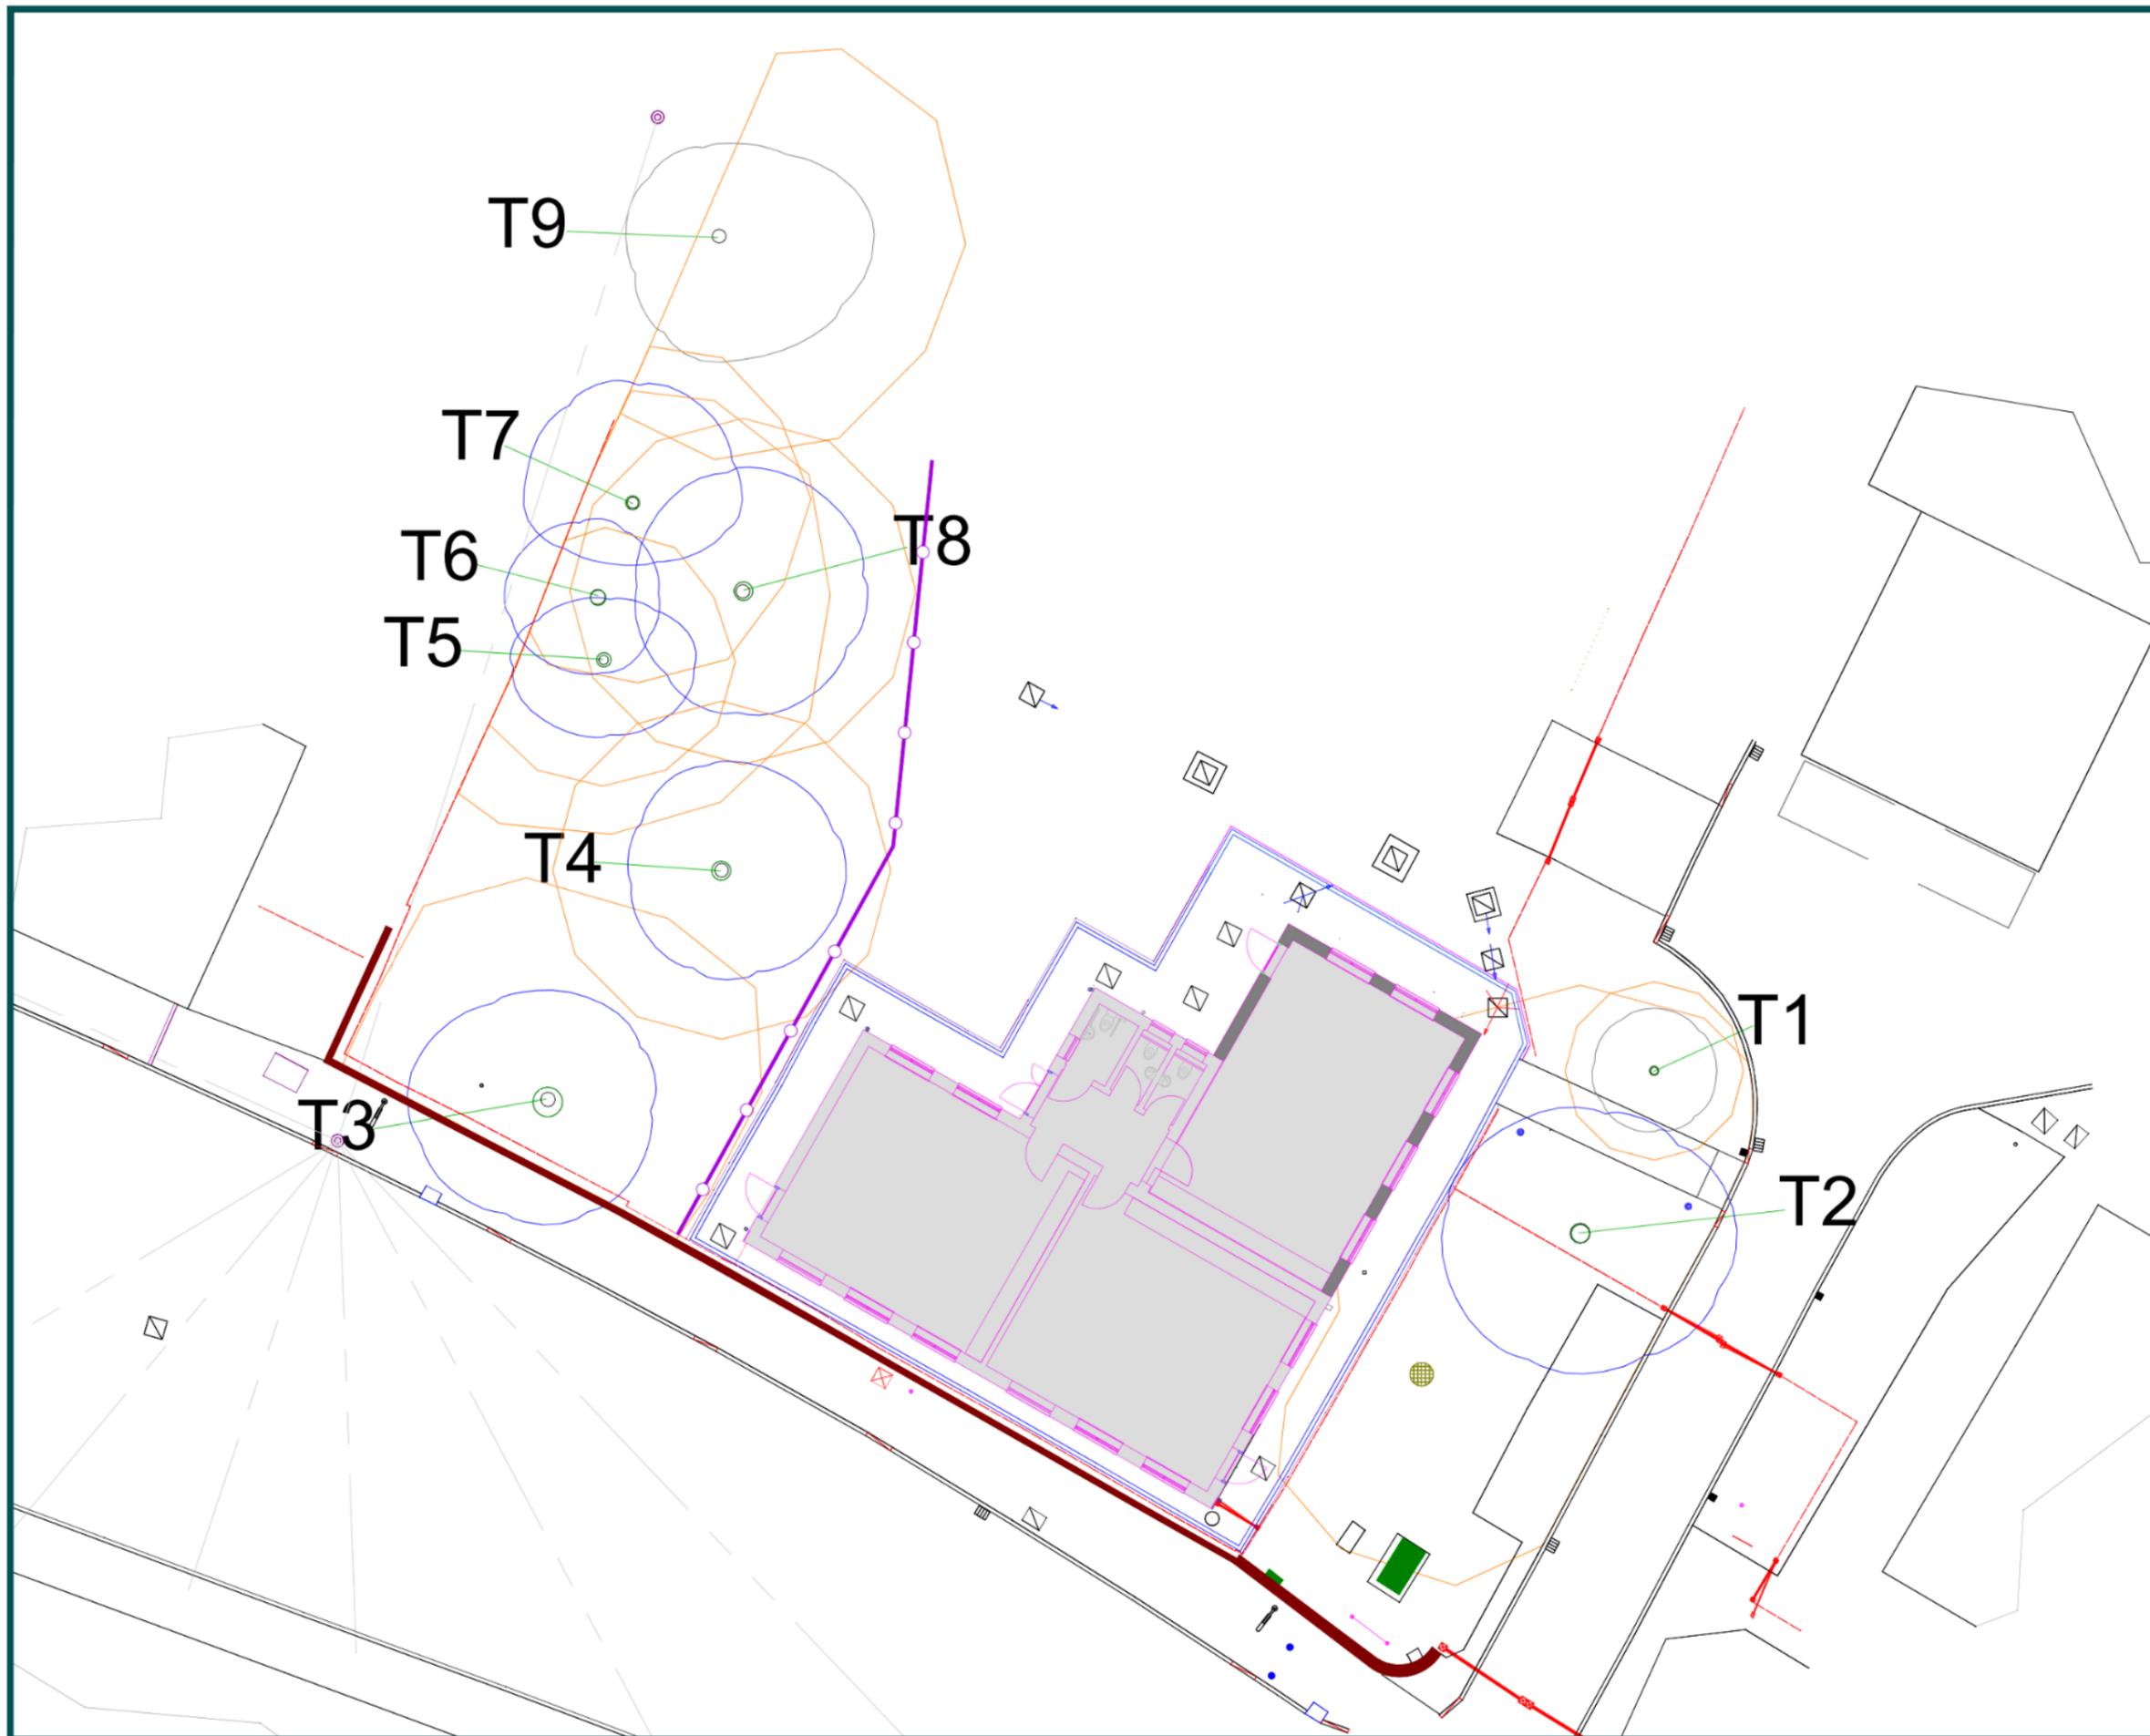
Drawing title
TREE PROTECTION PLAN

4.3.1 One Construction Exclusion Zone (CEZ) is to be established prior to the commencement of any works onsite. The CEZ should be set out as per the locations on the tree protection plan, parallel to the existing hardstanding, protecting retained trees T3 – T8 adjacent to the proposed area of work; a full exclusion zone around T3-T9 is not necessary, due to their distance from the development. Retained trees T1 and T2 are not recommended protection via CEZs due to the

4.3.2 Due to the low-impact nature of the works, and the distance between T3-T8 to the proposed works, the CEZ fencing will comprise of a reduced specification of tree protection fencing (relevant to BS 5837 Figures 2 and 3); for example, driven wooden posts with fastened 2m Heras panels.

4.3.3 CEZs are always to be afforded protection and will be protected by fencing. No equipment or machinery will be stored within CEZs, nor will vehicles or personnel enter these areas. Ground levels will not be changed within CEZs and existing vegetation will be left undisturbed. Regular checks of the tree protection fencing should be carried out by a suitably qualified arboricultural consultant. The indicative locations of the CEZs can be seen on the tree protection plan in Appendix 2; the precise fencing location may require minor adjustment onsite due to local site conditions, but is not expected to differ from that shown on the tree protection plan. In some instances, tree removal or facilitative pruning works will be required for fencing installation; tree protection fencing will be installed immediately after these tree works are completed.

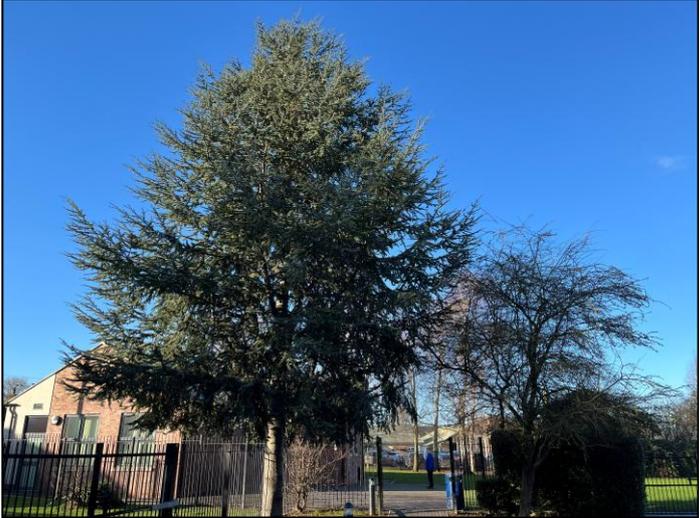
A photograph showing a large, mature evergreen tree in the foreground. Behind the tree is a black metal fence, and further back is a brick classroom building under a clear blue sky.	<p>T1 and T2, beyond the existing metal boundary fencing adjacent to the classroom building.</p>

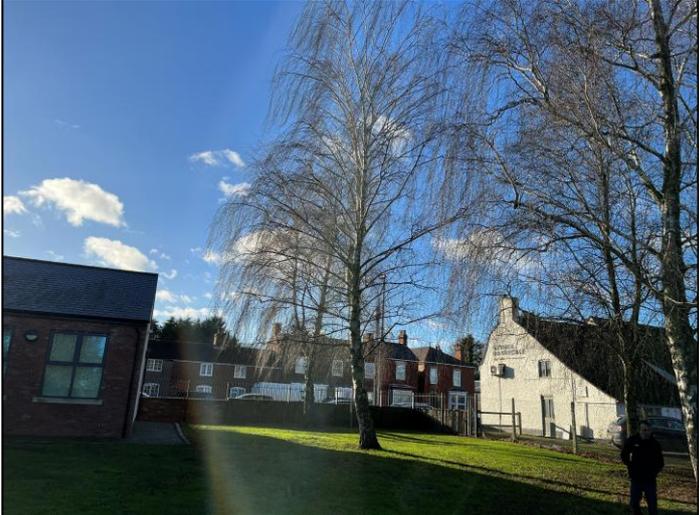
A photograph showing a row of trees, including a prominent weeping willow tree, situated west of a brick classroom building. The sky is blue with some clouds.	<p>T3 – T6, west of the existing classroom building.</p>
