# **APPLICATION FOR TREE WORKS**

## **TREE SUBJECT TO TPO**

### **QUADRING ROAD**

### **DONINGTON**

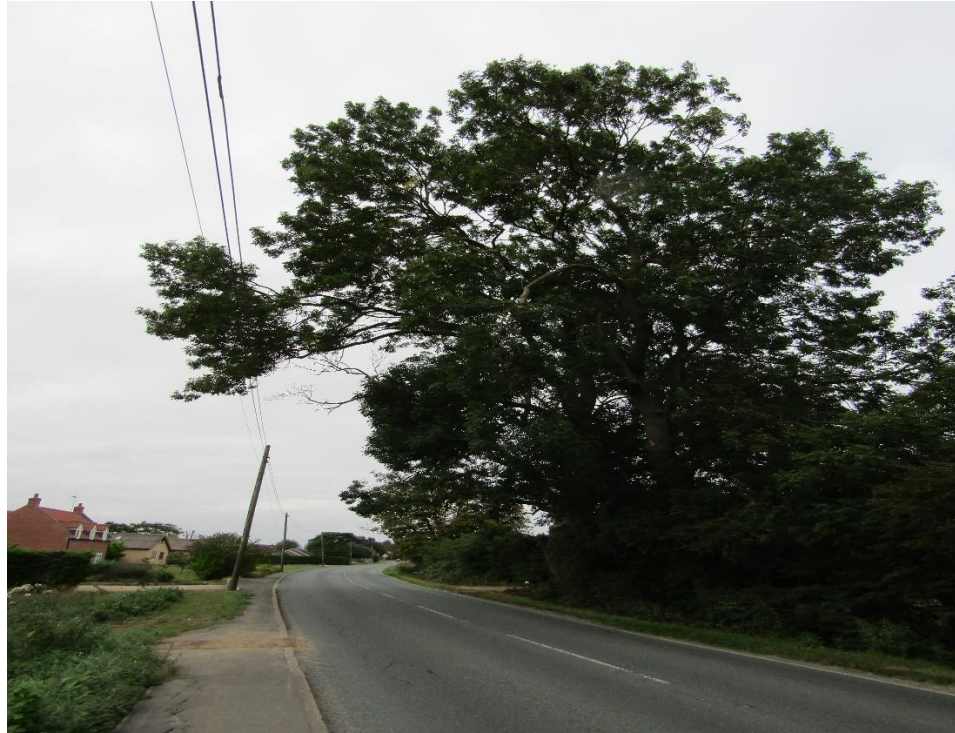
Ash 2. Requires removal because it has had numerous previous works permitted and from inspection some none permitted, probably when limbs have fallen from the tree in the past. This has resulted in nonnatural growth patterns, much of it extending over the highway. This in turn has meant that there are now dangerous limbs over the highway. Based on past permissions and current condition of limbs this looks as if it will be an ongoing frequent process. With the removal of the first tree this one will also be open to damage by wind where previously it hadn't. This will result in costly uneconomic work on a regular basis on a tree which has low visual quality and is an ongoing risk to road users. Also, any work will result in traffic management being required and possibly road closure on a major A road resulting in long diversions and massive inconvenience to the local people and people passing through to Spalding. In summery the tree is of low visual value and a poor example of its type; the tree is a potential hazard to road users and will continue to be so due to the brittle nature of the wood. Although it is of low consideration in planning terms, the cost of the works would be in the thousands with many tree surgeons not willing to take on the work and repeated works are not sustainable in any form as shown by the complete disregard of the previous owners to the condition and management of the trees resulting in the need for their removal. There are other ash trees within the land parcel are in far better condition and have far more life left in them. The retention of this tree which has limbs dying back could result in die back spreading to nearby trees.

Picture showing Ash 2. With large limbs overhanging the A152.

Replant with one standard Oak in position shown on the Block plan.

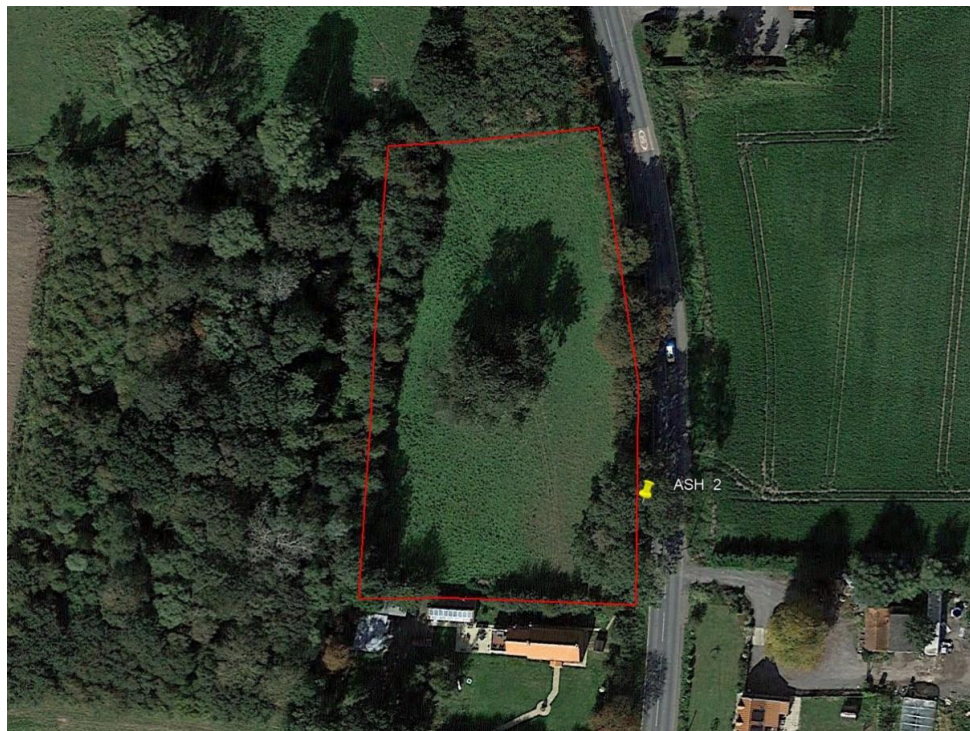
Picture showing the location of Ash 2. With the extent of the canopy overhanging the A152.
