APPLICATION No. HUS 0457 93

Reference: H05/0457/93

Description: Erection of replacement dwelling, including demolition  
of existing

Location : Mill Bank Holbeach Fen  
Spalding Lincs

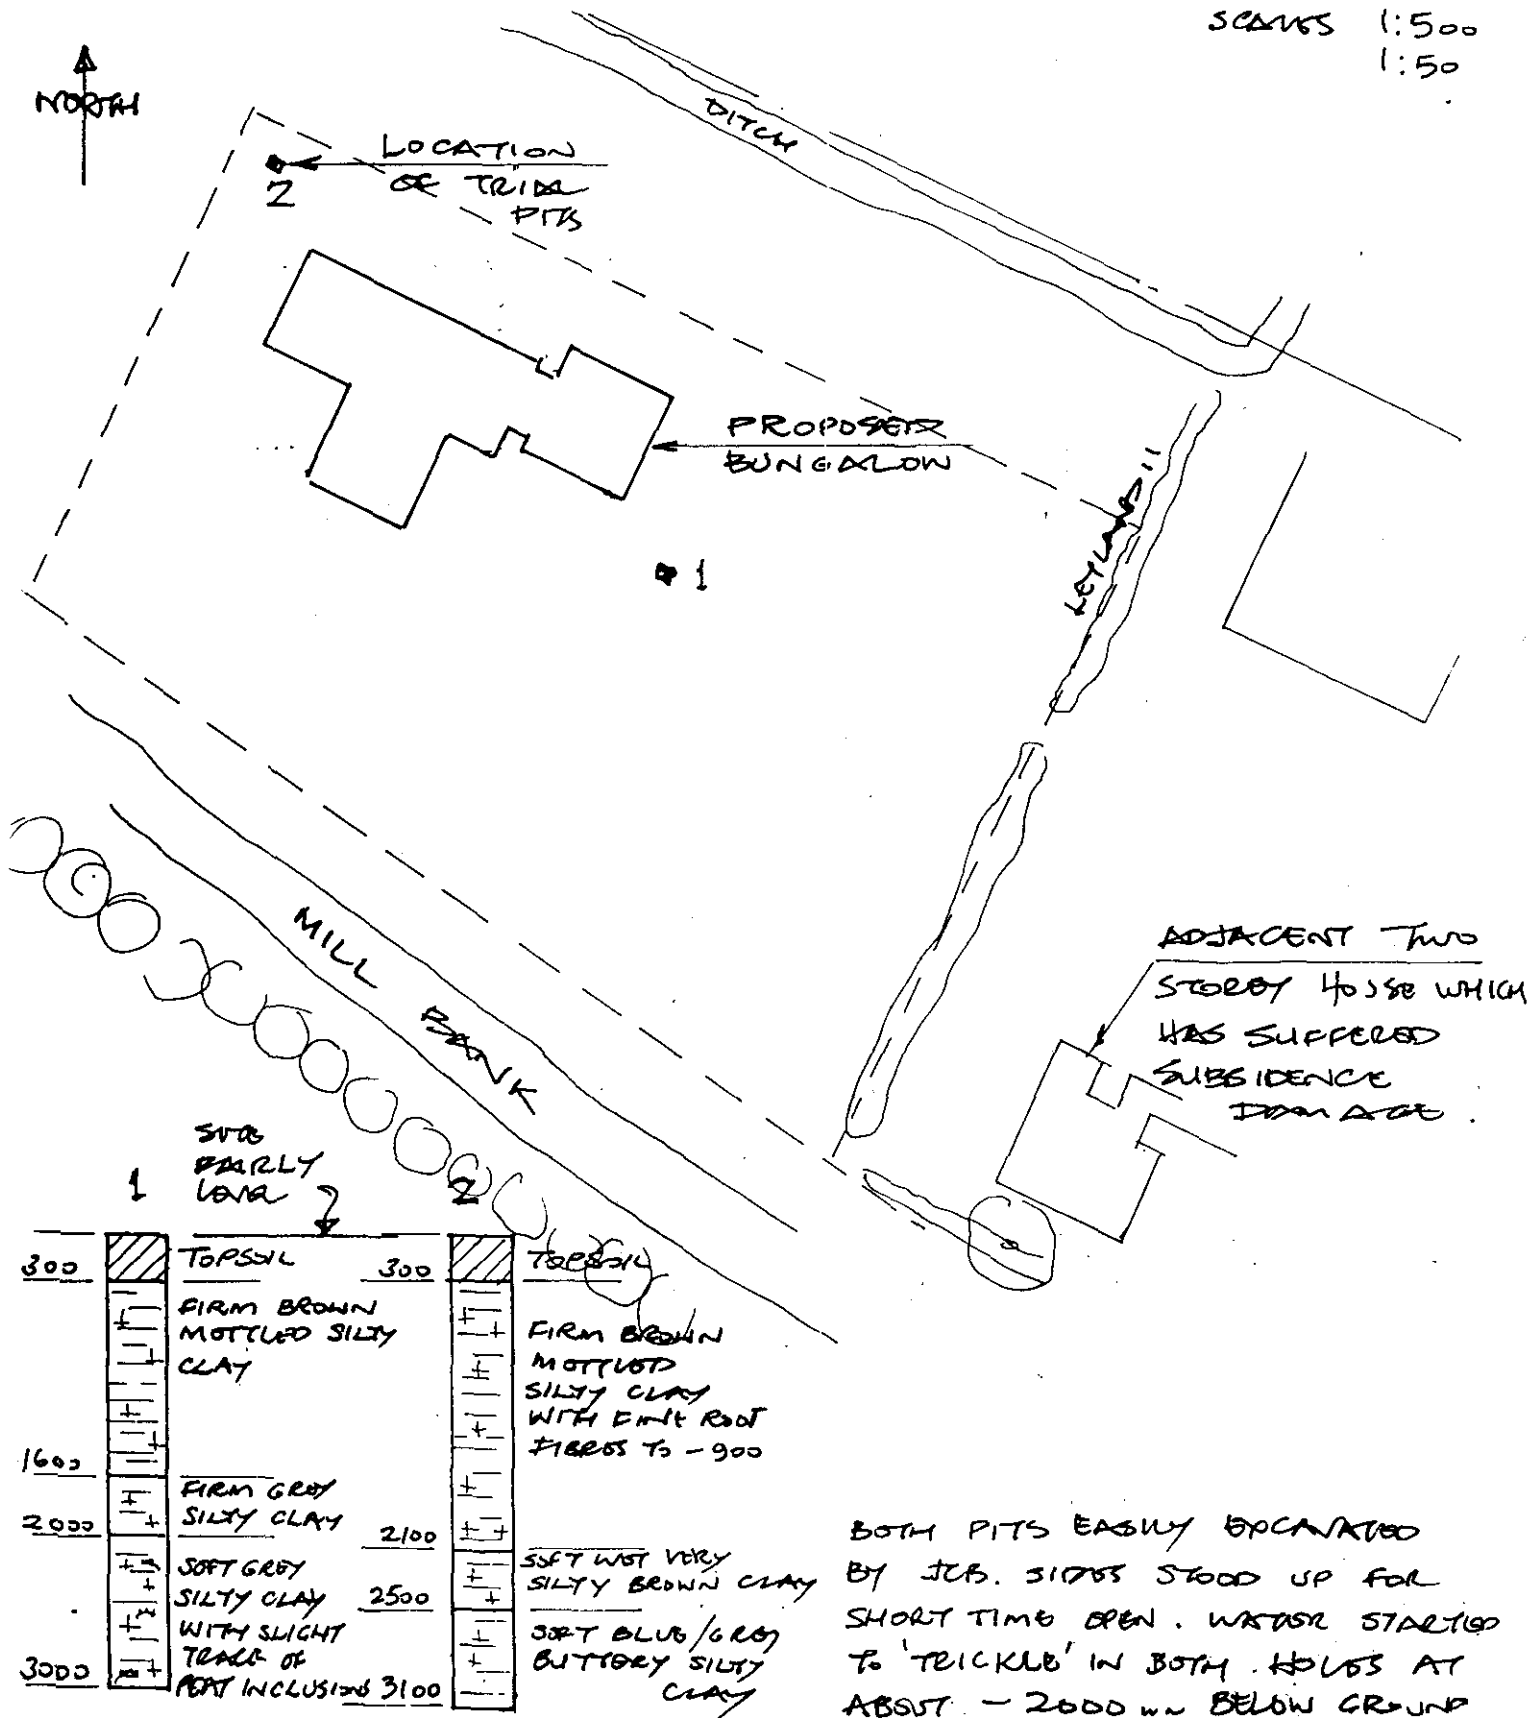
| Section: TRIAL PIT DETAILS | | |

We confirm witnessing the excavation of trial pits on this site with you and Mr. Knight on 25th May 1993. The location and details of the pits are shown on our sketch P93/46 SK01. The proposal is for a substantial sized detached bungalow with attached double garage in a field immediately adjacent to an existing two storey house which has suffered some subsidence damage. Whilst we have not investigated the cause of movement to the house we have seen a deep borehole which revealed very desiccated silty clays to depths of about two metres. The house has shallow foundations and we would suspect the desiccation would in the main be due to the trees around the property which have been responsible for the movement.

Both pits revealed generally similar ground conditions with up to 300 mm of topsoil overlying firm silty clay which became softer and wetter with depth. After about 2000 mm the ground becomes very soft with the typical soft buttery silty clay which was proved to depths of over 3000 mm.

Due to the obviously shrinkable nature of the strata it is important to keep a moisture stable condition at the formation level. This can be achieved by incorporating a path all round which is indicated on the plans and keeping control of planting close to the building. Trees should be kept well away and only small shrubs allowed close to the building.

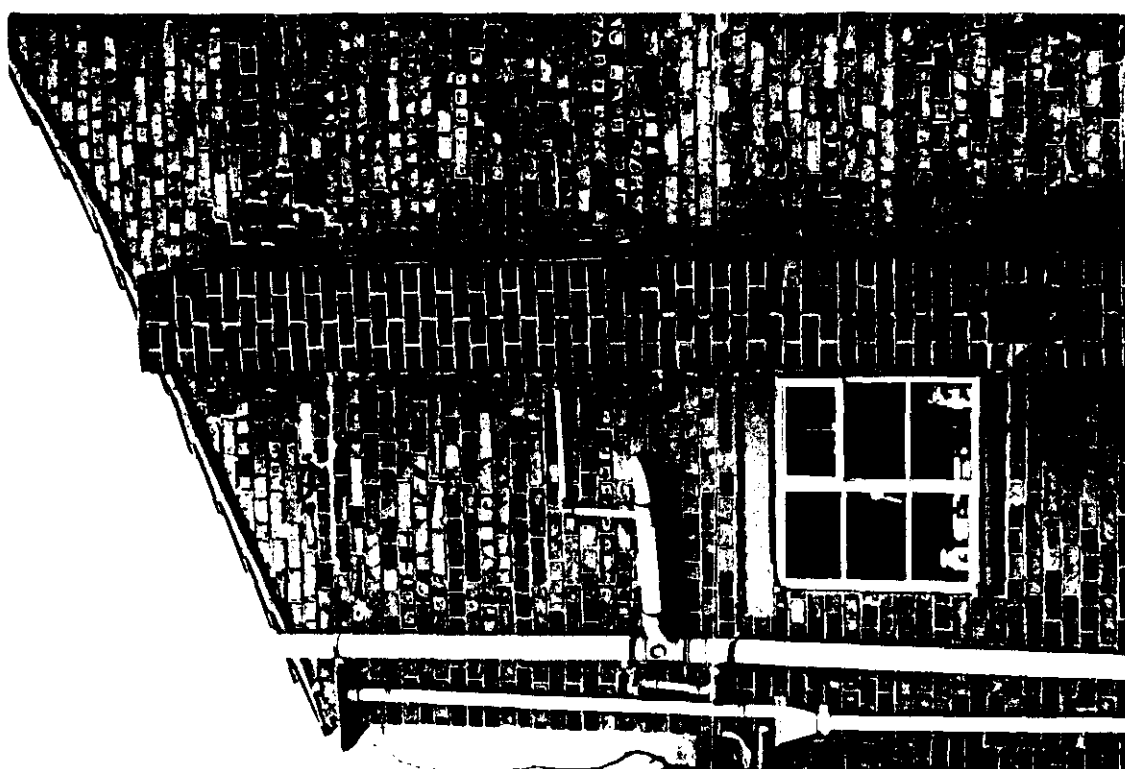
WEST GABLE, SHOWING MASTIC FILLED CRACKS  
AT HIGH LEVEL & CRACKING TO CHIMNEY

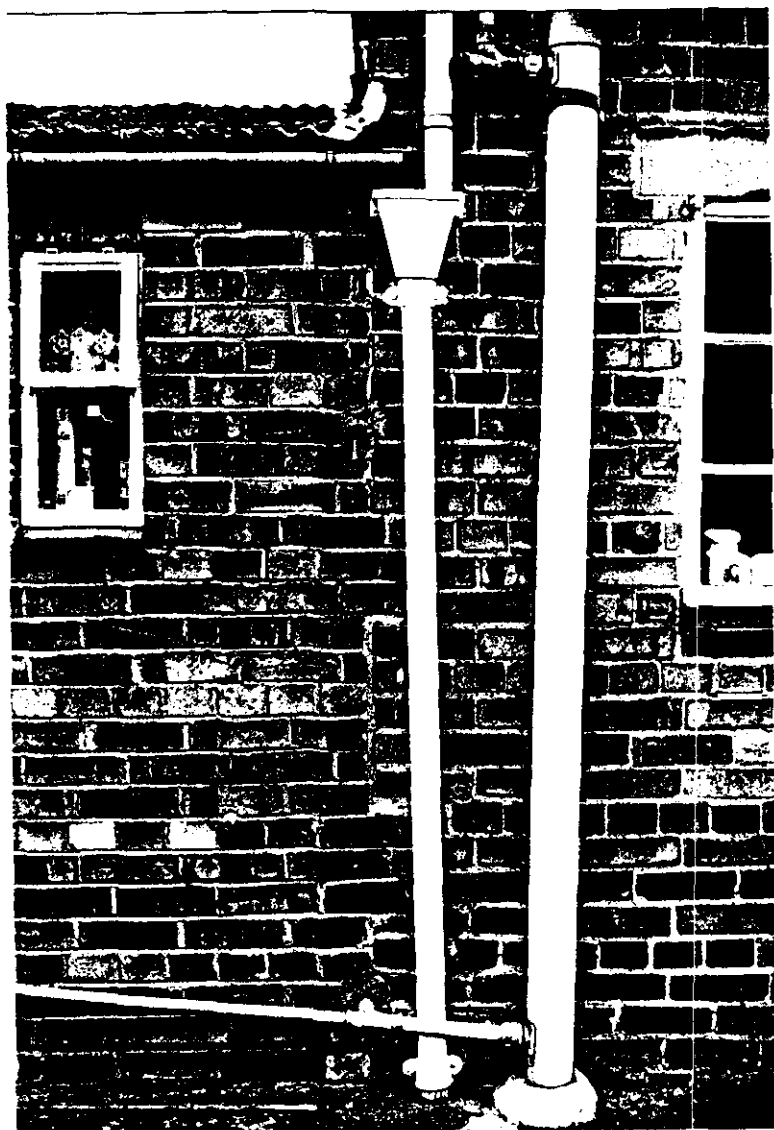
BULKY CEMENT FLASHING TO

BASE OF SOIL STACK

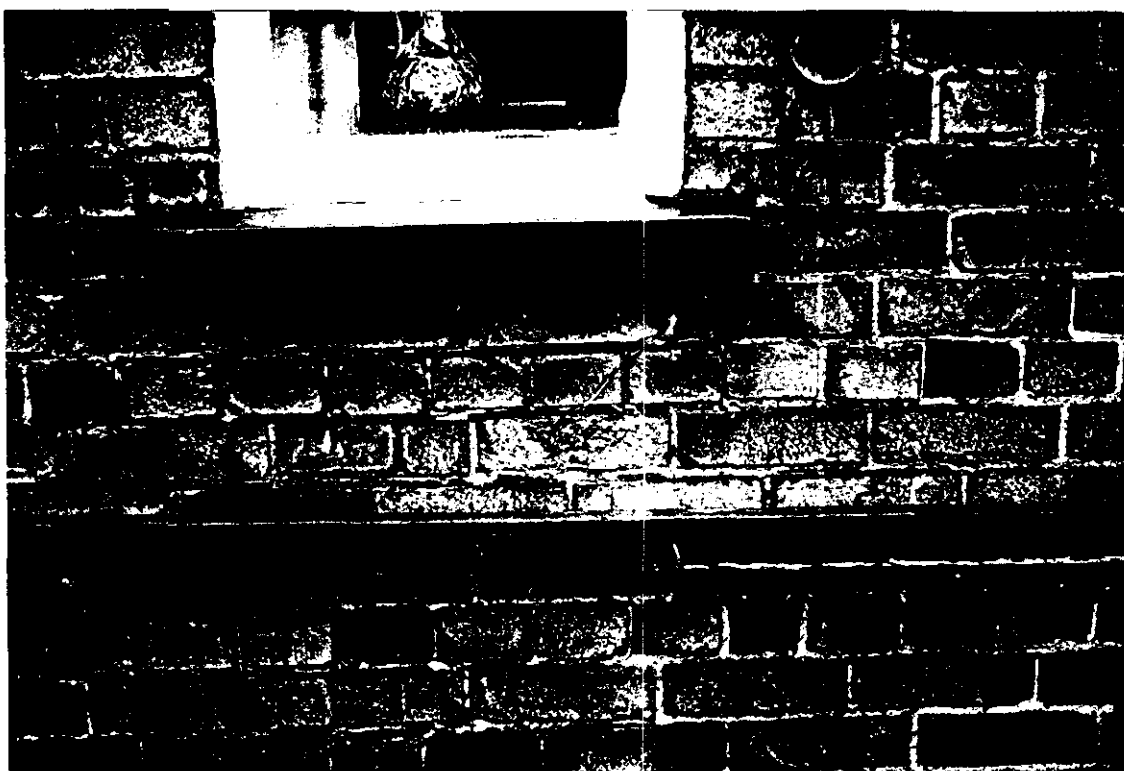
MINOR CRACKING BELOW LOUNGE EAST WINDOW

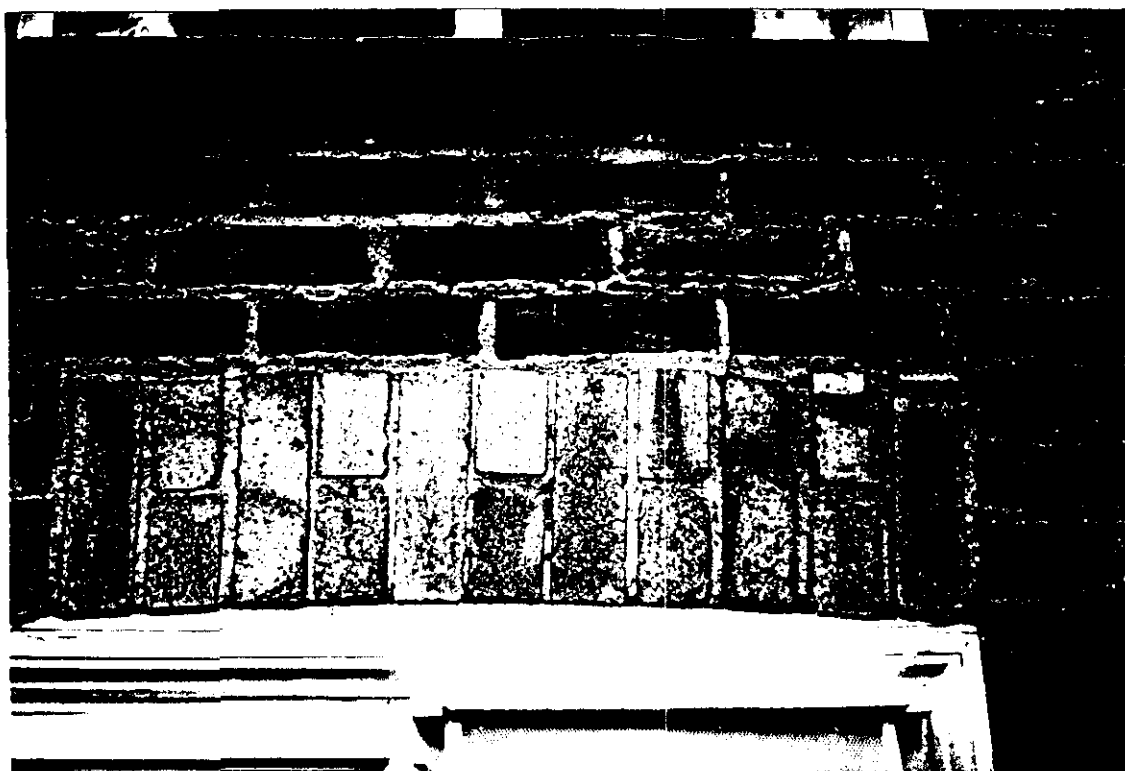
NORTH ELEVATION (REAR) CRACKING ABOVE STUDY WINDOW

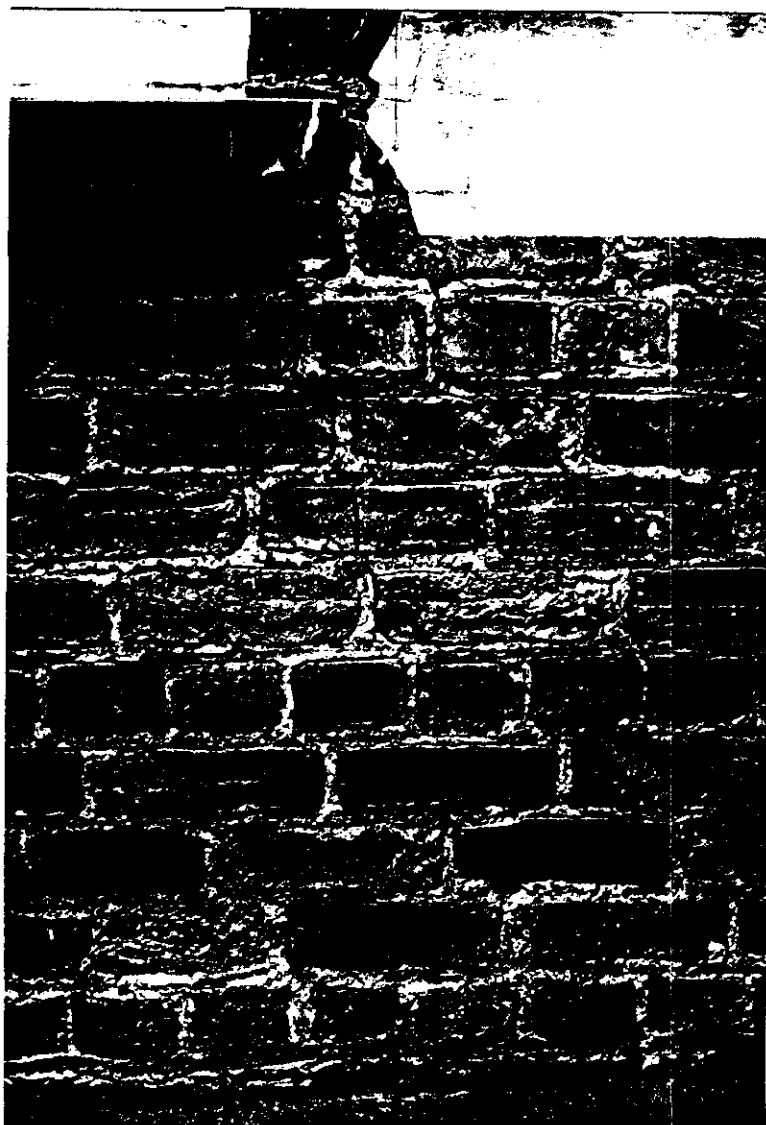
VERTICAL CRACK BELOW  
STUDY WINDOW

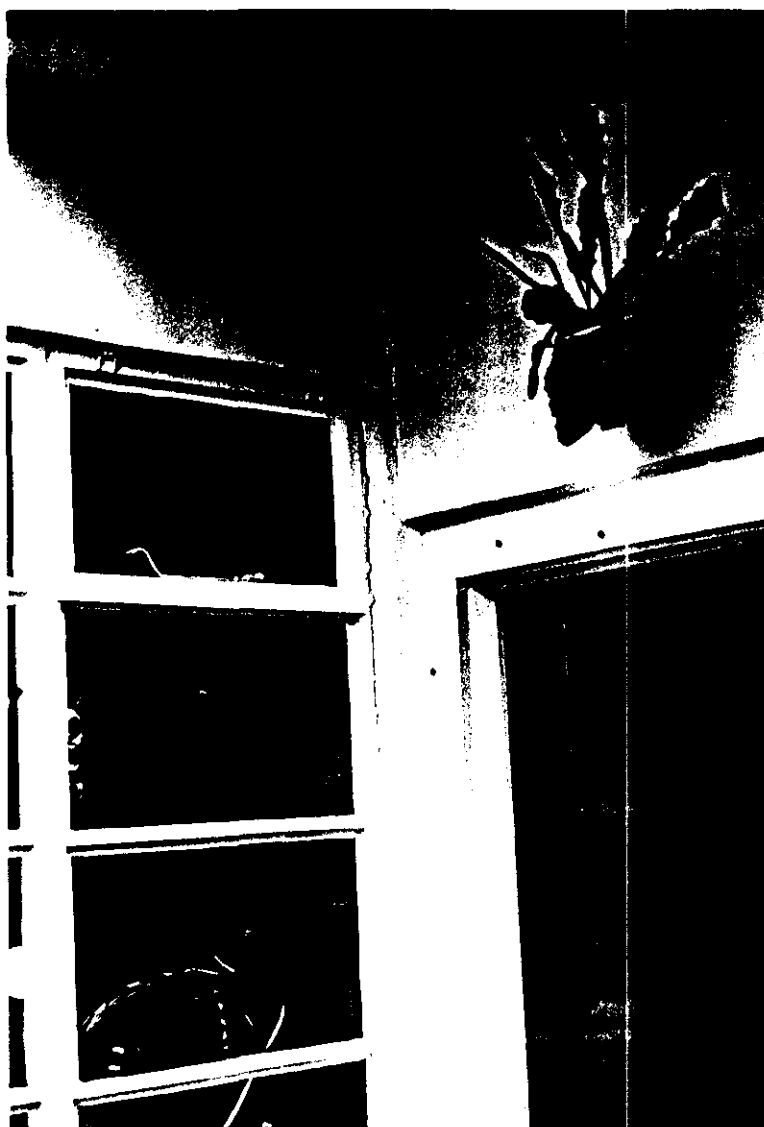
CONSERVATORY

VERTICAL CRACK OVER JAMB TO  
KITCHEN WINDOW CONTINUOUS WITH  
CRACK BETWEEN THE WEST WALL  
AND THE CEILING

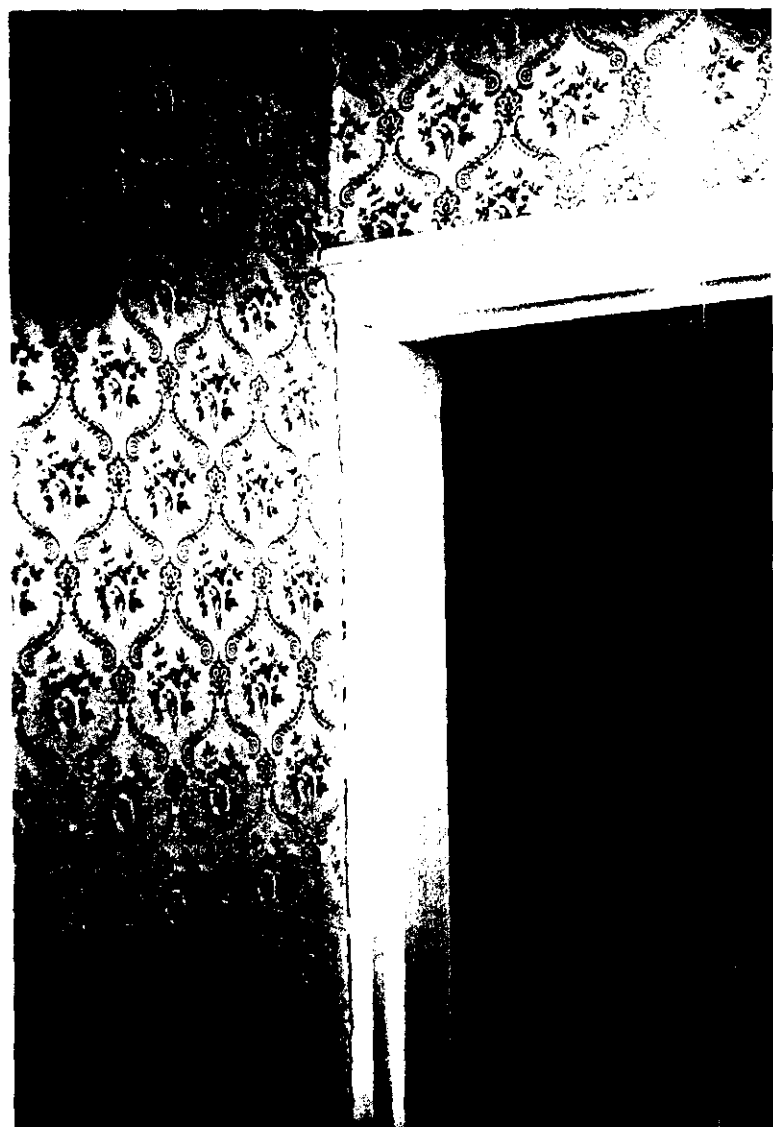
BEDROOM ONE VERTICAL CRACK  
TO SIDE OF DOOR JAMB
