Heritage Impact Assessment  
For  
Proposed Refurbishment, Extension and Internal  
Alterations

Riverside House (Formerly Bloodfold House)  
Bloodfold Farm  
Ravens Bank  
Holbeach  
PE12 8SP

**Proposal:** Refurbishment, extension and internal alterations

**Date:** 30<sup>th</sup> June 2016

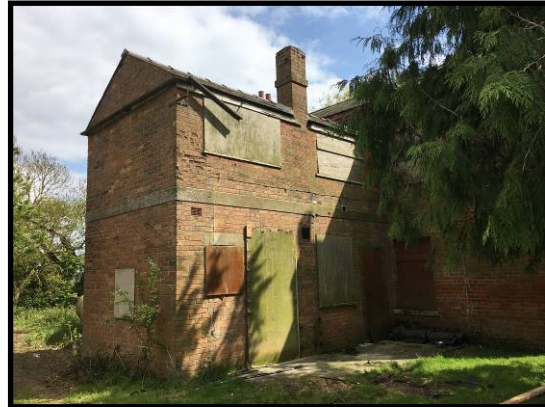
*Later unsympathetic extension to the rear of the dwelling*

The largest and most intrusive aspect of the external works will be the large extension to the rear which will measure 9.1m x 7m, this will act as a more sympathetic replacement to the existing extension which is currently to the rear of the dwelling. The existing extension is built in a modern brick using stretcher bond throughout, the brick is much lighter than the deep red of the main dwelling and their overall size and uniformity does not tie in with the traditional English garden wall bond at all. The proposed extension will be constructed using a brick that is far closer in colouring and the brick bond will be carried on throughout the new

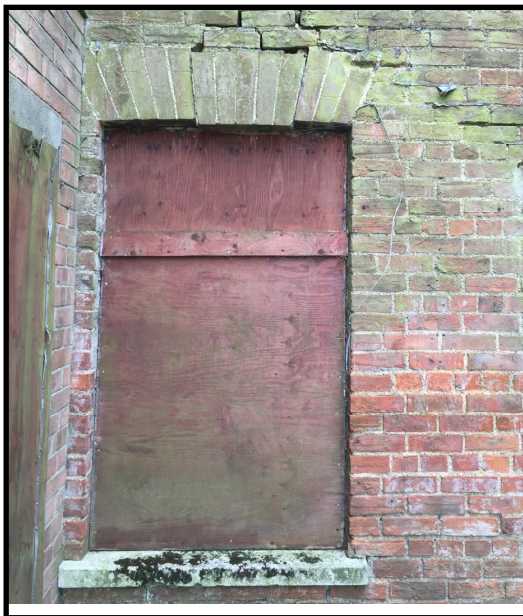
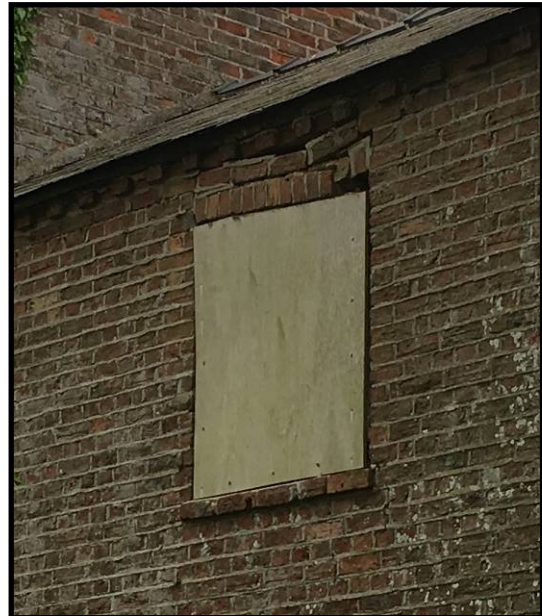
*Examples of where brick arches over openings have slipped and caused damage*

elevation wall. Once this work has been carried out the repair of the brick arch above the first floor window can be completed and the windows can be assessed and repaired/replaced where necessary. To the rear of the annex is the small lean-to kitchen which serves this part of the house, it is however in a poor state of repair and requires extensive work to be made good. This will be done in a sympathetic way that will see it re-constructed to match the existing in appearance, using the original bricks where possible, size and layout. Existing door and window openings will be reinstated and installed in a style to match the main dwelling.

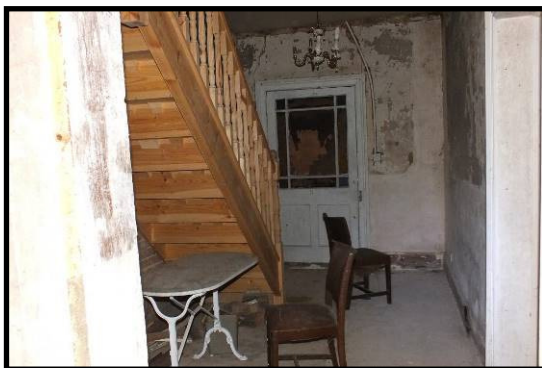
*Later replacement staircase in the hallway that detracts from the character of the hall*

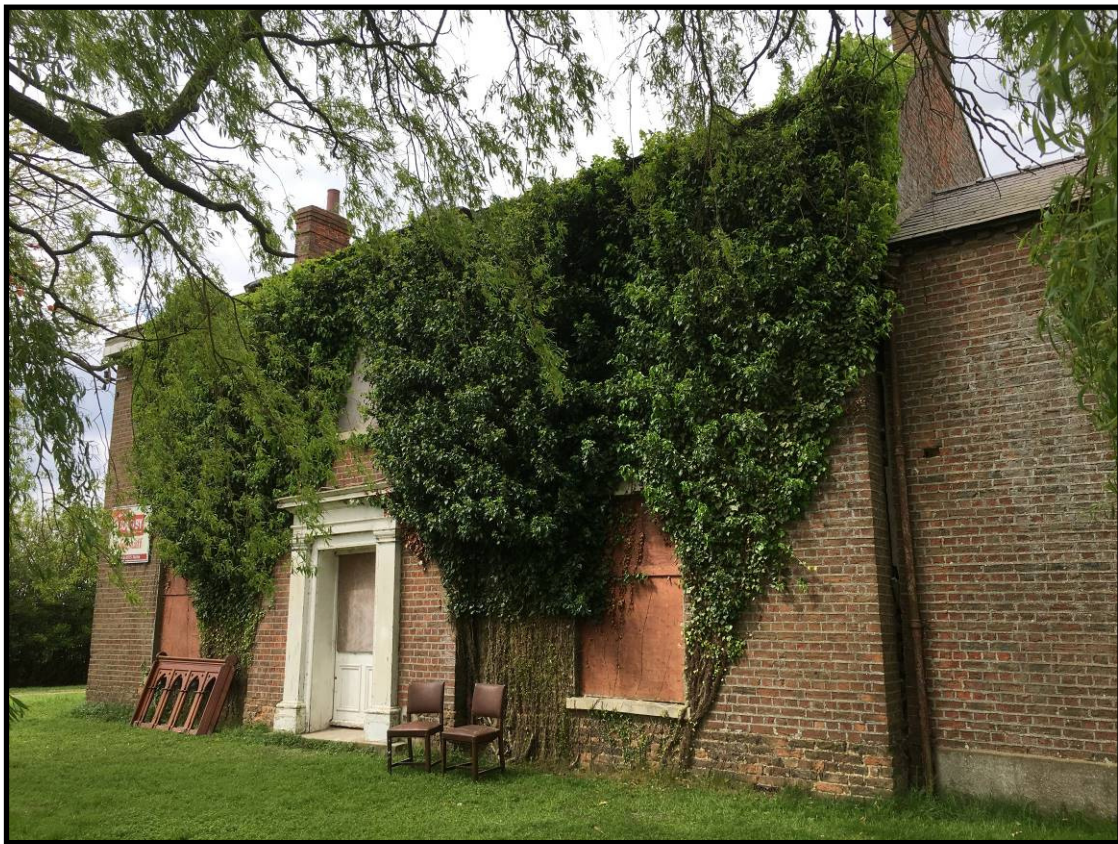
*Appearance of the front elevation of the dwelling as of June 2016*

elevation there is very little work required, the ivy, which has been left to almost completely dominate the principal façade, will be removed and any roots in order to attempt to stop the growth. Care will be taken when this work is carried out so as to not disrupt any of the mortar joints in the brickwork, it may also be necessary to trial dig around the roots so as to ensure they have not penetrated too far in to what foundation the building may have. The windows and doors are currently boarded over so their condition is not yet fully know, they will however be assessed once the boarding is removed and if repair is necessary this will be carried out. If it is decided a window or door is unrepairable they will be replaced to match identically with the existing that has been removed in order to be in keeping with the traditional appearance and style.

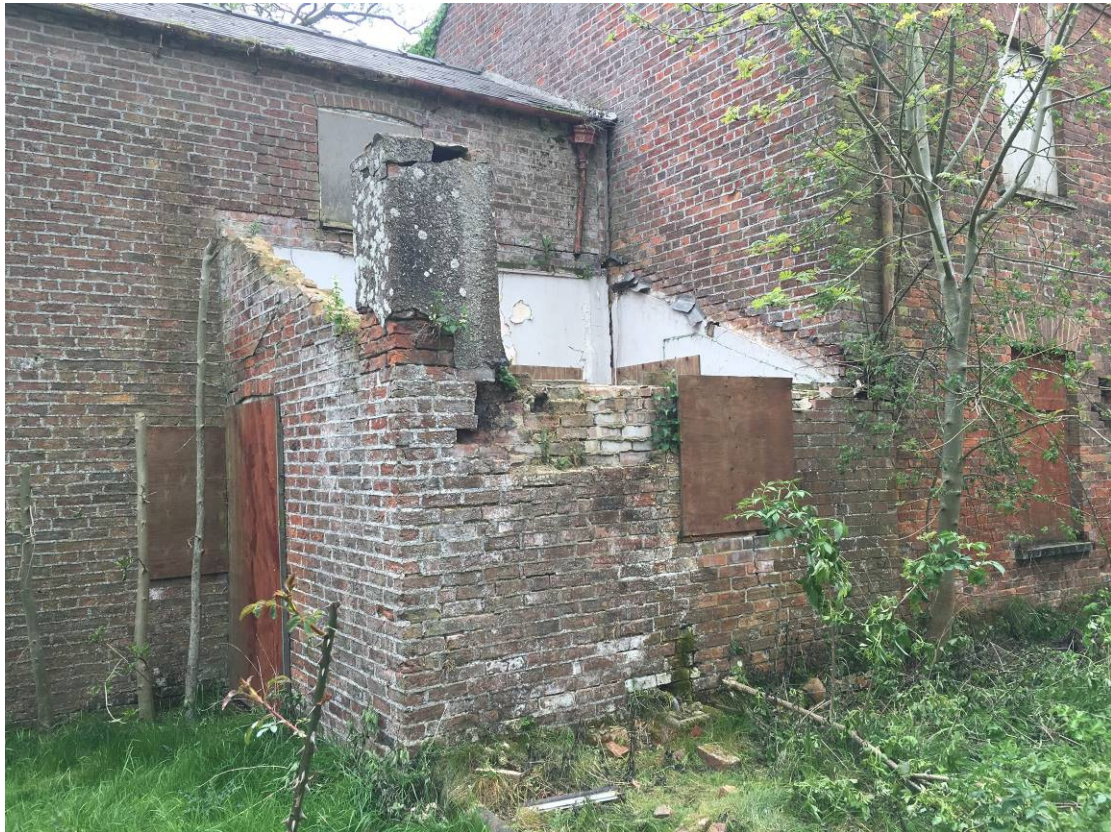
*Annex kitchen to the rear that requires demolition and re-building*
