## **Stage One Environmental Desk Study of**

**Plot 5, Highstock Lane, Gedney Hill**

**REPORT NUMBER 20-02-01**

## **Environmental Risk Assessment of Plot 5, Highstock Lane**

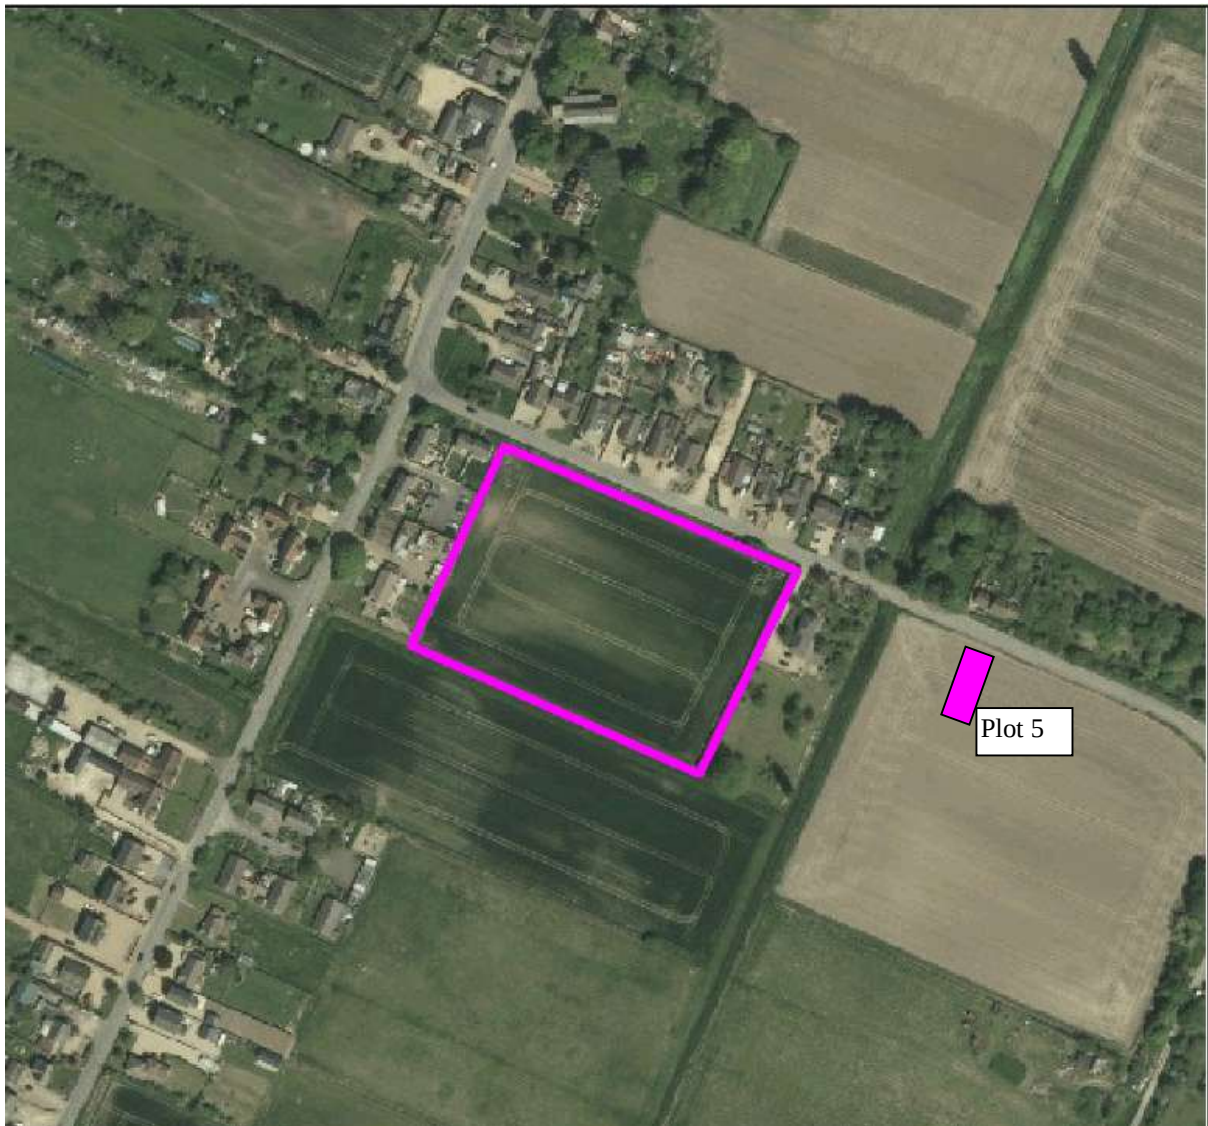
2.2 The Google satellite image (Figure 1) shows that site is in part of a field, in a rural area with very few houses along the road and fields in close proximity.

Figure 1 Google satellite image showing image from Sitecheck Report with original plot of land that was being assessed outlined in purple and plot 5 coloured in purple to the east

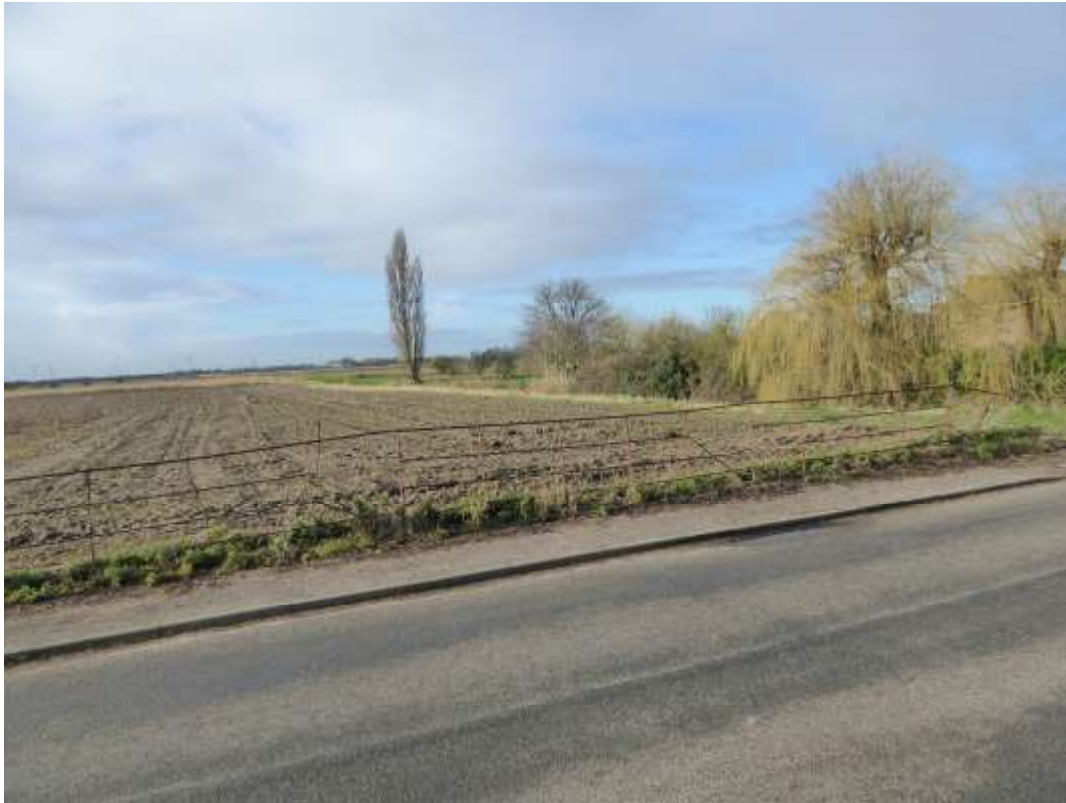
3.2 The site is part of a ploughed field, south of Highstock Lane and near the Highstock Drain to the west (photos 1, 2 and 3) where a block of six plots has planning permission for residential development. On the northern side of Highstock Lane to the east of this plot, construction of a few dwellings has started (photo 4). Further along Highstock Lane, to the east is a small collection of buildings at or near the cross road with Mole Drove. The public House that was at the cross road has been converted for residential use, whilst the other buildings near to it have no sign of significant commercial activity. All the buildings were very clean with no rubbish in the front or to the side. Beyond the buildings were fields

Photo 1 Approximate location of plot 5 of 6 development plots on this field

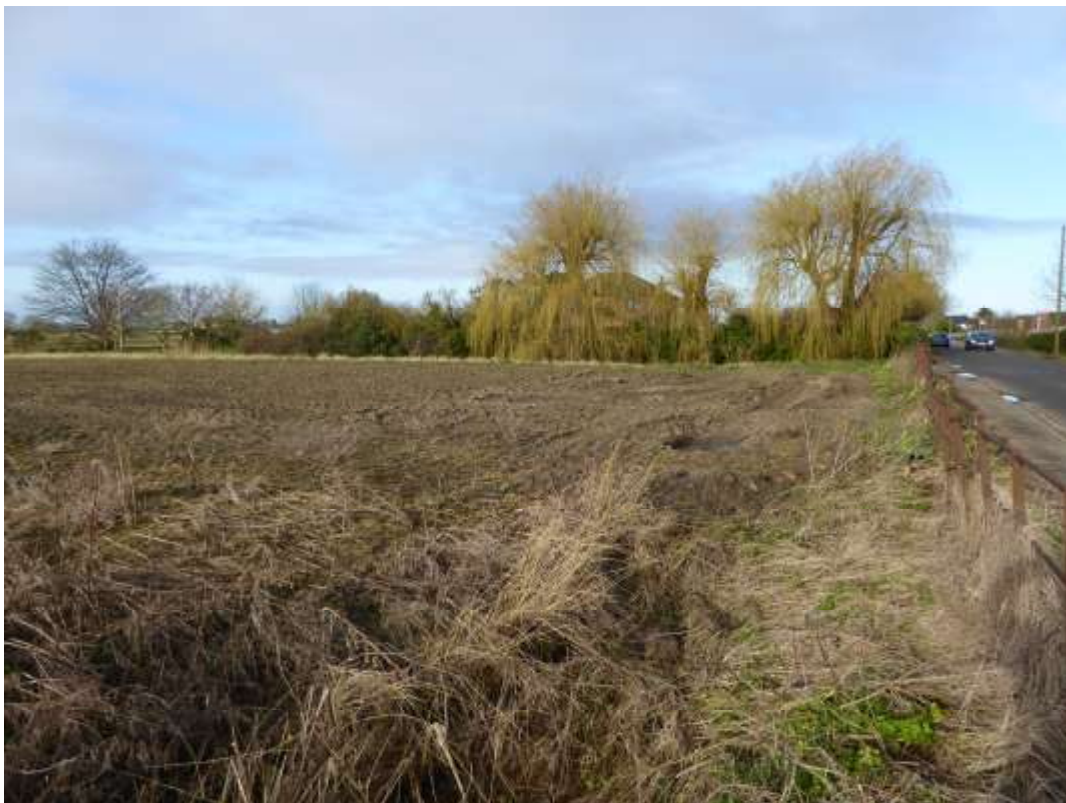
Photo 2 View from east to plot 5 on this development

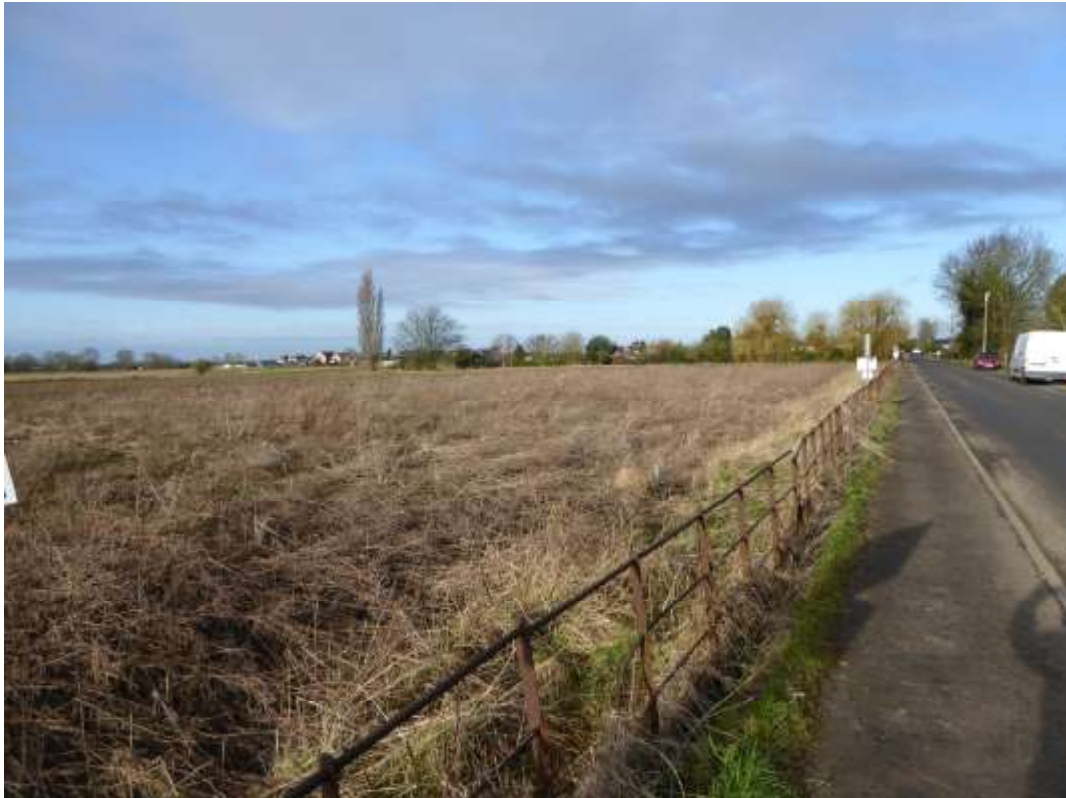
Photo 3 View from east end of development plot towards plot 5 from plot 1

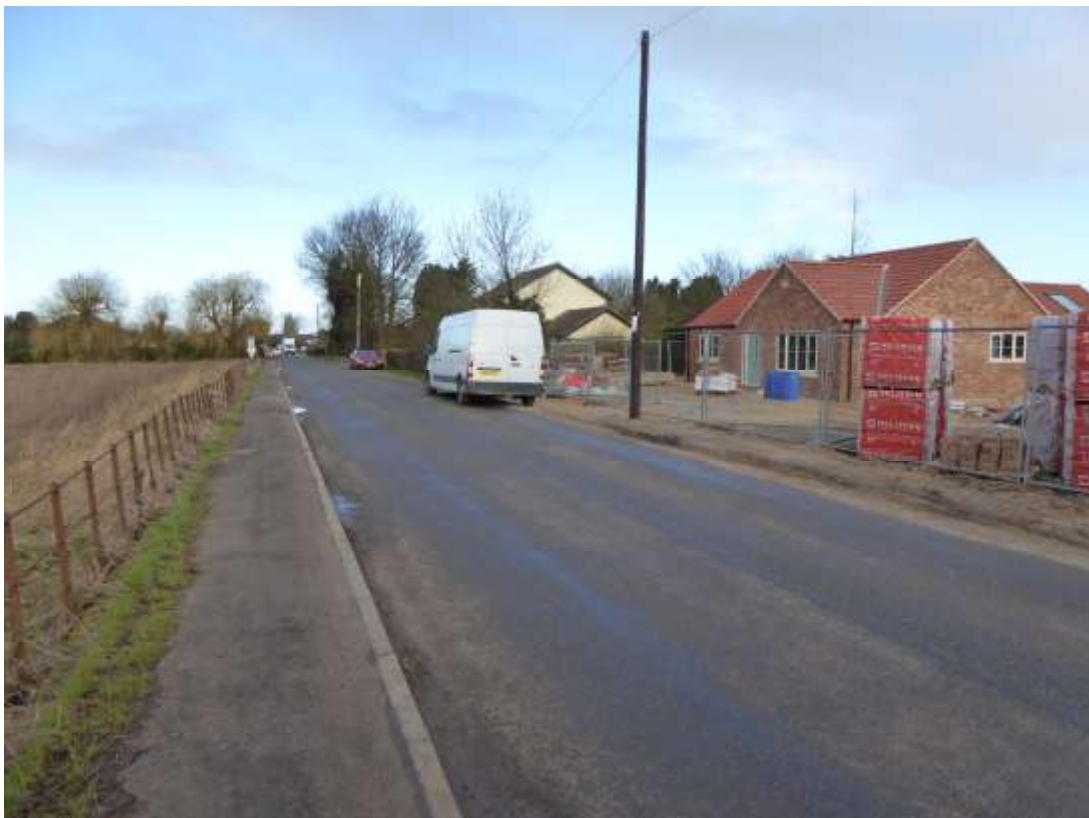
Photo 4 New developments across Highstock Lane

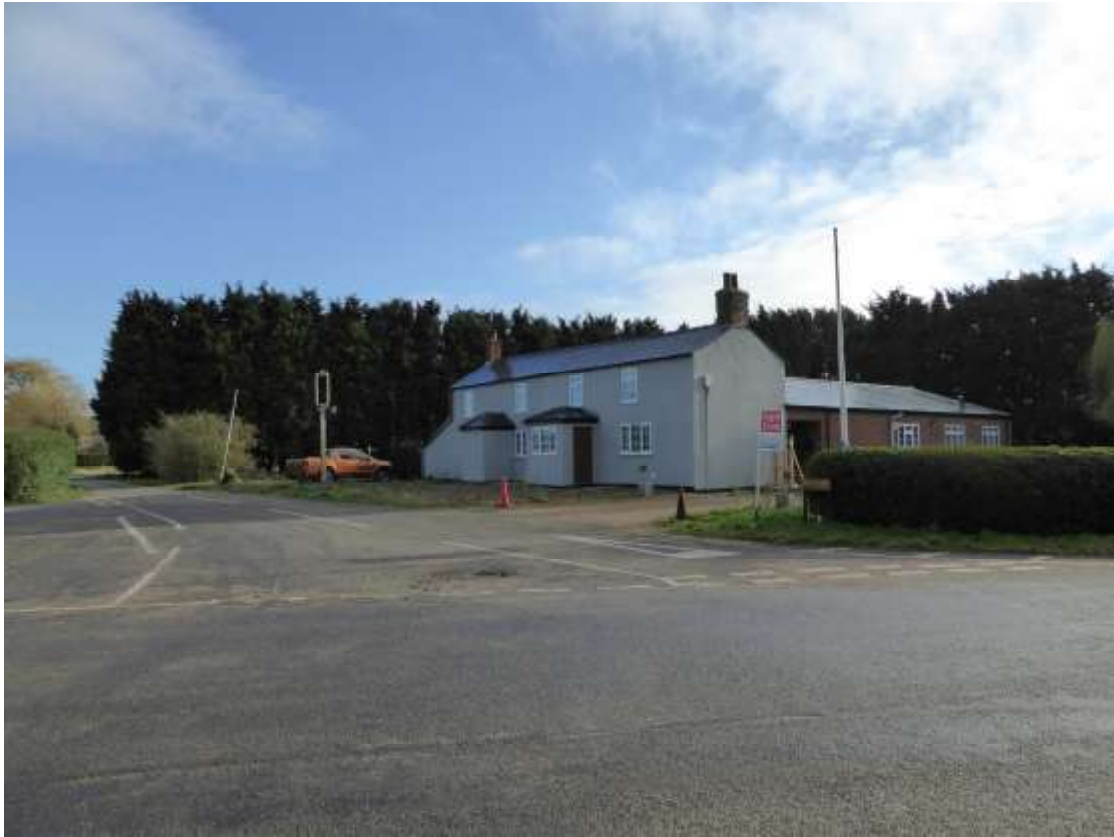
Photo 5 Closed Publick House at east end of site

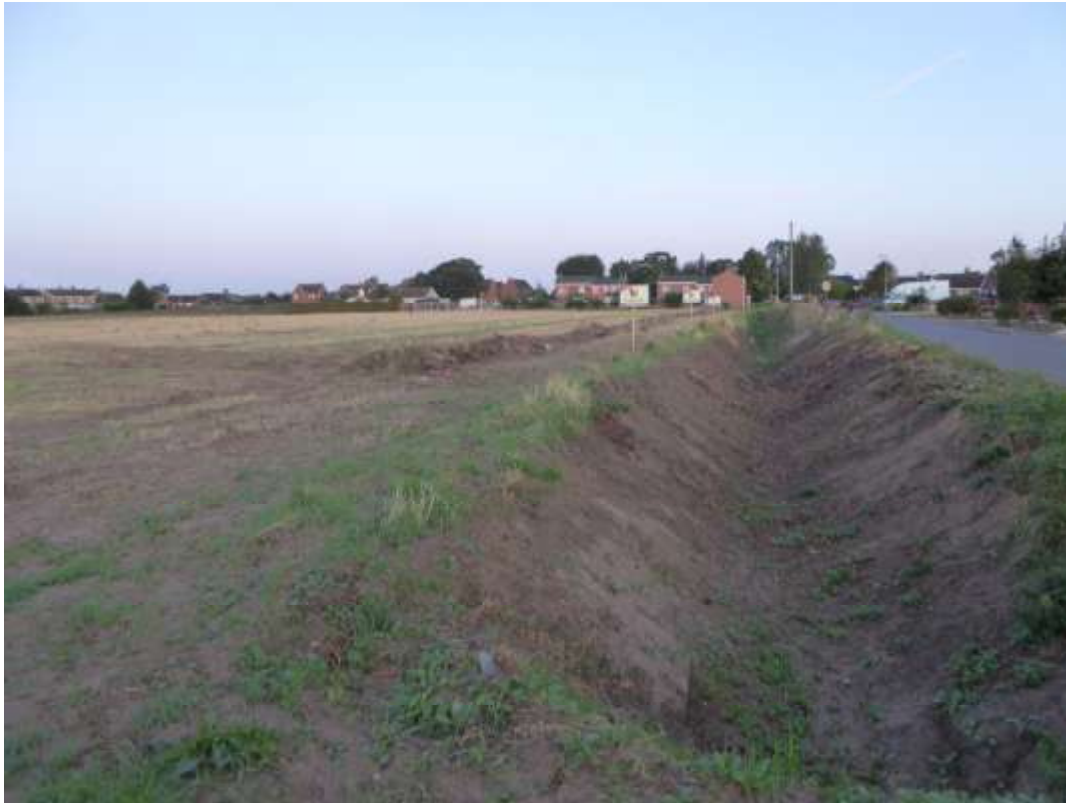
3.1 The site was visited when it was mainly sunny with broken thin cloud. The site is a field that is adjacent to Highstock Lane and the whole area is flat and level. Two ditches are on site (photos 1 and 2) flowing from the western boundary along the northern and southern boundaries into the Highstock drain near the eastern boundary. Both ditches were dry on the day of the visit and the surface of the field was covered in hard dry clay (photo 3). The field had been harvested some time ago leaving stubble from a cereal crop. A walk around the field did not find any evidence for deposition of rubbish or of oily materials. One of the houses on the western boundary (the fronts are on Station Road) had building materials in the back garden (photo 4). The front of that house showed that it was being refurbished, so only building materials for the house were on site.

Photo 1 Ditch adjacent to Highstock Lane, just been cleared of vegetation

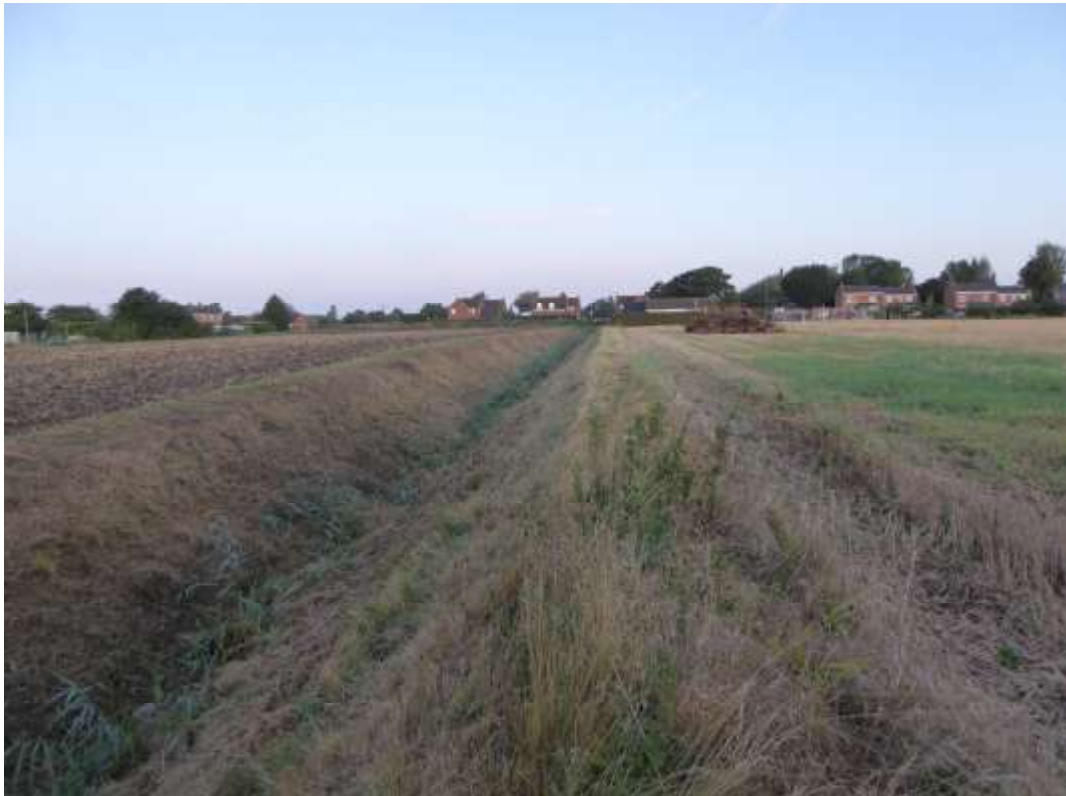
Photo 2 Ditch on southern boundary adjacent to an open field

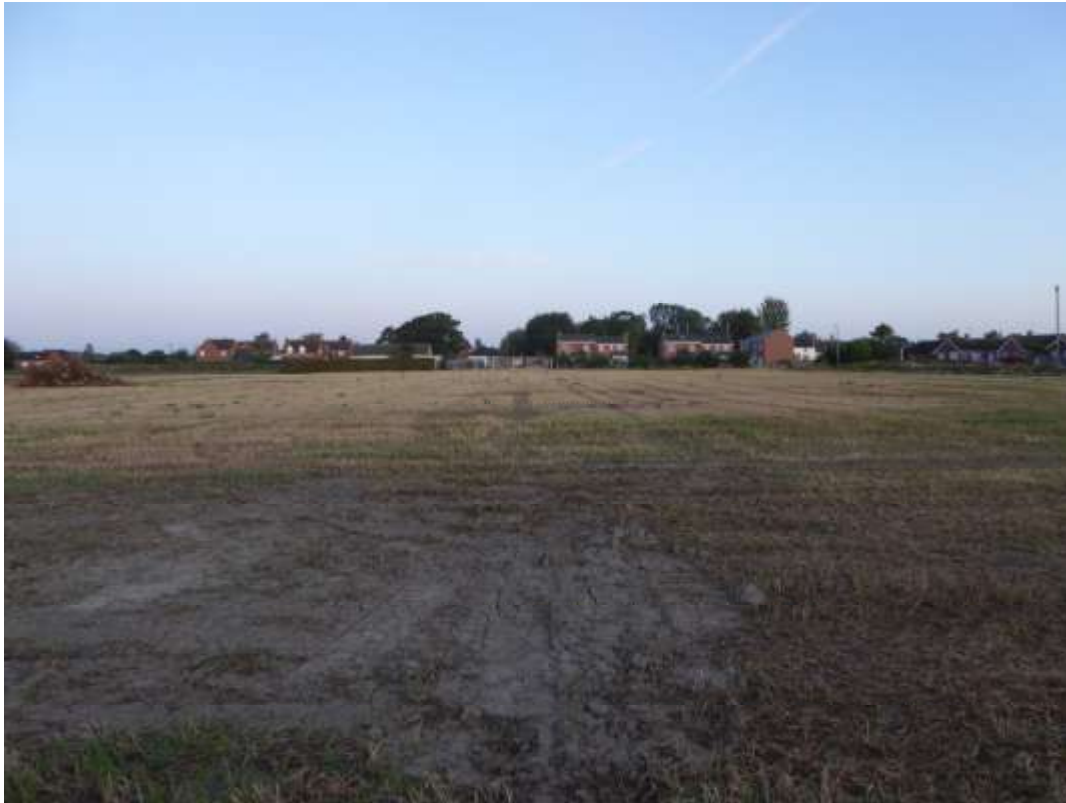
Photo 3 View from eastern boundary showing hard dry clay on the surface

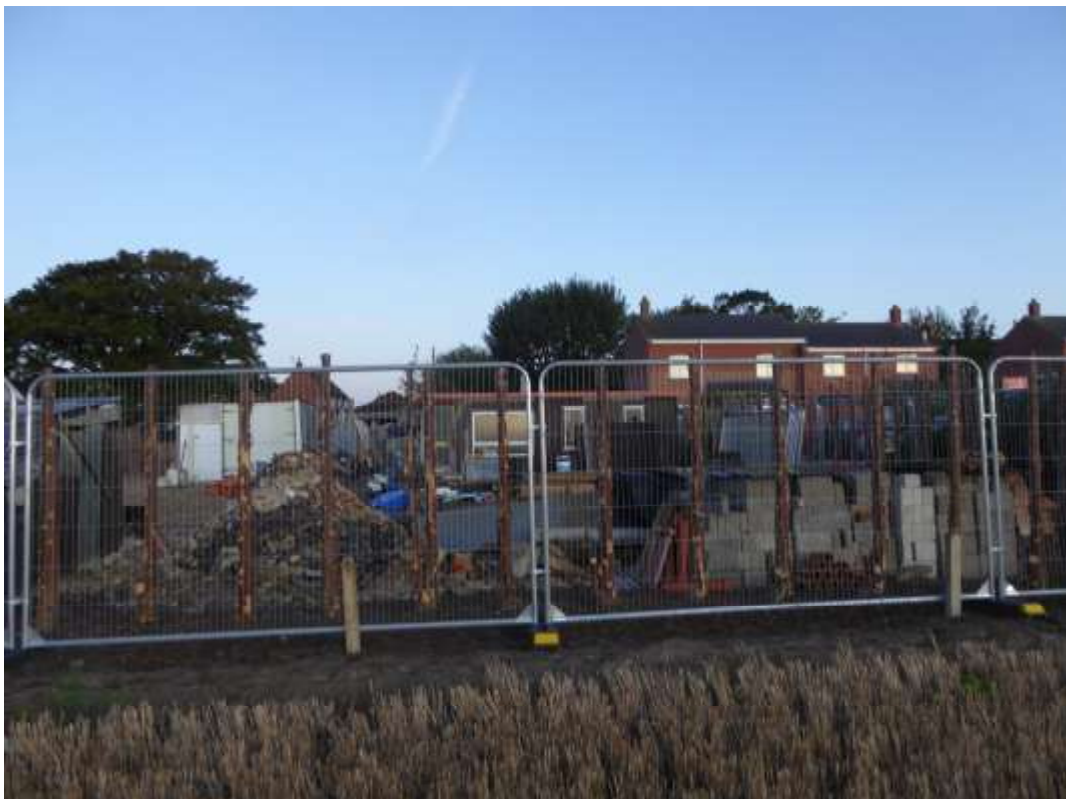
Photo 4 Rear of house on Station Road with building materials on site

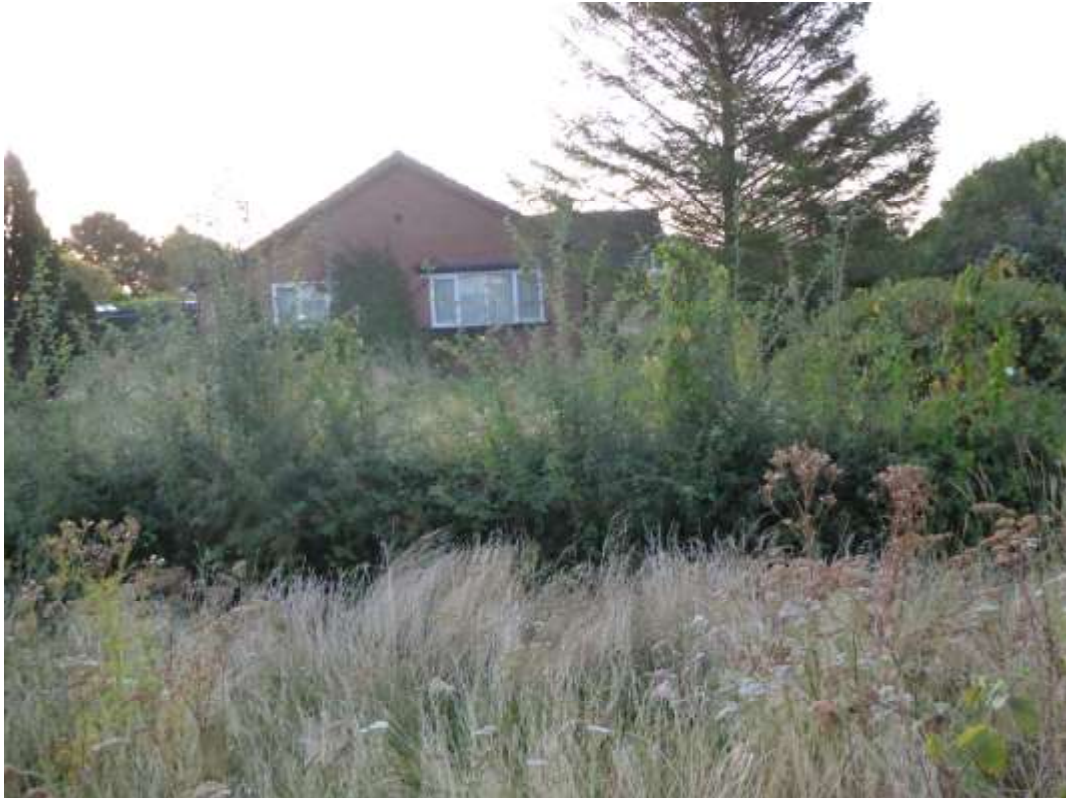
3.2 The road haulage services marked on the Sitecheck data report was just a residential building (photo 5) on the corner of Highstock Lane and Station Road with no other buildings or hard standing for haulage vehicles. This could just be the registered address of the business with no actual vehicles on site. A walk to where the garage services were marked near to Hubert's Close in the Sitecheck Data report did not find any trace of such a business. On further investigation, it was found located at the southern end of the village on Station Road more than 250 m from the site.

Photo 5 House on site of road haulage services from Station Road
