**Contamination Report Desk Study**  
Revision 0

**Job No. 25080**

**Proposed Residential Development  
Land to the East of Kelmar  
Main Road  
Holbeach Drove  
Lincolnshire  
PE12 OPS**

**July 2019**

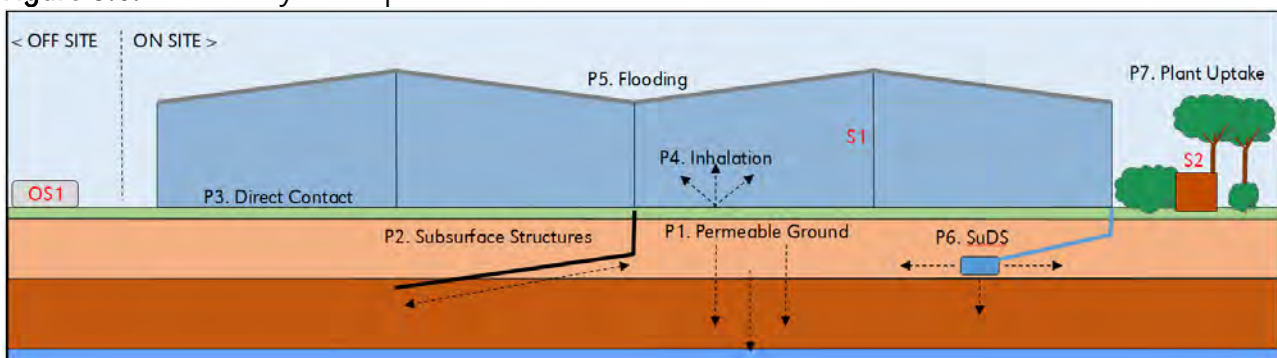
**Figure 5.6:** Preliminary Conceptual Site Model

- S1. Historic Horticultural Processes (Herbicides, Pesticides, Fungicides, Insecticides, and Fertiliser)
- S2. Bulk Storage Container (TPH)
- OS1. Bulk Storage Container (TPH)
