# **BS5837:2012 -Trees in relation to design, demolition and construction. Tree Constraints report in relation to trees at Tears Recovery, Long Sutton.**

**Prepared by: East Midlands Tree Surveys Ltd.**

**Date: 12/07/2022**

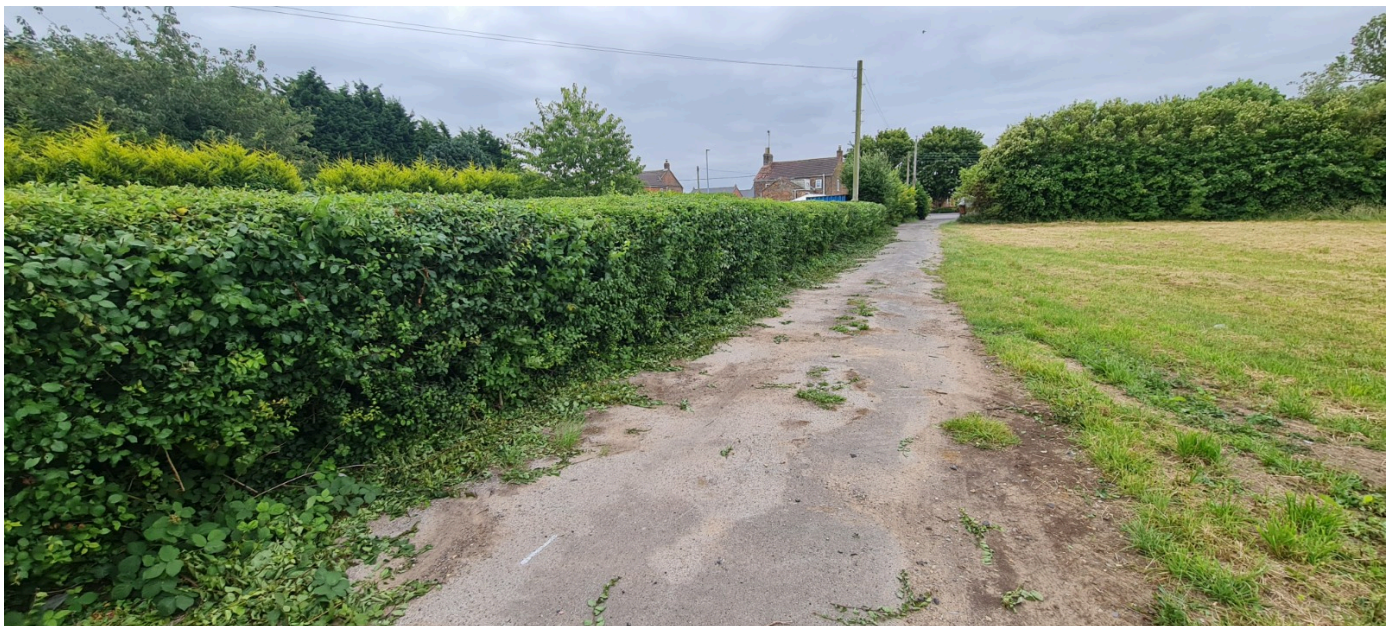
H1 is in good condition (looking south)

| Ref. | Species | Full Structure | Measurements | Spread | General Observations | Retention Category | RPA | Condition | Recommendations |
|---|---|---|---|---|---|---|---|---|---|
| H1 | Privet<br>( <i>Ligustrum vulgare</i> ) | Group | Height (m): 1.5<br>Stem Diam (mm): 90<br>Spread (m): 0.5N, 0.5E, 0.5S, 0.5W<br>Crown Clearance (m): 0<br>Life Stage: Early Mature<br>Rem. Contrib.: 40+ Years | N:0.5<br>E:0.5<br>S:0.5<br>W:0.5 | Managed hedge. | B1 | Area: 56 sq m, plus<br>a 1m buffer. | Physiological Cond: Good<br>Structural Cond: Good | No action required. |

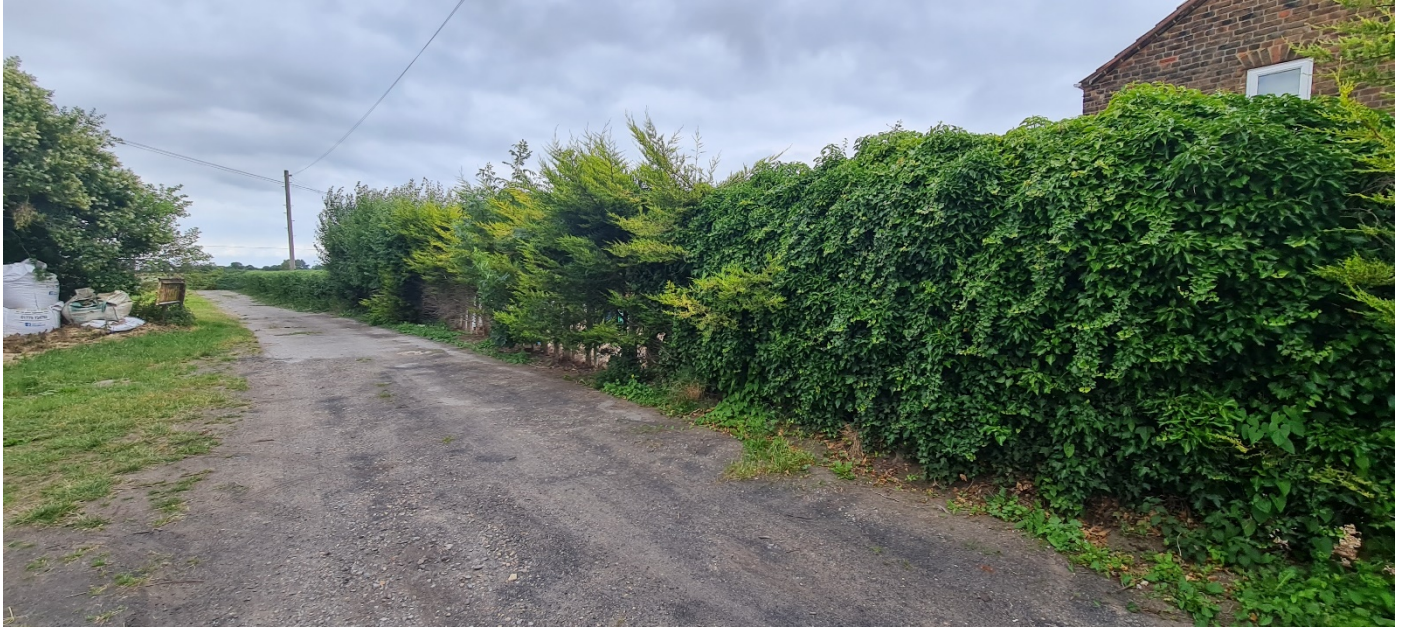
H2 is poor with significant dead patches in the mid-section, it appeared to be overrun with weed species in part.

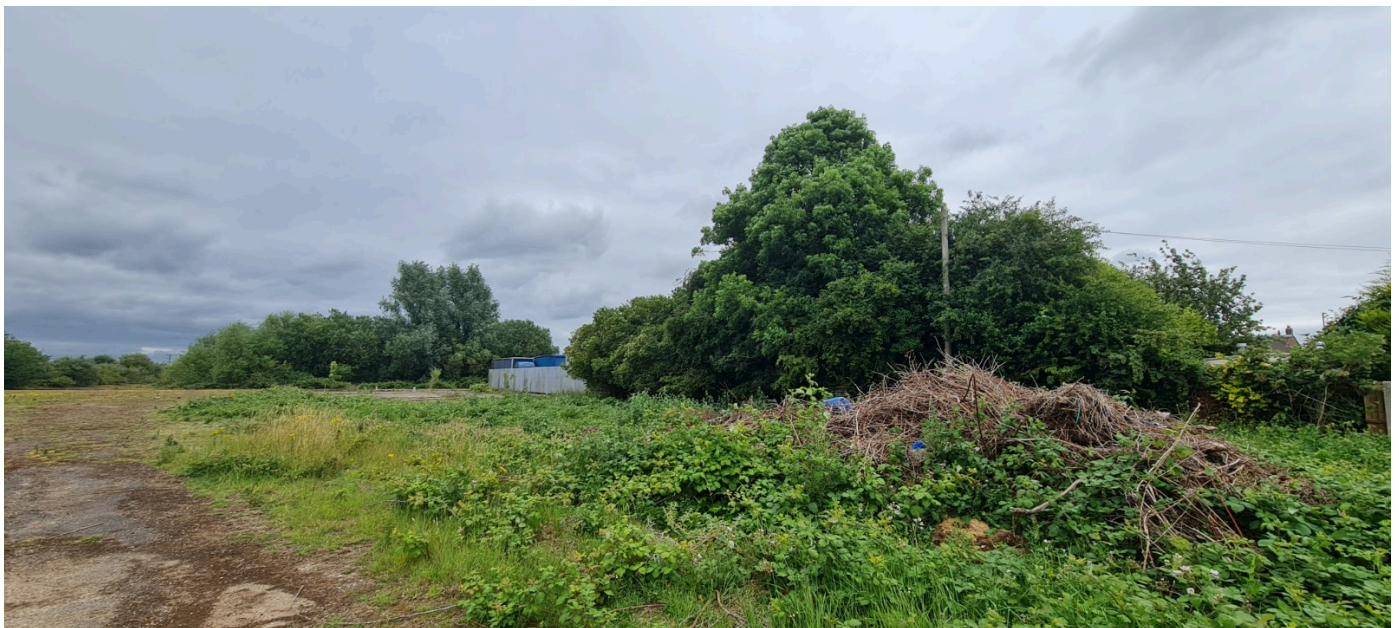
**G1 front & G3 in background.**

G1-G3 all appear to be in the main, naturally regenerated species with a part lapsed Blackthorn hedge on the western edge of G2.

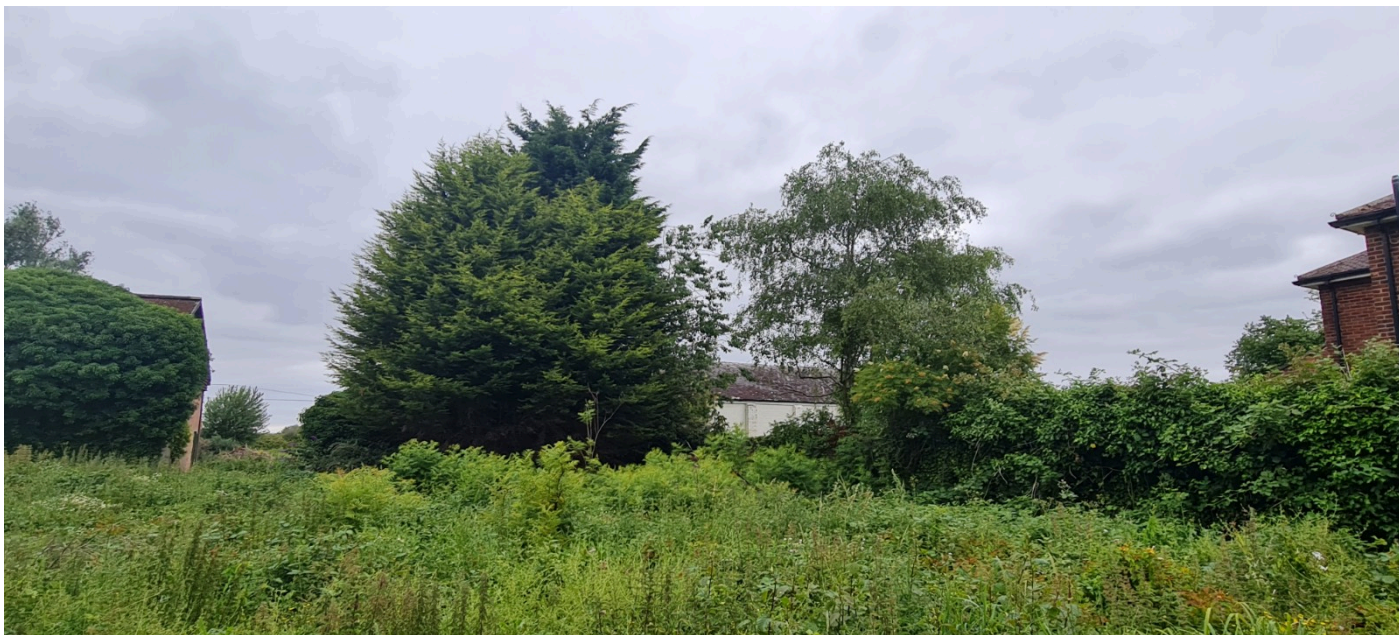
G4 is a small random group of Cypress, possibly planted to form a screen (NT1 to the right).

| Ref. | Species | Full Structure | Measurements | Spread | General Observations | Retention Category | RPA | Condition | Recommendations |
|---|---|---|---|---|---|---|---|---|---|
| G4 | Cypress<br>(Chamaecyparis sp.) | Group | Height (m): 12<br>Stem Diam (mm): 250<br>Spread (m): 4N, 4E, 4S, 4W<br>Crown Clearance (m): 0<br>Life Stage: Semi Mature<br>Rem. Contrib.: 40+ Years | N:4<br>E:4<br>S:4<br>W:4 | No significant defects | C1,2 | Area: 35 sq m, plus a 1m buffer. | Physiological Cond: Fair<br>Structural Cond: Fair | No action required. |

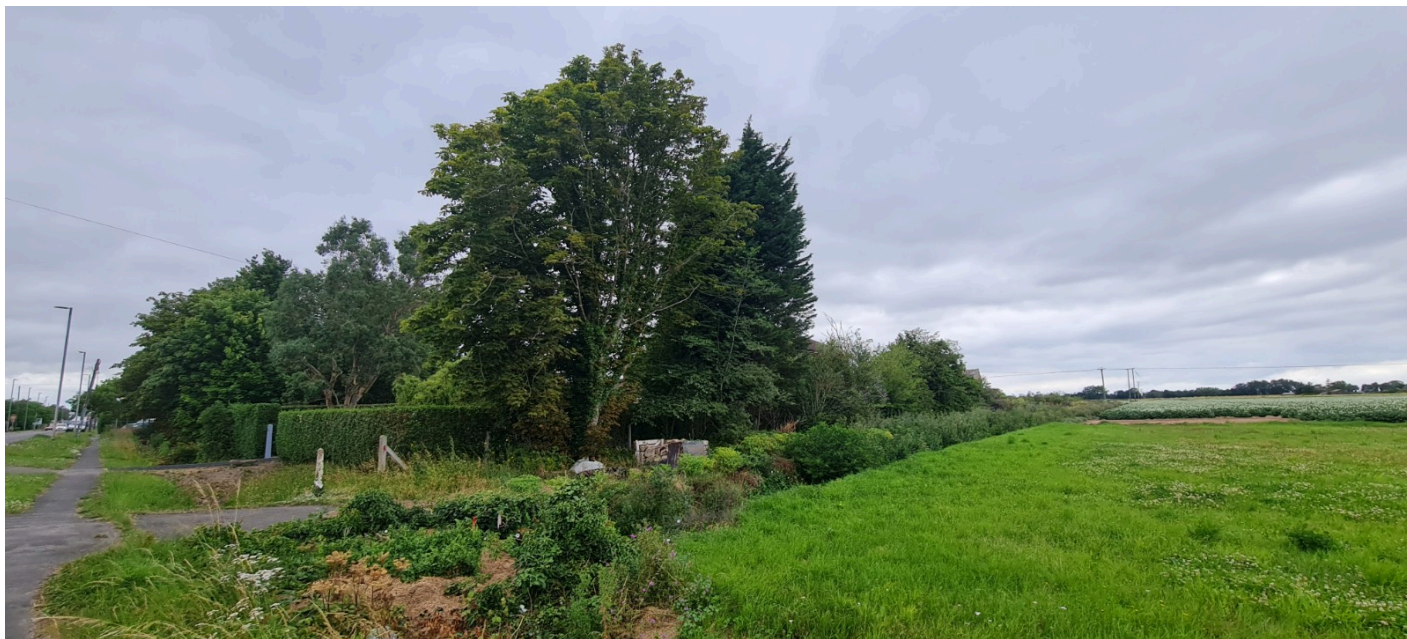
G5 is possibly the remains of a lapsed hedge with a single Horse Chestnut roadside.

| Ref. | Species | Full Structure | Measurements | Spread | General Observations | Retention Category | RPA | Condition | Recommendations |
|---|---|---|---|---|---|---|---|---|---|
| G5 | Mixed species<br>(Mixed species) | Group | Height (m): 14<br>Stem Diam (mm): 400<br>Spread (m): 4N, 4E, 4S, 4W<br>Crown Clearance (m): 1<br>Life Stage: Semi Mature<br>Rem. Contrib.: 40+ Years | N:4<br>E:4<br>S:4<br>W:4 | Single early mature Horse Chestnut closest to road and Cypress approx 20m along access. Remainder is a lapsed hedge in appearance with Elder, Buddleia Cypress and Hazel.<br>Average diameter and height taken.<br>Unable to survey effectively due to vegetation | C1,2 | Area: 106 sq m, plus a 1m buffer. | Physiological Cond: Fair<br>Structural Cond: Fair | Advise ivy and undergrowth is cleared and trees inspected in order to meet Duty of Care. |

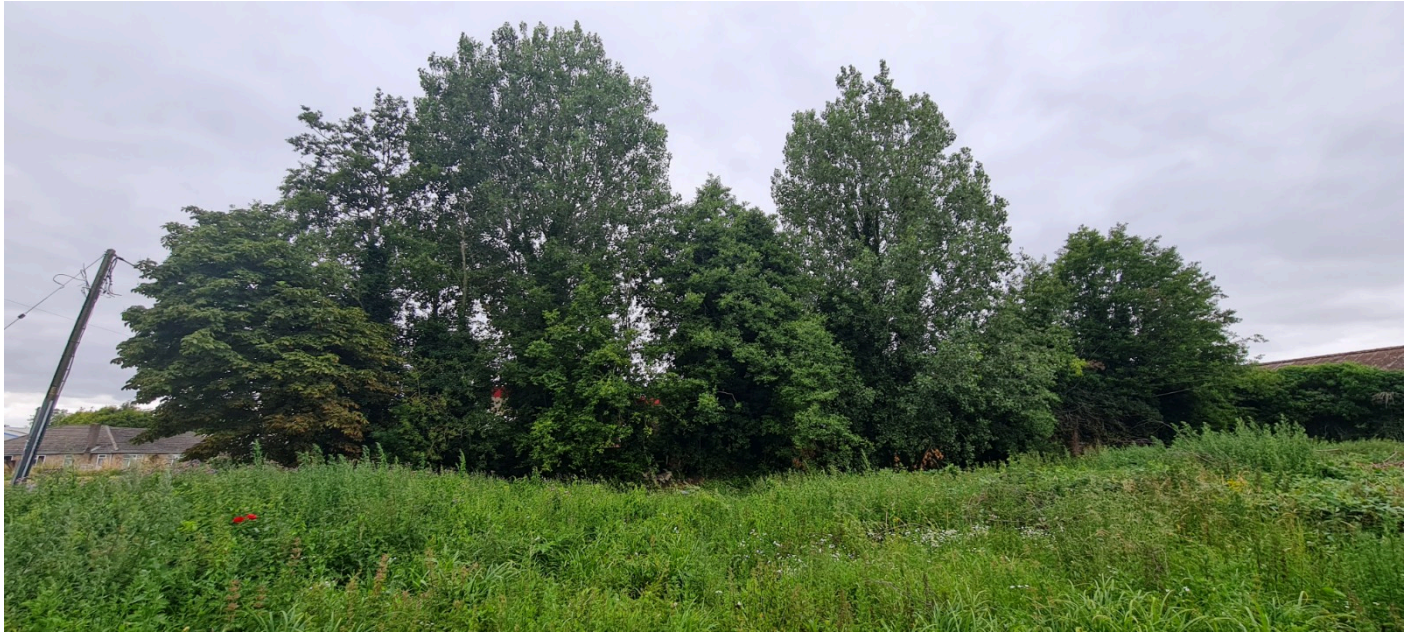
G6 appears to have been planted as a boundary screen perhaps, the trees were put in too close together which has resulted in poor form due to competition. The Poplars are questionable in terms of retention being so close to existing (and proposed) buildings.

| Ref. | Species | Full Structure | Measurements | Spread | General Observations | Retention Category | RPA | Condition | Recommendations |
|---|---|---|---|---|---|---|---|---|---|
| G6 | Mixed species<br>(Mixed species) | Group | Height (m): 16<br>Spread (m): 5N, 5E, 5S, 5W<br>Crown Clearance (m): 1<br>Life Stage: Semi Mature<br>Rem. Contrib.: 40+ Years | N:5<br>E:5<br>S:5<br>W:5 | Horse Chestnut, Poplar, Alder, willow<br>Unable to survey effectively due to vegetation.<br>Ivy climber.<br>Average diameter, spread, and height.<br>Moderate visually amenity value as a group, individually average specimens due do competition. | B1,2 | Area: 306 sq m, plus a 1m buffer. | Physiological Cond: Fair<br>Structural Cond: Fair | Sever ivy at base. |

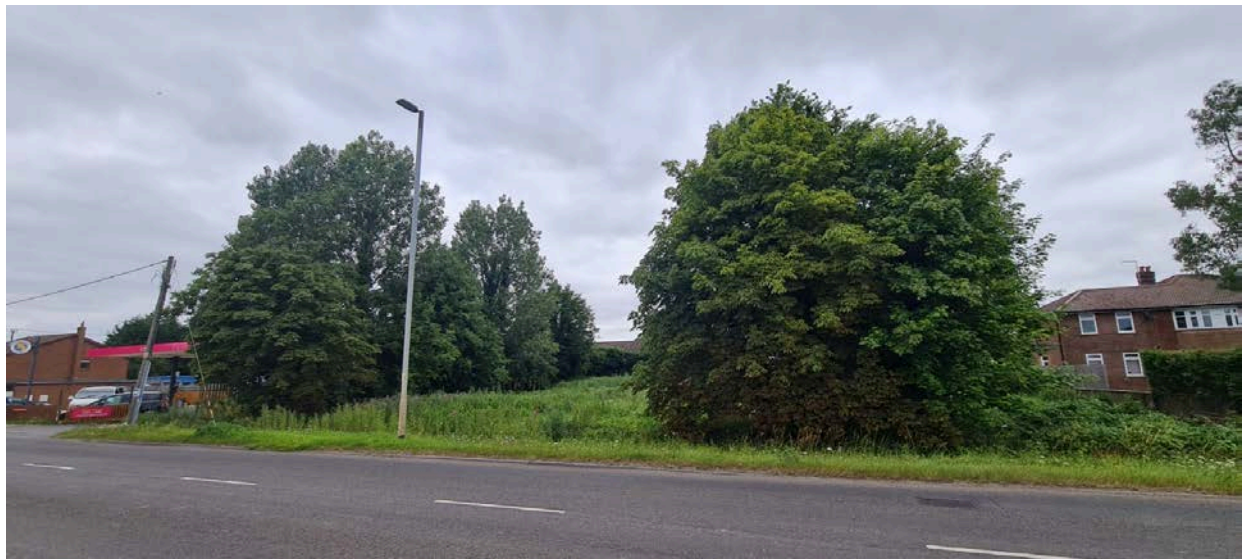
Image is G6 to the left and the individually tagged trees centre.

The individual trees closest to the road are all reasonable specimens although they are competing for available light and space. Most are heavily infested with ivy which precluded a more thorough inspection.
