# **CONTAMINATION REPORT DESK STUDY**

**Job No. 19855**

**Proposed Residential Development  
Land West of Lutton Gowts  
Long Sutton  
Lincolnshire  
PE12 9LQ**

**March 2016  
Revision A**

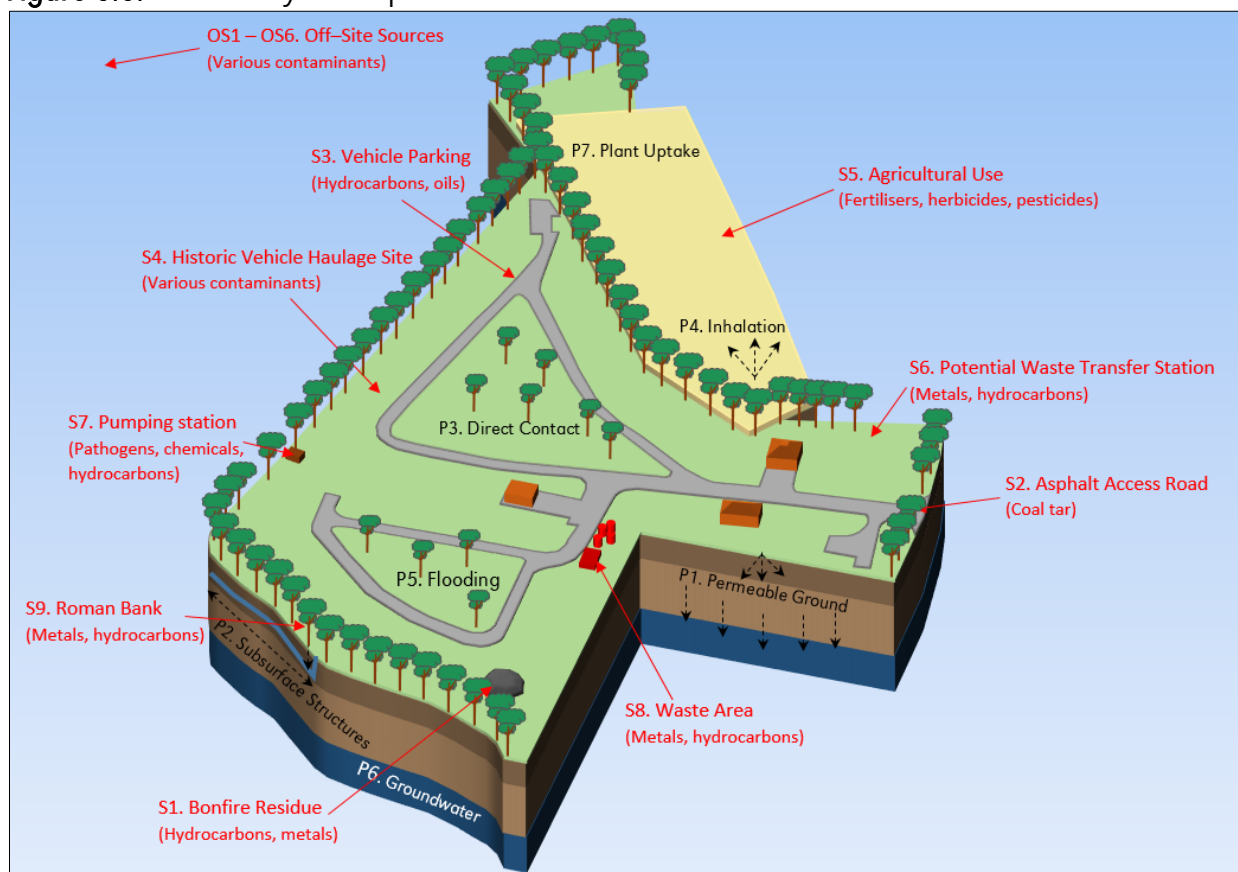
**Figure 6.6:** Preliminary Conceptual Site Model

A preliminary conceptual site model has been prepared based upon the site survey and desk study and is included at Figure 6.6.
