Walnut tree T1 of Lutton TPO No.5 2002 located at 41 Lime Walk, Long Sutton, Spalding, Lincs, PE12 9HG

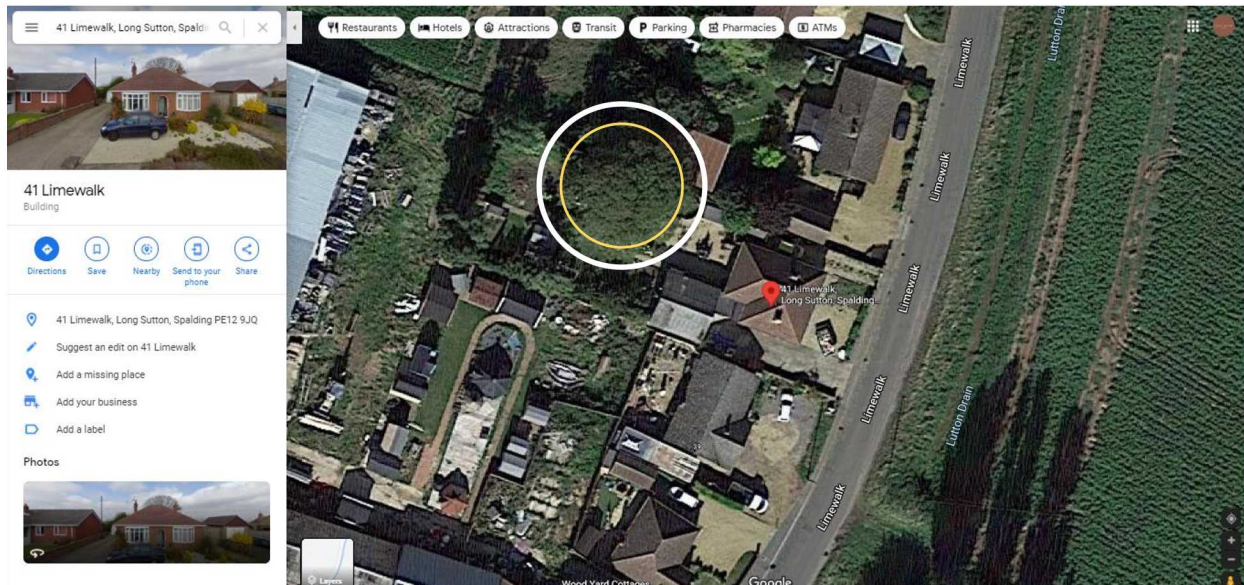
Figure 1: The above image details the location of the Walnut tree (T1 of Lutton TPO No.5 2002). As highlighted, the crown spread of the Walnut tree in the white circle has been measured to a spread of 10 meters from trunk to outer radius. The yellow circle highlights the proposed reduction the crown spread by 2.5 meters. (NB. The above is not an accurate scaled drawing, more to demonstrate an approximate suggested crown spread reduction).

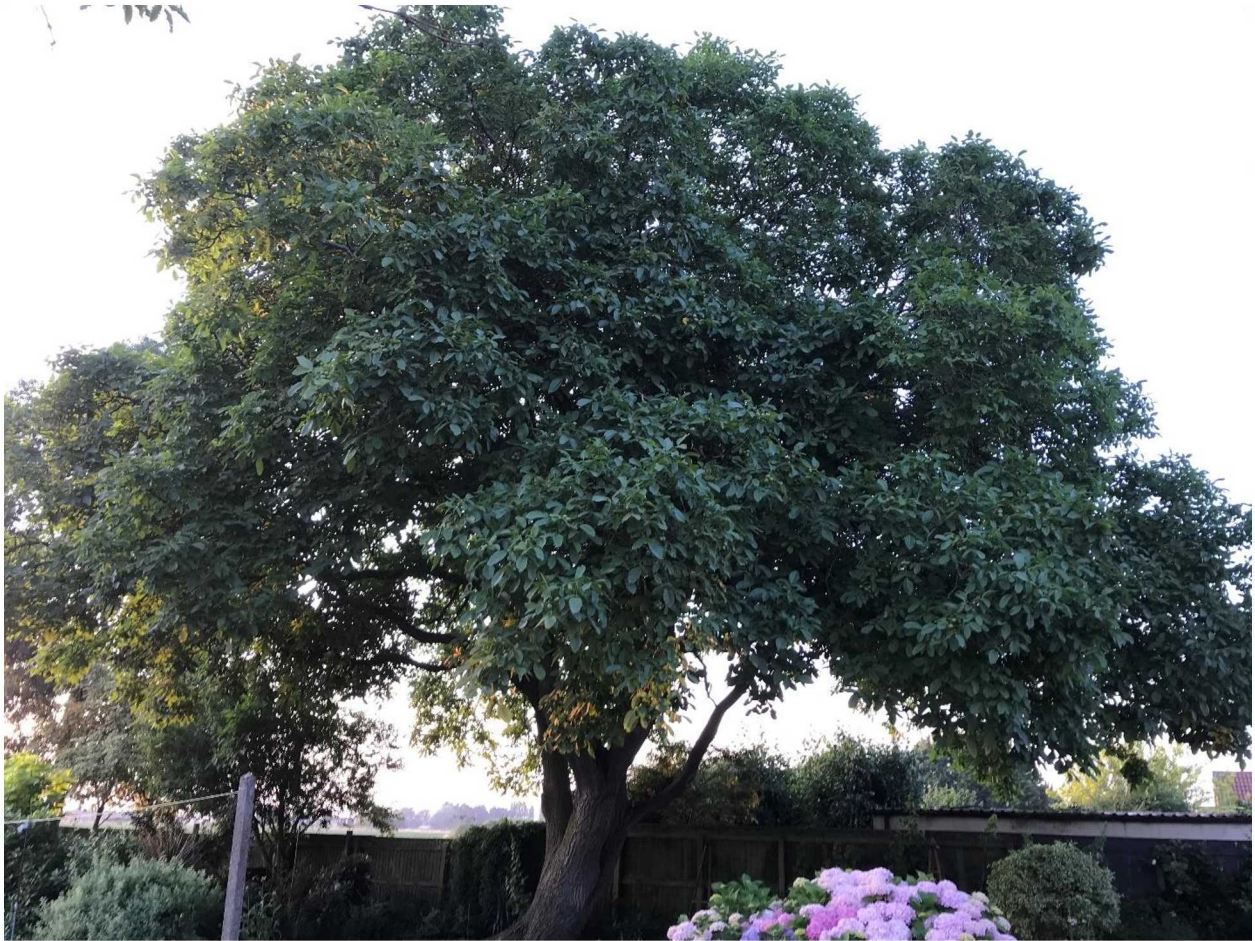
*Figure 2: The above image details the balanced shape and look of the tree in its current state. It also highlights the scale of the tree within the rear garden.*

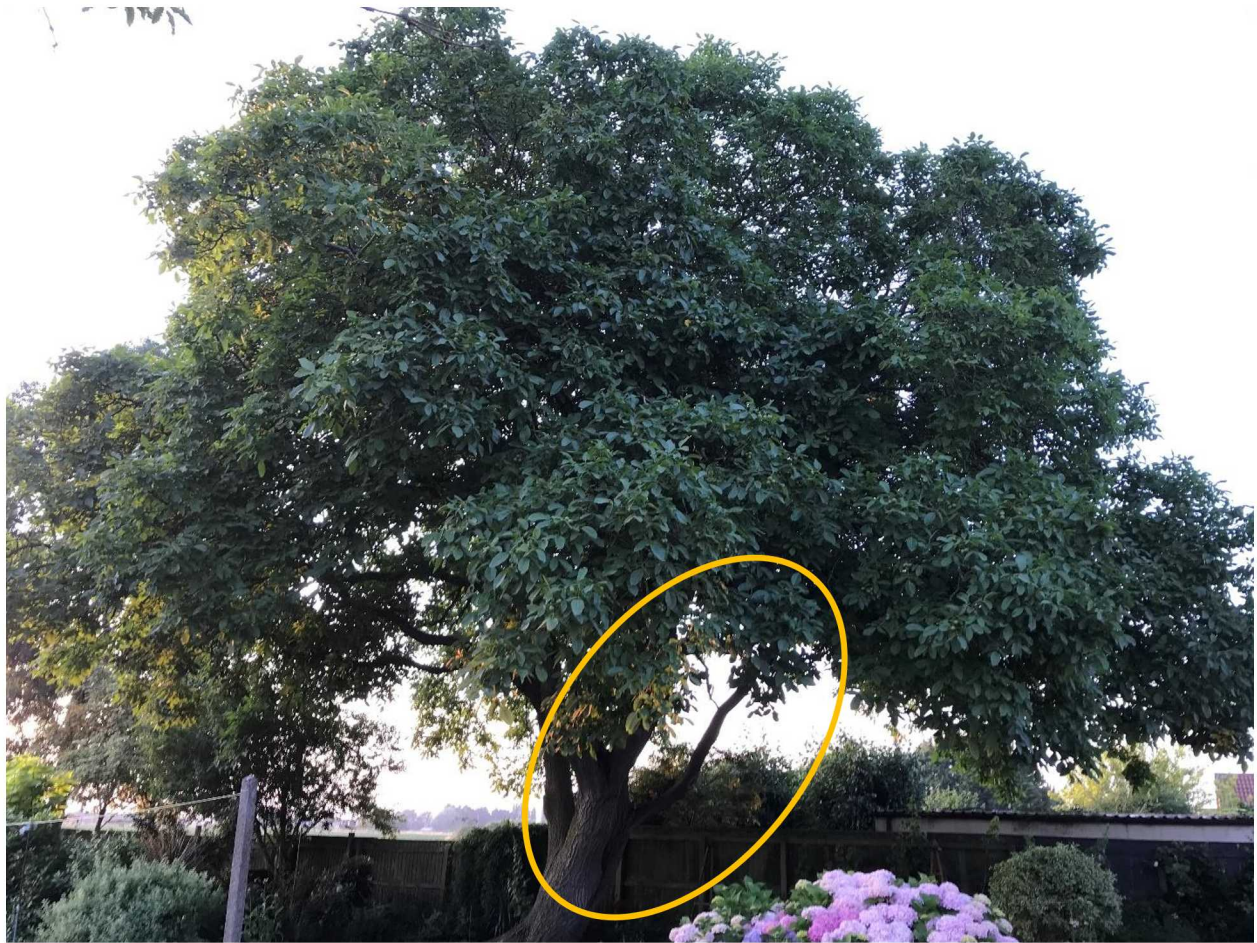
*Figure 3: This image highlights the North East facing overhanging branch towards the neighbour's garage. As proposed, a reduction of 2 meters on this limb back to existing growth points is suggested.*

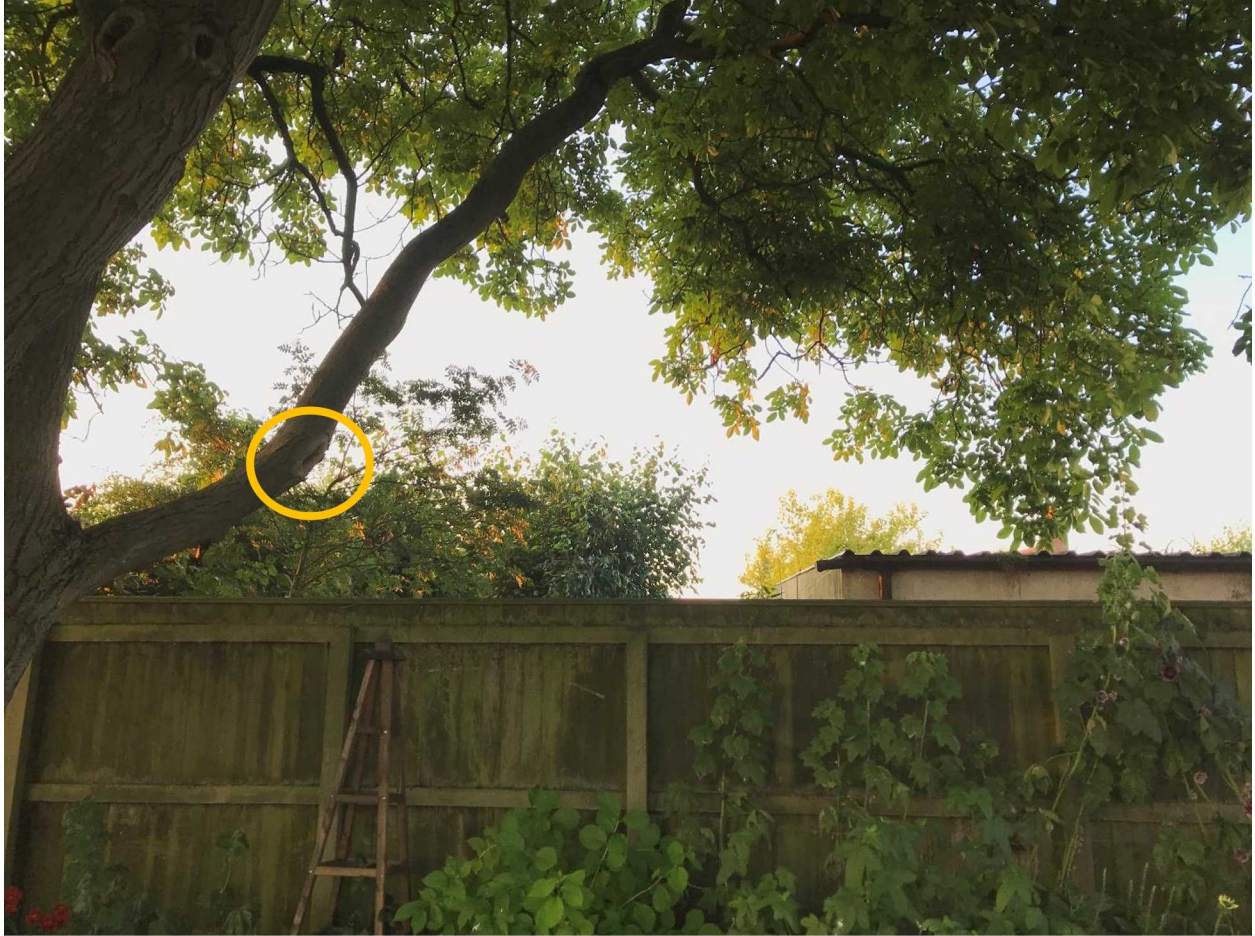
*Figure 4: This image highlights the existing wound that is a weak point to this North East overhanging limb that could pose a significant risk if it were to fatigue, potentially causing extensive damage to the neighbour's property.*

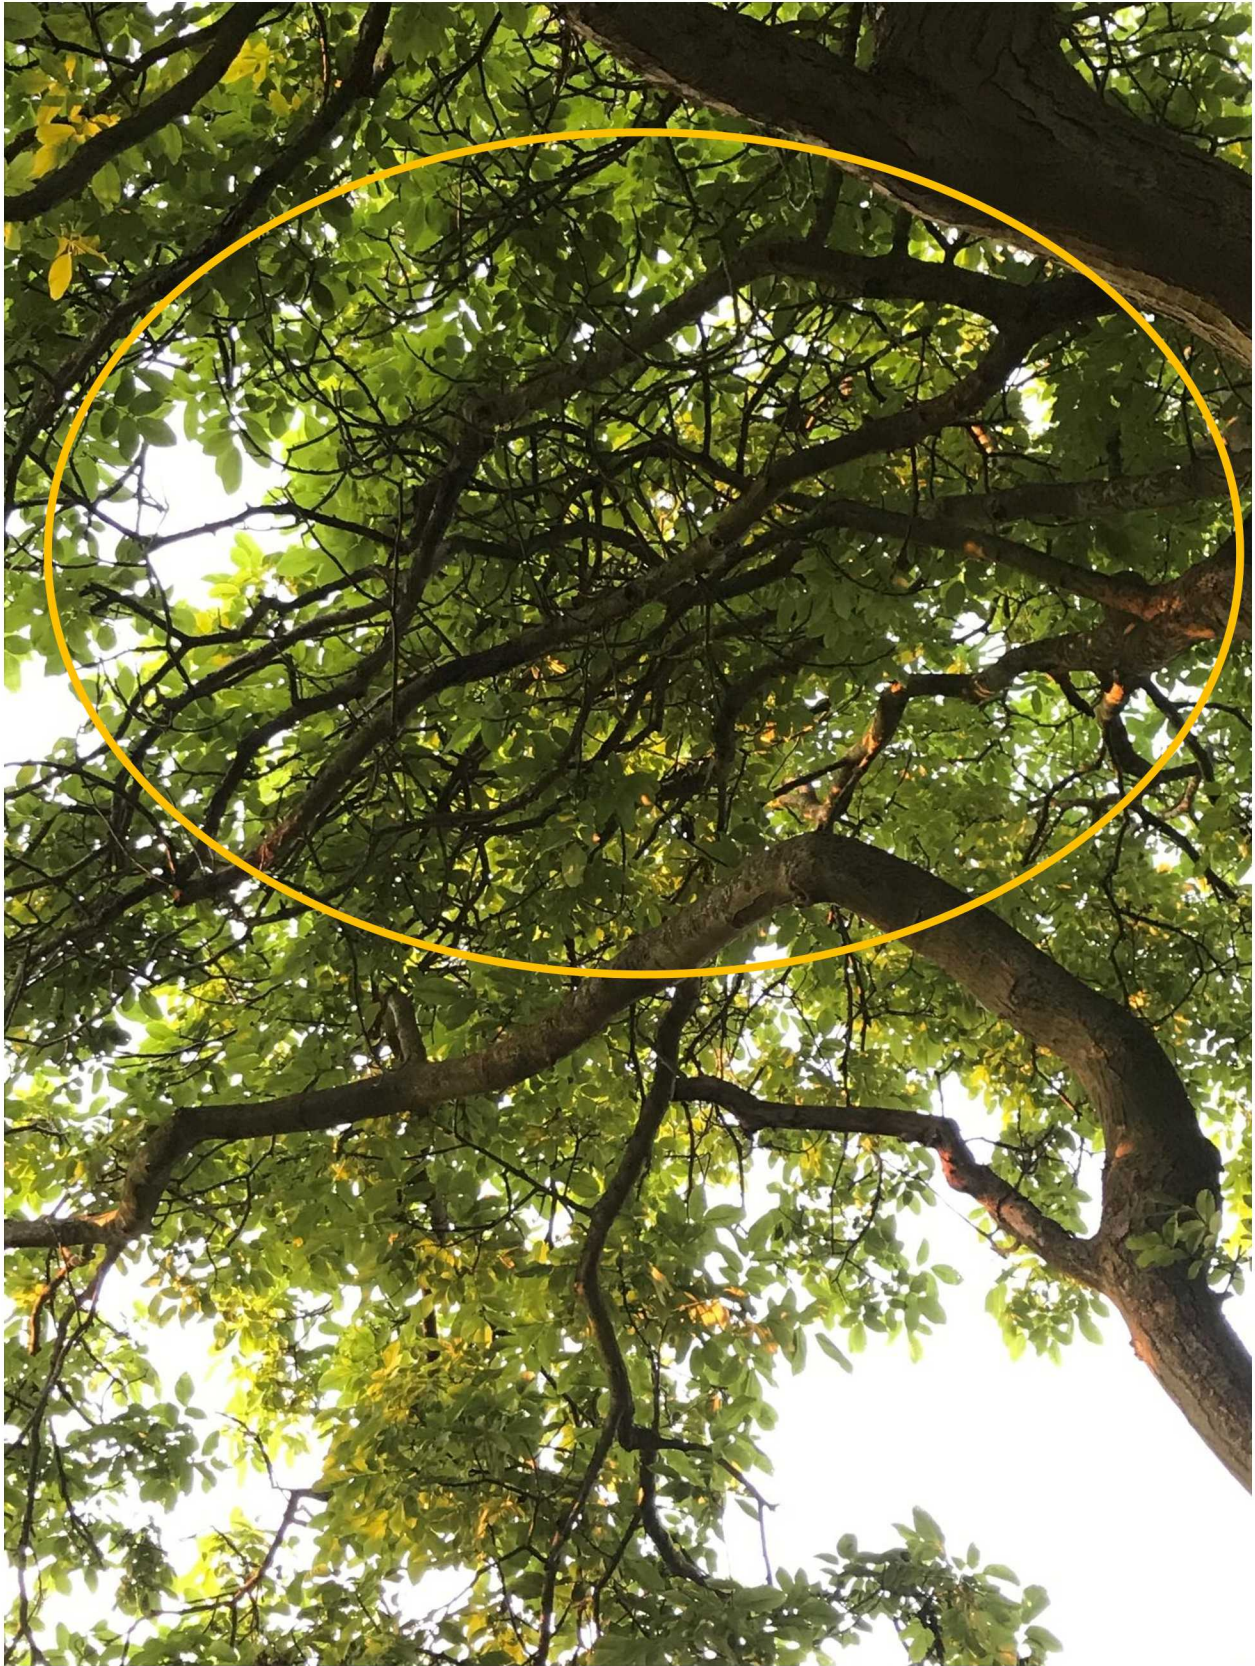
*Figure 5: This image highlights a particularly dense section of the canopy that could be subject to some selective thinning.*

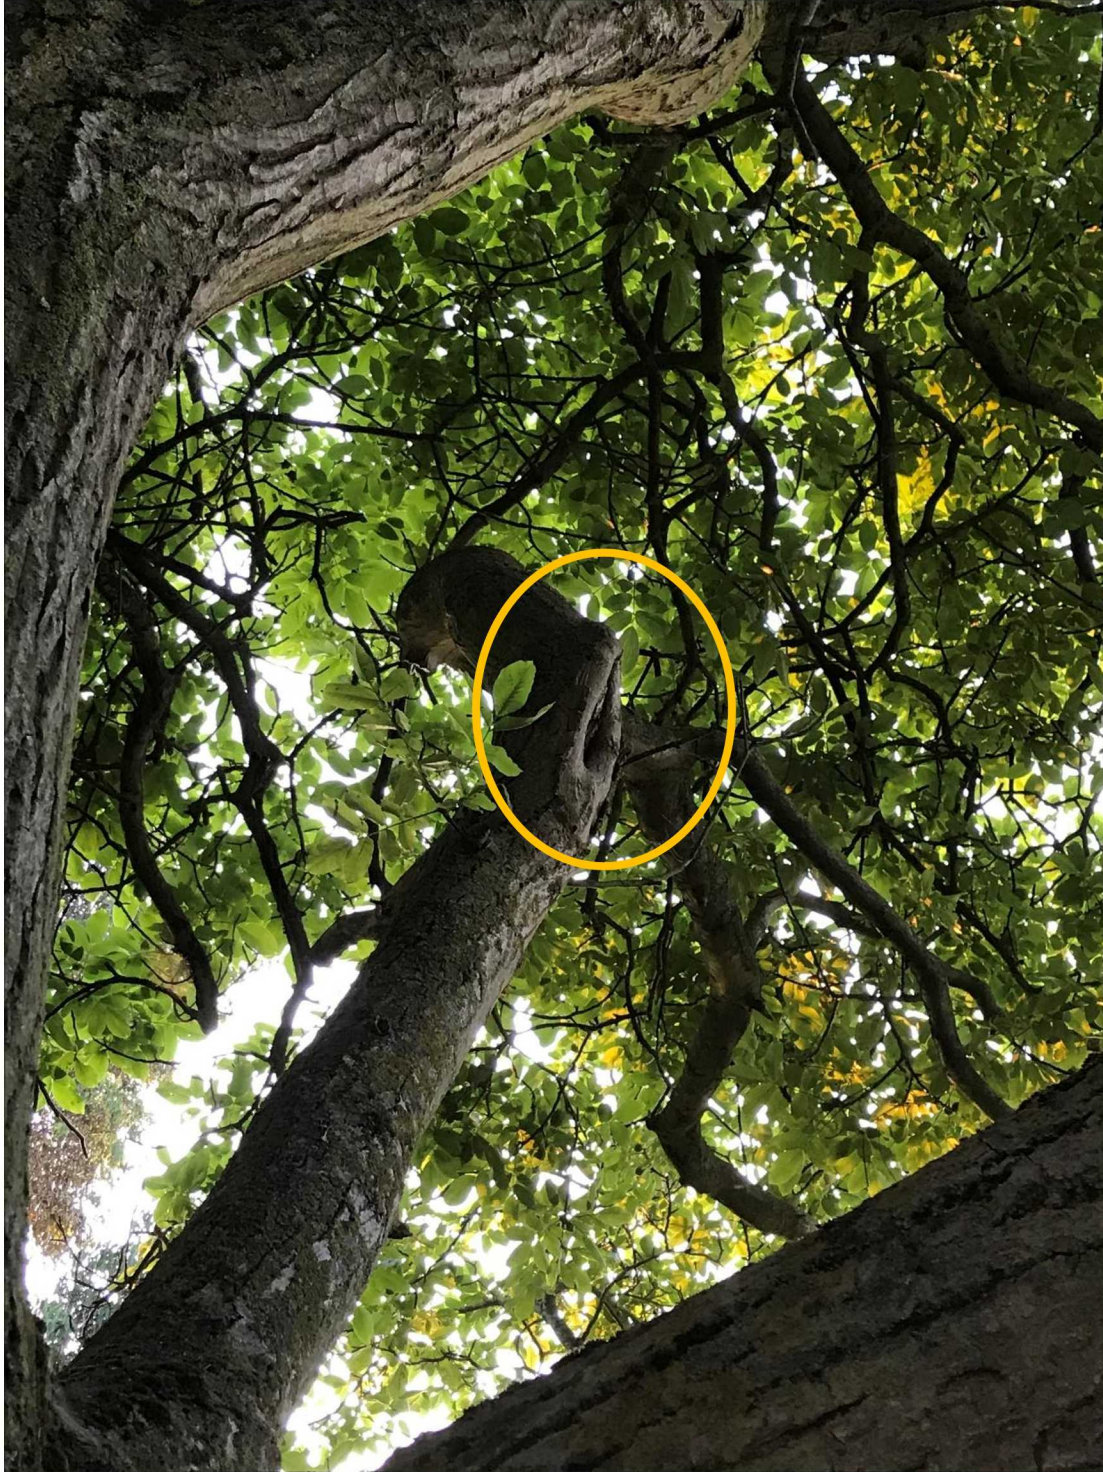
*Figure 6: This image highlights the North West limb that has an existing wound on it. This wound could pose significant risk of fatigue due to a mass of overcrowded branches on its outer limits. As highlighted in the previous image, subjective thinning would reduce its load and could consequently reduce risks of fatigue.*

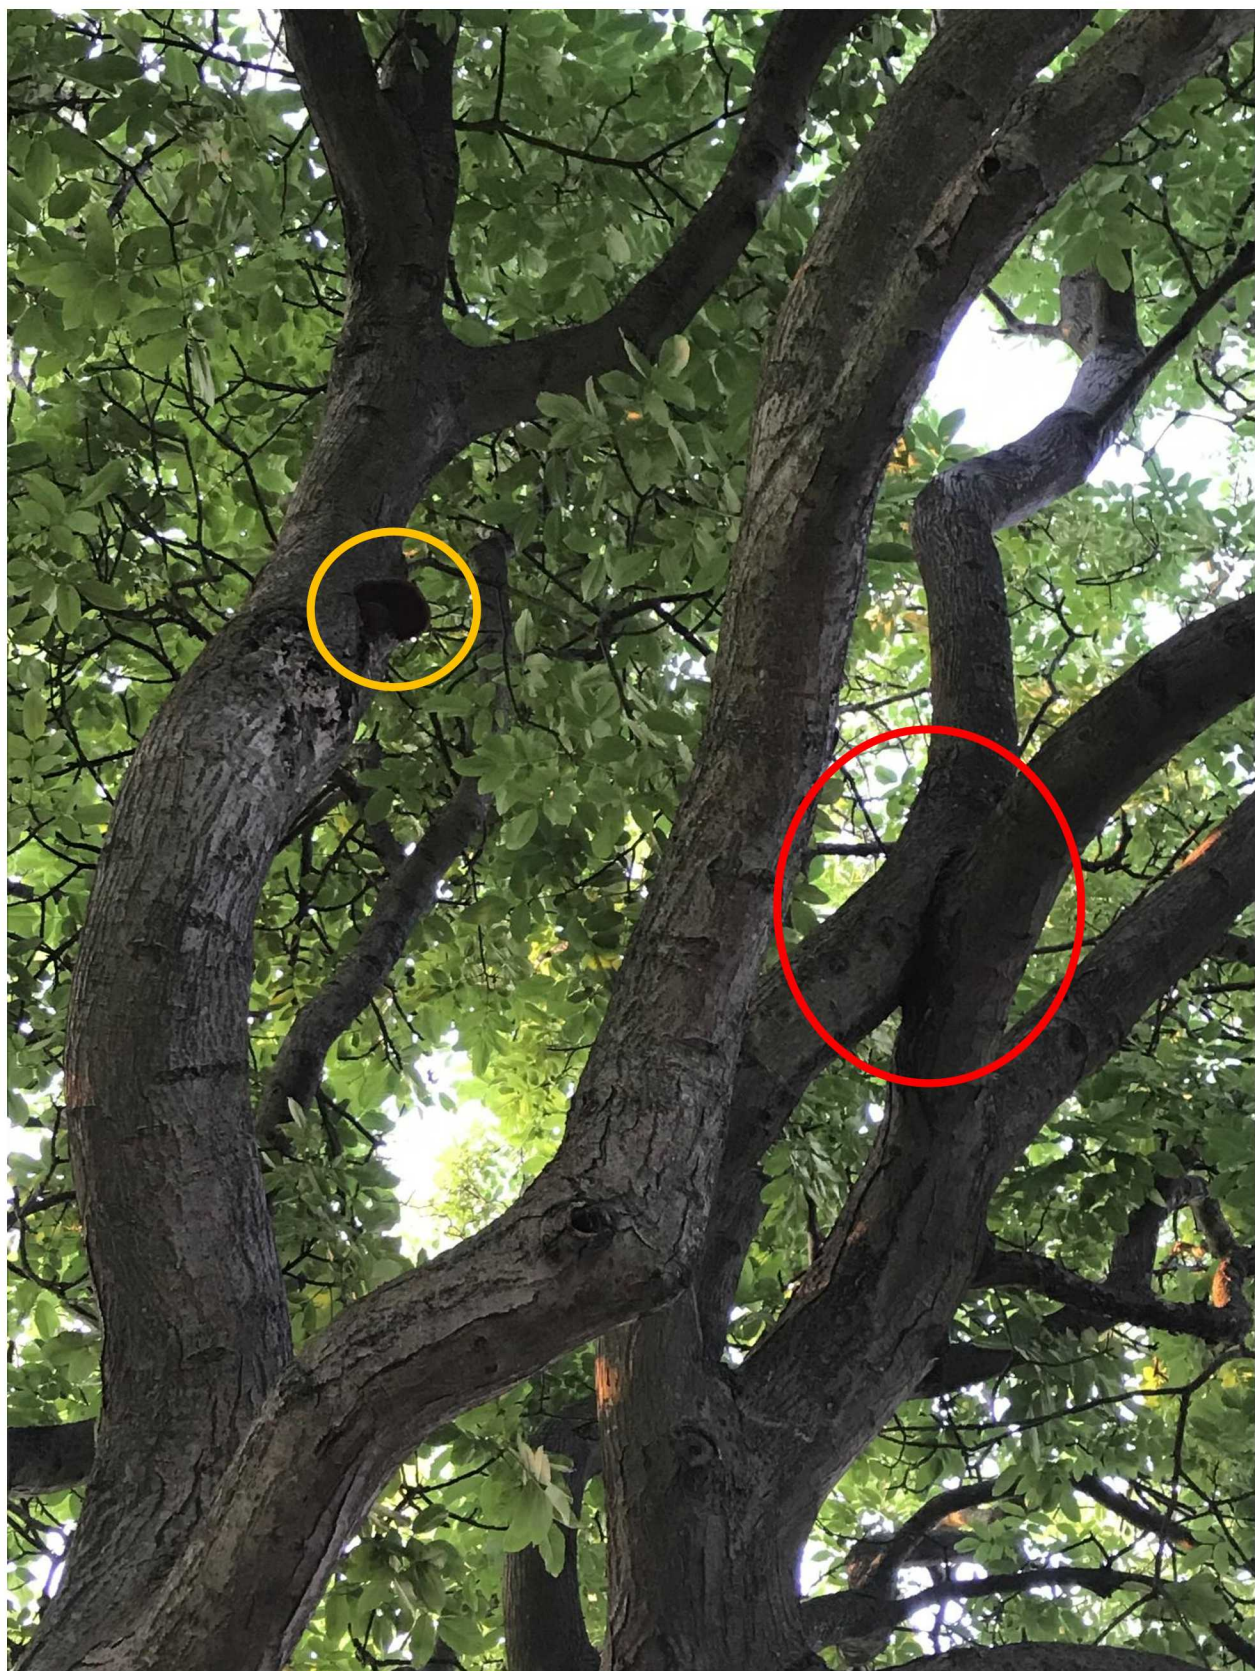
*Figure 7: This image highlights two points of concern. The yellow circle shows the presence of fungus Inonotus Hispidus. The red circle highlights two rubbing branches that could pose risk to branch fatigue. The overall canopy reduction and selective thinning would significantly reduce the load on the branches and consequently reduce the chances of branch fatigue.*
