## Design and Access + HIA Details

Address:- Seas End Hall. Moulton Seas End. Spalding. PE12 6LB

Proposal:- Proposed Refurbishment/Extension/conversion Of Coach House

Revisions:- REV A Mar 2026

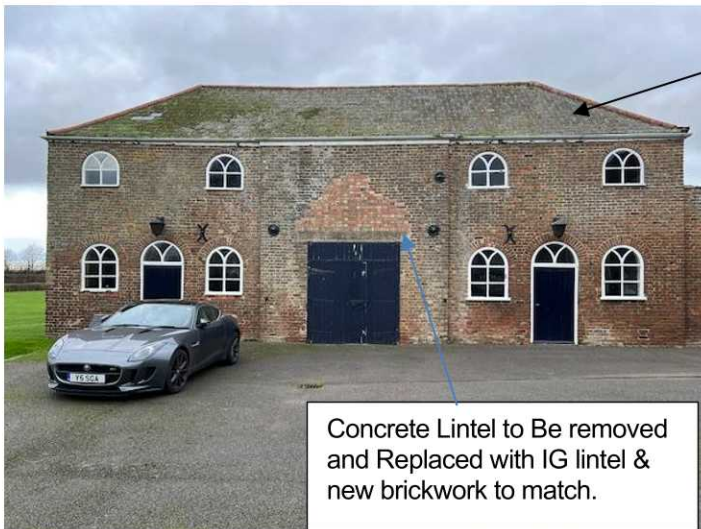
Front elevation Coach House

Slate Roof with Clay Hip  
ridge tiles to be cleaned.

Concrete Lintel to Be removed  
and Replaced with IG lintel &  
new brickwork to match.

Softwood white painted  
timber extended arched  
top single glazed  
windows, all require  
replacement like for like

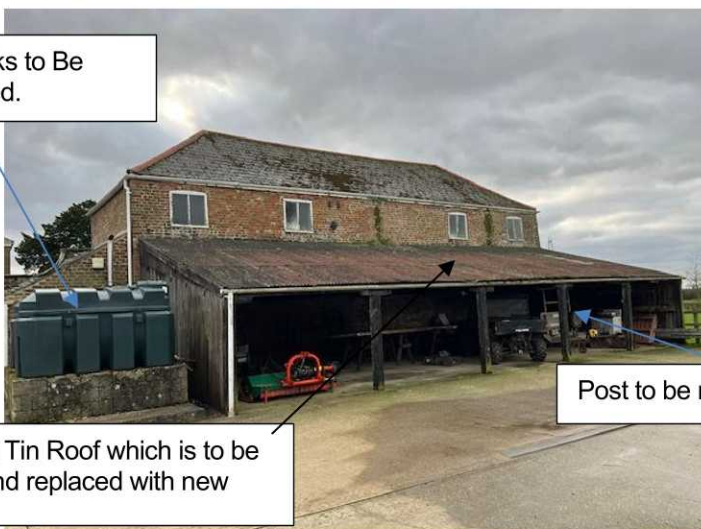
Rear elevation Coach House

Oil Tanks to Be  
relocated.

Corrugated Tin Roof which is to be  
removed and replaced with new

Post to be removed and reused

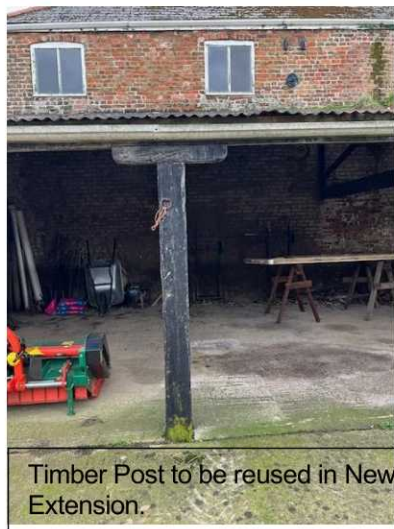
Timber Post to be reused in New Extension.

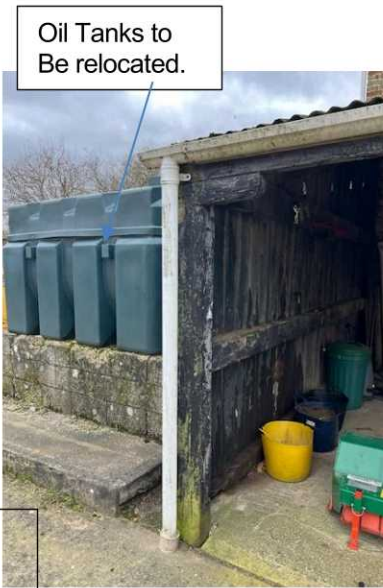
Oil Tanks to Be relocated.

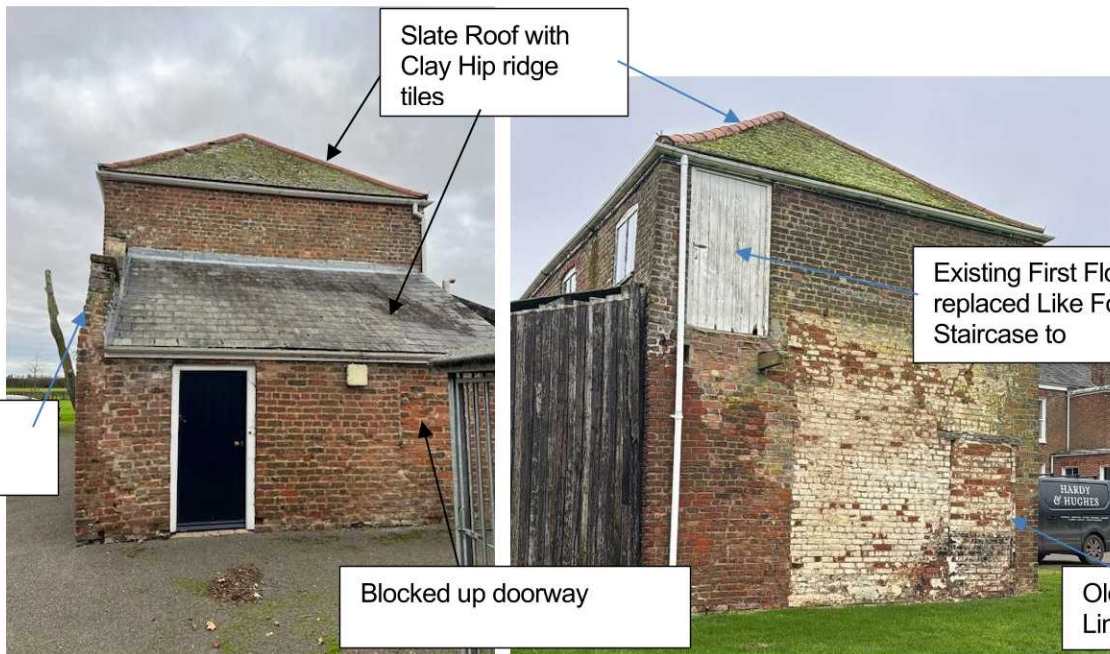
Gable Ends

Slate Roof with Clay Hip ridge tiles

Existing First Floor Door to be replaced Like For Like, New Staircase to

Re Build Required

Blocked up doorway

Old Door way and Lintel require repairs.

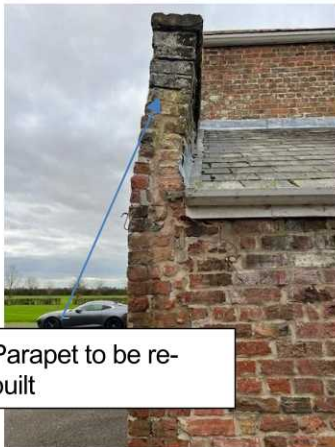
Repairs Required to Lean-to plant room walling, Parapet wall to be taken down with care, cleaned & bricks to be re-used mortar mix to match approved mix on dwelling. Bottom left corner of plant room to be re-built.

Parapet to be re-built

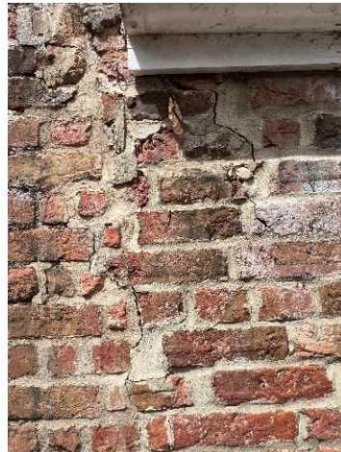
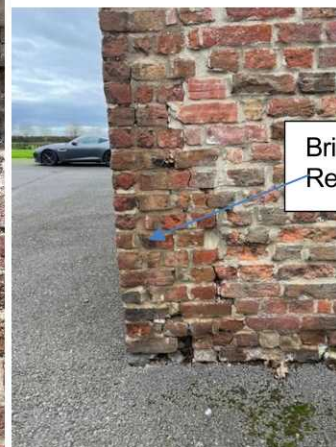
Brickwork to be Re-built

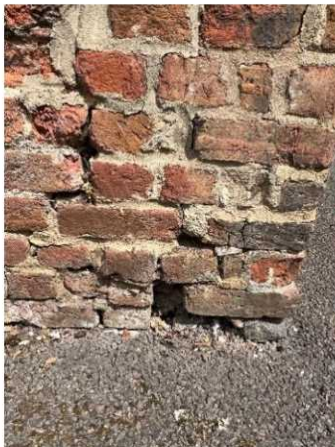
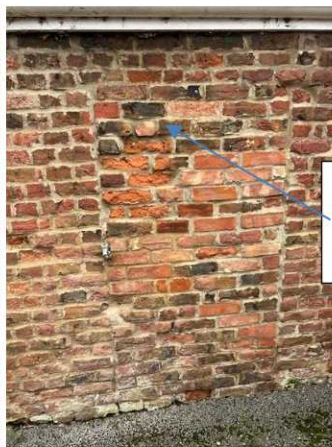
Old Door opening to be retained as is.

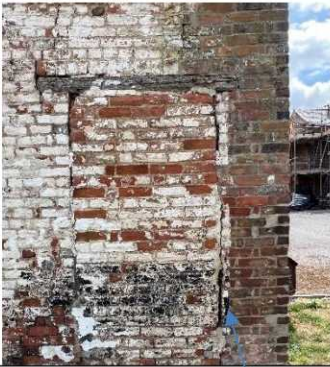
Blocked up Doorway  
showing  
Signs of movement.

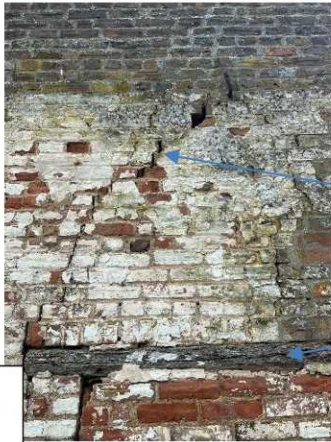
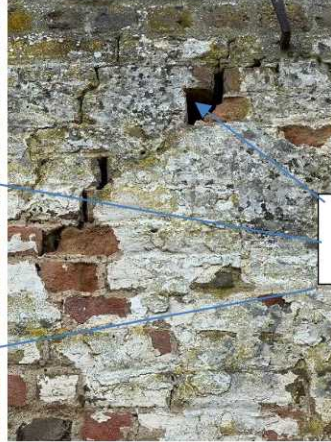
Timber Lintel Failure  
Causing cracking

The gable end of coach house has 1 first floor door and one 1 ground floor door that was bricked up some time ago and has since suffered movement due to the failing timber lintel. Lintel to be replaced with new steel lintel and bottom plate to allow for new oak lintel to the outside.  
Poor Mortar repairs around whole building will be raked out and re-pointed.

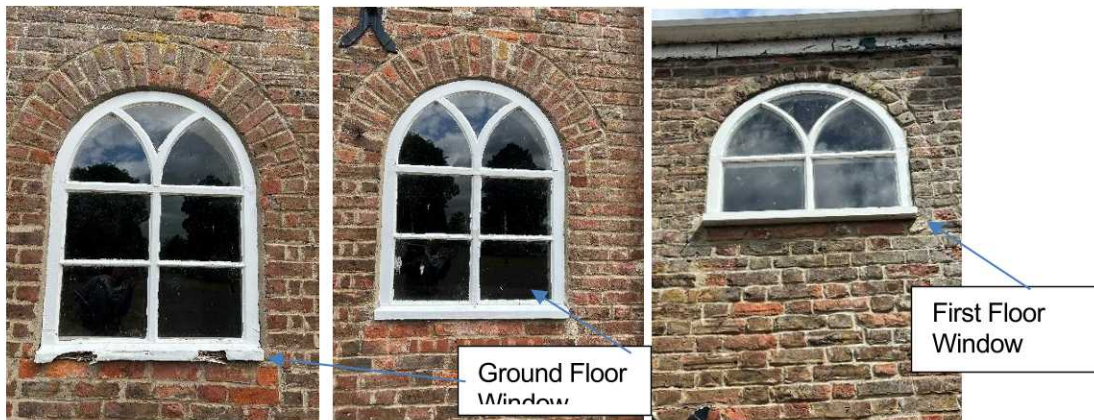
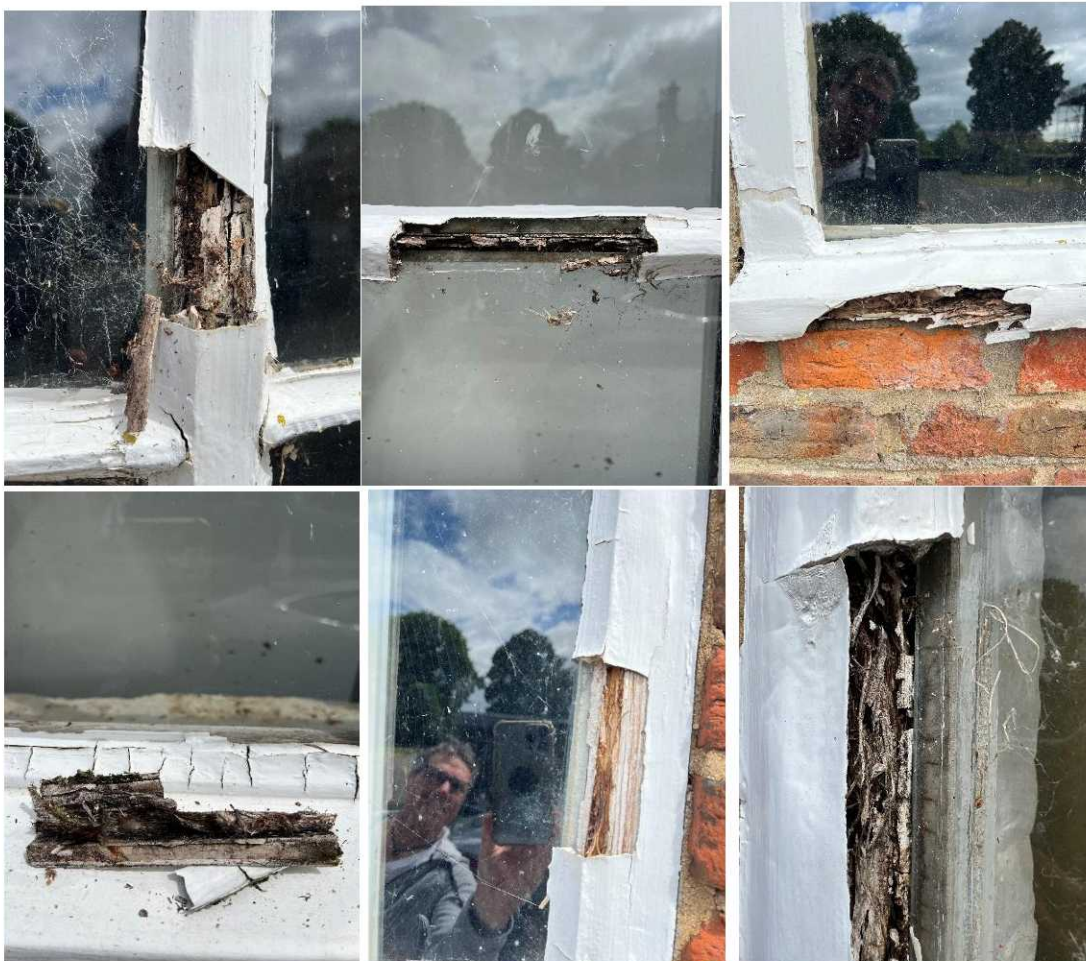
Unfortunately all the of the windows within the coach house are so poor they are beyond repair, and each window will require replacement, The joinery company that has been commissioned to repair the windows within the house will also be replacing the windows in the coach house, these will be a straight replacement like for like

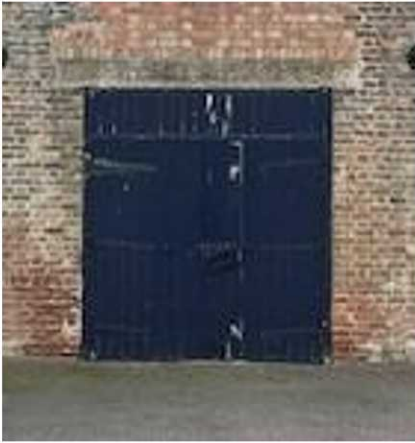
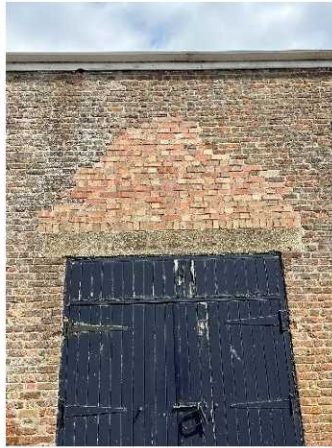
Main Central Double Doors are similar to windows and have suffered to rot due to poor maintenance over the years and will require replacement. It is also considered that the concrete lintel is not in keeping and will be replaced with a steel lintel with a bottom plate to allow for a new oak lintel to the front elevation.

Cast Iron Hinges have either been replaced or damaged, New cast hinges to be fitted to new doors.

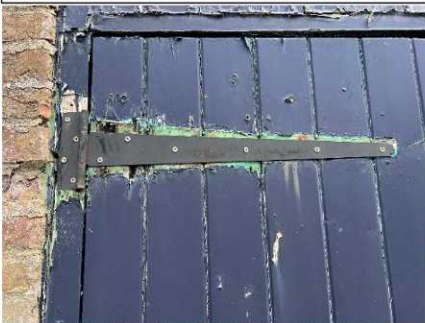
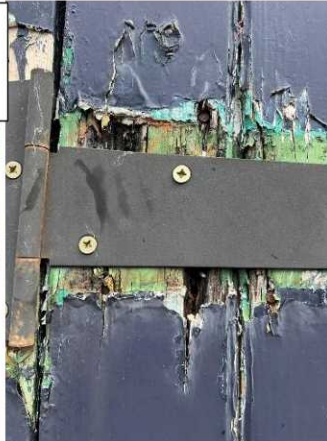
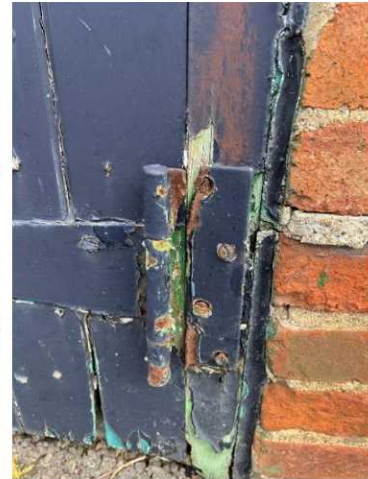
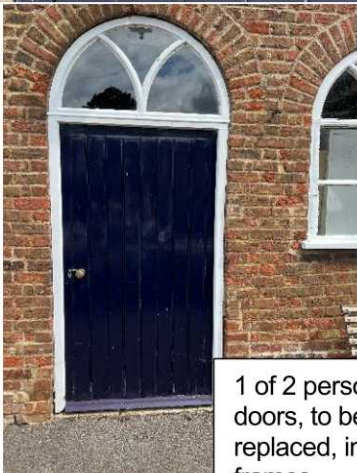
1 of 2 personnel doors, to be replaced, including frames.

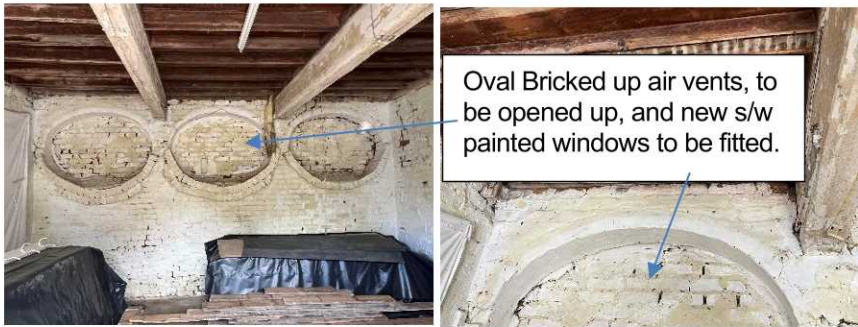
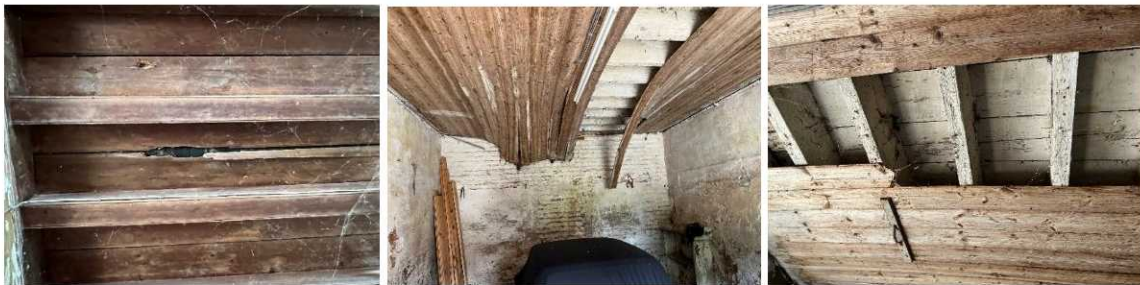
Floor joists have either been boarded up individually or the whole area boarded. Many of the upper boards will be replaced as all rotten.

New Floor joists to be fitted as required, underside of joists to have 15mm plasterboard sound deadening quilt fitted between joist, with new floor boarding

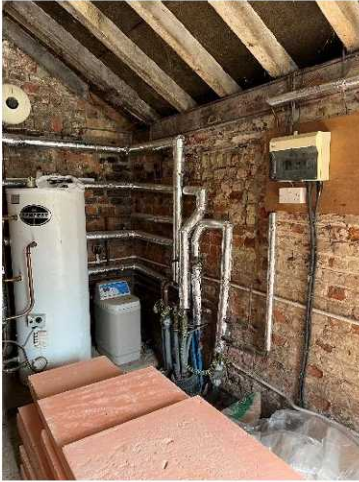
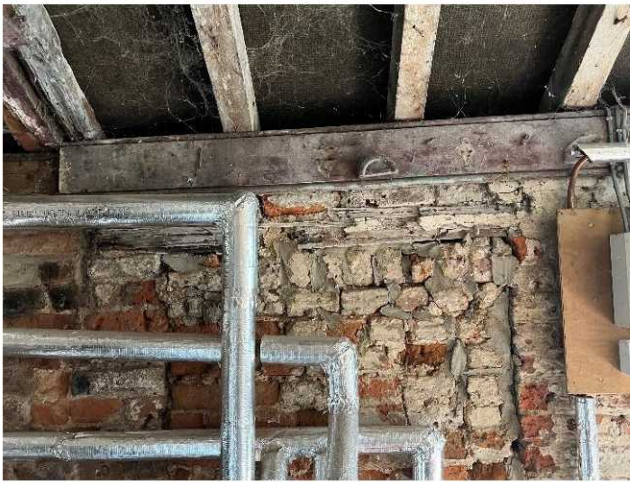
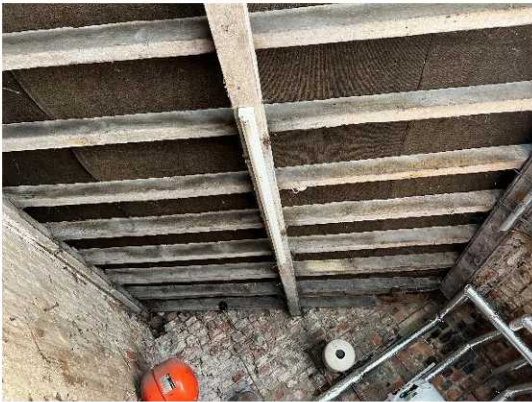
Internal Pictures of existing  
Plant room.

Roofing Timbers to Plant  
Room to be checked and  
treated for woodworm

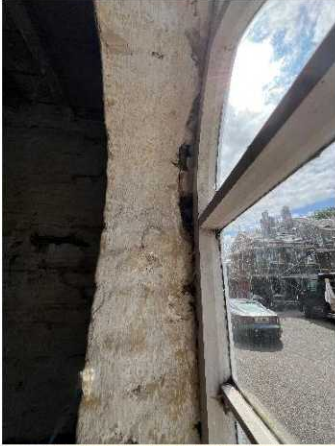
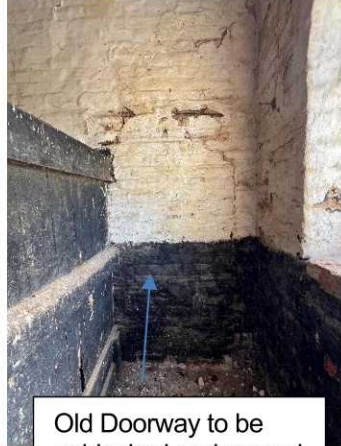
Old Doorway to be unblocked and reused

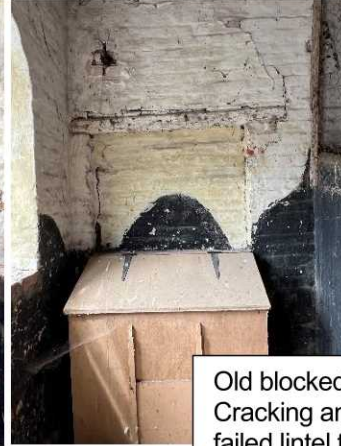
Old blocked up door to be retained  
Cracking and damaged due to failed lintel to be made good.

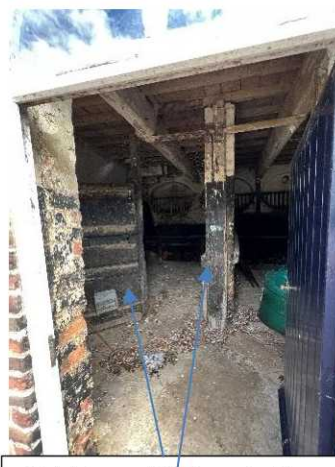
Old internal timber stables and posts to be completely removed

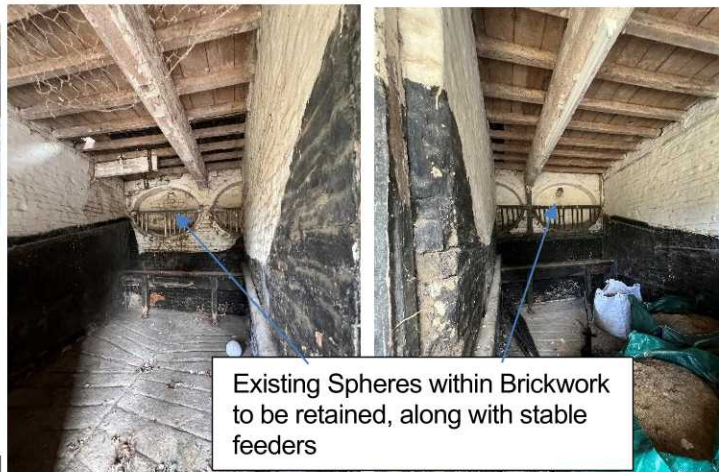
Existing Spheres within Brickwork to be retained, along with stable feeders

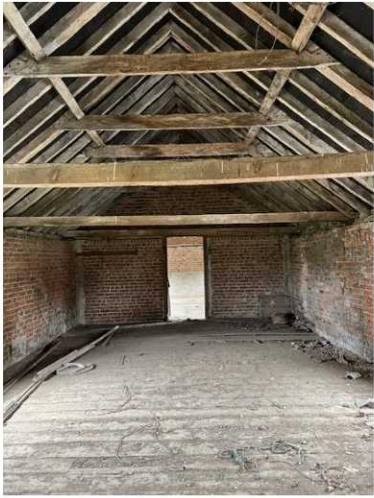
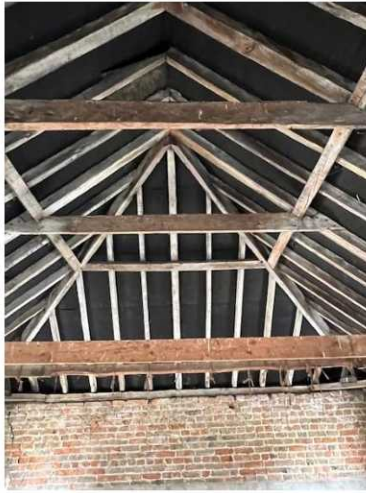
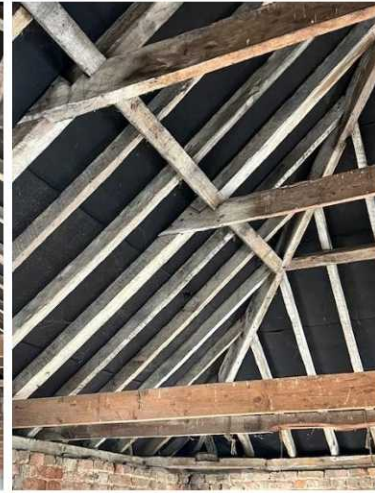
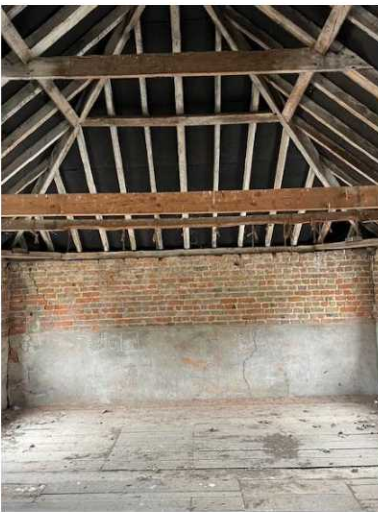
Existing Roofing structure to be retained and treated.  
New insulation to be used between the rafters and below the rafters,

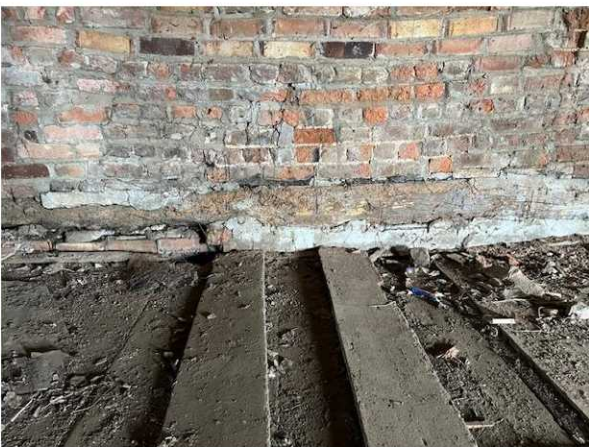
Existing planked floor to be removed, and replaced with new boards.

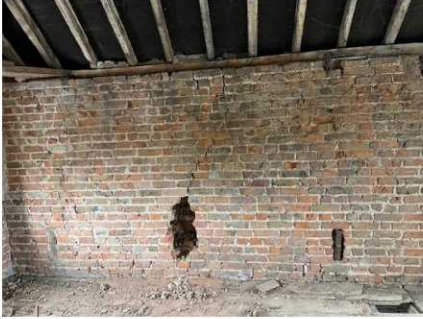
Internals walls to be re pointed, Walls to Have breather/building paper and new insulated stud wall built in front with plaster board finish.
