Design and Access + HIA Details

Address:- Seas End Hall. Moulton Seas End. Spalding. PE12 6LB

Our Ref:- SA/MLJ/001/2025

Proposal:- Proposed Refurbishment/Extension/conversion Of Coach House

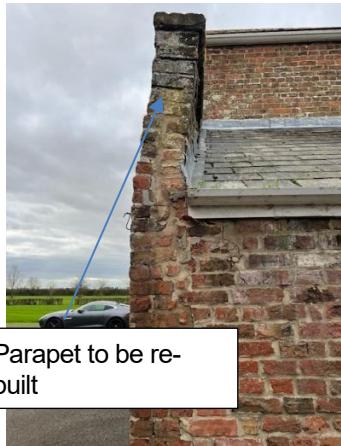
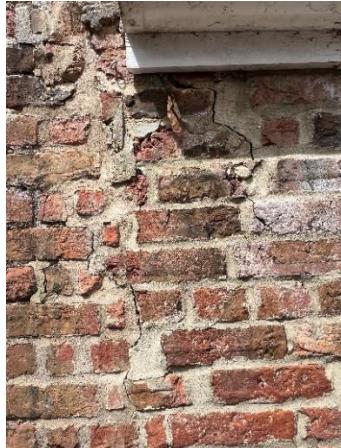
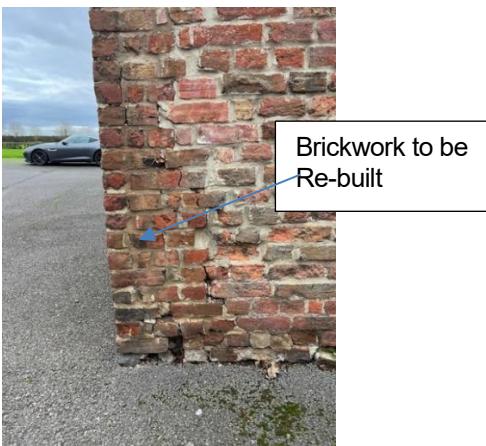
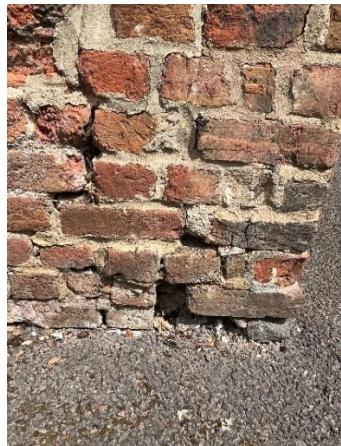
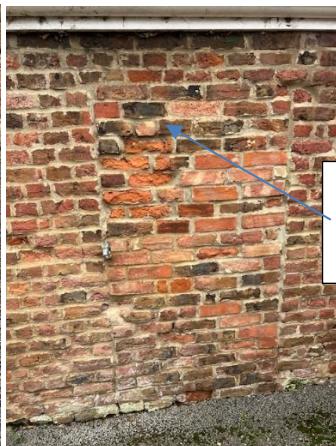
Walling Repairs

Repairs Required to Lean-to plant room walling, Parapet wall to be taken down with care, cleaned & bricks to be re-used mortar mix to match approved mix on dwelling. Bottom left corner of plant room to be re-built.

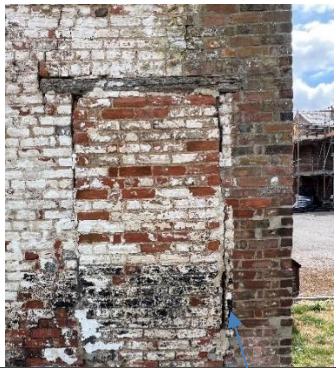
Blocked up Doorway
showing
Signs of movement.

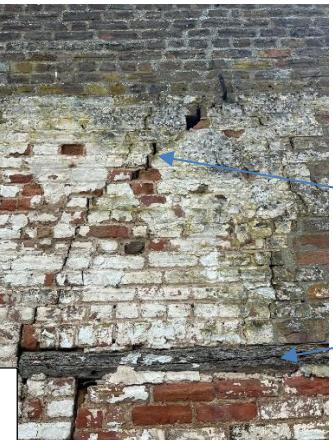
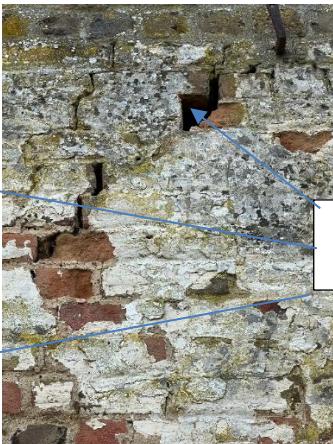
Timber Lintel Failure
Causing cracking

The gable end of coach house has 1 first floor door and one 1 ground floor door that was bricked up some time ago and has since suffered movement due to the failing timber lintel. Lintel to replaced with new steel lintel and bottom plate to allow for new oak lintel to the outside.

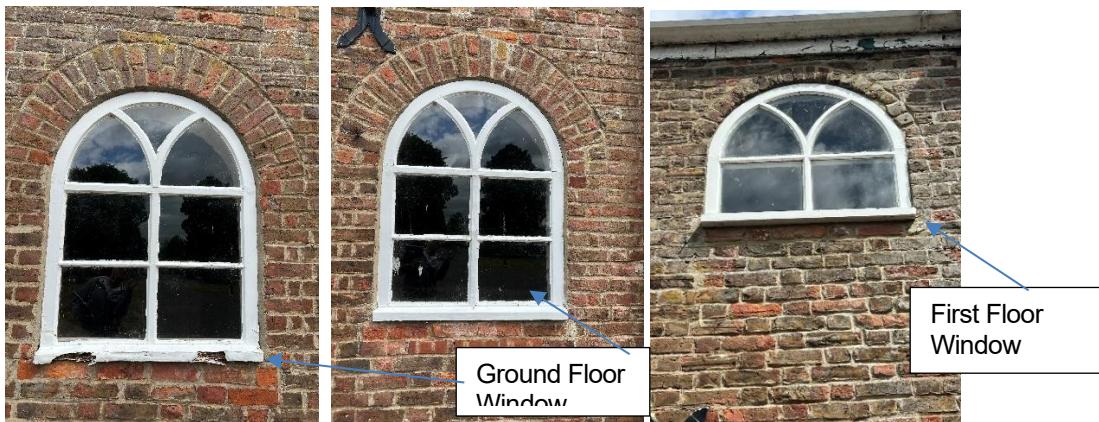
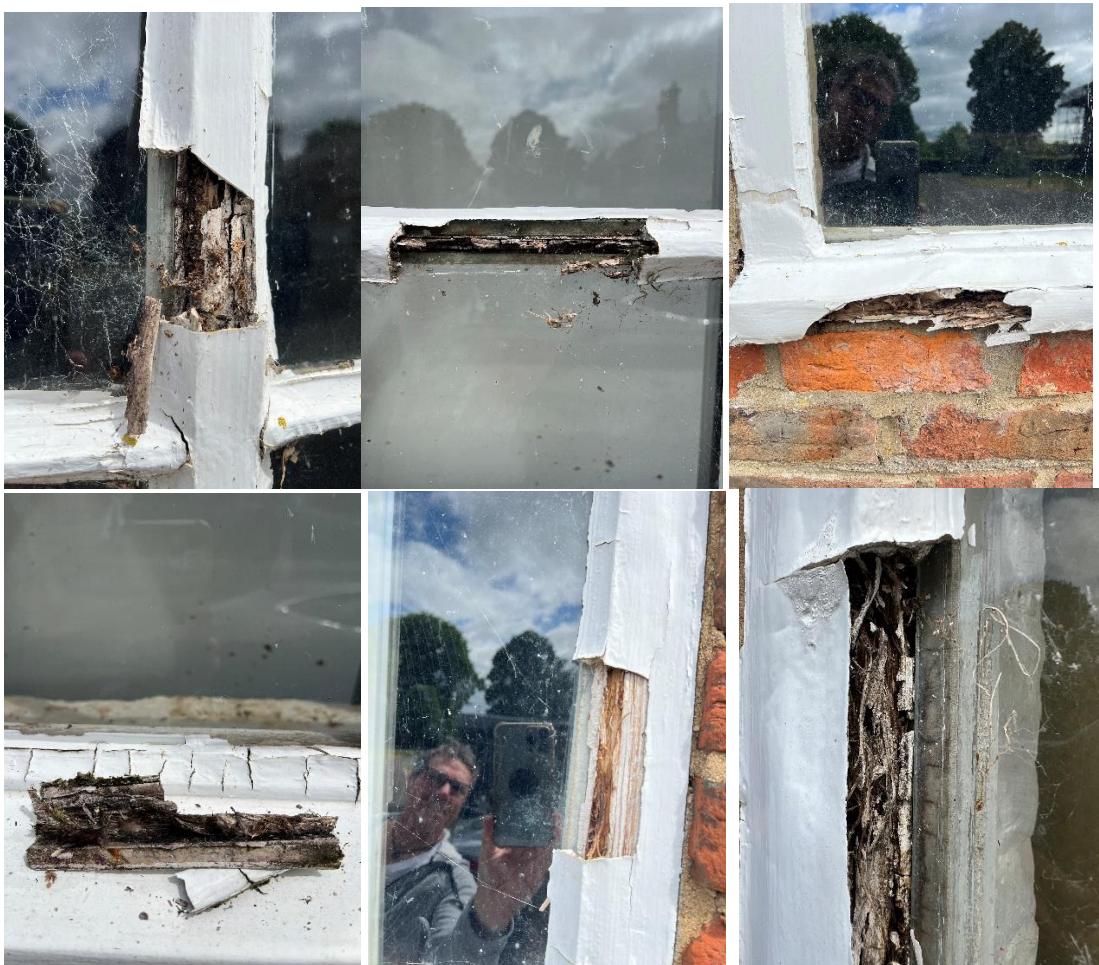
Windows

Unfortuantly all the of the windows within the coach house are so poor they are beyond repair, and each window will require replacement. The joinery company that has been commissioned to repair the windows within the house will also be replaceing the windows in the coach house, these will be a straight replacement like for like

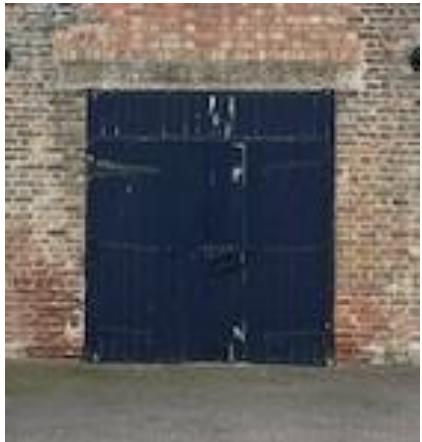
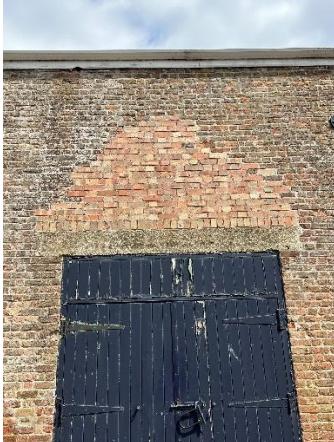
Doors,

Main Central Double Doors are similar to windows and have suffered to rot due to poor maintenance over the years and will require replacement. It is also considered that the concrete lintel is not in keeping and will be replaced with a steel lintel with a bottom plate to allow for a new oak lintel to the front elevation.

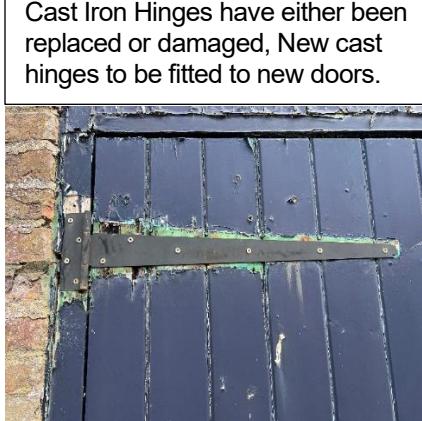
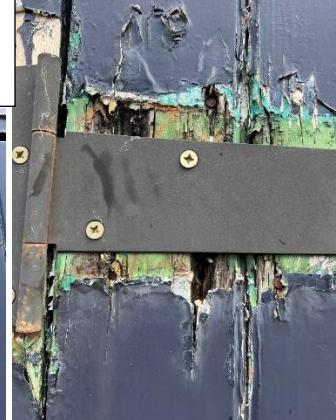
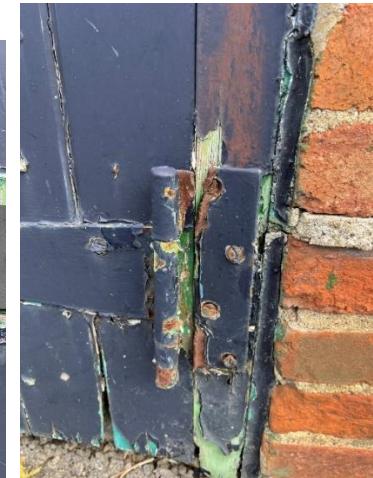
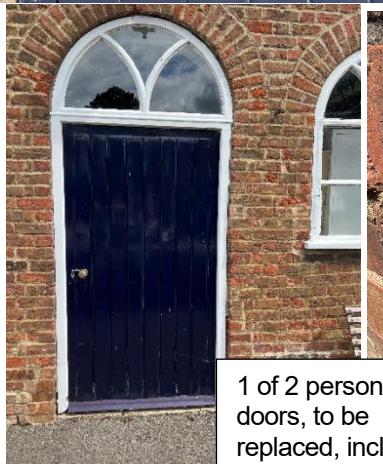
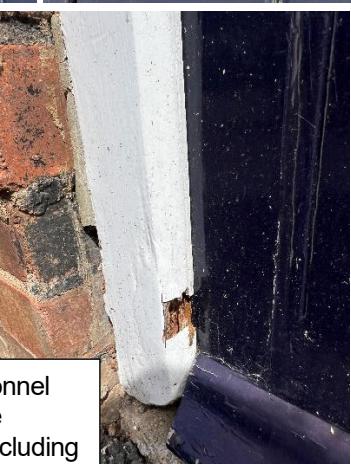
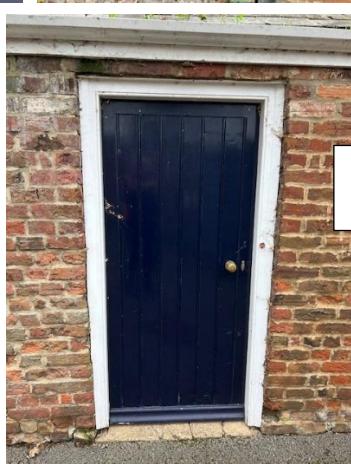
1 of 2 personnel doors, to be replaced, including frames.

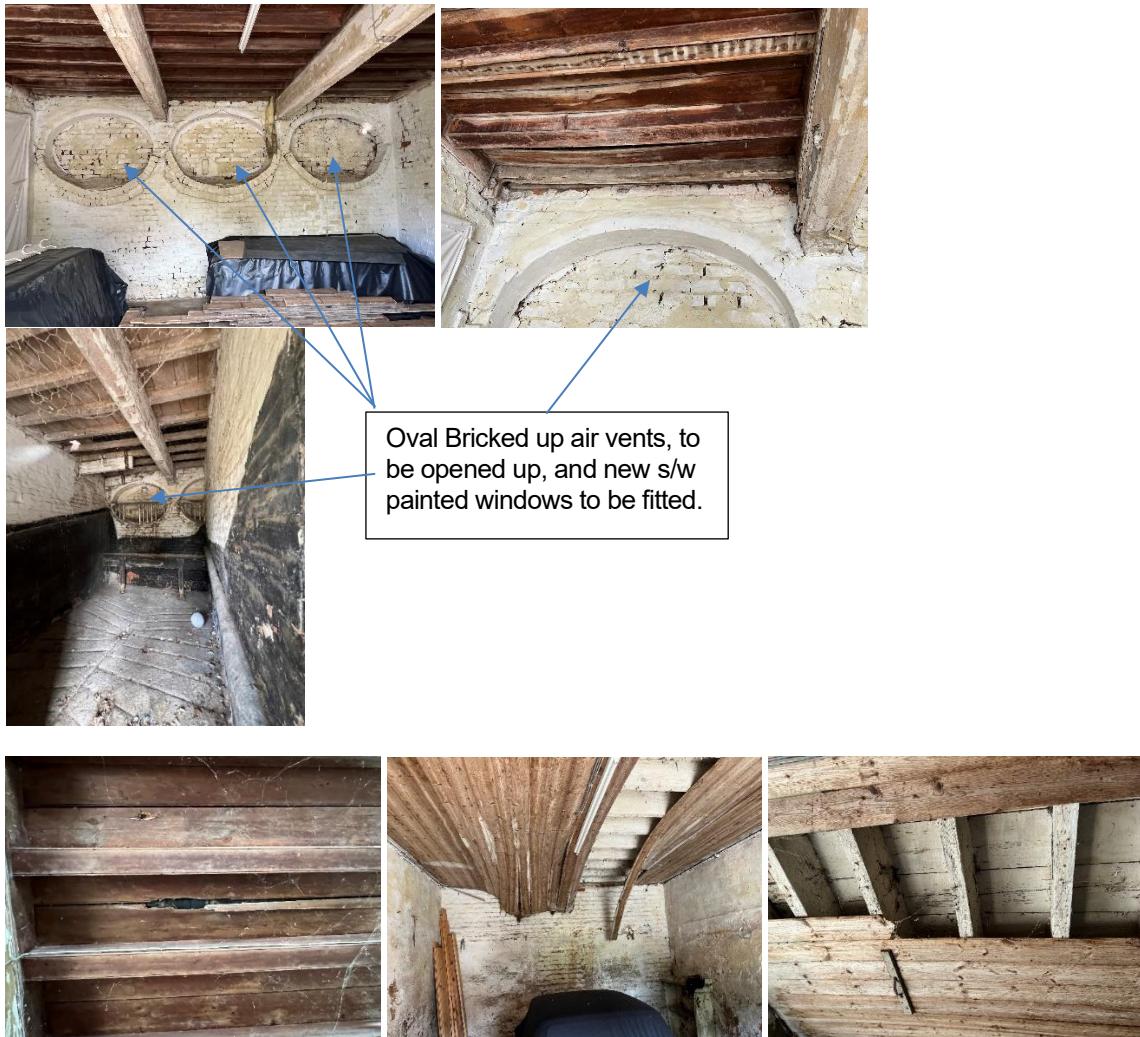
Floor joists have either been boarded up individually or the whole area boarded. Many of the upper boards will be replaced as all rotten.

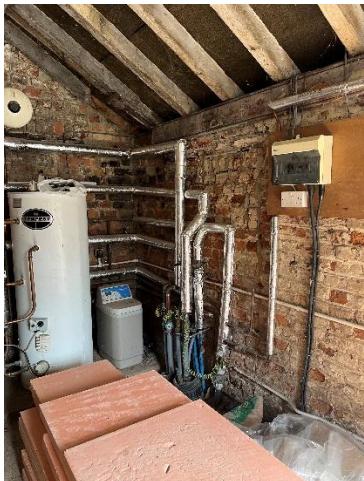
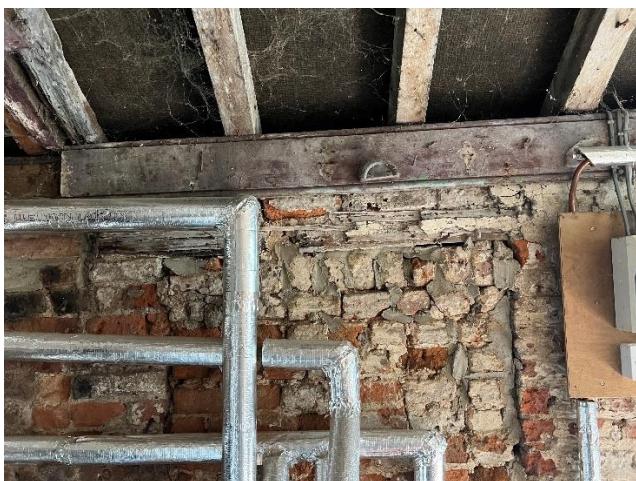
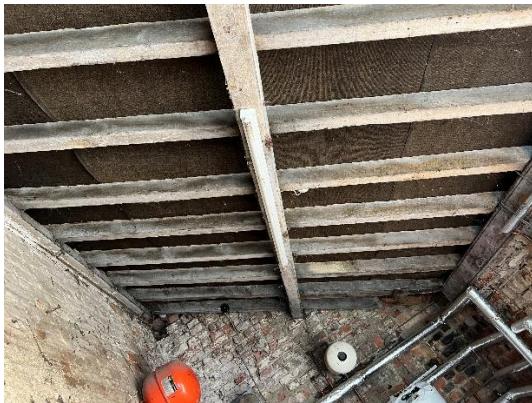
Plant Room.

Internal Pictures of existing
Plant room.

Roofing Timbers to Plant
Room to be checked and
treated for woodworm

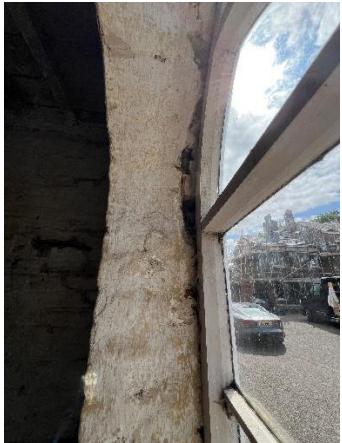
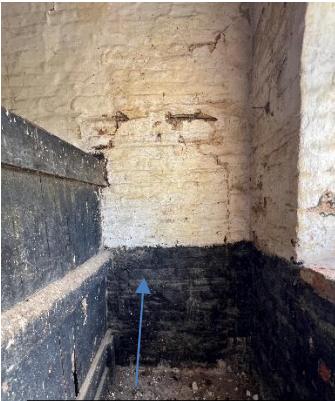
Old Doorway to be un blocked and reused

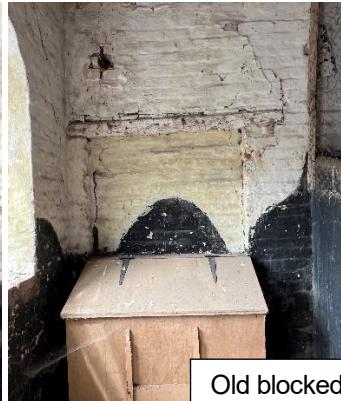
Old blocked up door to be retained
Cracking and damaged due to
failed lintel to be made good.

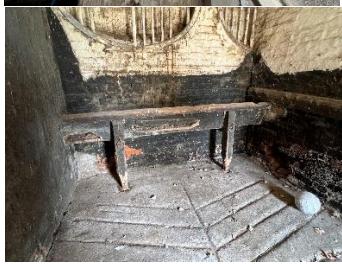
Existing Concrete floor to be
removed and replaced with, new
100mm concrete slab, 150mm
Celotex insulation and new
screed.

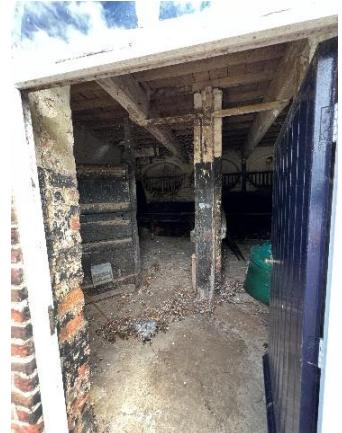
Old internal timber stables and posts
to be completely removed

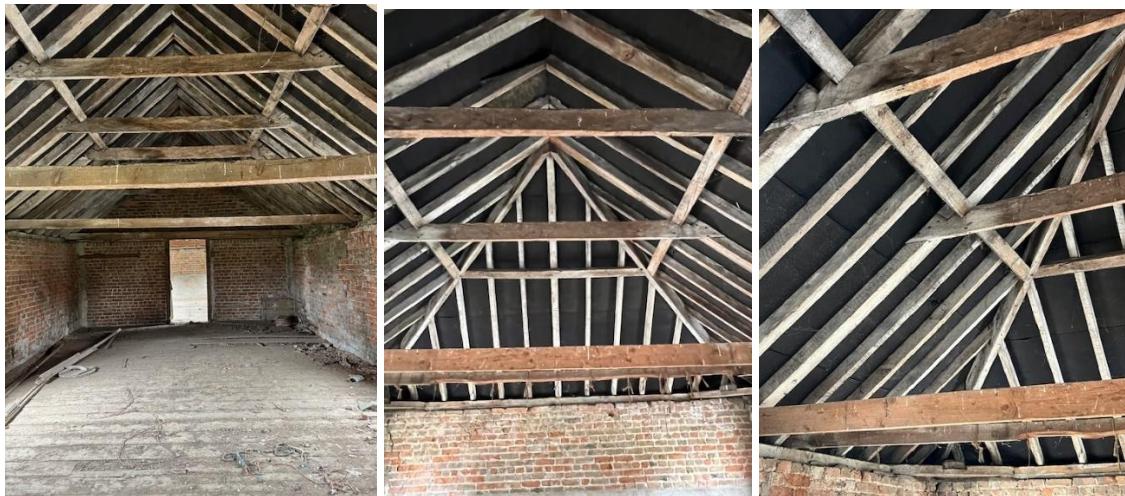
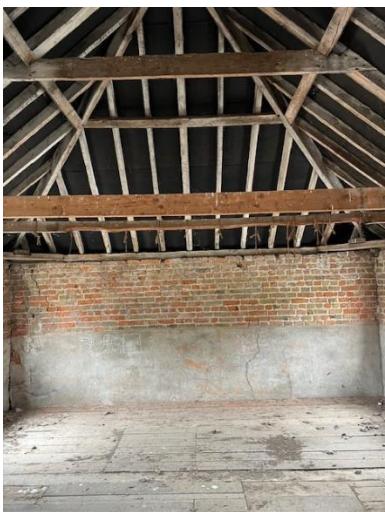
First Floor

Existing Roofing structure to be retained and treated.
New insulation to be used between the rafters and below
the rafters,

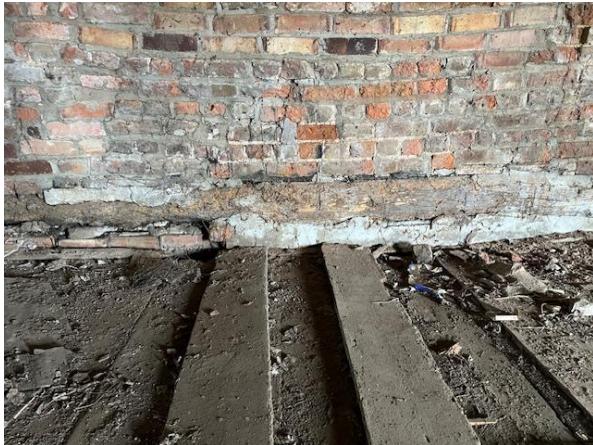
Existing planked floor to be
removed, and replaced with
new boards.

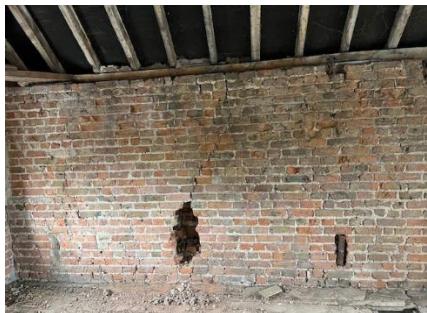
Internals walls to be re pointed, Walls to Have breather/building paper and new insulated stud wall built in front with plaster board finish.
